How is it possible? Why didn't we do anything?
A case history!

H.J. Pasman^{a,*}, R. Grollier Baron^b

Abstract

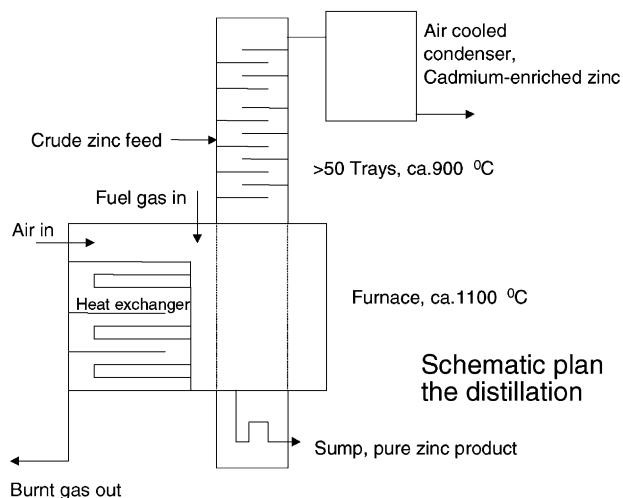
Fig. 1. Plan of a distillation column for the purification of zinc. The operating temperature is around 900 °C.

Contrary to a traditional column, there is no reboiler at the bottom, but the lower part is heated to 1100 °C by burning natural gas in a furnace built around the column, see Fig. 1. The top part is connected to an air-cooled condenser.

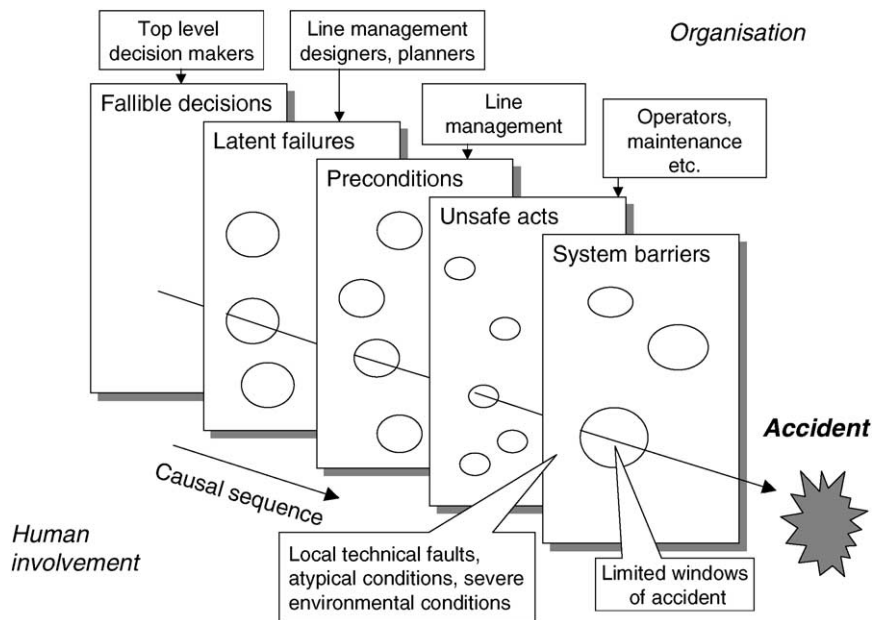
Fig. 3. Windows in the accident causation sequence as seen in the Tripod model (e.g. [2]).

and may be attributed to wrong decisions of designers and planners. Even further in the past there may have been situation resulting in fallible decisions of top-level decision-makers. Unsafe acts are carried out by personnel in direct contact with the equipment or structure, which leads to the accident. The whole sequence is illustrated in Fig. 3.

The plane of breached system defences in this case shows a relatively large window for the occurrence of an accident in the event “furnace exploding”. This occurs because the structure of the column is vulnerable and a relatively small pressure wave destroys the column, resulting in the release of a large amount of zinc aerosol. Therefore control of the furnace in relation with the window of operator unsafe acts is decisive for preventing an accident from occurring. The existing preconditions were also very bad. Stress because of simultaneous incidents elsewhere in the plant and, as we have seen, misperceptions and ignorance increased the risk of the accidents. These preconditions are partly due to latent failures in design and planning of process and procedures. The root causes are the fallible decisions by top management not to implement an integral safety policy and to provide the means and tools for such policy.
