Designs that lacked inherent safety: case histories[☆]

Roy E. Sanders*

PPG Industries, P.O. Box 1000, Lake Charles, LA 70601, USA

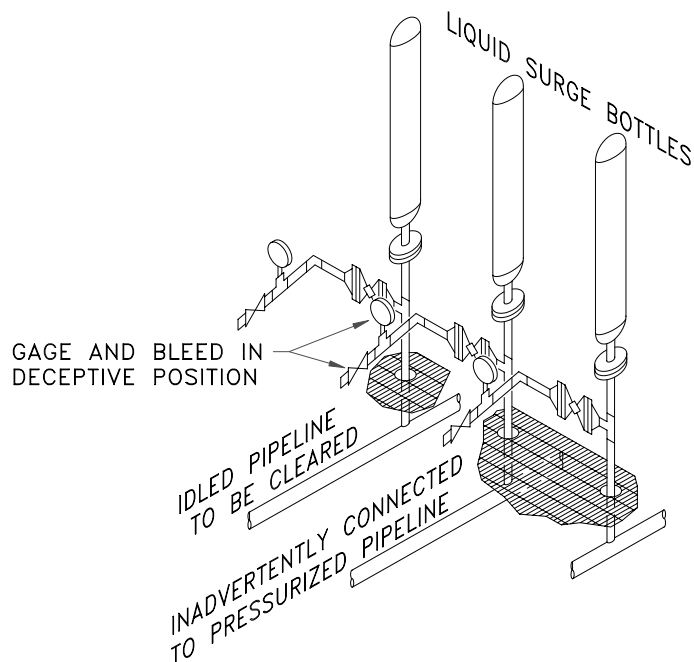
Fig. 1. Pipeline clearing incident.

The piping arrangement under nighttime conditions was deceptive in geometry and camouflaged by the rust colored primer versus the bright yellow colored paint of the adjacent fittings. There were three parallel 2 in. pipelines below the grating on the second level; each line had purge connections that confused the team (see Fig. 1 for details).

Each of the three pipelines had individual 3/4 in. horizontal purge piping connections were equipped with 3/4 in. quick connection fittings for purging. This piping and associated 3/4 in. valves were near the grating level. There were also three 4 in. diameter vertical bottles which were properly labeled. However, the purge connection for the north bottle was directly in front of the middle bottle. The purge connection for the middle bottle was directly in front of the south bottle and the purge connection for the south bottle was not painted the same bright yellow color. Lighting was fair.

Initially fumes were found throughout the area. It was difficult to identify the source of the leak. As a good operator response, the operators stopped the clearing procedure which isolated the source, even though they were unaware of this at the time. Residual acidic gases

Damage to analyzers and instrumentation from the intrusion of acid gases into the instrument air system was extensive. Repair costs were about \$ 300,000.

- The investigating team determined the accident was a result of human error by talented, well-trained, dependable operators. The operator took several steps to change fittings to make the hose connection. The piping arrangement was deceptive in both geometry and paint color. Under nighttime lighting conditions the piping connections are even more misleading.

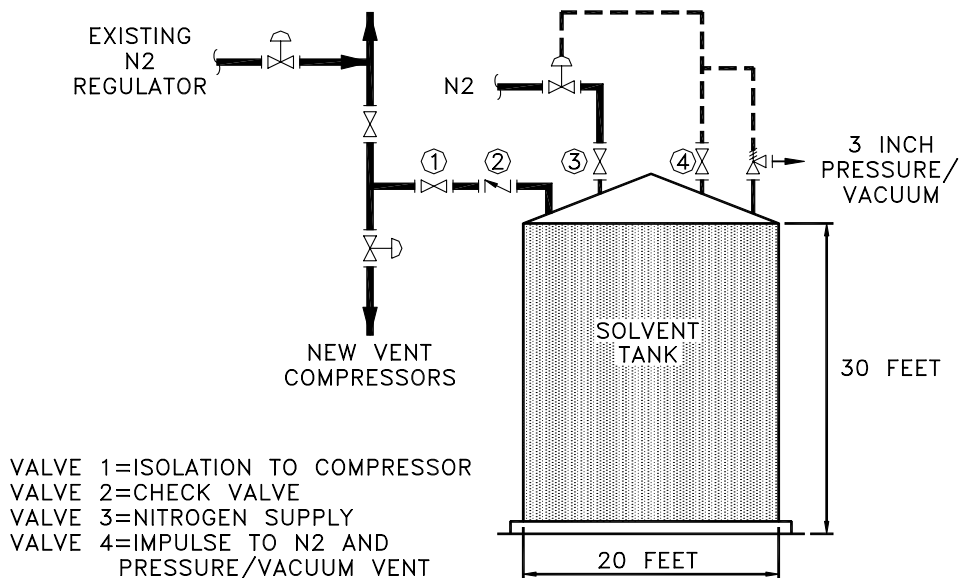
Fig. 2. Blocked impulse valve incident.

A perfectly good low-pressure solvent tank ended up as useless scrap metal after the vent system had been “improved”. This early 1990s mistake cost about \$ 100,000 to correct. Fortunately, there were no leaks and only egos were injured when the 20 ft in diameter and 30 ft tall vessel was destroyed. Prior to the incident, this unit was reducing volatile organic emissions step-wise within a tank farm by replacing simple hinged-breather vents with a more sophisticated nearly zero leakage system [11,12].

With all due respect to the findings of the investigating team, the root cause appears to be an inherent unsafe design. The new piping system looked simple but in fact this unique system was confusing. A check valve was installed on the vent header to prevent cross contamination. A small block valve was installed on the vacuum relief impulse line to provide easy isolation (see Fig. 2 for more details).

A small block valve is usually installed at the tank on any instrument impulse line just in case a leak develops on the small tubing. In this unit block valves are generally avoided on overpressure or vacuum relief devices. If a block valve which can defeat an overpressure device cannot be avoided, such a valve is locked open or car-sealed opened and a

The investigating team made several training and MOC recommendations and decided to eliminate the impulse valve (valve no. 4) connected to the pressure/vacuum vent. The elimination of the impulse valve removed the unintended trap for the operators.
