Learning from what went wrong—two case studies

Rande H. Grotefendt^{a,*}, J. Wayne Chastain^b

1. Case study no. 1: hydrogen contamination of a nitrogen system

2. Case study no. 2: catastrophic failure of maleic anhydride storage tank

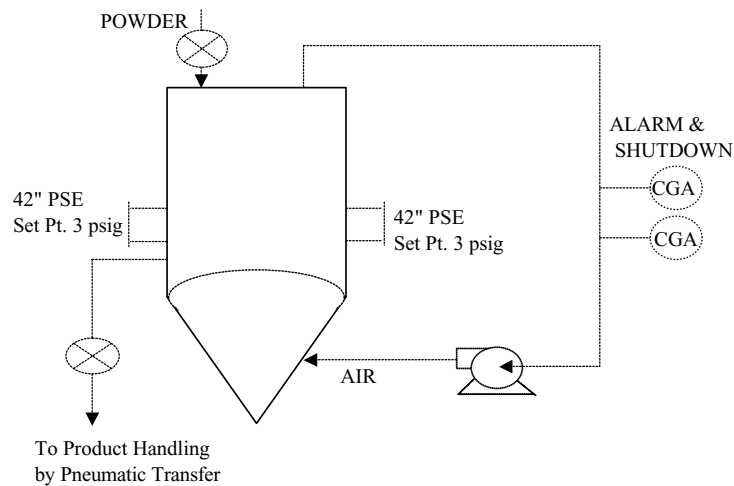
Fig. 1. Degasser piping diagram.

A polymer plant was shut down and was being prepared for maintenance. Hydrocarbon feeds, including the 350 psig hydrogen, were isolated from the process. Nitrogen at 90 psig was connected to the process by procedure to purge residual hydrocarbons out of the piping system and into a vent system. During the next 2 hours, combustible gas analyzers (CGAs) on enclosed cooling water surge tanks and the vents on several other vessels occasionally indicated the presence of flammables. Operators and supervisors responded to those alarms. Manual checks by personnel with portable CGAs did not detect any hydrocarbons in the vessels and no hydrocarbon odors were detected. About 2.5 hours from the start of purging, an explosion occurred in the final degasser and its auxiliary equipment. Automatic sprinklers tripped which extinguished the fire in the degasser. The plant emergency response team deployed fire hoses and eliminated hot spots. No one was injured. The degasser internals sustained significant damage but no appreciable damage was done to the 24,000 gallon vessel. Several auxiliary pieces of equipment were also damaged.

The final degasser normally contained polymer powder in an air atmosphere. Essentially all volatile hydrocarbons are removed from the powder before entering the final degasser. A blower recycled and purged air through the vessel to remove the small amount of residual hydrocarbons to a vent system. As an added precaution, two permanent redundant combustible gas analyzers in the recycle line were calibrated to alarm at 25% of the lower explosive limit of the process gas. The blower had been shut down for the maintenance activity that left stagnant gas by the CGA sensor. The final degasser operated about 1 psig pressure but was rated for 17 psig. Powder is transferred from the last degasser through a pressure lock and a pneumatic transfer system to product handling operations for shipment. Because of the potential for a dust and air mixture in the degassing system, or the inadvertent migration of hydrocarbon vapors entering the degasser from upstream processes, the degassing vessel had two, 42 in. diameter explosion panels set at 3 psig on opposing sides of the vessel (see Fig. 1).

An investigation initiated immediately after the area was declared safe to enter discovered that a nitrogen purge hose had been connected to the wrong side of the hydrogen block valve. This allowed 350 psig hydrogen to flow into the 90 psig nitrogen system. The hose was immediately valved off and disconnected and the nitrogen system was purged and cleared of hydrogen. There was no check valve in the temporary nitrogen connection. At the time of the event, the procedure did not require a backflow preventer because the process was depressured.

Hydrogen has very wide flammable limits (4–75%) and one of the lowest minimum ignition energy requirements (0.01–0.02 mJ). The normal hydrocarbon in the powder has flammability limits of 1–7%. It is believed that hydrogen backed into the nitrogen header, entered the degasser through upstream purging, and found an ignition source. Because of the wider flammability limits and lower minimum ignition energy for hydrogen, it is believed a static charge in the powder ignited the gas.

The powder is very coarse and not easily susceptible to dust explosions. Product quality requirements prevent the accumulation of any fines. Housekeeping in the production area is excellent and there were no accumulated solids that could have been shaken loose by the initial explosion to propagate a more serious event. Small amounts of unburned or charred powder were found in the vessel after the fire. Damage to the vessel was minimized because much of the force from the explosion exited the vessel through the explosion panels. Movement of the vessel by the explosion and exiting gases caused damage to auxiliary equipment. Some structural steel supports near the discharge of the explosion panels sustained enough damage to require replacement. The damage was repaired in the normal shutdown window.

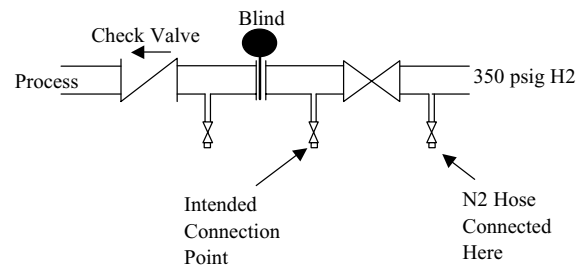
Fig. 2. Piping diagram of nitrogen purge connection points.

Purging of equipment occurs routinely through temporary lines. Trained and conscientious operators still have the potential to make mistakes. In this incident, the operator removed a plug from the wrong drain valve and installed a fitting to allow nitrogen to be connected (see Fig. 2).

With the hydrogen valve locked out, the operator was to purge the downstream header so that the Figure 8 blind could be rolled to isolate the process for confined space entry downstream. This incident occurred because sufficient controls were not in place to protect the system from a human error. The event was mitigated because of the fixed automated sprinkler protection and the relief panels. Designing

1. Procedure was implemented to require force-loaded check valves for backflow prevention for any temporary connection to piping that contains flammables. The check valve must be rated for the highest process pressure that can be seen.
2. Personnel access restrictions were increased at the blowout panels.

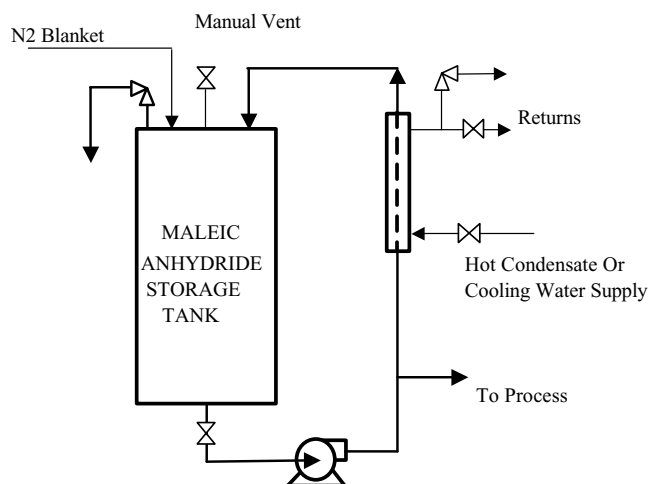
Fig. 3. Simplified diagram of maleic anhydride storage tank.

tank and a discharge line that split with one line going to the process and the second stream being recycled back to the storage tank. MA was continually recycled to keep the storage tank uniform and to provide a constant feed to the process. A stainless steel annular pipe heat exchanger had been added after initial plant startup to the recycle line to remove heat buildup in the tank from the energy added by the recycle pump. The exchanger was capable of using either hot condensate on startup or cooling tower water to remove excess heat during normal operation. The tank had a nitrogen blanket (see Fig. 3).

Efforts to unplug the recycle line focused on locating a suspected cold spot in the piping. Operations had determined that the piping around the pump was cool to touch but the heat tracer controllers indicated the line temperatures were 85–150 °C. The electric tracing controllers were checked and found to be working correctly so the set point for the colder section of pipe was increased. Investigations later showed the controls for the two tracers had been crossed and one section of tracer had been replaced with standard electric tracing that was not temperature limiting. This would allow excess power to heat the line. It is believed that the temperature in the piping reached the thermal decomposition temperature for MA (253 °C). This generated significant pressure from the decomposition gases generated and ruptured the exchanger annulus creating a hole in the inner pipe that was unknown to operations.

Numerous times operations opened and closed the hot condensate supply to the exchanger. Unknown to the operators, each time the condensate valve was opened to heat the exchanger, water entered the storage tank. The water initiated an exothermic hydrolysis reaction that converted

After 2 days, the crossed wiring on the piping heat tracers was identified and corrected. Operations noticed that the storage tank temperature had slowly increased from 90 to 160 °C and assumed the temperature increase was related to a tracing problem and having the temperature probe too close to the tracing. This was re-enforced later that day when the electric tracing contractor confirmed a tank heat tracer problem. The exchanger leak was detected by operations and it was locked out. Operations started developing plans to drain and dispose of tank contents the next day. Previous experience with small amounts of water contamination in tank trucks and other containers had resulted in plugging problems from the formation of the acid but no significant temperature rise had ever occurred.

The next morning the storage tank temperatures were reading above 200 °C when the relief valve opened. An emergency was declared and the emergency response team immediately applied water spray to contain vapors. All electric power was disconnected from the tank and piping, and a manual vent was opened on top of the tank. Actual pressure in the tank was not available because the tank pressure gauge pegged at 70 psig. White vapor exited the relief valve and vent. Due to the venting, pressure reduced in the tank and the relief valve reseated. The manual vent rate appeared to diminish. Suddenly a shrill sound was heard from the relief valve and the atmospheric vent rate increased and the discharging vapors turned from white to black. The insulation bands on the tank began to pop off and personnel were notified to clear the area. Minutes later the tank ruptured throwing debris up to 500 ft away. Significant damage to area piping was sustained. No fire occurred. There were no serious injuries.

Even though operations personnel were aware of the potential hazard of decomposition of MA, they failed to recognize that the hydrolysis reaction and not the heat tracing was causing the temperature to rise. It is theorized when the unreacted water was all vented out of the tank, the heat from hydrolysis increased the MA temperature to the decomposition reaction temperature. System design and previous experience clouded the hazards from personnel. Process heating media were designed to be failsafe and prevent heating MA anywhere close to the decomposition temperature. Cold spots in the line were usually caused by electric tracing problems. When water contamination had occurred in other MA vessels, the quantity was not enough to generate the heat to reach the decomposition temperature. The small amounts of water converting MA to maleic acid created a nuisance operability problem usually solved by a shutdown and several days of cleaning the system.

- The vessel pressure relief system was not designed to handle the decomposition reaction of MA because the following controls were deemed adequate:
 - design and operating temperatures were significantly below decomposition temperatures;
 - heat tracing systems were designed to be failsafe.
- Heat tracing had been changed so a section was no longer failsafe.
- The controllers were crossed during maintenance. When the MA flow stopped, the tracers overheated the MA, triggering a decomposition in the pipe and a rupture in the exchanger annulus.
- A stainless steel exchanger was added after the initial installation that was susceptible to chloride stress cracking.
- The exchanger provided a single source failure to introduce water into the MA to initiate the exothermic hydrolysis reaction that led to the decomposition reaction.

1. The piping design was modified to eliminate the single source failure for inadvertent water addition from the exchanger.
2. The replacement relief device was designed to protect the vessel from the exothermic decomposition reaction.
3. Pressure indicator with greater range was added to the vessel and temperature indication was modified so that there was no interference from the electric tracing.
4. The electrical tracing was replaced with temperature limited tracing. The MOC process was improved in electrical maintenance.
5. Critical electrical wiring and safety notes are now denoted on process and instrumentation diagrams.
6. The set point for the electric tracing was lowered to 65 °C.
7. An independent high temperature shutdown interlock set at 150 °C was connected to each heat tracer.
