Case study
Chlorine transfer hose failure

Giby Joseph*

US Chemical Safety and Hazard Investigation Board, 2175 K Street, NW, Suite 400, Washington, DC 20037, USA

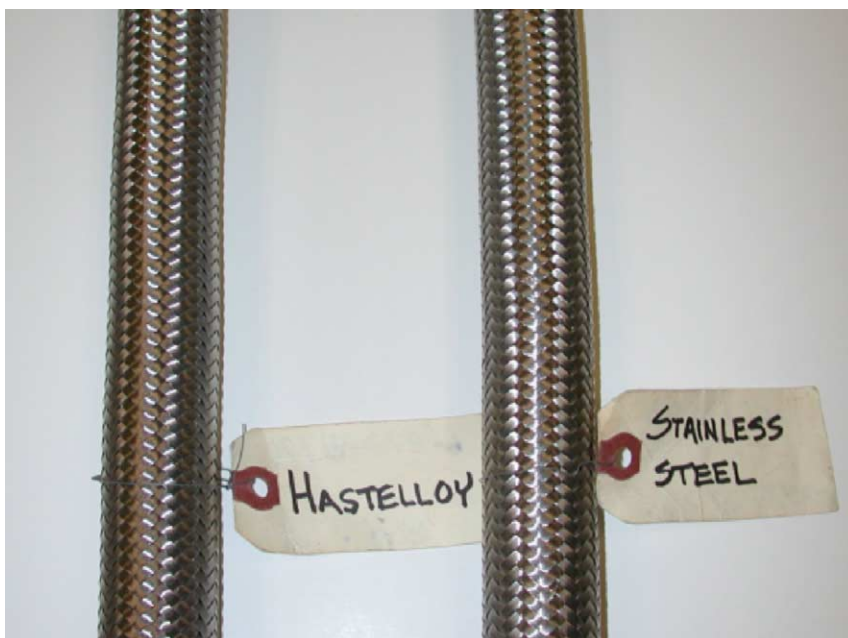
Hastelloy C-276 and 316L stainless-steel structural braiding appear to be identical (see Fig. 1). CSB investigators believe that the inability to visually distinguish these two structural braid layer alloys facilitated installation of the incorrect hose at DPC Festus. In fact, throughout the hose supply chain, there was no adequate mechanism (e.g., color-coding, stenciling, or stamping) to help identify similar looking hoses.

Fig. 1. Identical appearance of Hastelloy C-276 and 316L stainless-steel structural braiding.

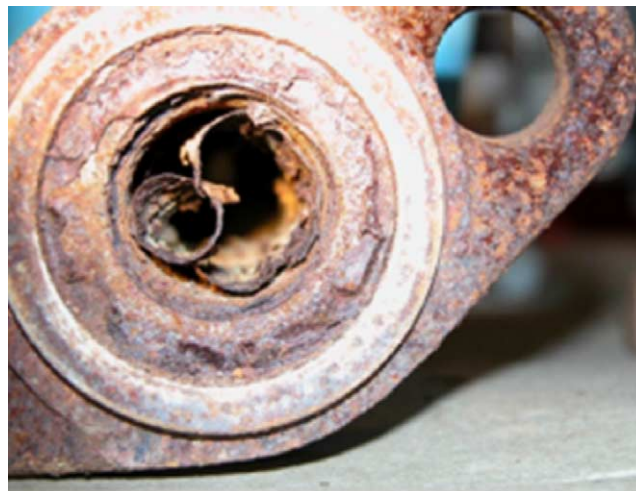
CSB concludes that the emergency shut down valves did not close because of the buildup of corrosion products around valve balls. Inspection of the repackaging system revealed evidence of corrosion within the pad air supply and tank car unloading assemblies, as well as in parts of the facility liquid and pad air carbon steel piping (Fig. 2).⁵ These corrosion products readily migrated to the valves.

CSB identified three possible sources of the corrosion-producing moisture:

Fig. 2. Corrosion buildup in chlorine repackaging piping system.

- Pad air used to provide pressure for the transfer of liquid chlorine from the tank car.
- Ambient moisture intrusion into the piping.
- Wet chlorine in the tank car.
