## Environmental hazard analysis and effective remediation of highway seepage

Risk assessment and minimisation of environmental hazards are critical issues to consider in the geotechnical engineering projects. A case of highway pavement seepage induced by groundwater, at a locality along the section of Hua-Qing Highway of Guangdong Province, China, is presented for environmental hazard analysis and effective remediation. The environmental hazard analyses were based on in situ hydrogeologic investigation, rock–soil testing and integrated environmental understanding. The analyses indicate that the highway seepage was caused by elevation of groundwater hydraulic pressure in low permeable strata near the highway pavement, which was controlled by landform, hydrology, weather and road structure. The risk source of groundwater ‘flooding’ was the groundwater and surface water in the ring-like valley around Fenshui Village. A blind-ditch system for effective remediation of the pavement seepage hazard was proposed and successfully implemented by declining groundwater table near the highway based on the comprehensive assessment of various conditions. This geotechnical accident shows that the

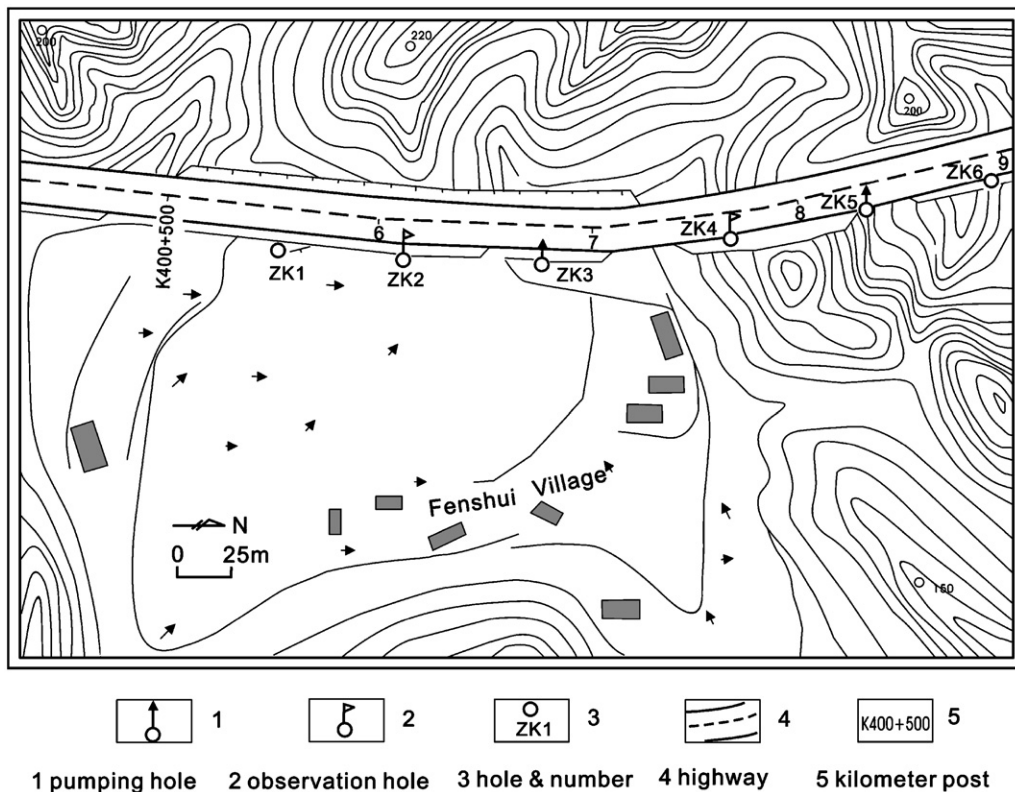
The study area is located in Fenshui Village, Huadu City, Guangdong Province (Fig. 2). The hills around the village with elevation of between 200 and 300 m, belongs to the hilly landform. The hilly hypsography varies in elevation of 50–100 m in this area.

Fig. 2. The landform, locality and investigation of the highway seepage.

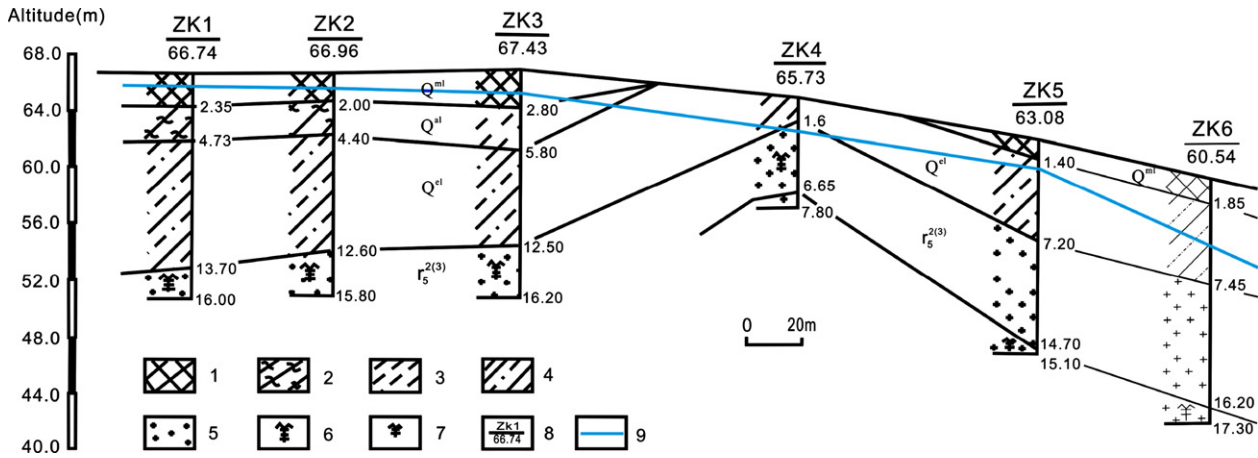
In order to observe the subsoil conditions and obtain representative samples, six investigation boreholes were drilled along the seepage section of the highway (Fig. 2). The geotechnical profile was divided into four layers from the top to bottom of the boreholes (Fig. 3). Details are described as below:

Fig. 3. Cross-section of the engineering geology obtained from the field investigation: 1, made ground; 2, mucky clay; 3, silty soil; 4, gravel clay; 5, granite; 6, well-weathered; 7, medium-weathered; 8, no. of borehole and height; 9, groundwater table.

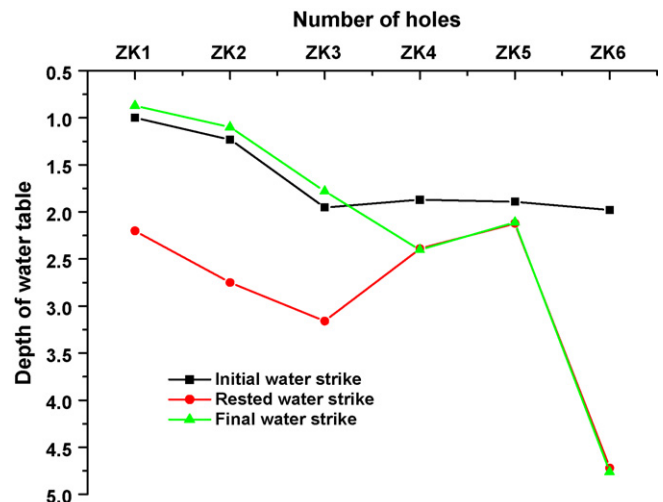
The depth of water table was measured carefully during drilling the boreholes. The results are listed in Table 1. ZK1, ZK2 and ZK3 have not been sunk to the medium weathered zone of granite. From the depth (mbgl) of water table (Fig. 4) and corresponding elevations in meter above datum (mAD) (Table 1), it is known that the initial water strikes are lower than those of the rested water strikes, which indicates that there is no

Fig. 4. Diagram showing the profiles of groundwater level (mbgl).

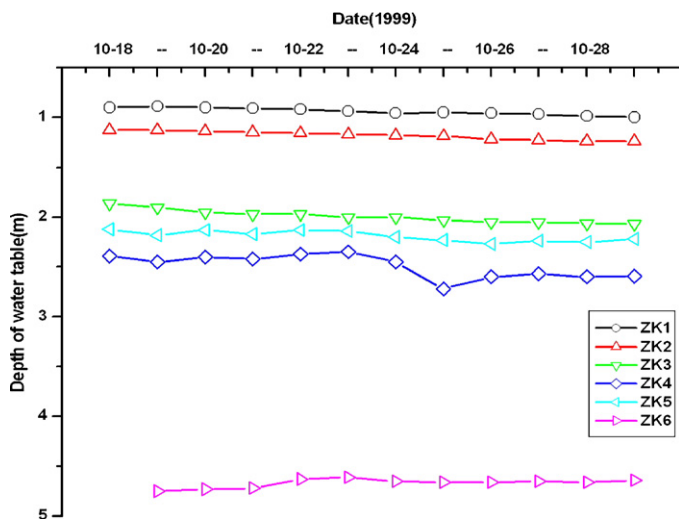
The permeability of the well-weathered granite is relatively large in the study area (Table 3). It is a water rich layer with specific flow of  $q=206.25 \text{ m}^3/\text{d m}$ . The monitored groundwater head in this layer is about 2.1–4.8 m with some fluctuation (Table 4 and Fig. 5), which is lower than the phreatic ground water level. The groundwater pressure of the confined water in the fissured granite is 43.0–125.8 kN. The groundwater recharge

Fig. 5. Groundwater hydrographs of the investigation boreholes (mbgl).

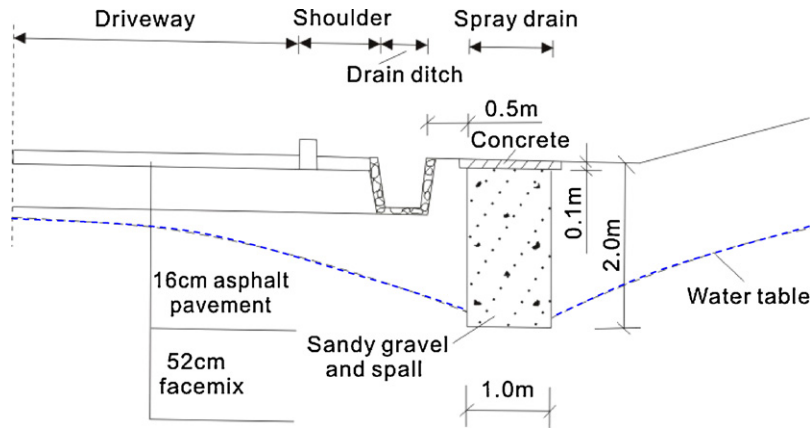
Fig. 6. Design of the blind-ditch system for the effective remediation.

The close pavement elevation to that of the valley bottom, the cracks and fractures of the highway pavement and abundant recharge from rainfall provided essential environmental conditions for the seepage problem in this case. When groundwater table or confined head rises to or over the pavement, seepage will occur under hydraulic pressure. As such seepage is directly connected with groundwater and characteristics of subbase soil, it is key point in remediation to cut off the hydraulic connection between groundwater and the subsoil of near and underneath the highway. For surface water, the drainage system has been constructed in either sides of the highway and can be drained properly. Therefore, the main aim of remediation method was to effectively decline groundwater table at the site.

Therefore, drawdown of groundwater table was adopted as the best remediation option to solve this environmental hazard in this project. With consideration of all factors above, a blind-ditch system was proposed in this highway section for remediation of the pavement seepage by draining groundwater away. Detailed design of the system is illustrated in Fig. 6. Along the K40 + 500–K41 + 100 section, the blind ditches were designed and constructed at the outsides of the highway drain,

0.5 m apart. The dimension is 2.0 m deep, 1.0 m wide, and the longitudinal gradient of the ditches is greater than 2% to secure the proper drainage. The blind ditches were filled by scree and gravels and covered by 10 cm thick concrete pre-constructed boards on the top, which can prevent surface water flows in directly. These designed blind ditches can discharge groundwater straight away to the lower gradient areas and change original hydraulic regime so that the drain system can effectively prevent the highway seepage. As a result, an artificial depression of water table was formed near the highway permanently. Therefore, even in the raining seasons, groundwater table in the upper gradient side cannot rise to the elevation to produce highway seepage. The blind-ditch system keeps the subgrade of highway dry by drawdown of groundwater table and cut-off the water flowing from the fissures of hillslope in the upper catchments to the highway subgrade. As the open drains have been designed and constructed outside of the road shoulders, there was no influence on road operation for normal traffics during the remedial construction. The geotechnical problem was solved by such a simple and practical engineering action with small workload and low cost on the basis of investigation and understanding of the hydrological, hydrogeological and other conditions. The environmental hazard caused by the highway seepage was hence diminished.
