# Environmental stress-corrosion cracking of fiberglass: Lessons learned from failures in the chemical industry

T.J. Myers<sup>a,\*</sup>, H.K. Kytömaa<sup>a</sup>, T.R. Smith<sup>b</sup>

<sup>a</sup> Exponent Inc., 21 Strathmore Road, Natick, MA 01760, USA

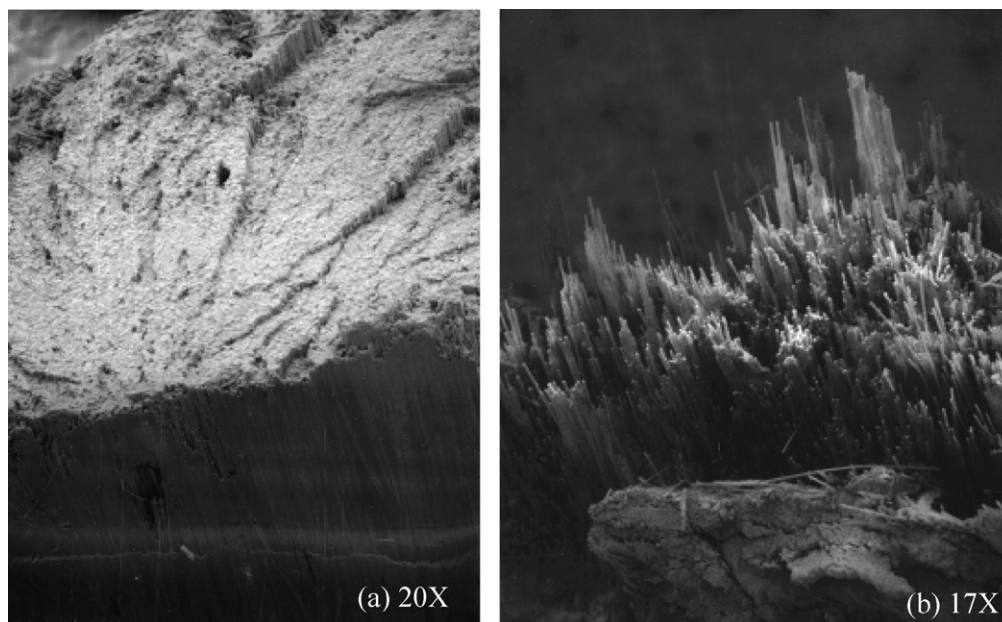
Fig. 1. (a) On the left is a photomicrograph at 20× magnification of the ESCC fracture surface of a failed beam in an FRP grating. The fracture exhibits a smooth, planar surface and the glass fibers are even with the surface of the resin matrix, characteristic of ESCC. (b) On the right is a photomicrograph at 17× magnification of the fracture surface of an exemplar grating beam that was mechanically overloaded. The fracture surface exhibits an irregular surface and broom like structures from fiber pull out from the resin matrix, characteristics of mechanical overload.

fracture surface in Fig. 1b is rough with broom like structures due to glass fiber pull out from the resin matrix. The fracture surfaces of most individual fibers are distributed significantly above and below the fracture surface of the resin matrix.

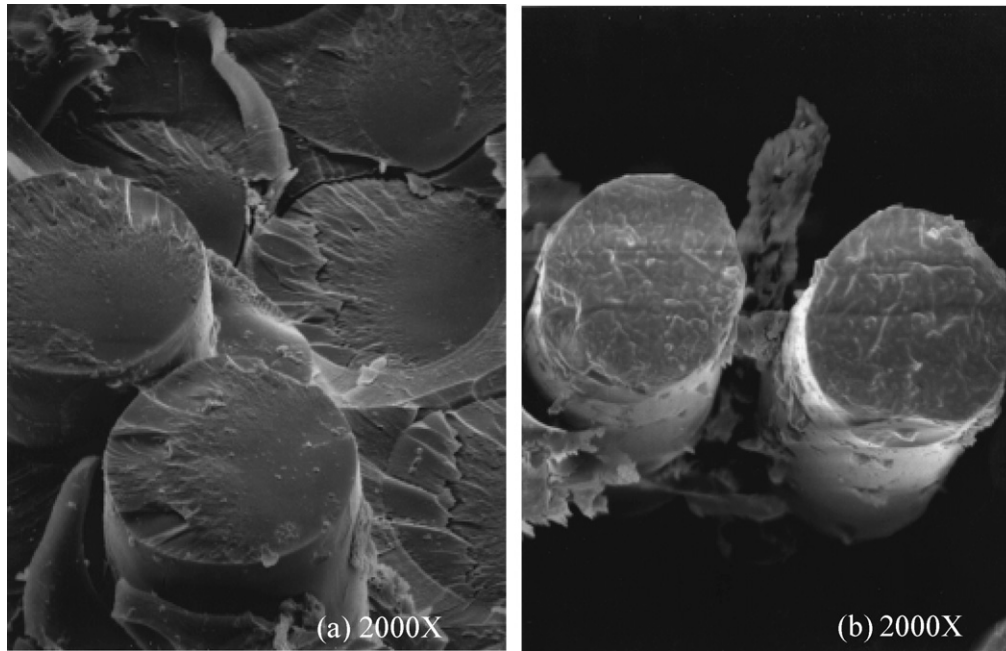
Fig. 2. (a) On the left is a photomicrograph of individual fibers from the ESCC fracture surface in Fig. 1a at 2000 $\times$  magnification. The ESCC failure mode creates fracture surfaces on individual fibers with mirrored smooth regions and hackles. The mirrored regions are visible on the right hand side of fibers in the figure. The hackles, present on the left hand side of fibers in the figure, transition into river lines in the resin matrix. (b) On the right is a photomicrograph of individual fibers from the mechanically overloaded fracture surface in Fig. 1b at 2000 $\times$  magnification. This failure mode creates rough fracture surfaces on the fibers and the fracture surfaces appear significantly above and below the resin matrix fracture surface due to fiber pull out.

Higher magnification images of these fracture surfaces are shown in Fig. 2 where fracture surfaces on the individual fibers are visible. The fibers on the ESCC fracture surface in Fig. 2a shows two regions on each fiber: a flat mirror region, which results from slow crack growth in the fiber, and a second region of rougher radial ridges (hackles), which are caused by rapid crack growth when the fiber finally fails. The hackles transition into river lines within the resin matrix. In contrast the fracture surface on the mechanically overloaded fibers in Fig. 2b do not have mirror regions but only rough surfaces indicative of fast fracture growth. In ESCC fracture surfaces, the mirrored regions are larger where the stress was lower during crack propagation and smaller where the stress was higher [7]. For a propagating crack, stress is typically lowest near the origin of the crack and becomes larger as the crack propagates and the original load is being supported by a smaller cross-section of material [8]. Hence, larger mirrored regions will typically be found near the fracture origin. As will be shown in one of the case studies, fibers that continue to be exposed to an acid environment after fracturing may exhibit axial, longitudinal, and radial cracking [9].

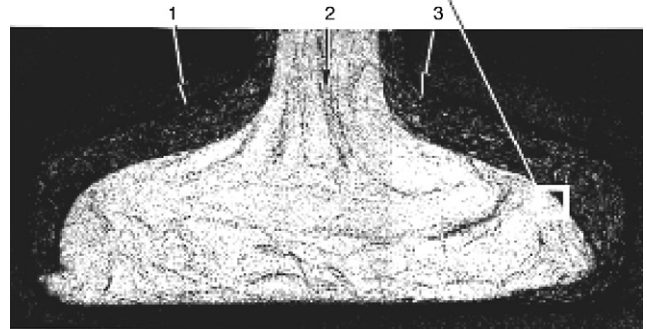
Cross-sections of undamaged regions of beams were examined and a photomicrograph of the bottom or tension flange of a beam is shown in Fig. 5. The beams were created using a pul-

Fig. 5. Photomicrograph of bottom tension flange of I-beam. Resin lean region is labeled 2 and contains structural glass fibers. Resin-rich layers labeled 1 and 3 are present on top and sides of tension flange, but not on bottom of tension flange.

trusion process and consisted of a central section of continuous structural E-glass fibers aligned along the length of the beams. A protective resin-rich layer labeled 1 and 3 in the figure was present on the sides of the beam and the top of the bottom tension flange. However, this resin-rich layer was not present on the bottom of the tension flange or the top of the compression flange. Fig. 6 schematic shows the location of the protective layer on the beams. The lack of a protective layer on the bottom of the tension flange was significant because this is the maximum tension stress location in the loaded beams. As a result,

the structural E-glass fibers under tension were exposed to acid causing ESCC to occur. Although the resin rich protective layer was also missing on the top flange of the I-beam, this flange was not subject to ESCC because it was in compression.

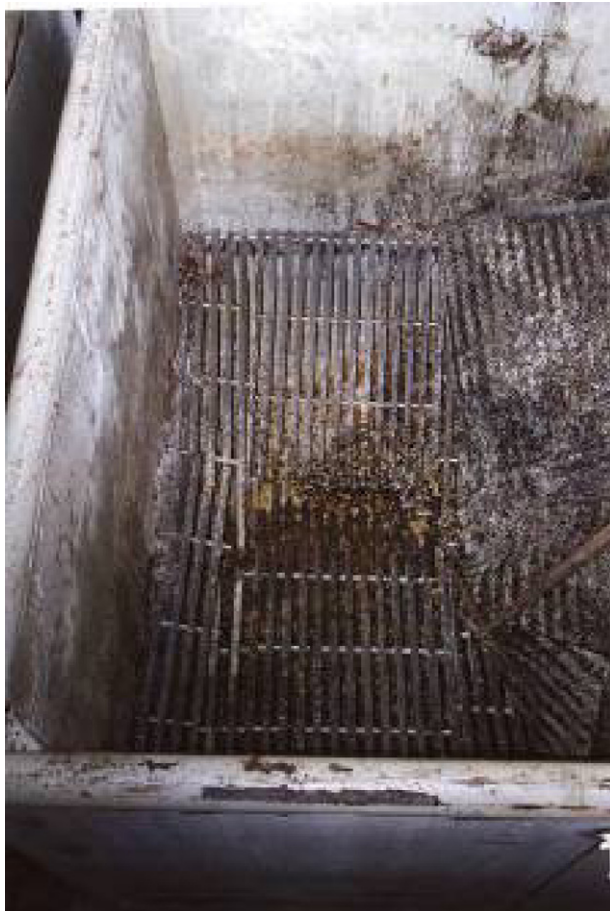
After opening the chambers and removing the biological media, it was found that the fiberglass gratings had failed at mid-span as shown in Fig. 4. The fracture surfaces were examined with a scanning electron microscope (SEM) and were previously shown in Figs. 1a and 2a. These fracture surfaces had the distinct characteristics of ESCC and so it was necessary to determine why these beams had been susceptible to ESCC.

Fig. 4. Grating beams fractured at mid-span in biological media chambers.

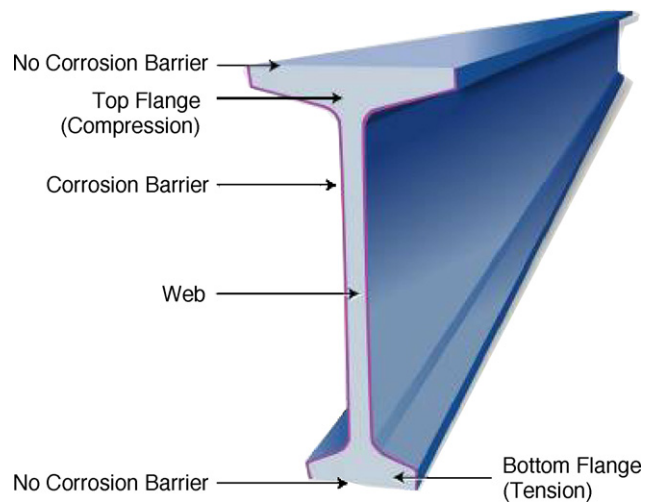
Fig. 6. Schematic of cross-section of grating beams. Corrosion barrier is present on web of beams but not on the upper surface of the top flange or lower surface of the bottom flange.

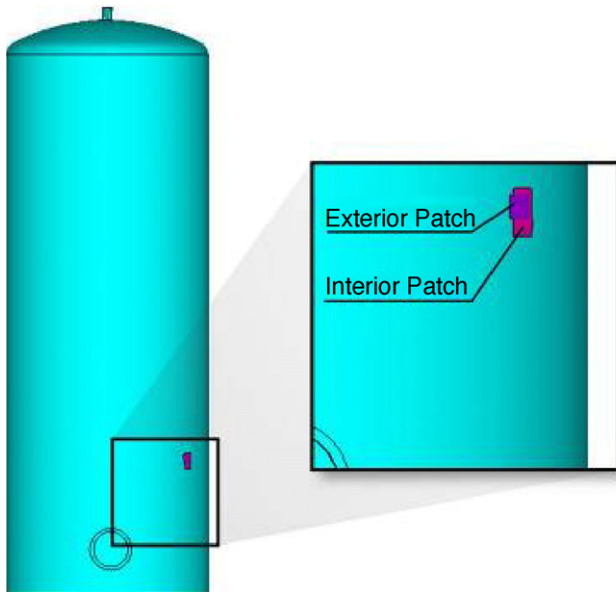
A 43,000 gallon tank, 37 ft tall and 14 ft in diameter was in use in a tank farm to store acid solutions with HCl concentrations ranging from 5 to 17%. After 1.5 years of use a small leak from the tank shell was observed approximately 8–10 ft from the bottom of the tank. The tank manufacturer was called to patch the tank and reported finding a 3" × 6" star-crazing in the interior 100-mil corrosion liner in the area of the tank leak. The damage was claimed to have been caused by a point loading impact. During a later inspection it was noted that several star-crazing marks and linear scratches in the corrosion liner were present in other regions of the interior of the tank. Chopped mat and resin patches were field bonded to both the tank interior and exterior to arrest the leak. It was reported that the technician applying the patch had not completely ground out the crack, but merely scuffed the surface of the area of the leak before applying the patch. The locations of the interior and exterior patches are shown in Fig. 8. The inner patch covered a larger area of the tank than the outer patch.

Fig. 8. Location of interior and exterior patches on tank.

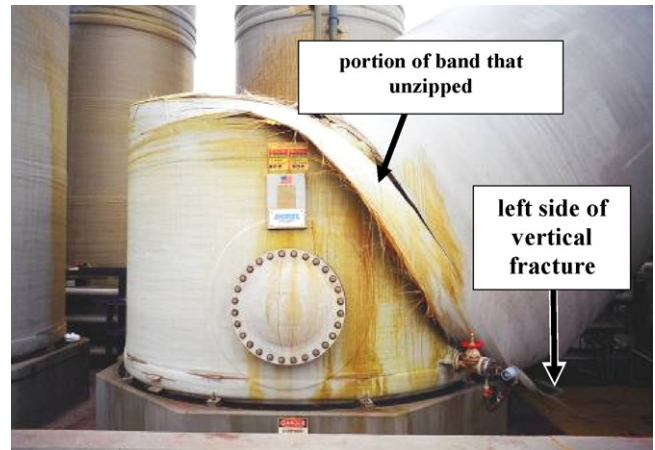
Fig. 10. Close-up view of bottom of collapsed tank. The band that unzipped circumferentially and the post incident location of the left side of the fracture surface are visible in the photograph. The right side of the fracture surface is not visible in this photograph.

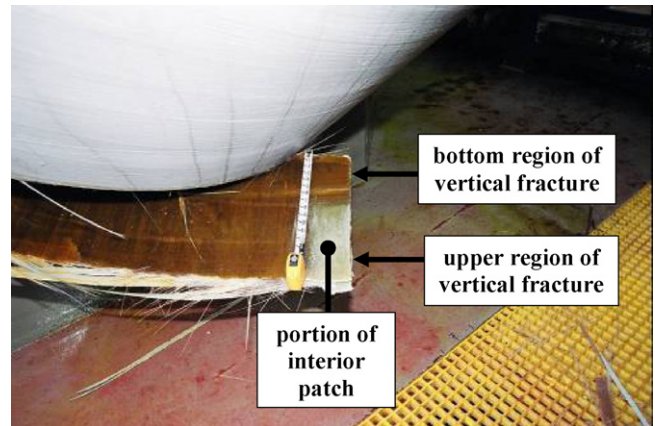
Fig. 11. Left side of initial vertical fracture. The interior side of the band of the tank wall that unzipped circumferentially, is visible in the photograph. Portion of interior tank patch is visible on upper region of vertical fracture.

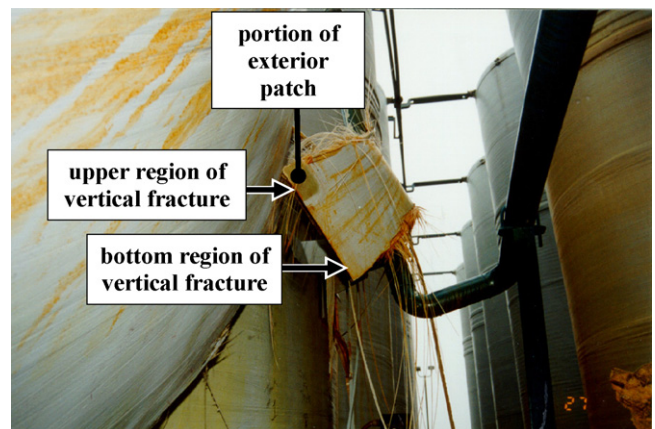
Fig. 12. Right side of initial vertical fracture still attached to tank. The exterior side of the band of the tank wall that unzipped circumferentially is visible in the photograph. Portion of exterior tank patch is visible in upper region of the initial vertical fracture.

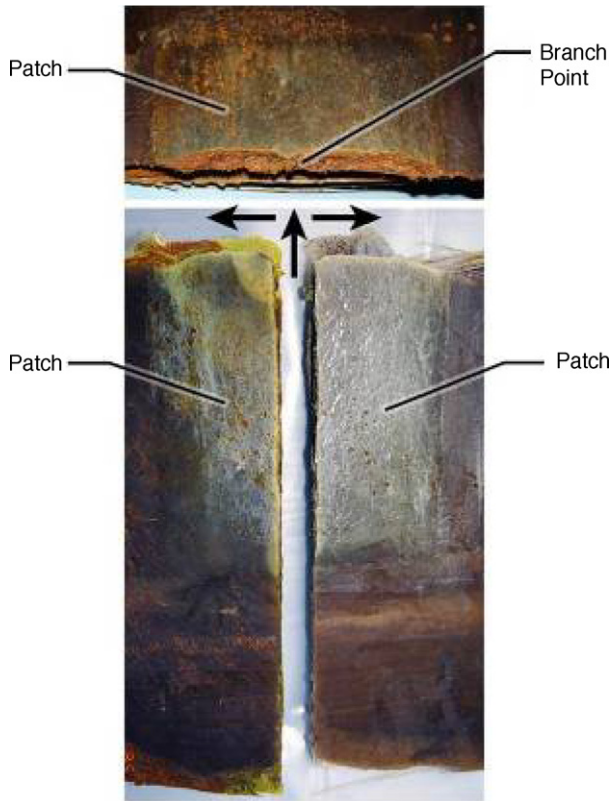
Fig. 13. Interior view of mating portions of tank wall near initial vertical fracture. The three portions of the original interior patch are visible near the intersection of the three surfaces. The vertical fracture surfaces in the figure correspond to the vertical fracture surfaces shown in Figs. 11 and 12. Note that the upper patch shows crack branching, where the vertical crack transitioned into two horizontal cracks. This clearly demonstrates that the origin of the cracking is in the vertical portion of the fracture. The black arrows indicate the branching of crack propagation at the top of the fracture surfaces.

branching and traveling horizontally. The relatively smooth, planar vertical fracture surfaces that lacked fiber pull out suggested ESCC as a failure mechanism. SEM examination of the fracture surfaces was used to further investigate the cause of the failure.

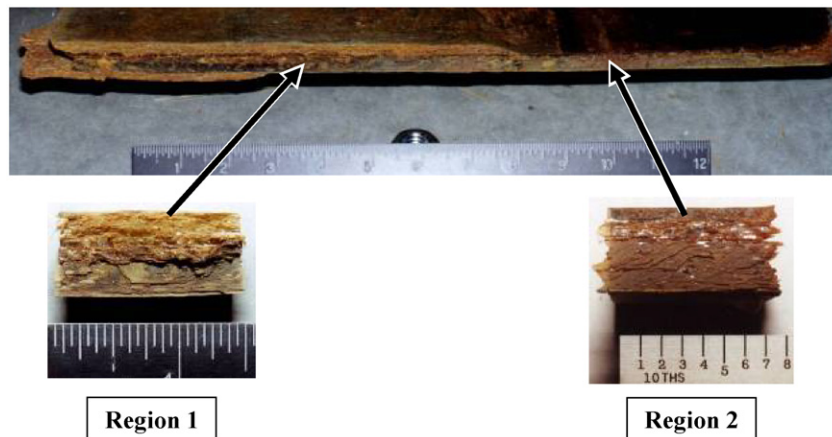
Samples removed from two regions with and without patches along the length of the vertical fracture surface on the right side of Fig. 13 are shown in Fig. 14. SEM images at increasing magnification are shown for each region in Figs. 15 and 16. The fracture surfaces exhibit characteristics of ESCC as described in the figure captions. However, each region has unique characteristics indicating crack growth from inside the patched region, region 1, and propagating beyond the patch through region 2. The fractured fibers in region 1 show significant cracking indicating they received long-term exposure to acid after their initial failure. Region 2 shows characteristics of ESCC, without additional cracking of the fibers indicating it had occurred more recently. Additionally, the location of mirrored regions on the left hand side of fibers in region 2, indicate that the crack propagated from top to bottom of the tank through this region (left to right as oriented in Figs. 14 and 16).

Fig. 14. Cross-sectional view of the vertical fracture surface on the right side of Fig. 13. Location of samples taken from two regions along the length of the fracture surface. Portions of interior and exterior patches are visible on the left hand side of the photograph. The orientation of the samples in the photographs correspond to the top of the tank being to the left and the interior of the tank being up in the figure.

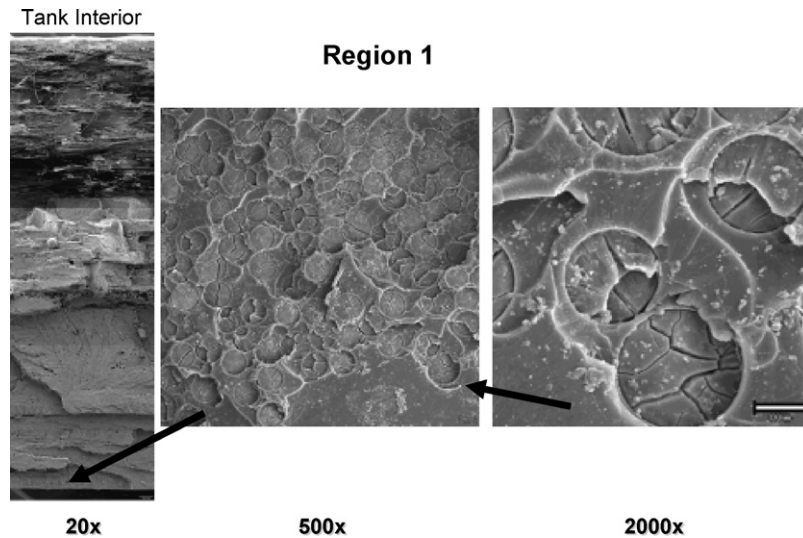
Fracture surfaces indicate failure by ESCC. Cracking within fibers indicates long-term exposure of fibers to an acid environment after the initial failure.

Fig. 15. View of fracture surface in the patched region, region 1, near the origin of the ESCC cracking. Image on left is the entire cross-section of the wall, images in middle and right are higher magnification views of regions indicated with arrows. The orientation of the samples in the photographs correspond to the top of the tank being to the left and the inside of the tank being up in the figure.

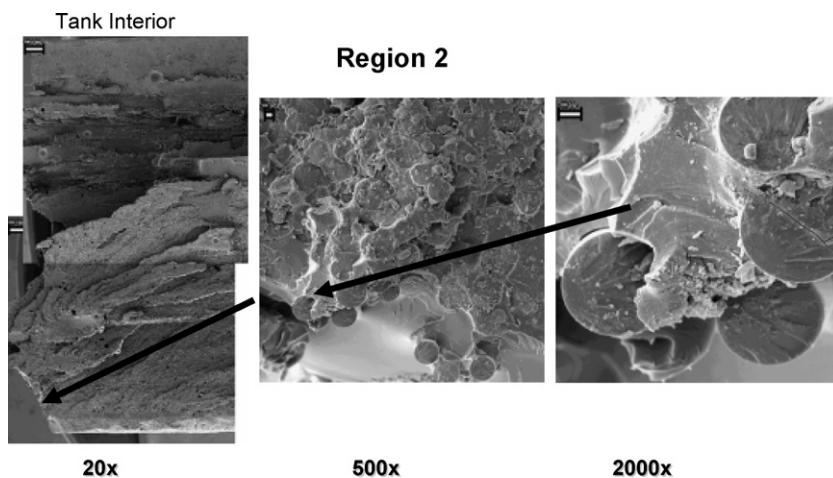
Fig. 16. View of fracture surface in region 2 away from the patch and the origin of the ESCC cracking. Image on left is the entire cross-section of the wall, images in middle and right are higher magnification views of regions indicated with arrows. The orientation of the samples in the photographs correspond to the top of the tank being to the left and the inside of the tank being up in the figure. Fibers show mirrored regions and radial hackling transitioning into river lines in matrix indicating failure by ESCC. Note also that the mirror zones in right hand photograph are on the left side of the fibers, indicating that the origin of the ESCC cracking is to the left of this location on the fracture surface, i.e. the fracture initiated to the left of region 2 in Fig. 14.

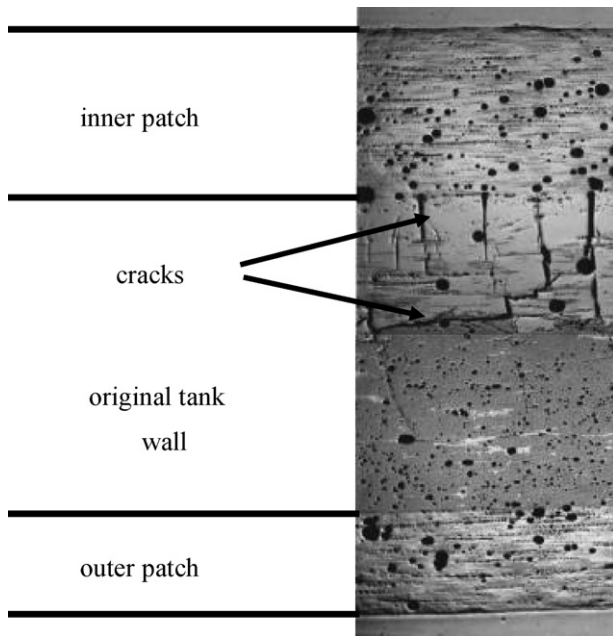
A photograph of the tank wall cross-section through the patched region is shown in Fig. 17. Cracks are present in the interior of the tank wall that end abruptly at the location of the interior patch indicating they were present before the patch was applied. This confirms that the technician who applied the patch had not fully ground out the damaged region of the tank before applying the patch.

The purpose of a repair patch as applied to a fluid storage tank is to restore both the fluid tightness and the structural integrity at the location in the shell that has been damaged or suffered a breach of the wall. A repair patch restores fluid tightness by supplying a complete seal around the breach. Structural integrity is restored by adequately creating a new path for the forces transmitted through the tank wall that circumvents the region of the breach. The patch applied to the tank only temporarily restored the fluid tightness of the tank without addressing the underlying structural damage to the tank.

Fig. 17. Cross-section of tank wall. The orientation of the sample in the photographs corresponds to the top of the tank being to the left and the inside of the tank being up in the figure. Cracks were present in the tanks inner corrosion barrier and tank wall before the patch was applied.

The preferred method for patching a damaged composite is to use a tapered or scarfed joint [15]. Scarfing the tank wall exposes, and provides a means for the repair patch to adhere

directly to, a complete cross-section of the tank wall reinforcement. This provides a relatively direct transfer of the forces in the tank wall into the patch. In the absence of scarfing, the patch merely adheres to the surface of the tank wall, creating an inferior connection with regard to strength and stiffness. Scarfing also serves to reveal the complete cross-section of the damage region, providing a means of assessment of the full extent of the damage.
