Runaway chemical reaction exposes community to highly toxic chemicals[☆]

Mark Kaszniak^{*}, John Vorderbrueggen

U.S. Chemical Safety and Hazard Investigation Board, 2175 K Street NW, Washington, DC 20037-1809, United States

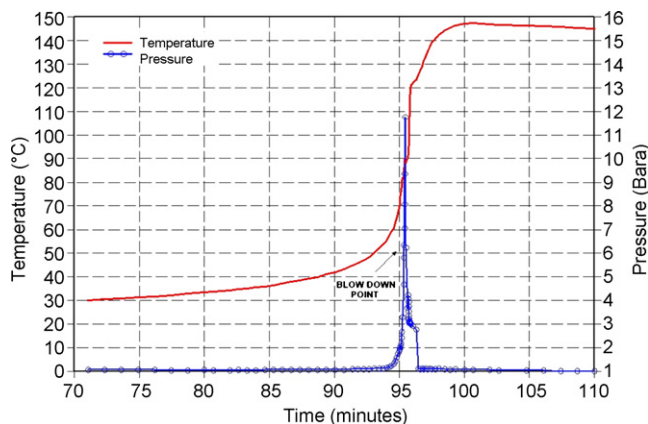
Fig. 1. Test cell reaction mass temperature and pressure as a function of time. The reactor rupture disc opened at six bara (75 psig).

The adiabatic calorimetry testing of the TAC recipe demonstrated the extremely energetic nature of the reaction. The tests showed that the reaction progressed very slowly for about 90 min, after which the temperature rapidly increased at a rate exceeding 500 °F/min (260 °C/min) with a pressure rise rate approaching 2260 psi/min (155 bar/min) (Fig. 1). Testing confirmed that the decomposition reaction is highly energetic and capable of causing severe damage to equipment.

Even with only a portion of reagents available for the reaction, the heat produced quickly exceeded the heat removal capacity of the reactor cooling system. The increase in temperature then caused the un-reacted allyl alcohol to boil, pressurizing the reactor. The temperature continued to increase above the TAC decomposition temperature. This caused a rapid increase in gas production, further increasing reactor pressure until the incorrectly torqued manway gasket blew out. The vent rate through the manway was not sufficient to keep the reactor pressure below the rupture disc setpoint, and the pressure in the reactor increased until the disc ruptured a few seconds later. The maximum reac-

tor pressure reached was thus at least 75 psig (five barg), the set point of the rupture disc. The peak reactor pressure during the runaway reaction could not be determined.^{13, 14}

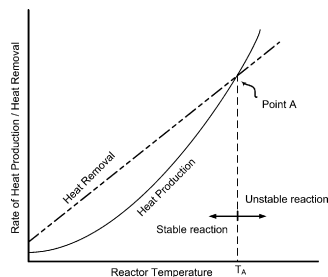
Fig. 2. Typical reaction heat production and cooling system heat removal versus reactor temperature.

control the reactor temperature and, as the temperature rose, the TAC decomposition reaction began to dominate, resulting in a runaway reaction. The increasing pressure blew out the manway gasket, and then the rupture disc. The vapor continued venting for many hours, until the reaction consumed all the reactants.
