Evaluation of Service-Induced Damage and Restoration of Cast Turbine Blades

C. Persson and P.-O. Persson

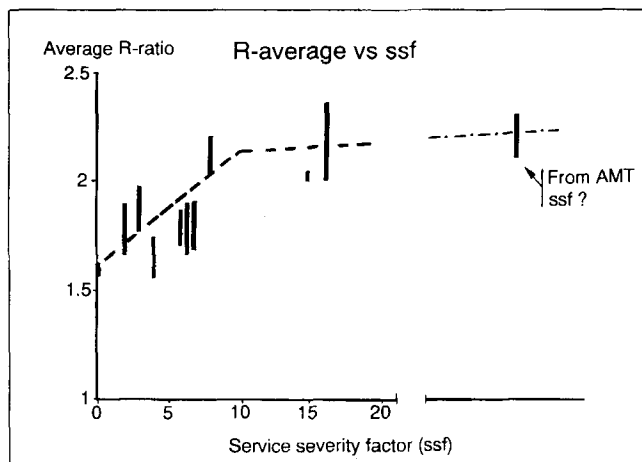
Fig. 1 Average R ratio measured at trailing edge versus service severity factor (ssf).

Evaluation by elliptic projection yields an average R ratio of approximately $R = 1.5$ for virgin blades. Up to a service severity factor of 8 to 10 (equals approximately 600 to 800 service hours for average engines), γ' elongation increases to approximately $R = 2.2$. Higher ssf values provide no further increase in average R ratio. This indicates that the equilibrium γ' raft level is reached, within approximately 700 service hours under the conditions regarding stress and temperature prevailing at the trailing edge.

At equal service exposure levels, a relatively broad scatter in R ratio is evident in Fig. 1, indicating differences in stress and temperature exposure for individual engines and blades during service. Scatter in R calculation as well as batch dependence probably also influences the R ratio scatter at constant service exposure levels.

The trend found in Fig. 1 makes it clear that using the R ratio, measured at the trailing edge, as a tool for lifetime prediction has little relevance, because the equilibrium R ratio level is reached at a service exposure where approximately 50 to 70% of the creep-rupture life (see section below on remaining creep life) of the blade still remains. For this reason, further investigations were initiated to evaluate the R ratio in other areas of the blade, i.e., middle and leading edge position. To attain a better resolution of obtained data, the fraction of γ' particles with R ratio ≥ 2.0 was calculated. In Fig. 2, this parameter is plotted versus increased service exposure (ssf) for trailing edge, middle, and leading edge positions of a few serviced blades.

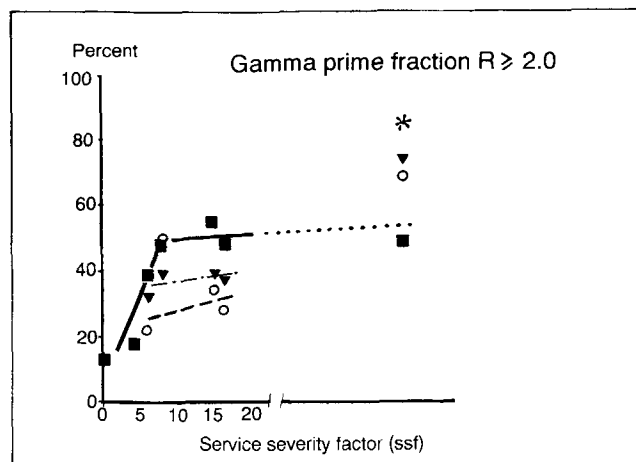
Fig. 2 Fraction of γ' particles with R ratio ≥ 2 versus ssf. Measured at trailing edge (■); midposition (○); leading edge (▼); creep test at 160 MPa (*).

Figure 2 illustrating the trailing edge measurements reveals the same trend as shown in Fig. 1, reaching an equilibrium γ' raft level at relatively moderate service exposure.

However, the middle and leading edge positions exhibit a slower increase in γ' elongation at low and intermediate ssf values. The AMT blades with considerably higher ssf values also exhibit a higher equilibrium level for γ' elongation at the leading edge and middle position. The fraction of highly elon-

The higher γ' raft values at the middle and leading edge positions imply a different combination of stress and temperature in those areas compared to the trailing edge. The results are based on very few data points, and more data should be evaluated to estimate the significance. However, the data suggest the possibility of establishing a damage parameter based on γ' elongation that is better matched to the total blade life than the R ratio measured at the trailing edge.

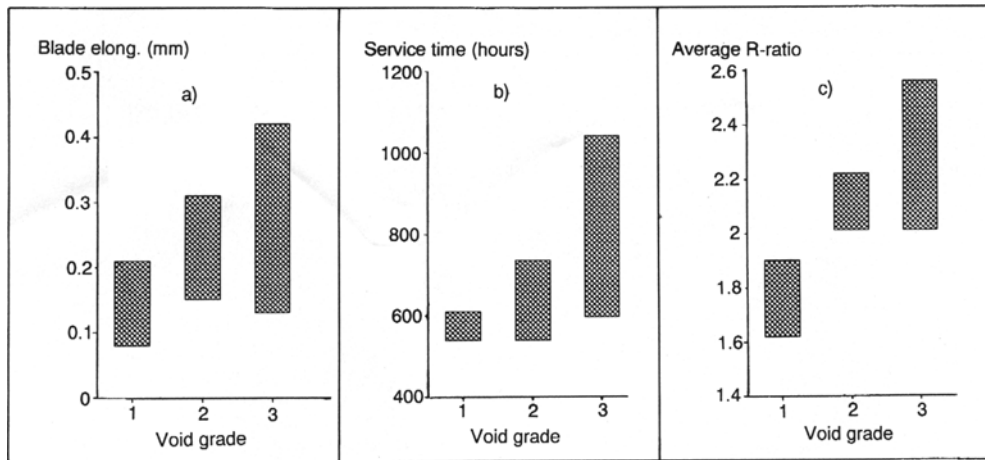
Fig. 3 Correlation of void grade to total blade elongation (left), service time (middle), and average R ratio at trailing edge (right).

The results were correlated to total blade elongation, running time, and average R ratio and are shown in Fig. 3.

Generally, all of the correlated parameters increase with increasing void grade, although extensive overlapping exists between the void grades. Accumulated creep damage according to void grade 3 (worst case) is represented by an interval in blade elongation of 0.13 to 0.42 mm and service times between 600 to 1040 h. These results indicate that severe creep damage is evident at the trailing edge even at moderate blade elongation and service times.

Regarding γ' elongation, no void formation occurred at R ratio levels below $R = 2.0$. On the other hand, the R ratio interval for void grade 2 is completely overlapped by grade 3, although grade 2 exhibits a lower average R ratio level. This is consistent with the results presented in Fig. 1 and 2 and suggests that the equilibrium γ' raft level is not reached until the accumulated creep damages have increased to void grade 2.

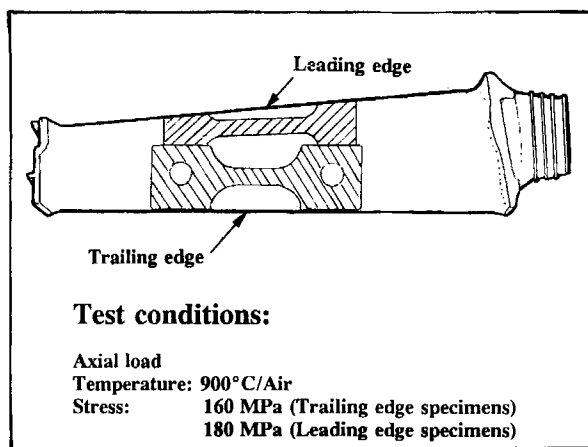
Fig. 4 Location of creep specimens and test conditions.

Specimens were taken from areas with a high degree of microstructural degradation near trailing edge and from less affected areas near leading edge according to Fig. 4. Twenty-one specimens from service exposed blades and (as reference) six

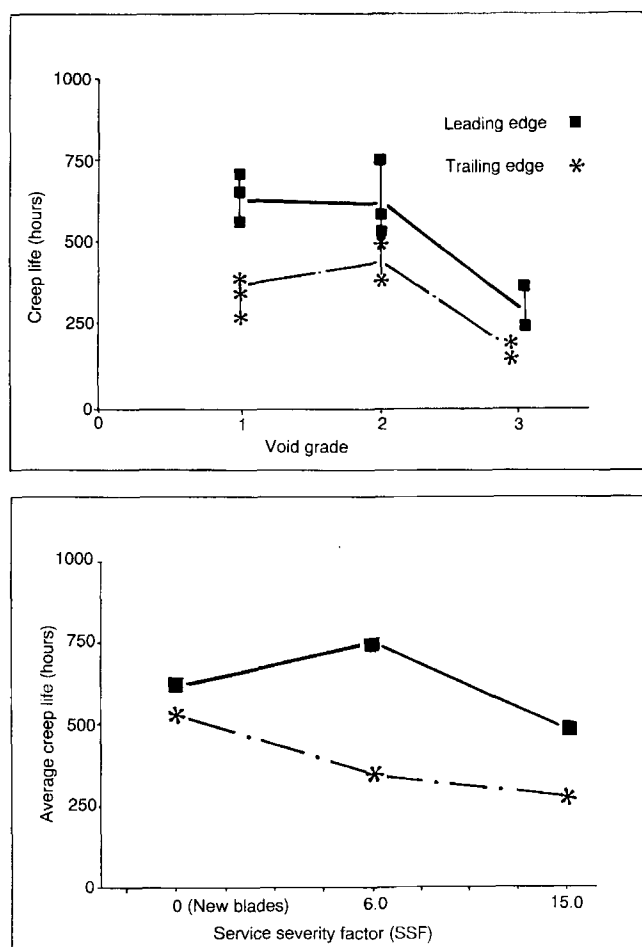
**Fig. 5** Comparison of residual creep life at trailing and leading edge versus void grade (above) and ssf (below).

Residual creep life at the trailing and leading edge positions has been evaluated based on void grade at the trailing edge and service severity factor, according to Fig. 5. At void grade 3 and high ssf values, creep life is reduced to 55% at the trailing edge and to 74% at the leading edge, compared to virgin blades. At the trailing edge, a substantial reduction in residual creep life is evident even at intermediate ssf values. This is because void grade 3 is represented among the tested specimens from intermediate ssf values.

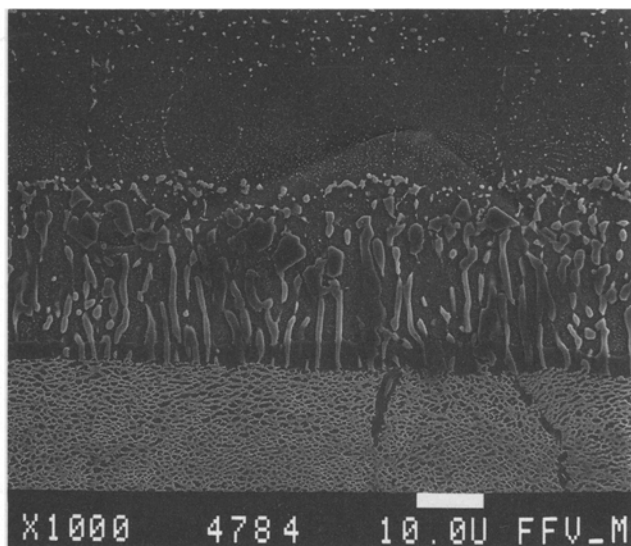
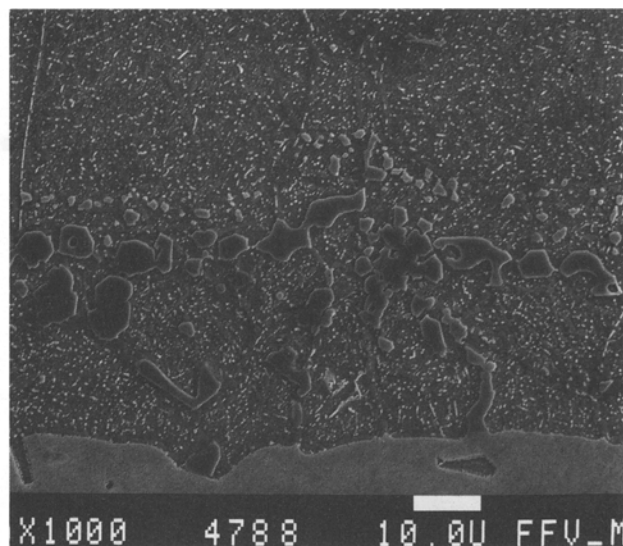
Fig. 6 Normal coating diffusion zone (left) and degraded coating diffusion zone after rejuvenation treatment (right).

The most significant effect on the coating during the rejuvenation process was the degradation of the diffusion zone. The normal and typical needle-like phase (Fig. 6) transforms to a blocky chromium-rich phase (presumably $M_{23}C_6$). The same type of degeneration has been observed^[6,7] for similar types of aluminide coatings in high-temperature aging tests. The degeneration of the diffusion zone to blocky carbides is also reported to detrimentally affect sulfidation resistance.

A subsequent overcoat process did not fully restore the coating microstructure. The blocky carbides precipitated during the rejuvenation process still existed, although minor re-precipitation of the needle-like phase was observed in the diffusion zone.
