# Analysis of Failed Nuclear Plant Components\*

D.R. Diercks

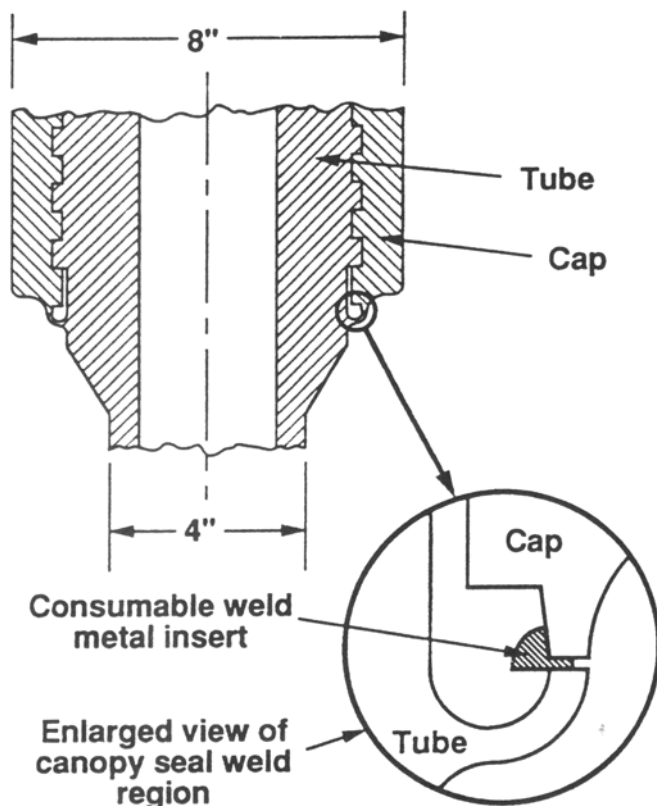
**Fig. 1** Schematic of portion of control rod drive head adapter tube assembly, showing enlarged view of canopy seal weld region.

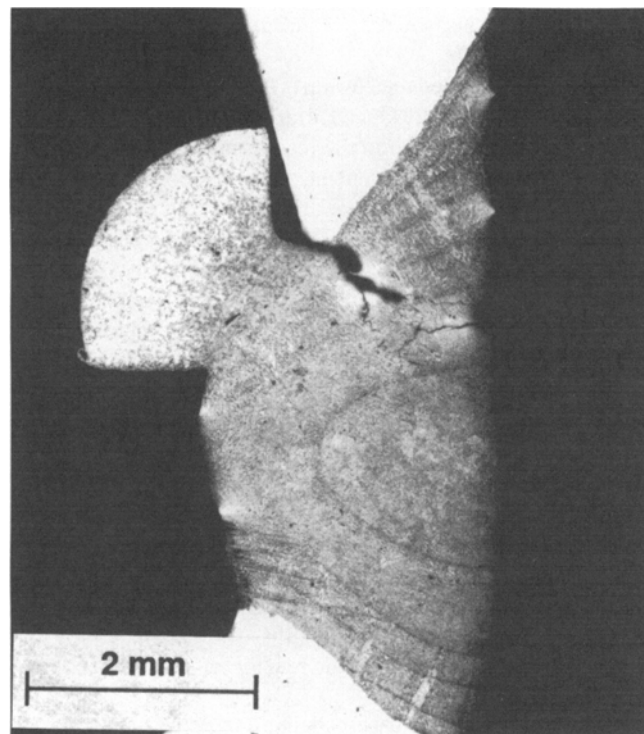
**Fig. 2** Appearance of failed weld region, with incomplete fusion of consumable weld metal insert.

insert is completely fused and blends smoothly into the adjacent base metal. In contrast, the appearance of a failed weld region is shown in Fig. 2. The insert is incompletely fused, and a crack has initiated at the resulting crevice between the unfused portion of the insert and the tube base metal below the insert. This highly branched crack completely penetrated the weld metal at this point, resulting in a leak. Similar cracks were observed at other locations in the welds where incomplete fusion

It was concluded that the observed crevices between the consumable weld metal inserts and the base metal were produced by failure to maintain the welding electrode exactly on the center line of the weld joint, thereby causing one side of the insert to be incompletely fused during the welding process. The resulting crevice provided a suitable environment for the buildup of corrosive species, particularly  $\text{Cl}^-$  and  $\text{SO}_4^{2+}$ , and also sometimes served as a point of stress concentration. These factors combined with the residual stresses from welding to cause the austenitic stainless steel base and weld metal to fail by TGSCC. It has been shown that dissolved sulfate levels as low as 0.1 to 1 ppm can significantly accelerate stress-corrosion cracking at 200 to 300 °C (390 to 570 °F) in lightly sensitized austenitic stainless steels in the simultaneous presence of 0.2 ppm dissolved oxygen.<sup>[11]</sup> Dissolved oxygen levels are normally much lower than this in PWR coolant systems, but higher levels of both oxygen and  $\text{Cl}^-$  and  $\text{SO}_4^{2+}$  can develop in crevices. The aggressive environment that was present in the crevices is indicated by the apparent attack of the unfused consumable weld metal insert opposite the main crack.

Subsequent seal weld failures have been repaired with an Inconel 625 weld overlay, and a video inspection is made of the welds during each plant outage to detect any additional failures. Because these components are located in a high radiation field, these inspections and repairs must be done remotely.

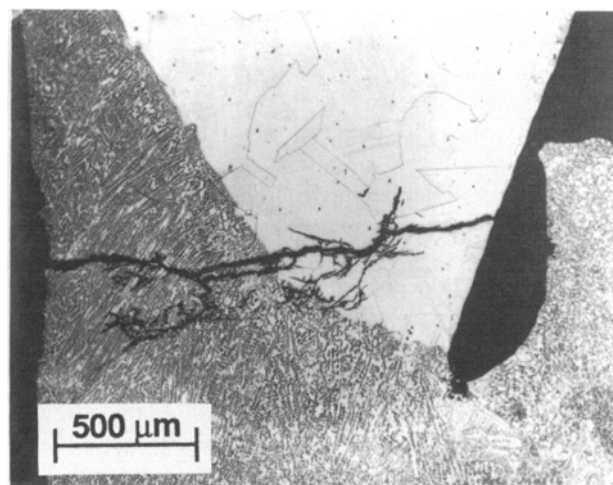
**Fig. 3** Transgranular crack that initiated in base metal in crevice region.

Figure 3 shows a location where a crack apparently initiated in the base metal in the crevice region rather than at the root of the crevice. This crack then grew transgranularly through the base metal and then through the adjoining weld metal. Minor attack of the unfused consumable metal insert opposite the main crack can also be seen in Fig. 3.

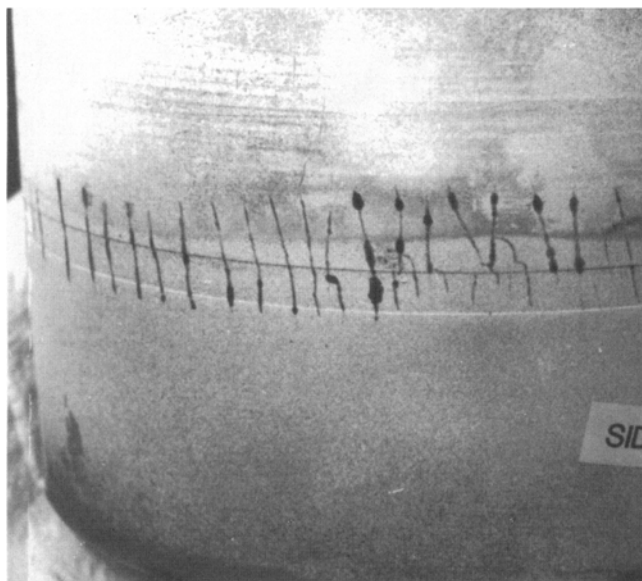
**Fig. 4** Axial cracks on recirculation pump shaft revealed by dye-penetrant examination.

A dye-penetrant examination was performed after decontamination, and typical results are shown in Fig. 4. The relief groove at the end of the shaft keyway is visible, and extensive cracking was evident around the entire circumference of the shaft in the vicinity of this groove. The cracks were relatively uniform in length, with a typical length of 13 to 19 mm (0.5 to 0.75 in.). They were typically spaced ~6 mm (0.25 in.) apart on this side of the shaft and slightly farther apart on the opposite side. Of the approximately 75 cracks detected, essentially all were axial in orientation, except for the few small circumferential components shown in Fig. 4.

A diffuse, wavy circumferential line marking the lower boundary of the chromium surface plating may also be seen in Fig. 4 immediately above the relief groove. The region above this line is plated, and a portion of the cracking lies within this region. The shaft was sectioned circumferentially near the center of the relief groove. This cut intersected the majority of the axial cracks near their midpoint. A second cut was then made ~20 mm (0.75 in.) above the first, producing a disc-shaped slice that contained approximately half the length of the majority of the cracks present. This slice also included most of the boundary between the chromium-plated and unplated portions of the shaft.

It was concluded that the cracking observed on the pump shaft was produced predominantly by thermal fatigue, although stress-corrosion cracking may have made a minor contribution in some regions. This conclusion is supported by the appearance of the cracks, most of which were relatively straight, had sharp tips, and were generally free of gross oxide buildup. It is further supported by the presence of apparent fatigue striations on the fracture surfaces, particularly in the crack tip regions. In addition, the relatively uniform orientation, spacing, and depth of the cracks suggests that the cyclic stresses responsible for the fatigue were thermal in nature. Finally, the service conditions of the shaft were conducive to thermal fatigue.

Several strategies have been developed to deal with this problem. The pump shafts are being monitored for cracks using mechanical vibration and mechanical resonance techniques, and cracks are weld repaired as they are discovered. In some cases, the transition region of the pump cover has been modified to reduce the thermal gradient responsible for the cyclic stresses. In addition, the surfaces of new and repaired shafts are being shot peened to produce residual compressive stresses before they are placed into service.

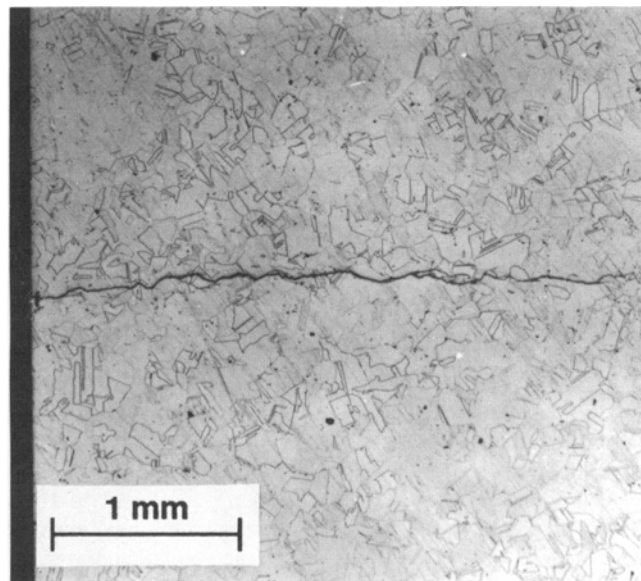
**Fig. 5** Metallographic cross section of cracked region in BWR recirculation pump shaft.

Two pie-piece segments, each of which included ~50 mm (2 in.) of the shaft circumference, were cut from this slice and again examined by dye-penetrant to determine the depth of the cracking. The typical depth was found to be ~2 to 3 mm (0.08 to 0.12 in.), and the maximum depth observed was ~4 mm (0.16 in.). Optical metallography showed the cracks to be transgranular and straight, and most exhibited very little branching (Fig. 5). At higher magnifications, the crack tips were sharp, and the cracks were relatively free of oxide. In a few instances, moderate crack branching was observed, with oxide-filled secondary cracks. The chromium plating apparently did not contribute to or influence the nature of the cracking. No significant grain boundary sensitization of the shaft material was observed, and the ASTM grain size was typically 2 to 3.

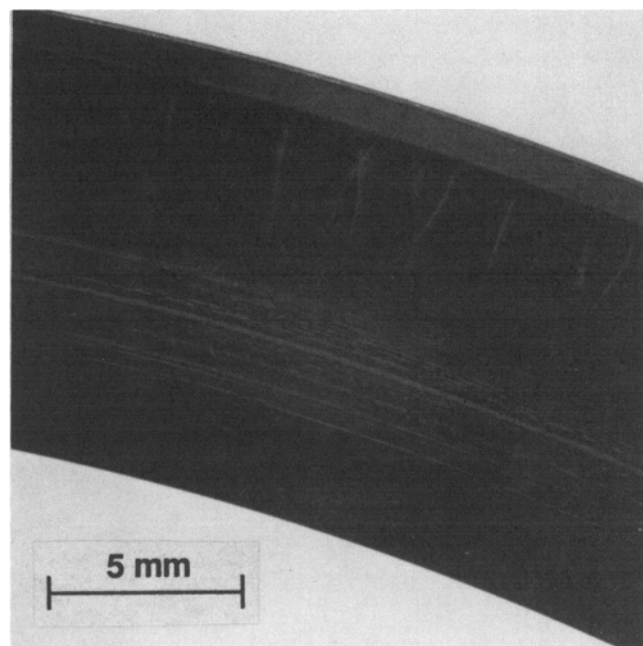
**Fig. 6** Damage observed on the sealing face of a failed wear ring.

Figure 6 shows the sort of damage observed on the sealing face of a failed ring. The circular grooves and surface roughening observed on this face have a maximum depth of ~130  $\mu\text{m}$  (0.005 in.), which is far in excess of the design tolerance on flatness for this surface. The fine parallel radial cracks mentioned above are also visible.

The solution to this problem appears to be the use of an alternate material for the wear ring. The other commonly used binder phase in cemented WC composites is cobalt, but its use in nuclear plants is precluded because of concerns about cobalt dissolution in the coolant and subsequent activation in the reactor core to <sup>60</sup>Co. Monolithic ceramic wear rings are presently being explored as an alternative to cemented WC.

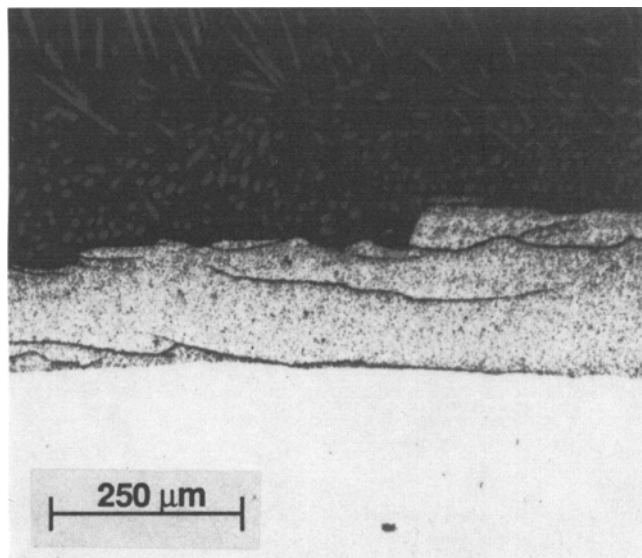
**Fig. 7** Nickel-depleted porous regions (light gray area with cracks) present at damaged surface of failed wear ring.

A metallurgical cross section through this region of surface roughening reveals the microstructure shown in Fig. 7. A porous, cracked layer ~20  $\mu\text{m}$  (0.001 in.) thick is visible, although in some regions its thickness was as great as ~150  $\mu\text{m}$  (0.006 in.). Energy-dispersive X-ray analyses reveal that these porous regions are depleted in nickel. The nickel binder phase is apparently dissolving or being leached out of the composite, leaving a porous mass of WC particles that are rather easily dislodged. This process leads to the surface roughening and grooving observed, and further damage is produced by the abrasive action of the extremely hard WC particles. The fine cracking appears to be caused by thermal stresses created by the heating of the ring after surface roughening and the resulting breakdown of the lubricating water film.

oxygen has been experimentally determined to be about 2.5 to 5.0  $\mu\text{m}/\text{year}$  (0.1 to 0.2 mils/year) under dynamic conditions.<sup>[13]</sup> However, other data have indicated that substantially greater corrosion rates can be expected under conditions of high dissolved oxygen,<sup>[13]</sup> such as may occur in BWR coolant trapped in a crevice. In addition, it has been observed<sup>[14]</sup> that surface passivation of nickel may not occur in acidic and neutral water at temperatures in excess of 100 °C (212 °F). Some acidification of the solution trapped in the crevice between the wear rings is possible under static conditions because of hydrolysis effects and the buildup of impurity species in the crevice. Loss of passivation by the nickel would leave it more susceptible to general corrosion and to galvanic corrosion in contact with the mating graphite ring.
