Investigation of Fatigue Failure of a Stainless Steel Orthopedic Implant Device

M. Sivakumar, U. Kamachi Mudali, and S. Rajeswari

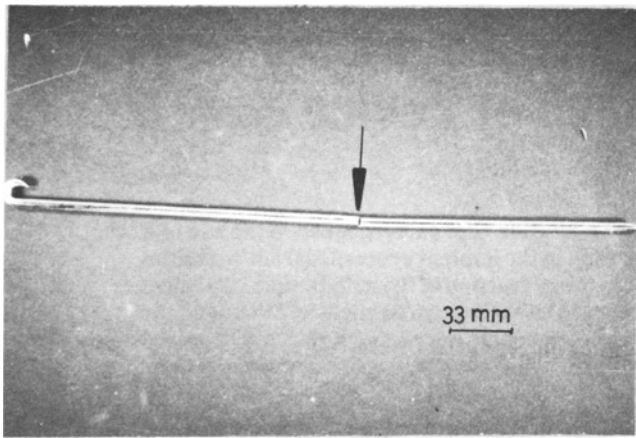
The rush nail (INOR, India) currently is used as a fixing device for the treatment of fractures. In the present study, fracture of the left femur of a 62-year-old patient was internally fixed with a rush nail. Three weeks later, the patient complained of severe pain in the vicinity of the implant site. Moreover, the patient required physical assistance to walk. Hence, radiographs were taken of the implanted region. The radiograph revealed that the nail had fractured. The fracture on the nail coincided with the location of the previous fracture of the bone. The fractured nail was removed (Fig. 1) and was subjected to failure investigation.

Fig. 1 Photograph of fractured rush nail. The unbalanced arrow indicates the fractured site of the implant.

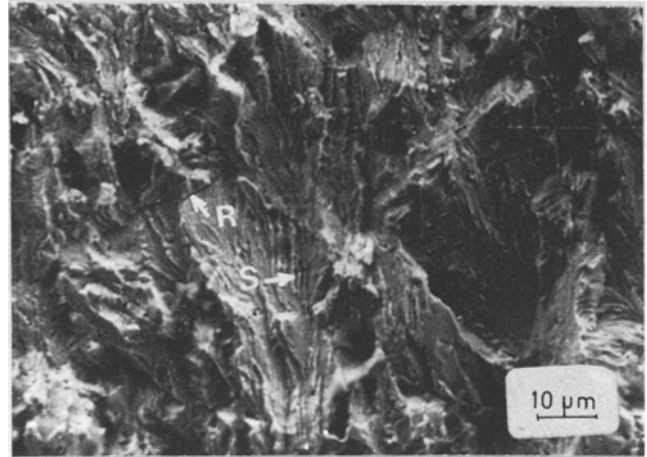
Fig. 4 Scanning electron micrograph of fractured surface, showing the tear ridges (R) between fatigue striation (S) patches.

other view of the fracture surface is shown in Fig. 4, which was taken near the crack initiation area. Tear ridges between fatigue striation patches are shown by arrow R. Intermixed regions of ductile tearing and striations are observed; that is, one grain may fracture by fatigue, whereas an adjacent grain may be oriented and sustain heavy shear band formation and fracture by tearing. The next grain may fracture by fatigue. A magnified view of the transition from fatigue striations to dimple structure is shown in Fig. 5. The fatigue striation is denoted by arrow F and dimple structures by arrow D in Fig. 5. The dimples are oriented uniformly in the deformation direction, as shown in Fig. 6. The longitudinal structures revealed the overload.

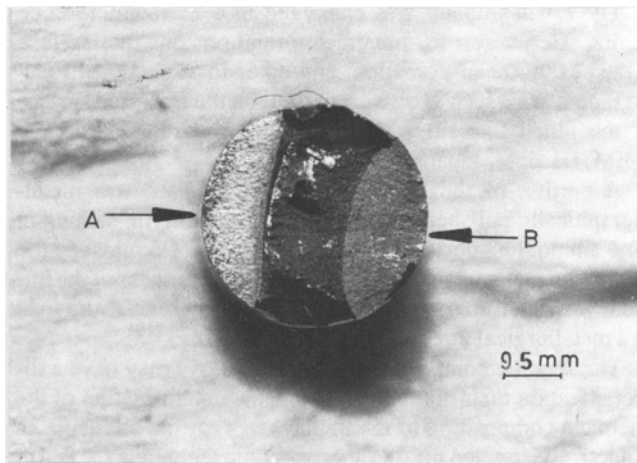
Stereomicroscopic examination of the fractured surface, shown in Fig. 2, revealed that crack propagation proceeded from both sides of the nail, as indicated by the arrows A and B. Two sets of "beach marks" were noted, and the final fracture occurred by ductile shear on the midsection of the nail.

Fig. 2 Stereomicrograph of the fractured surface of the rush nail, revealing that crack propagation proceeded from both sides of the nail, as indicated by arrows A and B.

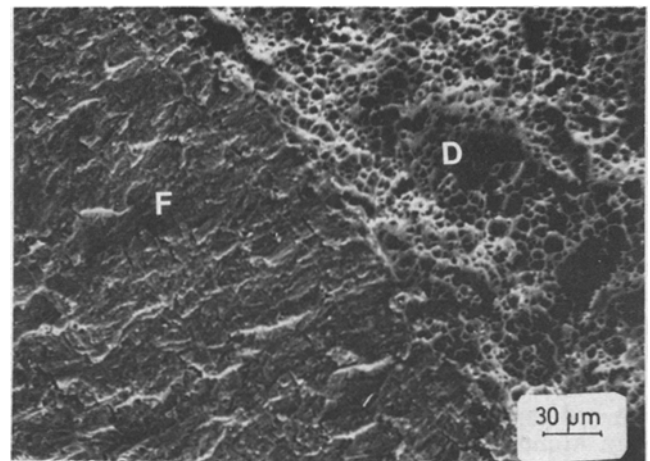
Fig. 5 Scanning electron micrograph showing the transition from fatigue striations to dimple structures. Fatigue striations (F), dimple structures (D).

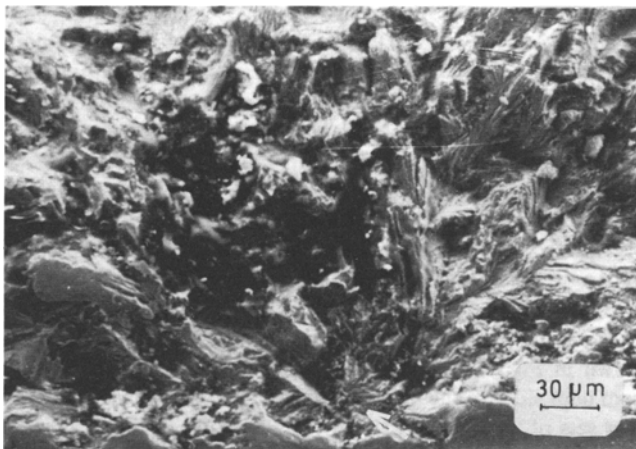
A magnified view of the fracture initiation point is shown in Fig. 3, which indicates the occurrence of fatigue striations. An-

Fig. 3 Scanning electron micrograph showing a magnified view of the fracture initiation point (unlabeled arrow).

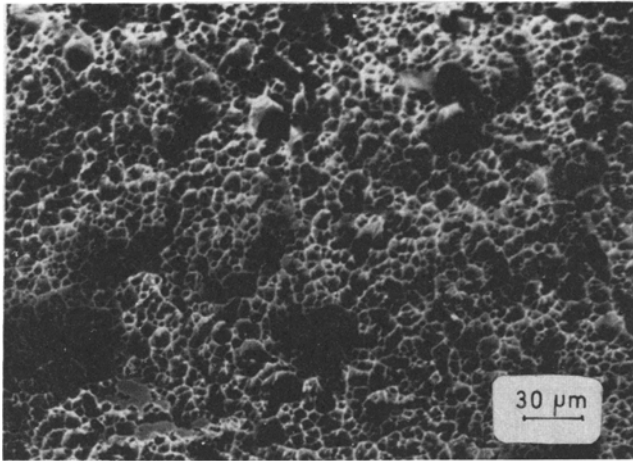
Fig. 6 Scanning electron micrograph showing the dimple structure oriented uniformly in the deformation direction.
