Failure Analysis of an Ammonia Refrigerant Condenser Tube

N.G. Muralidharan, R. Kaul, K.V. Kasiviswanathan, T. Jayakumar, and B. Raj

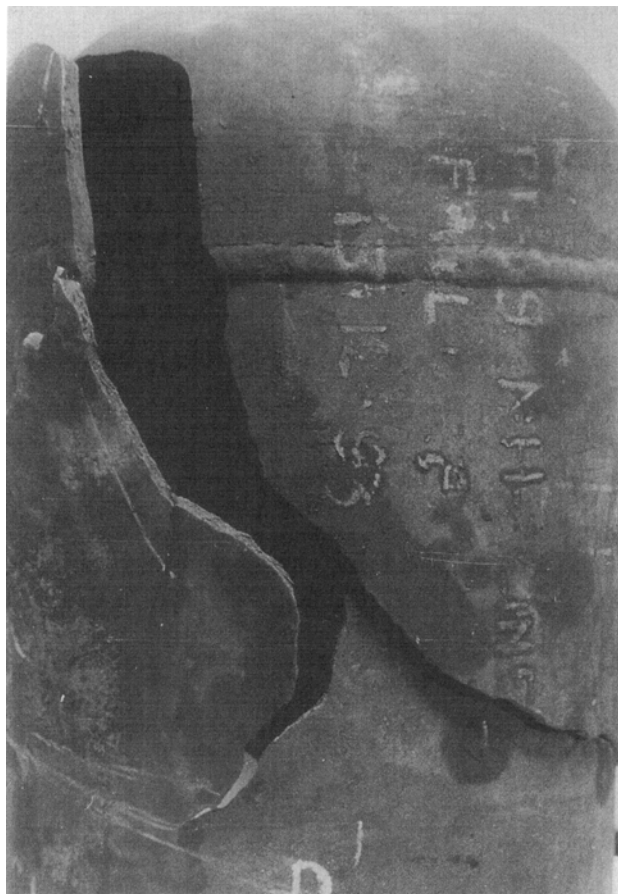
The failed component is shown in Fig. 1. Figure 2 is a schematic that shows the extensive crack pattern on the component.

On the diametrically opposite side of the main fracture location, a longitudinal crack running across the pipe-to-dished-end weld was also noticed. No sign of significant plastic deformation was associated with the failure. The weld joint exhibited nonuniform penetration. Moreover, the weld joint of the two components, which differed in thickness, had a sharp taper of 2 to 3 mm on the inner surface.

Fig. 1 As-received failed condenser tube

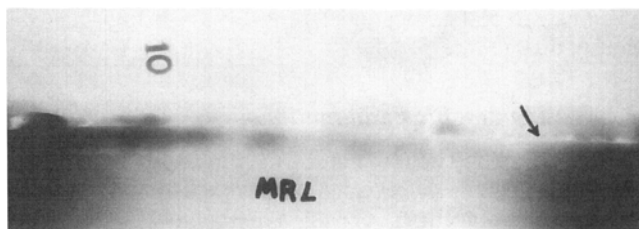
Radiographic examination of the circumferential weld of the failed component revealed lack of penetration throughout most of the weld length. A positive print of the X-radiograph is shown in Fig. 3.

Fig. 3 Positive print of an x-radiograph of the pipe-to-dished-end weld showing area of lack of penetration

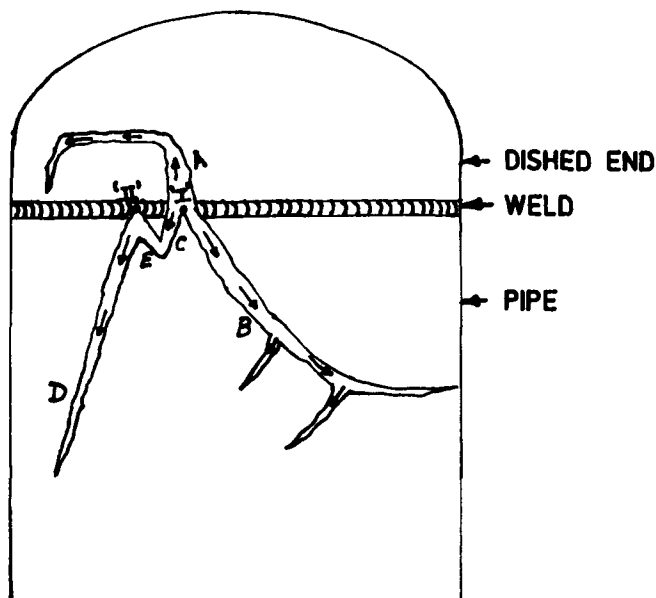
All fractured surfaces were associated with chevron marks. The directions of crack propagation, as indicated by the chevron marks, are schematically shown in Fig. 2. The fracture was initiated from two locations: zones I and II. The main crack propagated from zone I toward A and B in the longitudinal direction and then subsequently deviated in the circumferential direction, while a second crack propagated toward C. From zone II, another crack propagated in the longitudinal direction toward D. The fracture surface corresponding to location E shows evidence of failure by tearing. The partially separated part of the pipe, DECB, was deflected out with respect to the remaining part of the component, probably due to impact loading during final failure.

Fig. 2 Schematic showing directions of crack propagation, as indicated by chevron marks

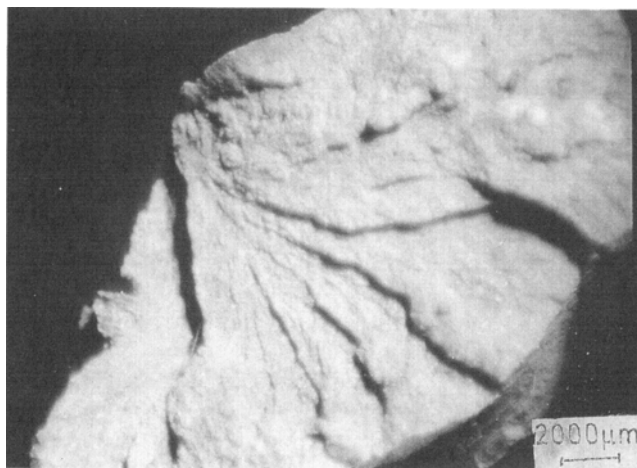
Fractographic examination of the fracture surfaces at low magnification revealed their brittle nature. The presence of chevron marks on the fracture surfaces (Fig. 4) indicated lack of ductility for the material as well as the direction of crack propagation. Both crack nucleation sites, as shown in Fig. 2,

Fig. 4 Chevron marks on fracture surface

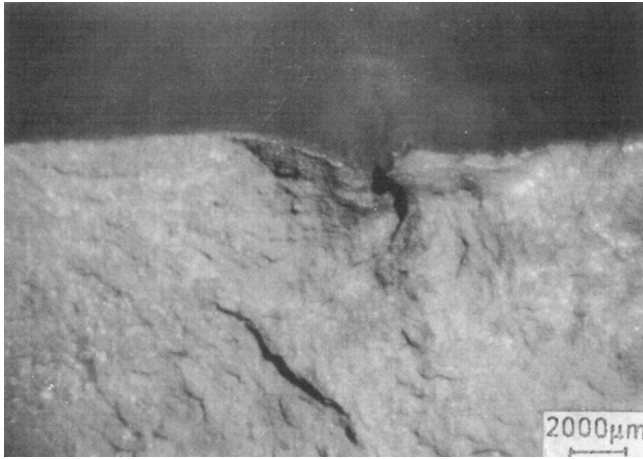
exhibited large regions of lack of penetration (Fig. 5). Several microcracks emanating from this area were also noticed. Near the crack nucleation zone, the fracture surface was found to be intergranular in nature (Fig. 6).

Fig. 5 Area of sharp lack of penetration at crack nucleation site

The area of lack of penetration in the condenser tube weld was a probable stress-concentration site and thus a favorable region for the initiation of hydrogen-induced cracking. Diffusion of hydrogen to an inclusion site results in either decohesion of the inclusion/matrix interface or nucleation of a crack at the inclusion site. Because cracking by hydrogen embrittlement is diffusion controlled, it takes time (in days or months) for the cracking to appear. The maximum susceptibility to hydrogen embrittlement occurs at about room temperature (Ref 14).

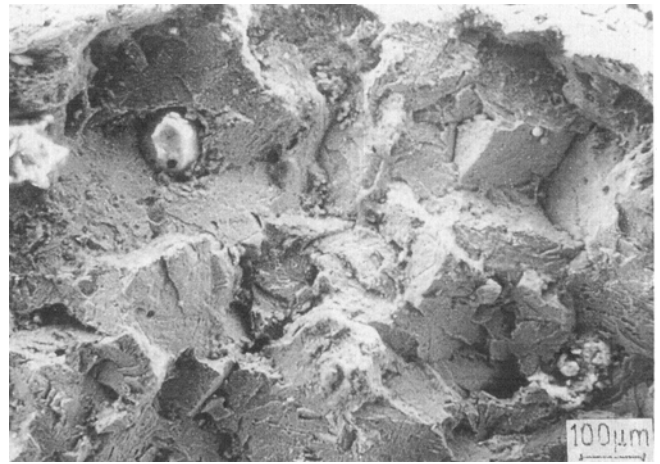
Fig. 6 Intergranular nature of fracture surface near crack nucleation site

Fractographic and metallographic evidence clearly indicated that the failure started at the area of lack of penetration in the weld and propagated in a brittle manner. In the crack initiation zone, cracking was intergranular. This region also exhibited blisters around inclusions. Microcracks emanating from inclusion sites and decohesion of inclusion/matrix interfaces were also noticed.

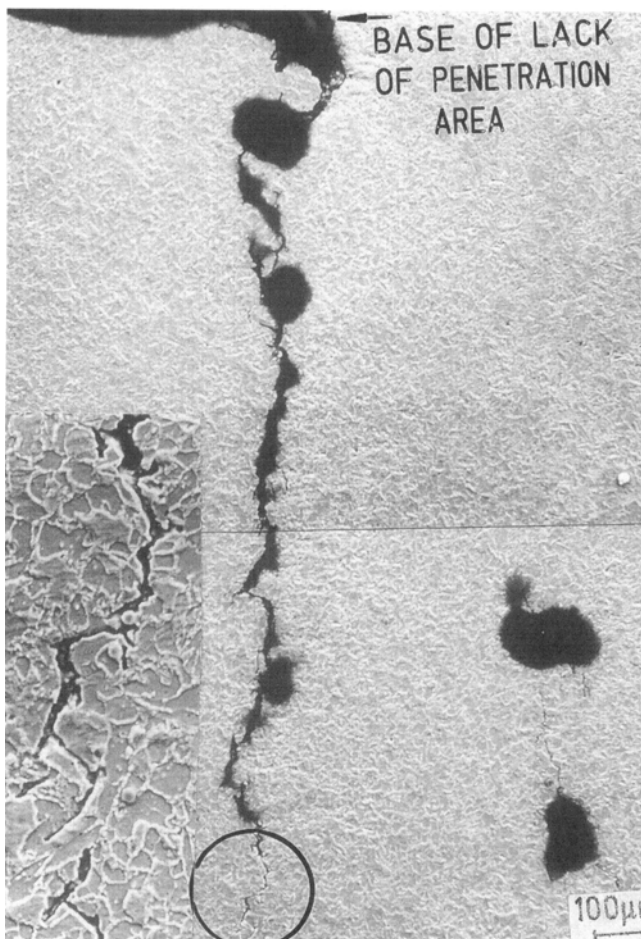
The weld specimen also exhibited an area of sharp lack of penetration. Figure 7 shows an intergranular crack emanating from this weld defect. This crack was seen to be propagating through inclusions (Fig. 8). A closer look at it and other cracks revealed that they initiated at inclusion sites (Fig. 9). Figure 10 shows blisters around the inclusions. These blisters would have been formed as a result of precipitation of molecular hydrogen at the matrix/particle interface. In addition, several cavities were present around the inclusions (Fig. 11). Energy-dispersive analysis of x-rays (EDAX) conducted on the inclusions revealed the presence of iron, manganese, aluminum, and sulfur, implying that the inclusions were composed of mainly MnS.

Fig. 7 Crack emanating from the base of the area of lack of penetration. The inset figure, a magnified view of the encircled region, shows the intergranular nature of cracking.

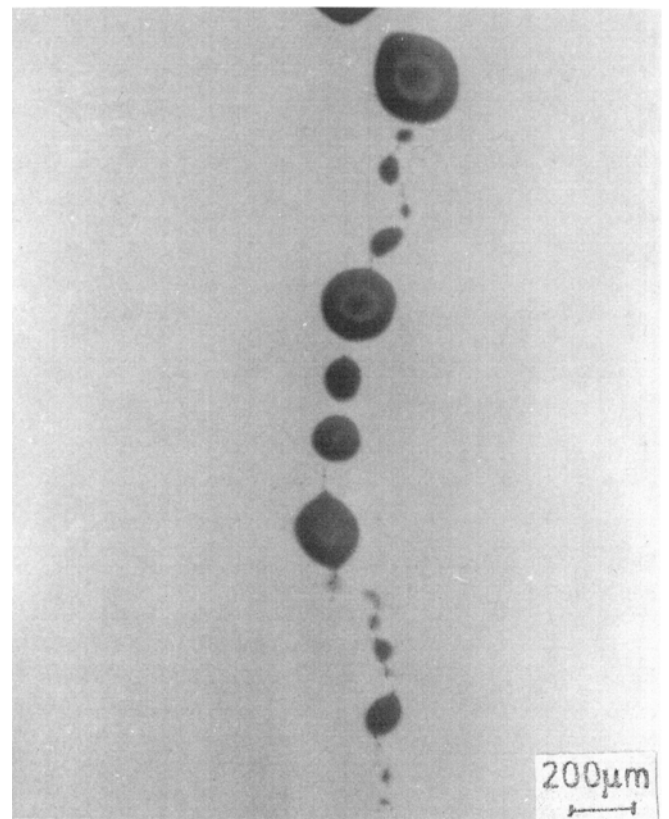
Fig. 8 Crack joining inclusions

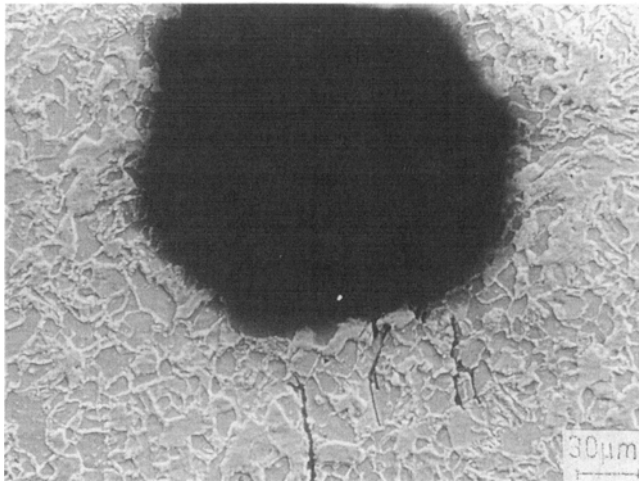
Fig. 9 Cracks emanating from inclusion sites

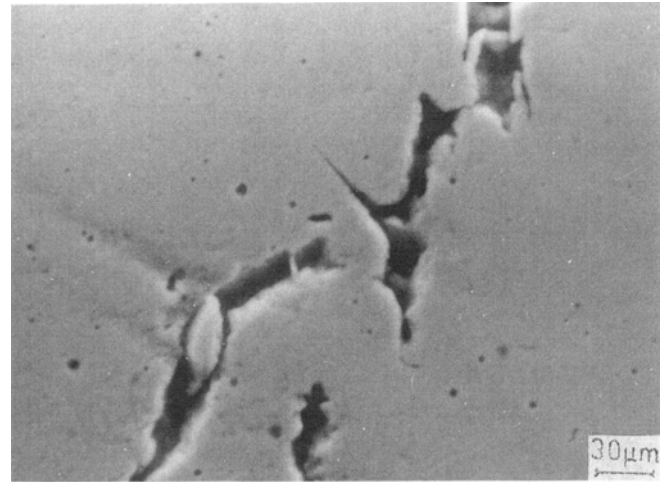
Fig. 10 Blisters around inclusions

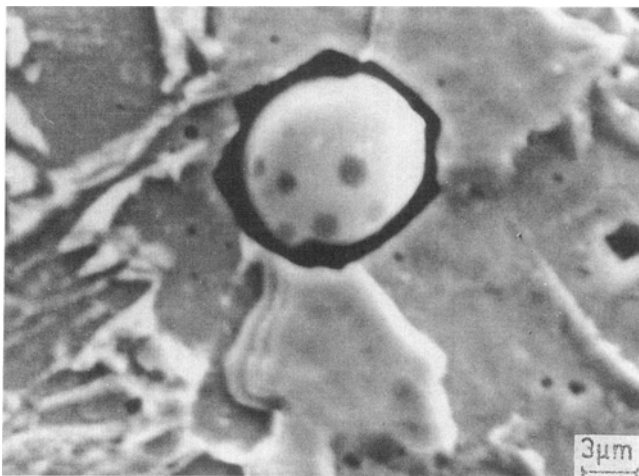
Fig. 11 Decohesion of inclusion/matrix interface

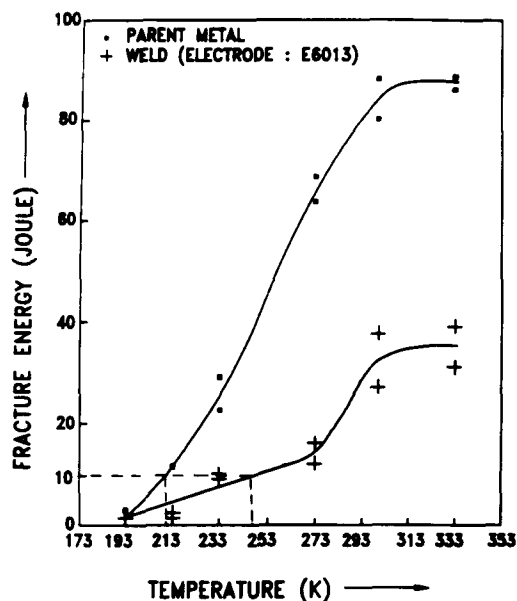
mens are given in Fig. 12 (Ref 3, 4). The tests were performed on a Tinius-Olsen model 358 J (Tinius-Olsen Testing Machine Co., Inc., Willow Grove, PA) impact machine with DYNATUP (GRC Instruments, Santa Barbara, CA) instrumentation, as per ASTM E 23 (Ref 3). The results of impact tests carried out on subsize Charpy specimens at different temperatures are presented in Fig. 13. Transition temperatures for subsize Charpy specimens from base metal and weld metal (using 0.25 J/mm² ligament area criterion, equivalent to 10 J for subsize specimens) were calculated as 210 and 247 K, respectively.

Fig. 13 Plots of absorbed energy versus temperature for sub-size Charpy V-notch specimens

Using Eq 1, the transition temperatures for the base metal and weld metal (20 J criterion for standard Charpy V-notch specimens) have been calculated as 227.5 and 264.5 K, respectively. The mean shift in transition temperatures is likely to differ at most by 12% (Ref 11). The conclusion is that the weld metal is below the ductile to brittle transition temperature when it is at room temperature.
