# The Use of XPS, FTIR, SEM/EDX, Contact Angle, and AFM in the Characterization of Coatings

M.J. Walzak, R. Davidson, and M. Biesinger

**Keywords** coatings, failure analysis, scanning electron microscopy

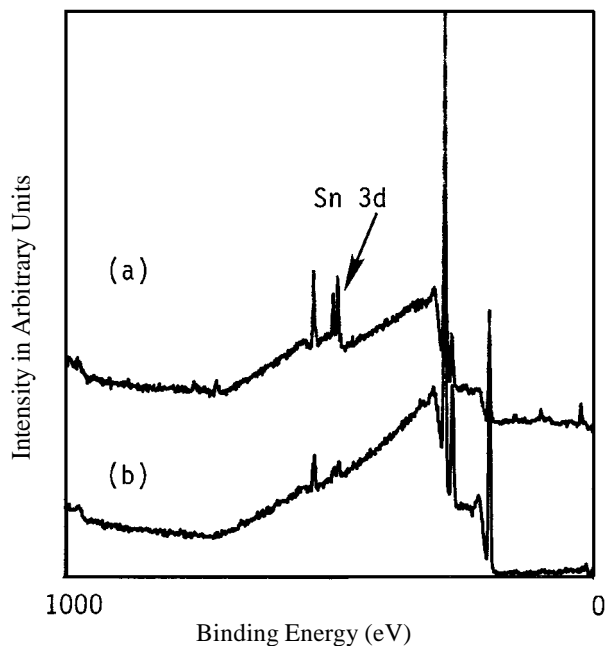
piece away from the bond, tin was seen in significantly higher quantities than in the cross section. This difference is shown in Fig. 1 and indicates that blooming is occurring because the tin additive is migrating to the surface. XPS analysis of the bulk and the surface of the second sample showed no tin was present. No tin was present in the PVC adhesive. Tin was present on both sides of the failed bond area at levels similar to that seen on the surface of the molded part. Blooming of the tin additive to the surface of the polymer was interfering with the bonding of the two parts. Knowledge of the cause of the bonding failure helps the manufacturing facility trace the defective parts and correct the problem. This knowledge can also narrow the search for the cause of the problem. If the problem lies with one particular piece, the search for a solution can be concentrated in this area, and the problem solved more quickly.

**Fig. 1** XPS spectra of the molded PVC piece (a) at the surface and (b) in cross section. The tin 3d<sub>3/2</sub> and 3d<sub>5/2</sub> at 493 and 485 eV binding energy are indicated. The peaks are much stronger in the spectrum of the surface than in the cross section.

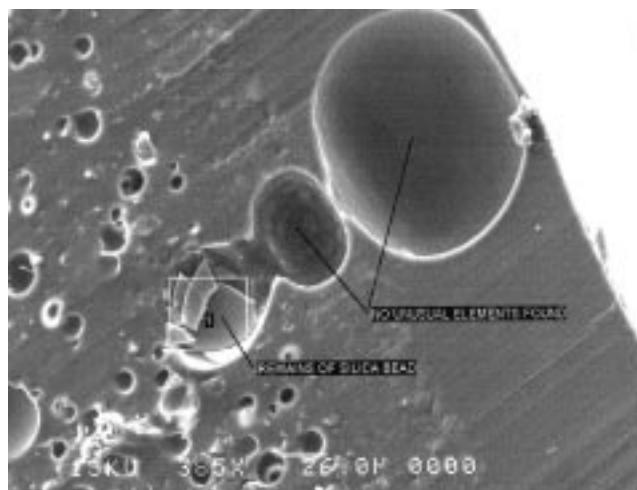
SEM/EDX is extremely useful in examining defects in coatings because with the current multilayer coatings it is extremely difficult to determine the source layer for many defects. The defect becomes apparent in the top layer, but the origins can be obscure. In Fig. 2, a micrograph of a coating defect is presented in cross section. The defect manifested itself as a pinhole in the coating. The sample was polished to expose the cross section of the defect, and in this manner the layer of origin for the defect was uncovered. As shown in the micrograph, the substrate is filled with hollow glass beads. Where the defects have occurred, a very large glass bead is present near the surface. It appears that the trapped gas in the bead expands when the sample is heatcured and forms bubbles in the subsequent layers. The gas in the uppermost layer of the coating escapes through the pinhole defect at the surface.

**Fig. 2** Scanning electron microscope micrograph of the cross section of a defect in a coated polymer surface. The cross section shows the broken silica bead in the substrate giving rise to the pinpoint defect at the surface of the coating. The micrograph was collected at 15 kV at a magnification of 385 $\times$ . (Art has been reduced to 60% of its original size for printing.)

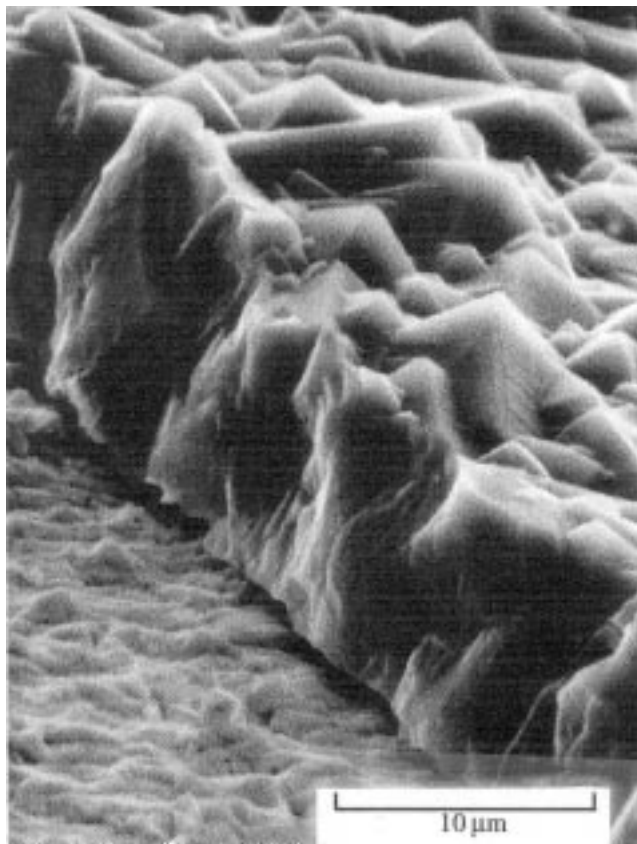
substrates. Figure 3 shows a micrograph of a diamond coating on a tool bit. The micrograph shows that the edge of the diamond coating is not attached securely to the substrate but rather sitting on top of it. SEM provides a quick and useful check of the adhesion of such coatings to the substrates.

**Fig. 3** SEM of a diamond coating on a tool bit collected at 20 Kv at a magnification of 3270 $\times$ . The coating is approximately 7  $\mu\text{m}$  thick. (Art has been enlarged to 102% of its original size for printing.)

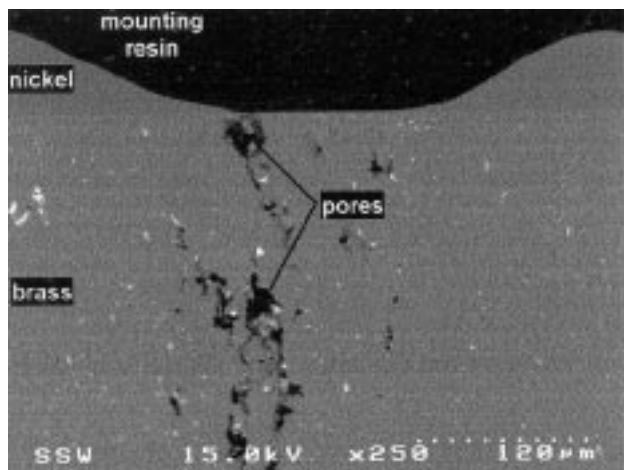
**Fig. 4** SEM backscattered electron image (BSE) showing the cross section of a defect in a nickel-coated brass piece. The porosity in the brass, which gives rise to the defect, is clearly seen in the cross-sectional image.

In this example, a nickel/chromium plating company was having a problem with pits in the plating of brass fixtures. Initial examination (plan view) of the pit showed that the coating was still intact in the pitted area and no contaminants were found. A portion of the samples were then mounted in a polymer resin and metallographically cross sectioned and polished to reveal the pitted area. SEM imaging of the pit in cross section showed a large amount of porosity within and at the surface of the brass substrate (Fig. 4). This porosity will cause an exclusion of the electric field at the pore opening, and thus the electro-deposition of the nickel plating is inhibited (Ref 7). Sufficient plating will occur, however, to seal off these pores. With this information and by working with the brass supplier, the manufacturer remedied the problem.

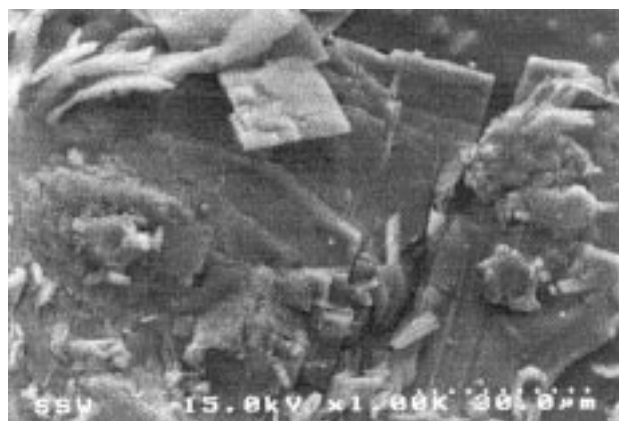
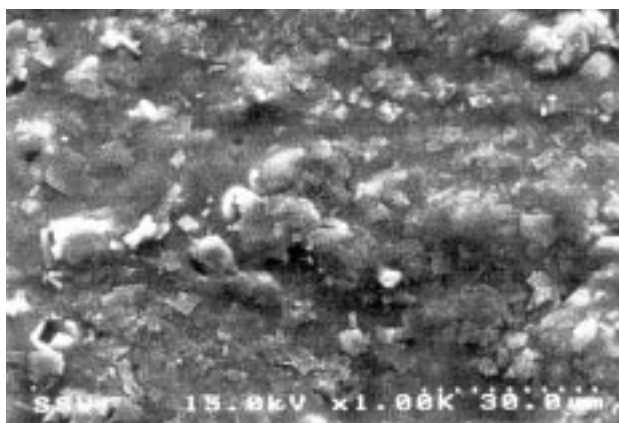
**Fig. 5** SEM micrographs of good and bad coated parts. (a) The surface of sample A, the bad part, showing the very large (10 to 30  $\mu\text{m}$  square) crystals on the surface. Figure (b) is a micrograph of the surface of sample B, the good part, showing small flat particles (approximately 3  $\mu\text{m}$  square) at and just beneath the surface.

The samples were analyzed first using SEM/EDX to determine the appearance of the residue on a microscopic level and to obtain the elemental composition. The micrographs of the surfaces are presented in Fig. 5(a) and (b). From Fig. 5(a), the micrograph of the surface of the good part, small crystals can be seen lying at and just under the surface of the coating. Figure 5(b) shows that the crystals are from 10 to 100× larger and lie on the surface of the material. The EDX results are presented in Table 1. Both the crystals and the matrix material were analyzed by EDX for Sample A, the defective surface, and the small crystals on Sample B, the reference part were also analyzed. The presence of significant quantities of sulfur in the crystals on the surface of sample A was surprising, and the origin of such material at the surface was unable to be hypothesized. In this case, the manufacturer was unable to provide guidance.

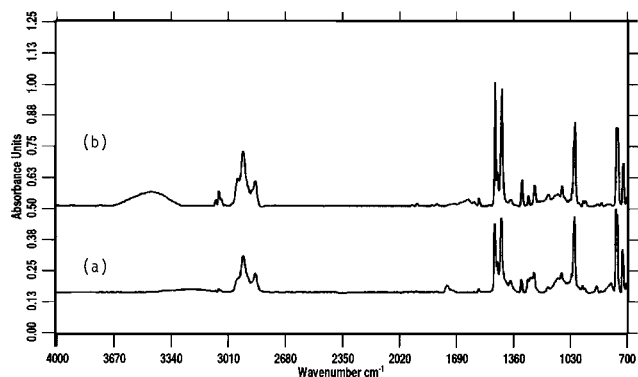
Sample A was then analyzed using FTIR-ATR. The sample was pressed against a germanium crystal, and a spectrum was collected. The spectrum was compared to that collected from Sample B and found to be quite different. A library search of the spectrum of sample A gave a good match for benzothiazylsulfide, a sulfur-rich accelerant used in rubber processing. Figure 6 shows a comparison of the spectrum of sample A and the benzothiazylsulfide. The match was consistent with the type of material being molded and the elemental composition, as measured by EDX. The unsightly appearance was caused by the presence of the accelerant in crystalline form at the surface. The accelerant had migrated through the rubber and the coating to the surface of the molded, coated part.

**Fig. 6** FTIR-ATR spectra of the surface of (a) sample A, the bad coated part, and (b) the library spectrum of benzothiazylsulfide.

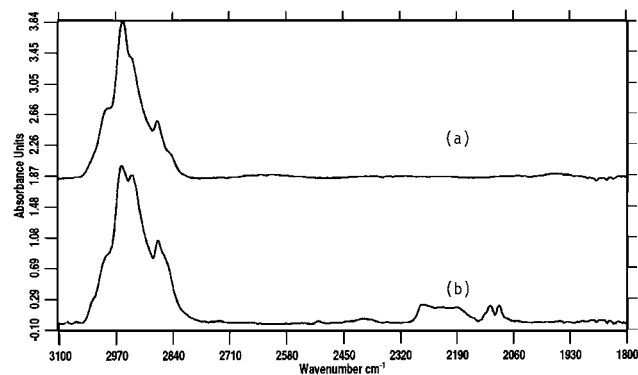
and the spectrum is shown in Fig. 7(a). Spectra of the white deposit showed peaks in the region from 1960 to 2300  $\text{cm}^{-1}$ , which are consistent with the presence of cyanide, isocyanate, or nitrile groups. A representative spectrum is shown in Fig. 7(b). Depending on the area analyzed, the peaks varied significantly in intensity and position, indicating that there are a number of reaction products present in the deposit, but they all have a similar set of functional groups.

On presenting data to the manufacturer, the process chemicals were found to become trapped within the porosity of the coating and to bleed out later as a complex mixture of caustic and cyanide reaction products. This scenario was consistent with the SEM/EDX results and with the FTIR spectra of the deposits. Because SEM/EDX is not particularly sensitive to nitrogen, it was not surprising that it was not seen in the EDX spectra. The problem was attributed to cyanide bleed out. The process was modified and the defect was corrected.

**Fig. 7** Microscopic FTIR spectra of (a) the clear coating on the metal and (b) the white deposit on the surface of the finished piece. The peaks occurring between 1960 and 2300  $\text{cm}^{-1}$  indicate the presence of cyanide, isocyanate, or nitrile groups.

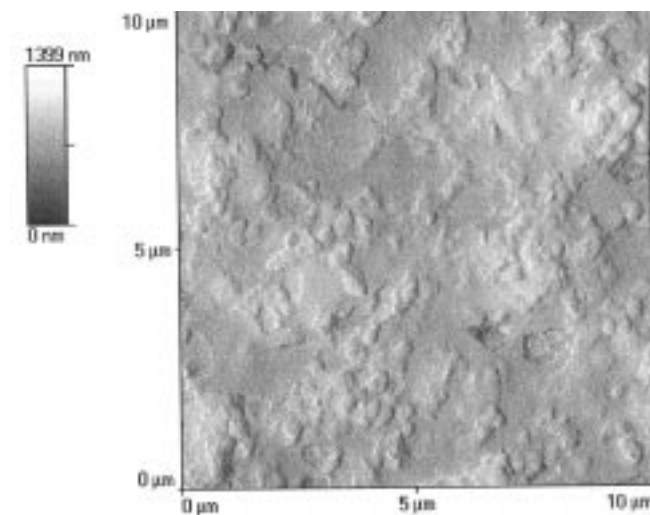
Figure 8 shows a typical two-dimensional representation of a weathered, coated painted surface. This sample was obtained from a manufacturer of painted metal materials. The surfaces became much rougher during weathering tests, and the manufacturer needed a numerically valid and statistically significant measure of the roughness of the surface as a function of changes they were making to the coating. Initially, more than thirty 10  $\mu\text{m}$ -square areas on a single sample were examined, and the roughness data were calculated to determine the variability encountered over the surface. After the variability of a single sample was determined, a smaller number of areas on subsequent samples were probed and roughness results were averaged. AFM also allows a number of additional calculations to be made on the scans such as line scans, bearing ratios, and peak/valley measurements. Although pictorial representations of the surface can be obtained from the SEM micrographs,

**Fig. 8** AFM two-dimensional representation of the surface of a weathered, painted metal surface. The micrograph shows a 10  $\mu\text{m}$  square area from which average roughness, average peak height, maximum peak height, and a height histogram can be generated.
