Evaluation of the In-Service Performance Behavior of Honeycomb Composite Sandwich Structures

J.E. Shafizadeh, J.C. Seferis, E.F. Chesmar, and R. Geyer

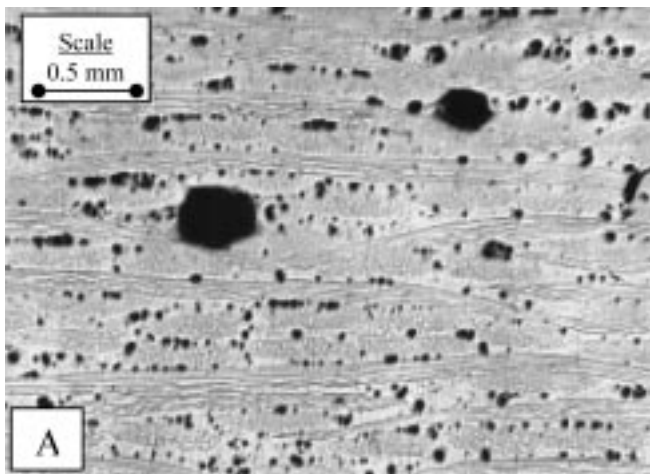
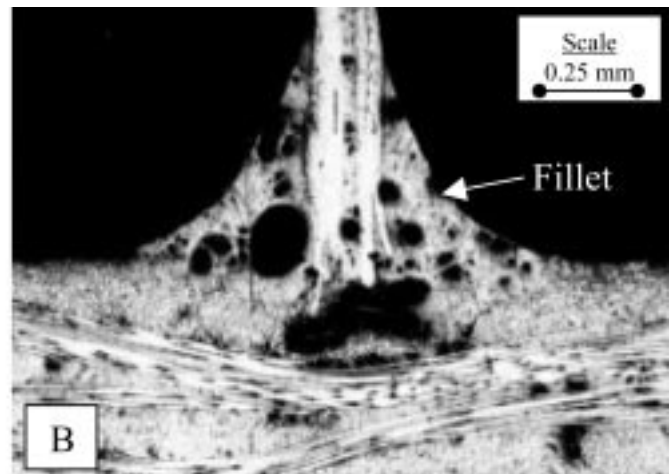
Outboard Flap Wedges. The flap wedge is located on the outboard trailing edge of the wing, as shown in Fig. 1 and 2. The flap wedge is bolted on the main flap assembly and is designed to extend with the flap to give the aircraft lift during takeoff and landing. When the flap wedge was constructed, a Nomex (E.I. DuPont de Nemours & Co., Wilmington, DE) honeycomb was used in the core, and the facesheet was fabricated from low-flow epoxy prepreg. (Prepreg is a thin sheet of fibers that has been uniformly impregnated with a polymer matrix.) The prepreg used in the flap wedge was a fairly common prepreg and had many advantages and disadvantages to its use. The prepreg was a self-adhesive prepreg and did not require an adhesive film to adhere to the honeycomb core, but it also had known porosity problems. Past research has shown that laminates fabricated from this type of prepreg can contain 3 to 5% voids (Ref 8). These voids are typically found both in the face sheet and skin to core fillet, as demonstrated in Fig. 3.

Fig. 3 Example of typical porosity problems with (a) laminates and (b) honeycomb core fillets

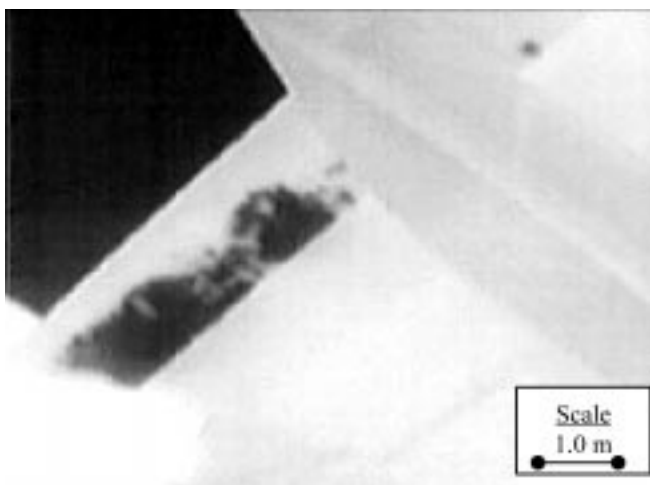
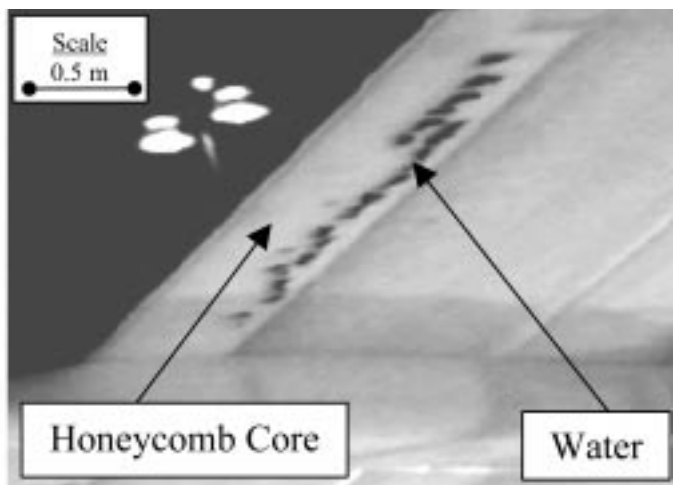
the face sheet. However not all of the voids were filled. Through the “unsurfaced” voids, water was able to migrate into the face sheet. Once in the face sheet, the water caused microcracks to develop in the skin through a freeze-thaw mechanism. The microcracks that developed formed between the voids in the laminate and created a leak path from one void to another. As a result of the high porosity and the incomplete surfacing of the wedge, leak paths were created from the surface to the honeycomb core. Once in the honeycomb core, the voids in the honeycomb core fillets allowed water to travel from one cell to another. Through microcracks in the face sheets water was able to migrate freely through the outboard flap wedge, as shown in Fig. 4 (Ref 9).

Fig. 4 Infrared images of two 767 outboard flap wedges showing the location of water in honeycomb sandwich structures. (Dark areas represent liquid water.)

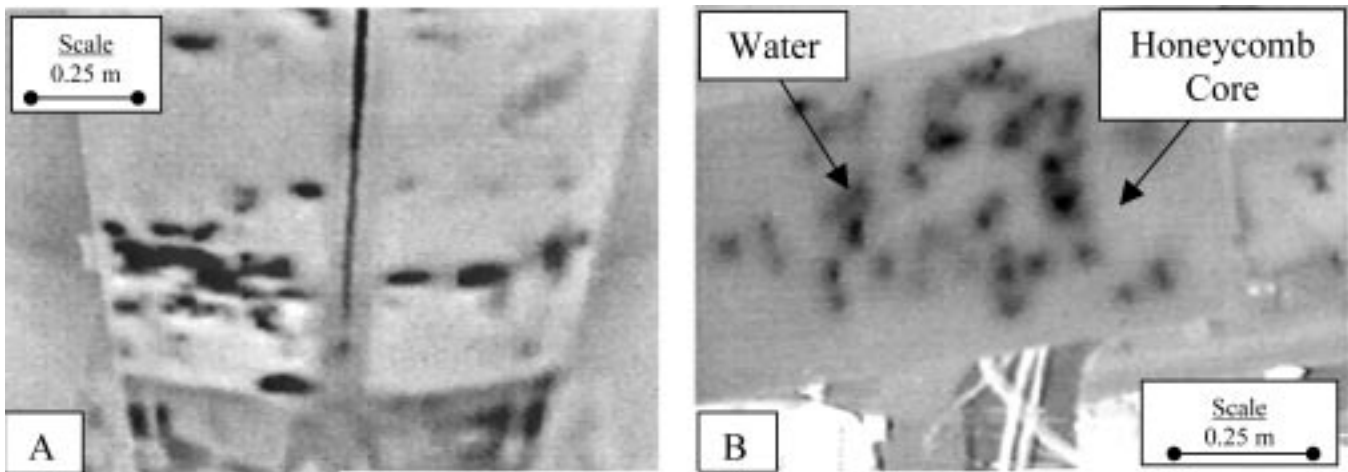
tach the necessary actuators and fasteners. After drilling, the holes were then filled with a potting compound. (Potting compound is a filled thermosetting material used to provide a substantive attachment point for the fasteners in the honeycomb core.) During fitup, the fasteners were wet installed in the fitting locations and torqued with a force greater than 130 N. Wet installation involves coating the fastener with a sealant material to prevent water ingress. Over time, cracks form in the sealant and potting compound as a result of thermal and mechanical cycling. The cracked potting compound resulted in a leak path being formed from the service environment of the landing gear door directly into the honeycomb core. The leak path for water ingress began outside the door. It then followed the fitting itself into the potting compound, then directly into the honeycomb core. Once in the honeycomb core, the water spread from the localized area around the fitting to the rest of the core, as shown in Fig. 5.

Through cracks in the potting compound, originally designed to prevent water ingress, water was able to infiltrate and spread throughout the honeycomb core. In Fig. 5 the effects

of the cracked potting compound can readily be noticed. As shown in Fig. 5(a), water can be seen in a band pattern approximately 0.3 m from the aft end of the panel. It is in this location where a series of holes was drilled and potted in the honeycomb to attach the fitting for the door actuator. On the aft door, depicted in Fig. 5(b), a greater number of spots can be seen. The pattern of these spots can also be traced back to eight large potted regions where the hinge fittings and actuators were fastened to the honeycomb core.

Fig. 5 Infrared images of the 767 (a) forward and (b) aft nose landing gear doors showing the location of water in honeycomb sandwich structures. (Dark areas represent liquid water.)

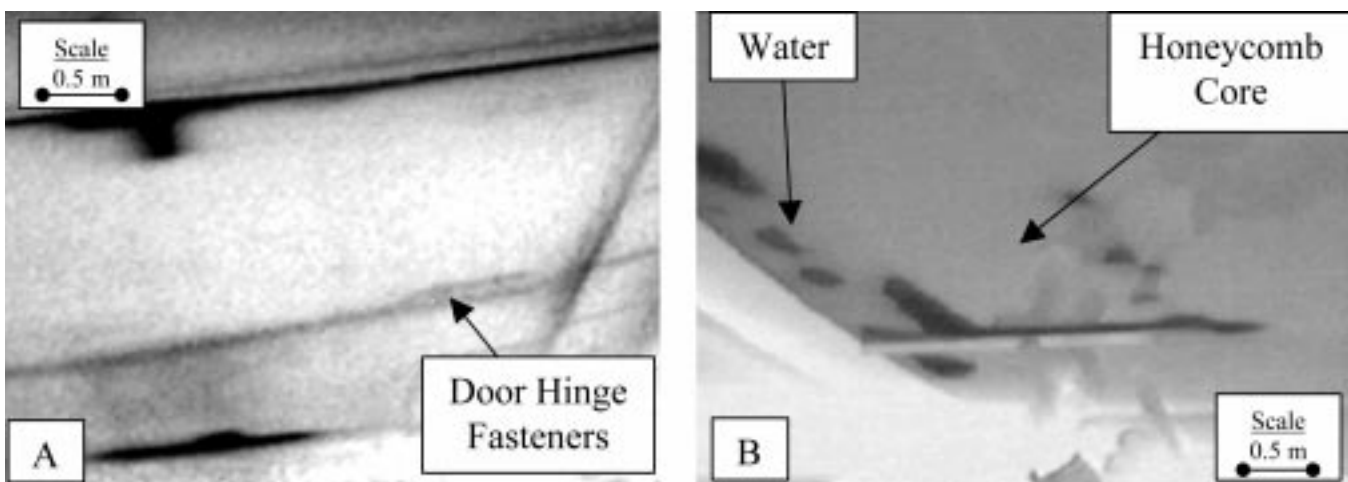
Figure 6 presents thermographic images of the main landing gear doors. In the figure large blotches of water appear to pool in the landing gear doors. The large blotches are a result of core septumization and the large holes drilled in the core for different types of fasteners. Figure 6 also shows the edges of the panels. The leading and trailing edges of the main landing gear door contain a metal erosion plate that was sealed and fastened to the edges of the honeycomb core. The erosion plate was attached to the panel to prevent degradation of the leading and

Fig. 6 Infrared images of (a) the body and (b) leading edge of the 767 main landing gear doors showing the location of water in honeycomb sandwich structures. (Dark areas represent liquid water.)

trailing edges of the panel when the panel was placed in the air-stream during takeoffs and landings. The erosion plate was attached to the panel with more than 30 fasteners that led from the service environment of the panel directly into the honeycomb core. The cracking of the potting compound allowed water to migrate into the core and was responsible for the water pattern shown in Fig. 6. In the figure water ingress into honeycomb core around the fasteners of the main landing gear door hinge fitting can also be seen.

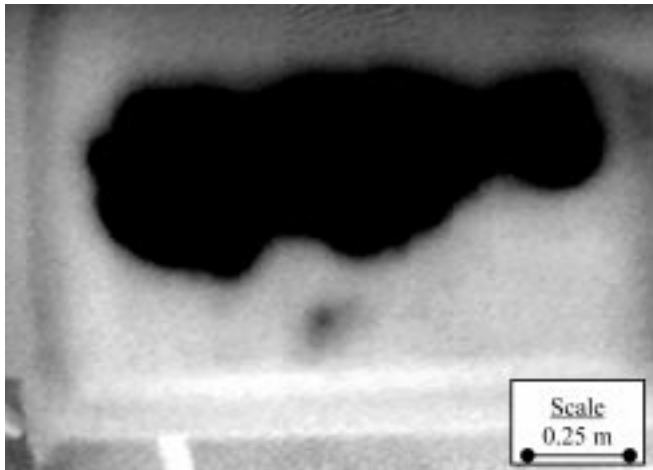
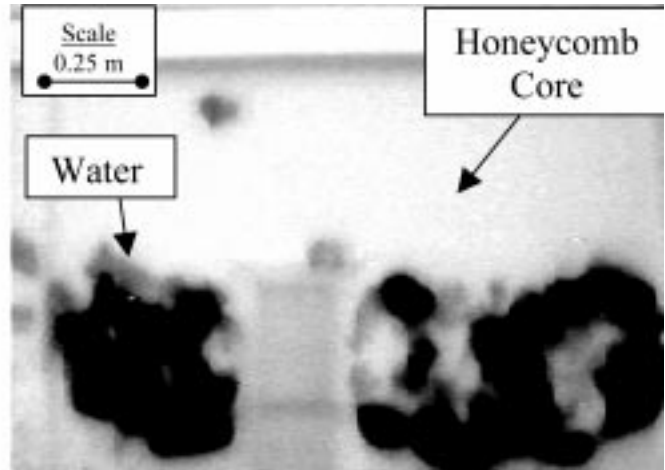
resistant. After several years of service, a large number of panels developed problems. Microcracks were found on the paint finish of the panels. The microcracks extended through the facesheet, and the cells of the honeycomb core were found filled with water. Several studies were conducted to determine the source of the microcracking. The Kevlar lamina in the panels were determined to be the source of the microcracks through intensive studies. Kevlar fibers are highly anisotropic and have extremely different coefficients of thermal expansion in the radial and axial directions. When exposed to severe repeated environmental cycling (as seen on commercial aircraft), the radial and axial expansion of the fibers cause large localized stress fields to develop in the lamina (Ref 10, 11). At very low temperatures the stress fields created in the lamina approach, and exceed, the yield strength of the matrix. Matrix yielding and microcracking relieves some of the internal stresses caused by the Kevlar fiber. With continued cycling, the microcracks expand and create leak paths from the surface of the panel to the honeycomb core. Once water enters the

Fig. 7 Infrared images of two 767 upper fixed wing panels showing the location of water in honeycomb sandwich structures. (Bottom view.) (Dark areas represent liquid water.)

On the 767, all of the upper fixed wing panels do not have the same facesheet gauge thickness. The outboard panels have thinner skins than the inboard panels. When water ingress problems in these panels appeared, the thinner-skinned panels were found to delaminate first. These panels delaminated first because the leak path in these panels was shorter than in other panels with thicker skins. The shorter leak path in the outboard panels allowed water to accumulate and delaminate the facesheet sooner. The panels thermographically inspected and shown in Fig. 7 represent panels that have thicker facesheets and have not yet delaminated.

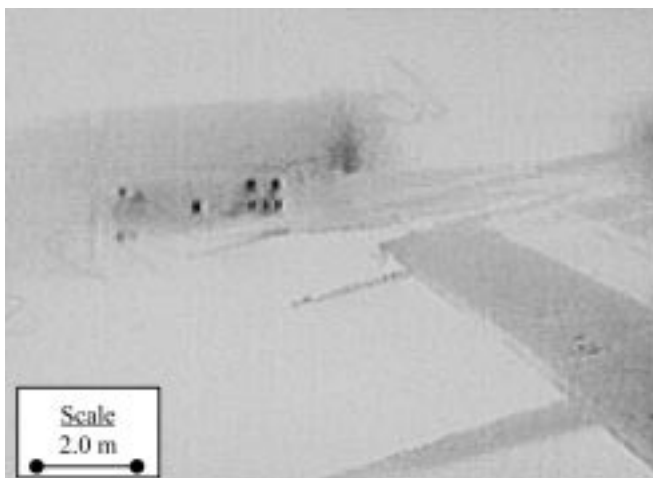
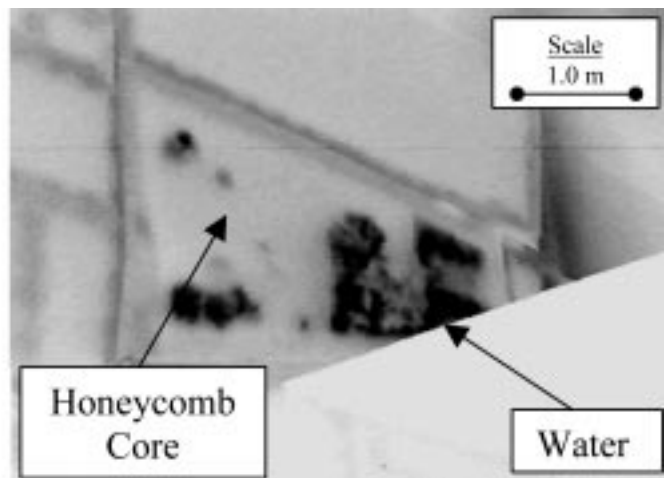
Fig. 8 Infrared images of two 767 escape slide doors showing the location of water in honeycomb sandwich structures. (Dark areas represent liquid water.)

Escape Slide Doors. Through thermographic analysis, water was also observed to accumulate in the escape slide doors. The mechanisms of water ingress in the escape slide door are a combination of the problems seen with the other composite parts described earlier. In the body of the escape slide door potting problems are again believed to be responsible for water ingress. In Fig. 8, the pattern of water migration throughout the door is shown.

On the door, holes approximately 5.0 cm in diameter were drilled in the honeycomb core to attach the pack board. The pack board was used to affix the emergency escape slide system. The pack board was affixed to the door with a group of six large fasteners in the aft section of the panel and another four fasteners in the forward section of the panel. Cracks in the potting compound allowed water to ingress and spread throughout the door.

Around the escape slide door a dark "halo" region can also be seen outlining the panel. This halo is attributed to Kevlar filler plies in the solid laminate edge band. Kevlar was used in the edge band to bring it up to the nominal required thickness of the part. The Kevlar edge band extends from the edge of the honeycomb core bay all the way to the edge of the panel. At the edge of the panel, the Kevlar was exposed to the air from which it was able to wick moisture into the edge band of the panel. It is the wicking of water into the panel that is responsible for the halo around the door.
