High-Temperature Corrosion Observed in Austenitic Coils and Tubes in a Direct Reduction Process

B. Campillo, C. Gonzalez, G. Hernandez-Duque, and J.A. Juarez-Islas

The subject of this study is related to the performance of austenitic steel coils and tubes, in a range of temperatures between 425 and 870 °C for the transport of reducing gas, in an installation involving the direct reduction of iron-ore by reforming natural gas. Evidence is presented that metal dusting is not the only unique high-temperature corrosion mechanism that caused catastrophic failures of austenitic 304 (UNS S304 00) coils and HK-40 (UNS J94204) tubes. Sensitization as well as stress corrosion cracking occurred in 304 stainless steel coils and metal dusting took place in HK-40 tubes, a high resistance alloy. The role of continuous injection of H₂S into the process is suggested to avoid the high resistance metal dusting corrosion mechanism found in this kind of installation.

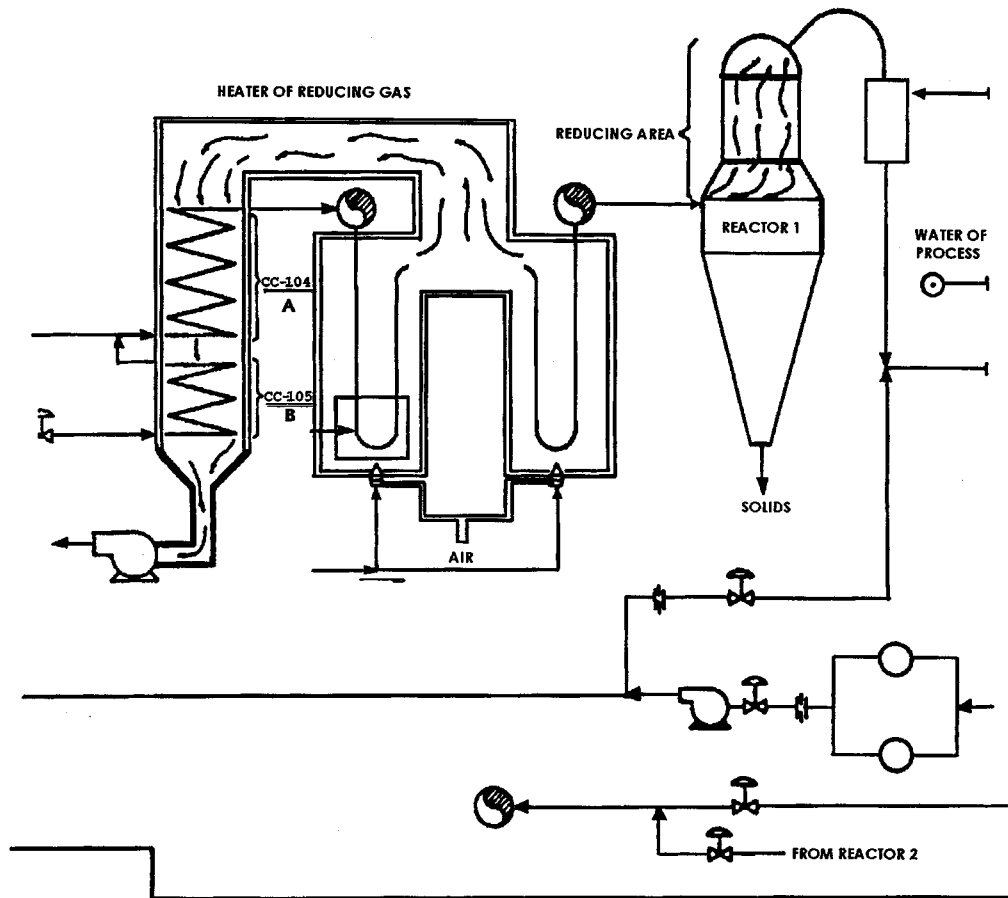
A schematic diagram of heater 3 in the direct reduction process at Ispat is shown in Fig. 1, where 304 stainless steel (UNS S30400) coils were removed after a catastrophic failure occurred in two different locations: (1) in the second stage of the preheating zone of the reduction gases (CC-104); and (2) in the recollection zone of exhaust gases (CC-105). The same diagram also shows the region (marked with a square in Fig. 1), in which a section of a tube of a heat-resistant alloy of the HK40 type was removed after catastrophic failure.

Fig. 1 A section of a diagram of heater 3 of the direct reduction process from which coils (section CC-104 **A** and CC-105 **B**) and tubes were removed after catastrophic failures occurred

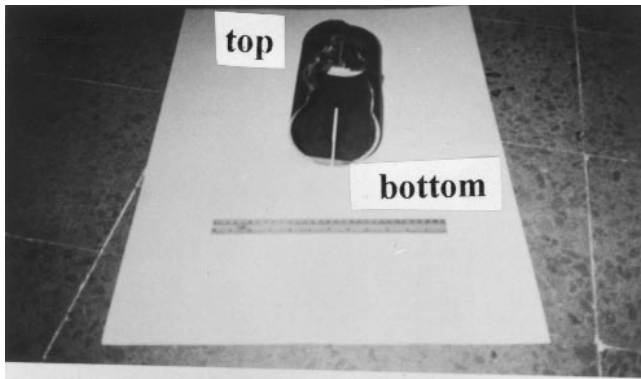
2a

Figure 2(a) shows a section of a 304 stainless steel coil, which was located in the middle of the coil (section CC-104 of Fig. 1, $T \approx 650\text{ }^\circ\text{C}$), where a hole bigger than 10 cm in diameter was ob-

served in the upper part of the coil after the catastrophic failure occurred). It is important to mention that holes with diameters smaller than 5 cm were also observed along the total length of the coil, and the holes were always positioned on the top part of the coil. Figure 2(a) shows a transverse section of the coil. On the bottom of the coil, it was observed that its wall thickness was bigger (1 cm) than that of the original centrifugally cast tube (0.5 cm). It can be observed from the bottom to the top of the coil that the wall thickness decreased until failure occurred.

Fig. 2 (a) Transverse section of a 304 SS coil located in section CC-104 A, removed after a catastrophic failure. (b) Longitudinal section of a 304 SS coil located in section CC-104 A, removed after a catastrophic failure. The length of the ruler is 30 cm.

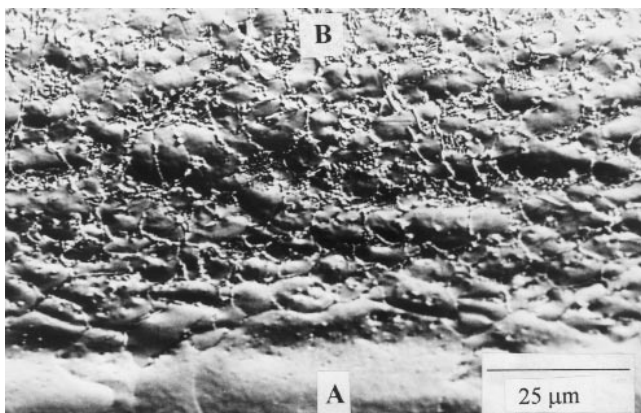
Figure 3 shows a transverse optical photomicrograph of the exploded coil of Fig. 2. The region marked **A** corresponds to the microstructure observed in areas close to the outer diameter of the coil, which basically shows a microstructure of austenitic grains and no sign of any kind of high-temperature corrosion. The region marked **B** shows the microstructure in areas close to the inner diameter of the coil. It can be observed how the high-temperature corrosion phenomenon, known as sensitization, is present; in this phenomenon, the grain boundaries rich in chromium precipitates formed a continuous layer. Figure 4 shows the microstructure observed in the thickest section of the pipe of Fig. 2, which consisted of deposited material from dissolution of the sensitized grains at the top of the coil. The white areas are rich in Fe and Cr and the black areas are rich in Fe and Ni, as detected by SEM microanalysis. By optical observation,

Fig. 3 Optical micrograph of the exploded coil of Fig. 2. The section marked A corresponds to areas that do not show evidence of sensitization (close to the outer diameter). The section marked B shows evidence of sensitization (close to the inner diameter of the coil). 1000X

it can be stated that this morphology was due to the slow dissolution of grains located in the upper section of the coil. This dissolution of the sensitized grains (which explains the observation of a very thin wall on the top of the coil and a very thick section

on the bottom) results in a thick section at the lowest part of the coil, as the dissolved grains are deposited (by gravity) to the bottom of the coil.

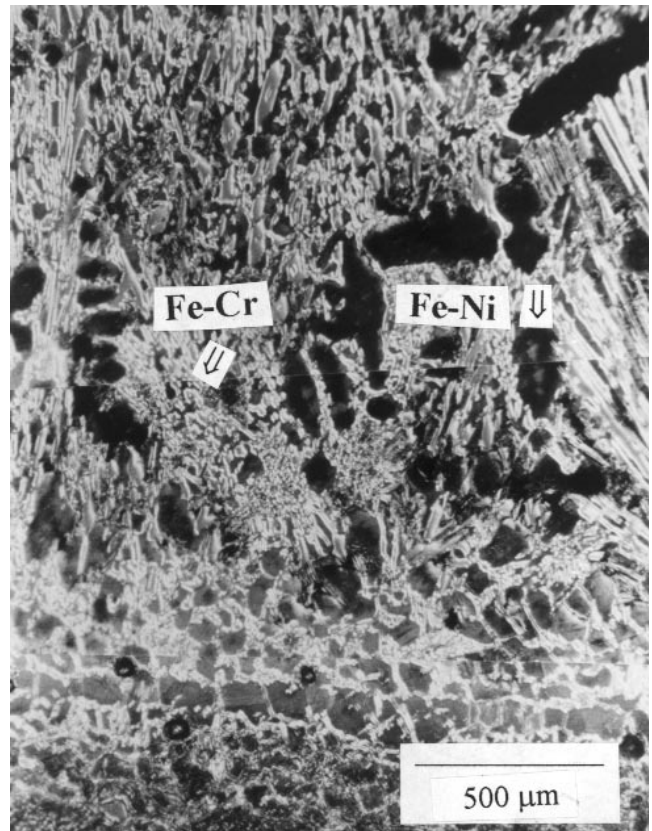
Fig. 4 Microstructure observed in the thickest section of the coil, where material was deposited from the upper part of the coil. The deposit region is denoted Fe-Ni and Fe-Cr. 50X

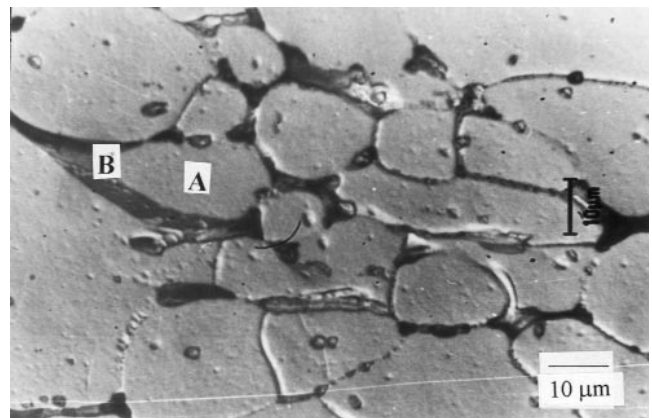
Fig. 5 Microstructure of a 304 SS coil, where depletion of chromium was detected at the grain boundaries. In point A, 18wt% Cr was detected, and in point B, 15wt% Cr was found.

Microanalysis of the sensitized austenitic grains shows a depletion of chromium. For instance, at point A of Fig. 5, the amount of Cr decreased from 18 to about 15 wt.% close to the grain boundary (point B). Figures 6(a) and (b) show the map-

As these precipitates form, local depletion of both Cr and C occurs in the parts of the grain close to the boundary, as shown in Fig. 5. In this specific case, the sensitized process occurs when the 304 stainless steel coils are heated to a temperature close to 650 $^{\circ}\text{C}$, the operating temperature of the second stage of the preheating zone of reduction gases in heater 3. When the heater is occasionally shut down for maintenance, the 304 stainless steel coils are cooled slowly over a period of 48 h from 650 $^{\circ}\text{C}$ to room temperature. It is important to mention that this sensitization phenomenon has only been observed in coils located in the second stage of the preheating zone (CC-104) at a temperature close to 650 $^{\circ}\text{C}$. However, despite the presence of traces of sulfur, no other kind of corrosion mechanism was detected.

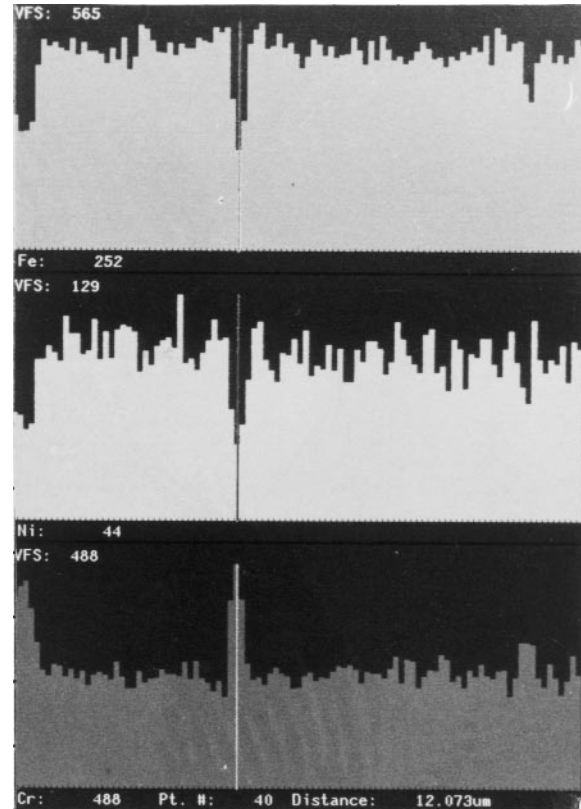
ping and line scans of elements, respectively. It can be observed that Cr is concentrated at grain boundaries and in regions where slip bands are present. Experimental evidence of this phenomenon is shown in Fig. 6(c), where it can be observed that in intergranular spacing, there is a detachment of particles in which an void of about 10 to 20 μm is present, causing the intergranular corrosion of stainless steels as a result of the precipitation of carbides of the type Cr_{23}C_6 (as identified by mapping and line scans) in the intergranular region and a corresponding depletion in the chromium content.

Fig. 6 (a) SEM mapping of chromium in a 304 SS coil. (b) SEM line scan analysis of Cr, Fe, and Ni. (c) Microstructure of a 304 SS coil, where there is detachment of particles in which voids are present (arrow shows the position where particles were detached leaving voids).

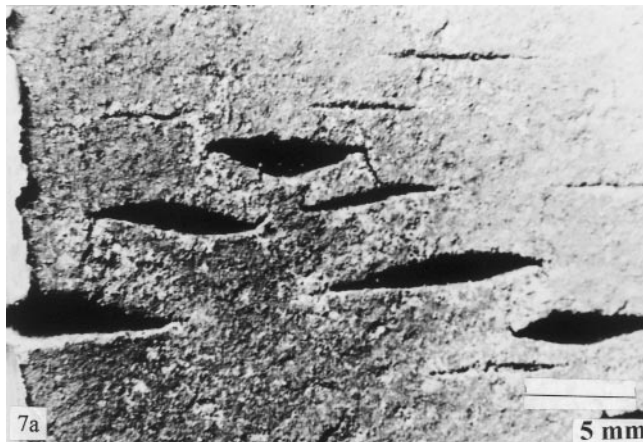
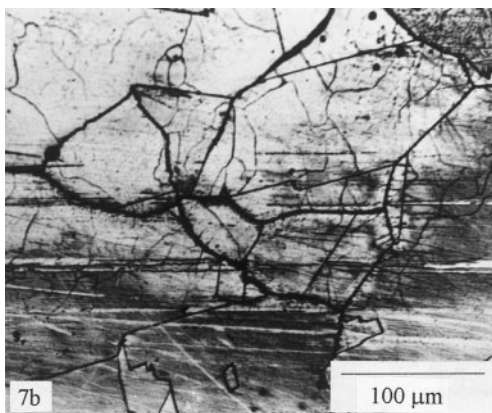
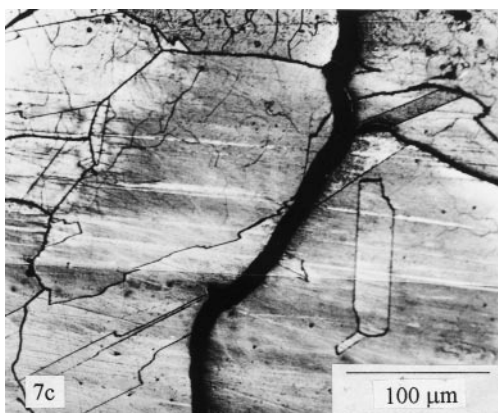
Figure 7(a) shows a series of elongated rhombohedral cracks located on the inside wall of the coil of section CC-105A. Figure 7(b) shows a transverse section of the cracks, which are stress corrosion cracks that run along the grain boundaries. Figure 7(c) shows another area of the grains affected by stress corrosion cracking. Figure 8 shows an x-ray diffraction pattern of the corrosion products removed from the inside wall of the corroded coil. The identified species were Fe_3O_4 and FeS , as a corrosion product is due to some sulfur

being present in the reducing gases, which suggests that the corrosion process of stress corrosion cracking is accelerated by the presence of this element.

Fig. 7 (a) Elongated rhombohedral cracks are observed in the inside wall of the coil located in section CC-105 (section B, Fig. 1). (b) and (c) The microstructure observed in transverse sections of the rhombohedral cracks. Both at 500X

tinuous protective scales of chromium sesquioxide under certain conditions, resulting in a discrete presence of sulfide precipitates immediately beneath the protective oxide scales. In our case, FeS can be detected by x-ray diffraction, which allows the presence of the assumption that this sulfide is the product of an accelerated attack caused by a rich amount of sulfur present in the gas (about 4 to 7 ppm of S).

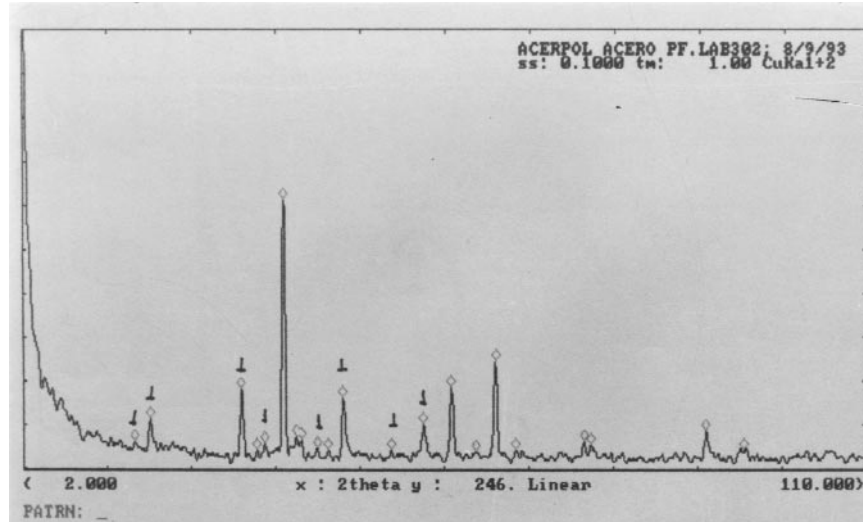
Fig. 8 X-ray diffraction pattern (counts per second; cps vs KeV) of corrosion products removed from the inside wall of a 304 SS coil section CC-105 (section **B**, Fig. 1). Peak notations are 1 = FeS; others are Fe₃O₄.

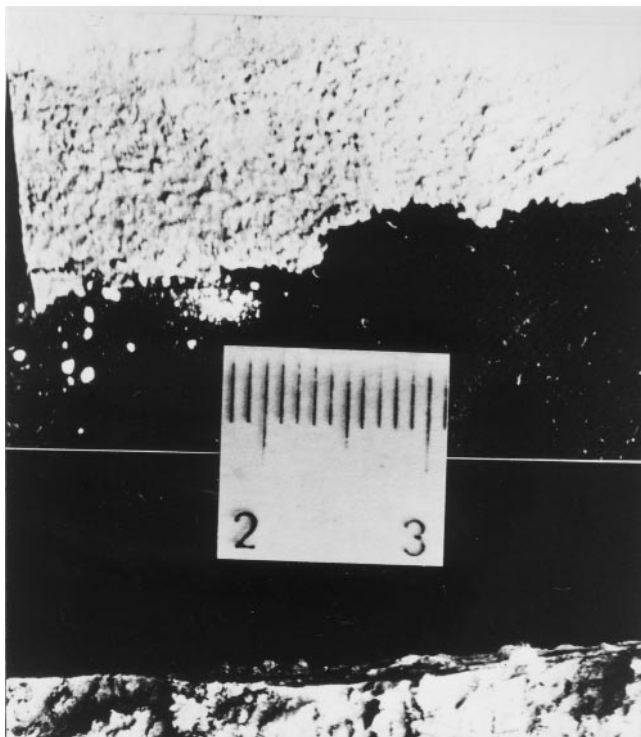
Finally, a tube was located in the region of high temperature marked by a square in Fig. 1, which showed a composition of 1.35–0.42% C, 1.45–1.55% Mn, 1.42–1.53% Si, 24–27% Cr, 33–36% Ni, Fe balance. Alloys of this composition are fully austenitic and exhibit high strength at elevated temperatures. They can withstand considerable temperature cycling and severe thermal gradients and are well suited for many reducing, as well as oxidizing, environments. These heat-resistant steel castings are extensively used for applications involving service temperatures in excess of 650 °C. Strength at these elevated temperatures is only one criteria by which these materials are selected, because the applications also involve aggressive environments to which the steel must be resistant. The atmospheres most commonly encountered are air and flue gases; such atmospheres may be either oxidizing or reducing and may be sulfidizing or carburizing if sulfur or carbon is present. As shown in Fig. 9, the phenomenon of metal dusting occurred in this alloy.

Fig. 9 Metal dusting observed in the inside wall of HK-40 heat-resistant alloy tube. The distance scale is in centimeter units of length.

This implies that the use of a continuous injection of H₂S into the reducing atmosphere in the direct reduction process will probably solve the problem of metal dusting in the temperature range between 900 and 1000 °C (*i.e.*, H₂S/H₂ ≈ 10⁻⁴, a_c ≈ 1). It will not solve the problem at lower temperatures, because carbon activities will be higher and different values of the ratio H₂S/H₂ will be needed. It will also not solve the problem of stress corrosion cracking and the sensitization observed in the range of temperatures between 200 to 650 °C.
