Influence of Service-Induced Microstructural Changes on the Aging Kinetics of Rejuvenated Ni-Based Superalloy Gas Turbine Blades

E. Lvova and D. Norsworthy

Keywords gas turbine blades, HIP, IN738 alloy, nickel-based superalloys

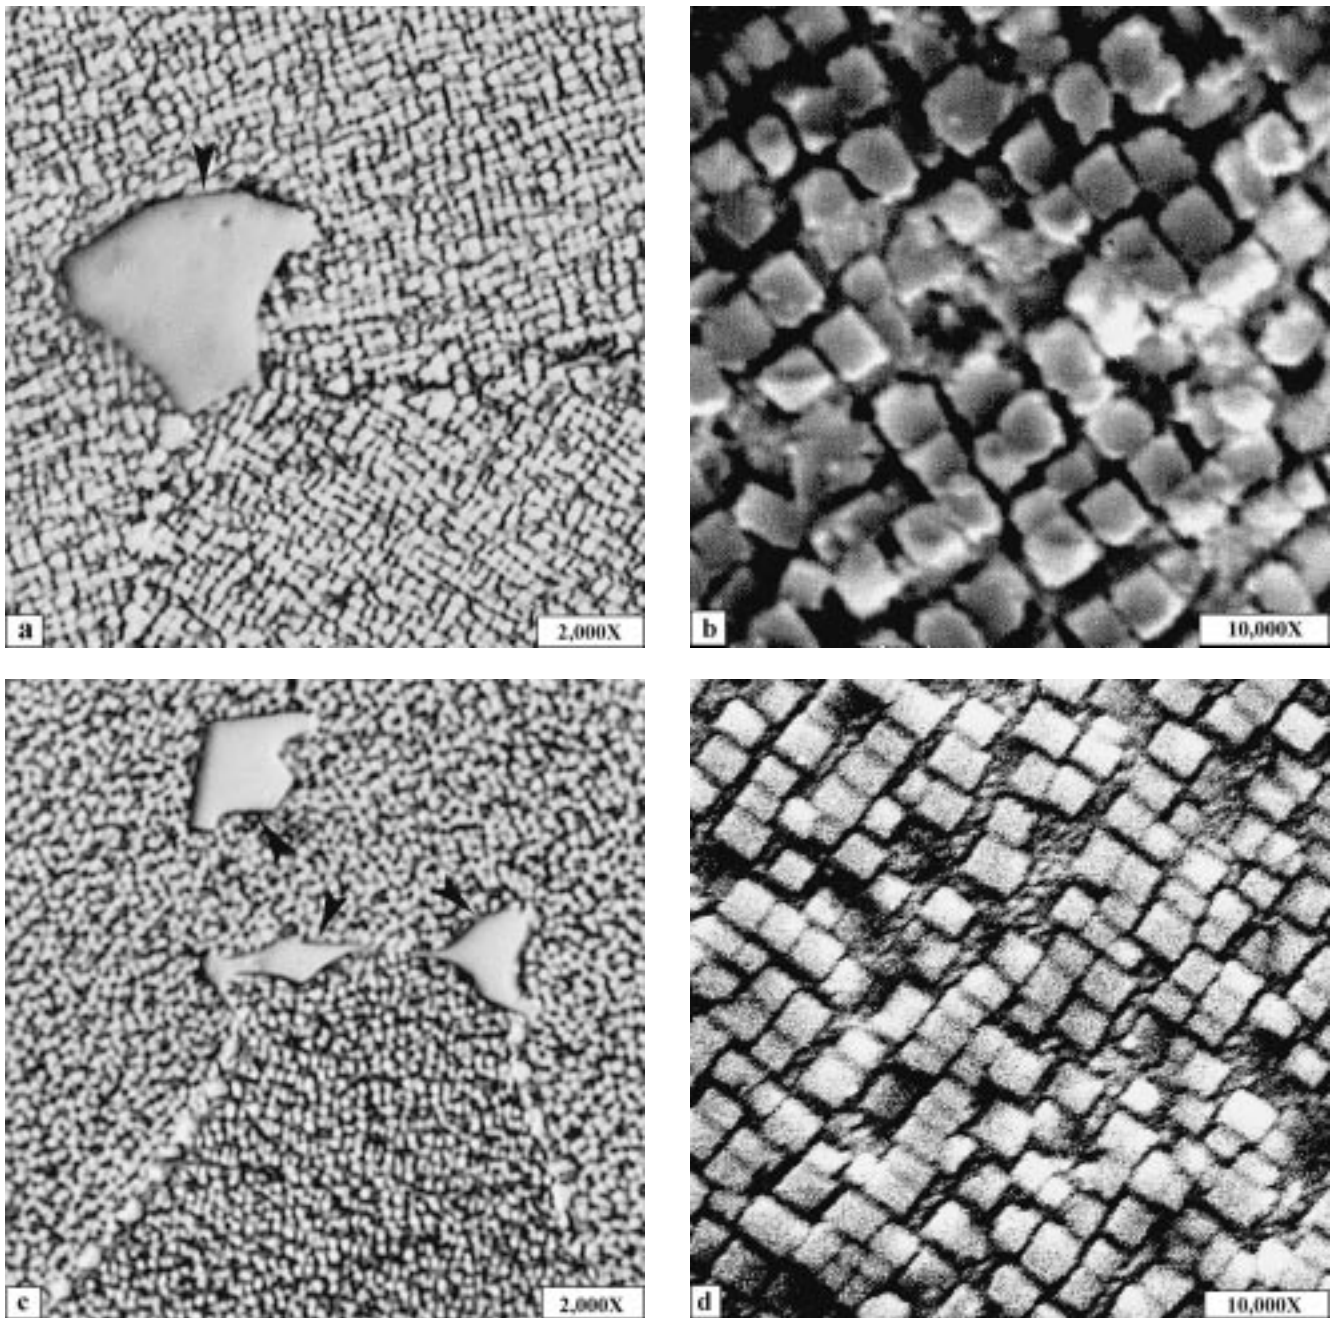
Fig. 1 Microstructure of (a) and (b) Blade 1 and (c) and (d) Blade 2 root specimens in the as-received condition. (a) and (c) Optical micrographs and (b) and (d) SEM micrographs. Arrowheads indicate primary MC carbides (etchant—electrolytic chromic acid)

The microstructures of the root specimens of Blade 1 and Blade 2 are presented in Fig. 1 (the microstructures of the Blade 3 and Blade 4 root specimens are very similar to that of Blade 2). The root microstructure is typical for a virgin cast superalloy: γ' phase exists in three distinctive morphologies—eutectic lamellar γ' formed between dendrite arms, primary cuboidal γ' , and secondary spheroidal γ' ; primary MC carbides formed at the grain boundaries and in the interdendritic areas; and fine globular secondary $M_{23}C_6$ carbides decorating the grain boundaries. The micrographs of the Blade 1 and Blade 2 leading edge specimens at one-half airfoil height are presented in Fig. 2 (the microstructures of the Blade 3 and Blade 4 leading edge specimens are very similar to that of Blade 2). Service-induced changes in the leading edge microstructure compared to that of the root are significant and typical for service-exposed gas turbine blades.^[1–7,11] The micrographs revealed severe overaging induced by thermal and stress exposure during service. The primary γ' precipitates coarsened considerably at the expense of the secondary γ' ; the grain-boundary $M_{23}C_6$ carbide particles coarsened and coalesced, overloading the grain boundaries and

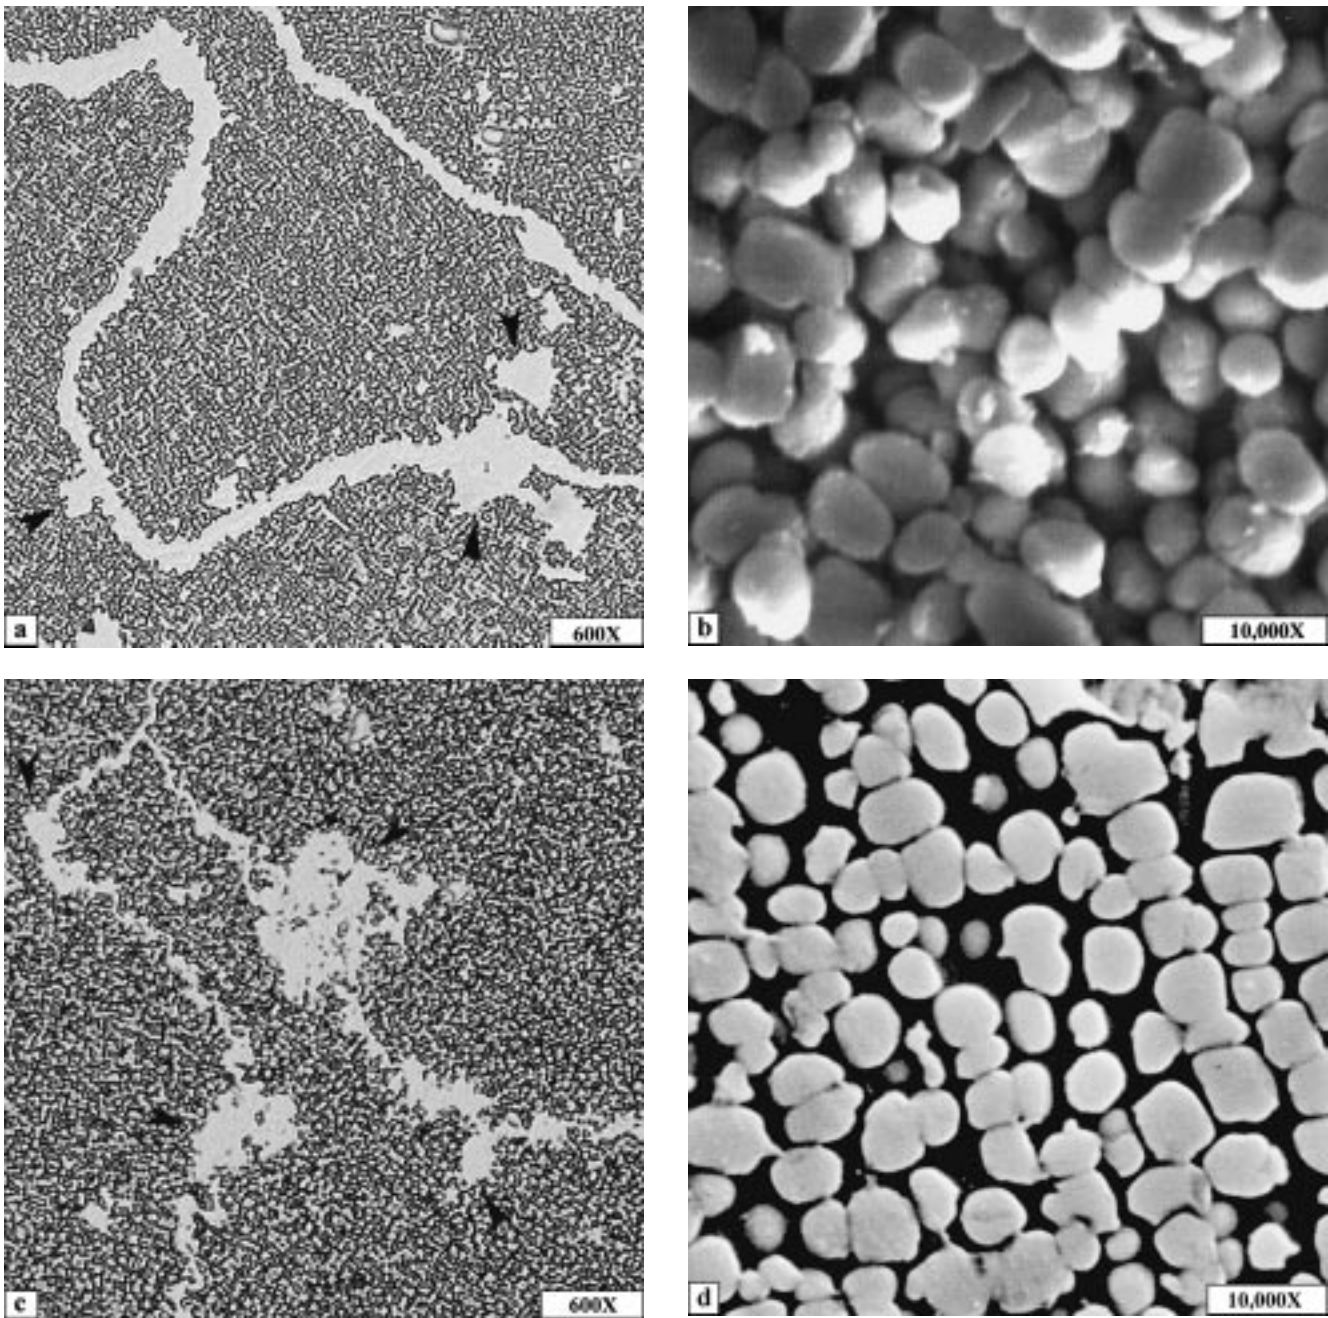
Fig. 2 Microstructure of the (a) and (b) Blade 1 and (c) and (d) Blade 2 leading edge specimens in the as-received condition. (a) and (c) Optical micrographs and (b) and (d) SEM micrographs. Arrowheads indicate degenerated primary MC carbides (etchant—electrolytic chromic acid)

forming continuous films at some areas; and primary MC carbides degenerated.

The service-induced deterioration of the airfoil microstructure caused a significant reduction of the stress-rupture life, ductility, and microhardness compared to that of the root. Excessive grain-boundary $M_{23}C_6$ carbide precipitation led to decreasing creep resistance by preventing grain-boundary sliding, initiating void formation, and decreasing overall plasticity. Coarsening and coalescence of γ' precipitates caused a decrease of the tensile strength. The results of the stress-rupture and microhardness tests are presented in Table 2 and 3, respectively.

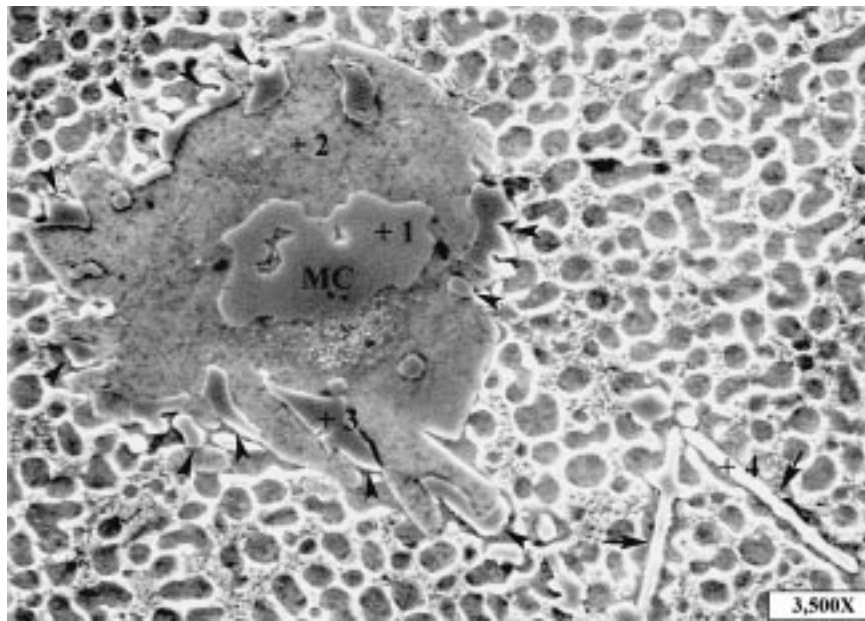
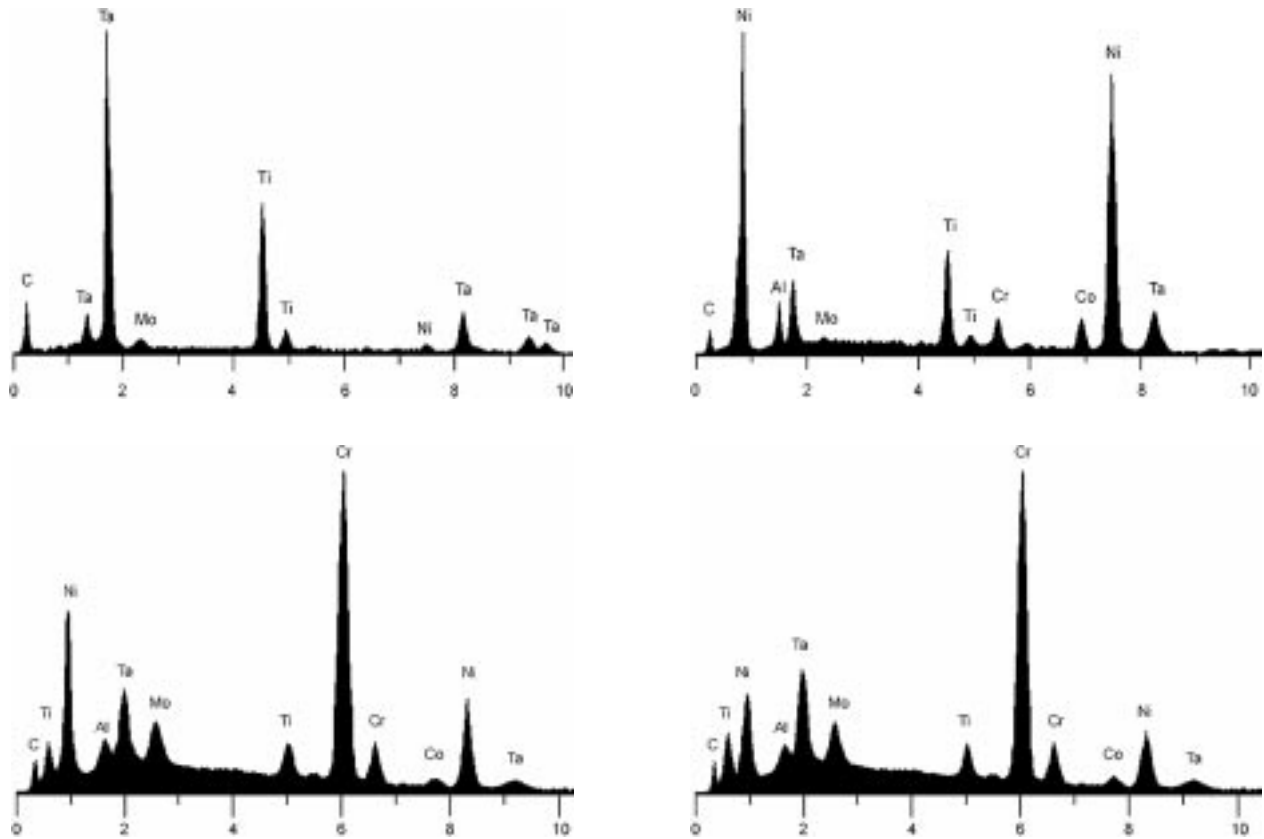
Fig. 3 SEM micrograph and EDX spectra of the degenerated MC carbide in the Blade 1 leading-edge specimen in the as-received condition. $M_{23}C_6$ carbides formed at the edges of the original MC carbide (arrowheads). $M_{23}C_6$ carbides precipitated also in the lathlike morphology (arrows). Energy-dispersive X-ray spectra from marked locations in the micrograph are shown (etchant—Kalling's reagent)

The MC carbide decomposition reaction was assumed to be $MC + \gamma \rightarrow M_{23}C_6 + \gamma'$.^[3–5,14] $M_{23}C_6$ carbides form at the periphery of the original MC carbides, and the area adjacent to the MC core is supposed to consist of γ' phase. The EDX spectra of the decomposition zone surrounding degenerated MC carbides in the service-exposed Blade 1 and Blade 2 leading edge specimens given in Fig. 3 and 4 did not confirm this assumption. These spectra demonstrate the presence of a substantial amount of carbon, which indicates that the phase from which they were taken cannot be γ' . The comparison of the spectrum from the γ' particle with that from the MC decomposition zone in Fig. 4 illustrates the difference.

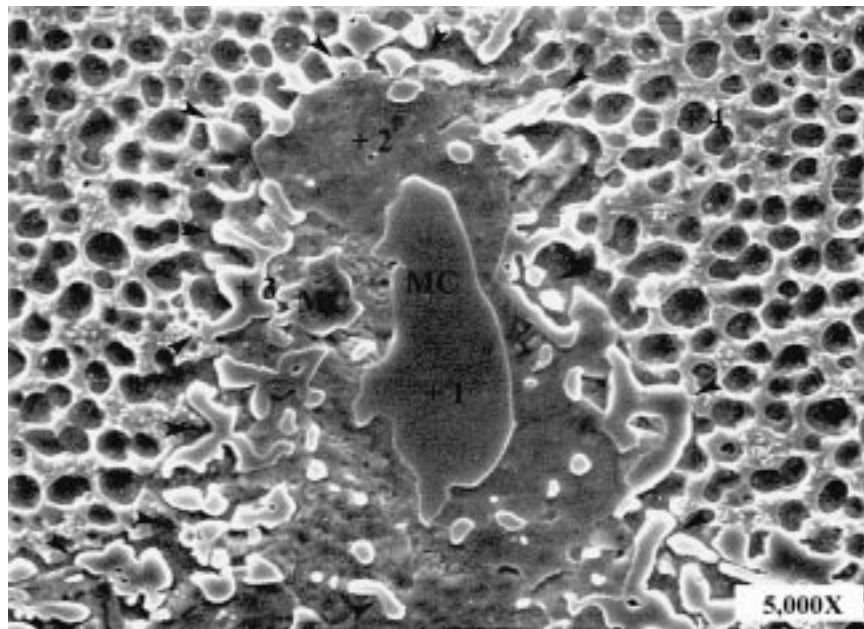
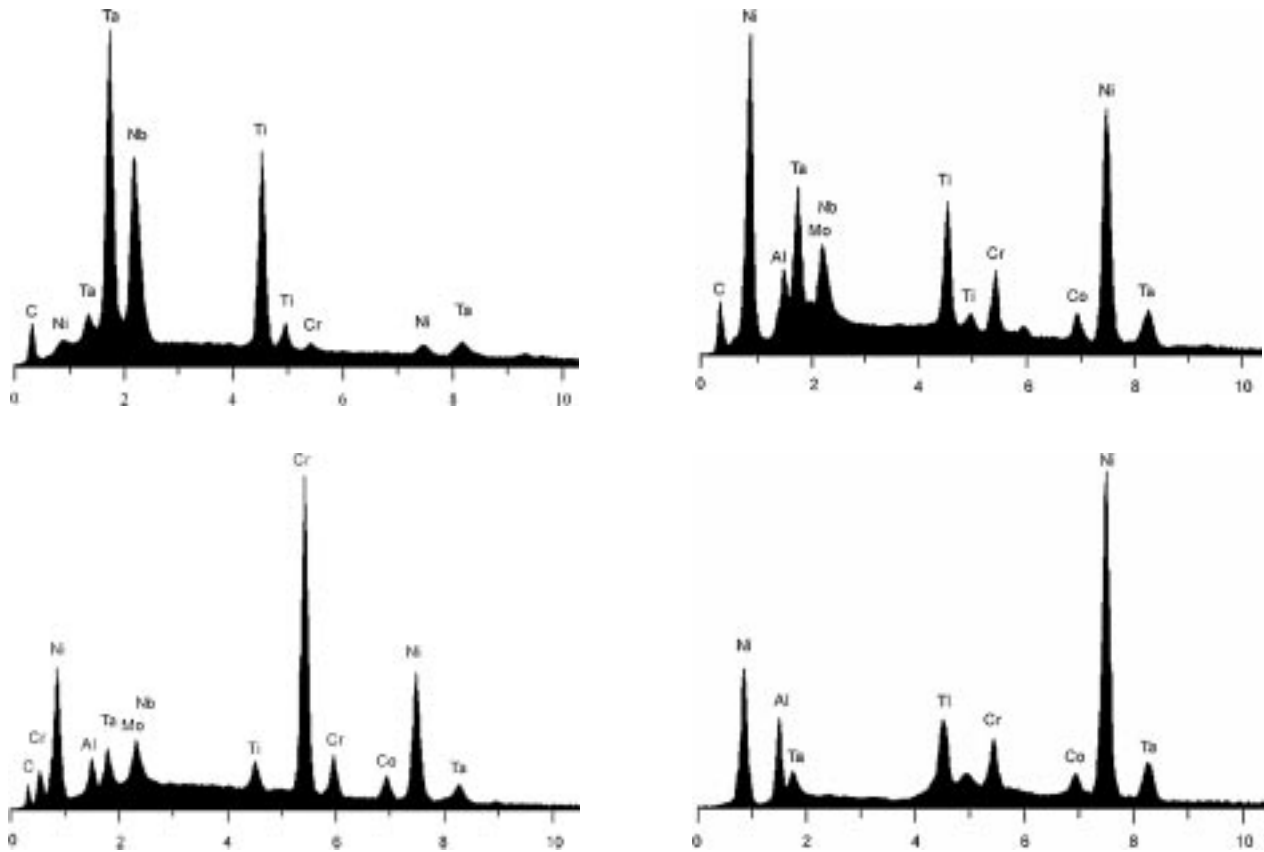
Fig. 4 SEM micrograph and EDX spectra of the degenerated MC carbides in the Blade 2 leading-edge specimen in the as-received condition. Arrowheads indicate $M_{23}C_6$ carbides formed at the edges of the original MC carbides as a result of MC decomposition. Energy-dispersive X-ray spectra from marked locations in the micrograph are shown (etchant—Kalling’s reagent)

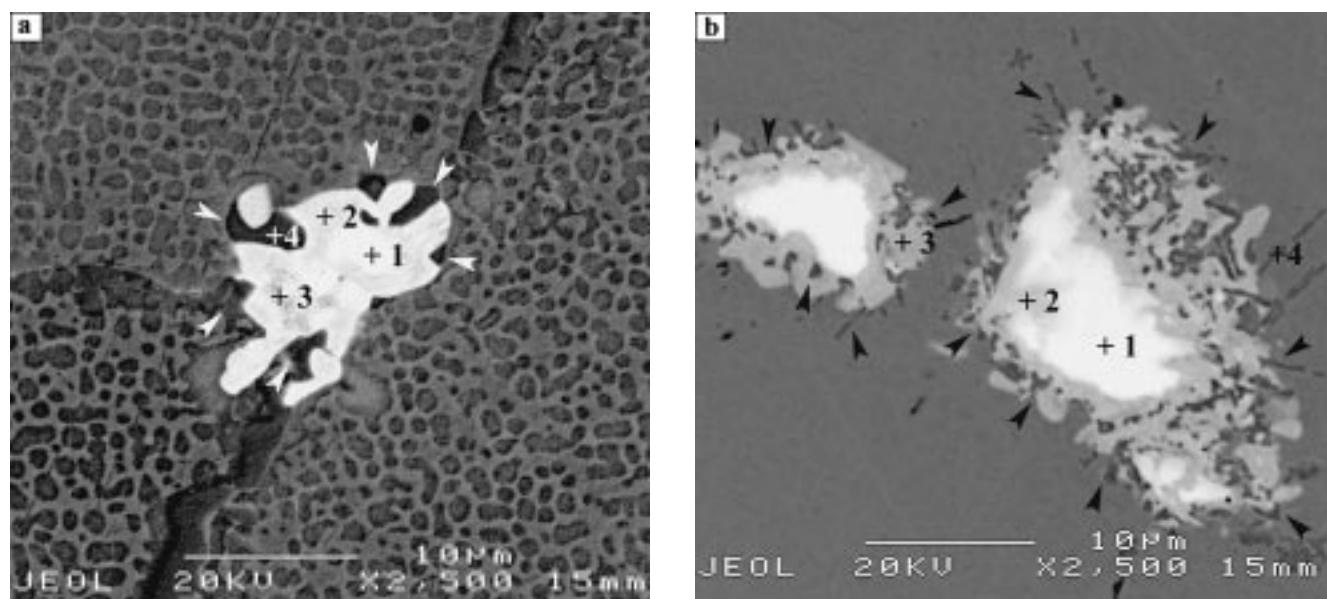
Fig. 5 SEM-BEI micrographs of the degenerated MC carbides in the (a) Blade 1 and (b) Blade 2 leading-edge specimens in the as-received condition. Dark gray $M_{23}C_6$ carbides (arrowheads) formed on the periphery of MC carbides (light) as a result of the MC decomposition. EDS analysis data from marked locations are shown in the respective tables (as-polished)

BEI micrographs and the results of EDS analysis of the degenerated MC carbides of GTD-111 and IN-738 alloys are presented in Fig. 5. The BEI micrographs show a presence of dark $M_{23}C_6$ carbides at the MC periphery formed as discrete particles and as laths. A gradual change of the contrast of MC carbide toward its edges can be noted, indicating a change of its chemical composition (it is known that the elemental concentration of MC carbides can vary in a wide range). There is a noticeable difference between γ' contrast and that of the MC decomposition zone. If one of the products of the MC decomposition were γ' phase, it would have had the same contrast as the original

γ' phase. This observation allows us to conclude that γ' phase does not form during MC decomposition.

The EDS analysis results show a substantial change of the MC carbide elemental concentration toward its edges; a tendency of carbon content to decrease from the center to the periphery is evident (Fig. 5). Apparently, diffusion of carbon from the metastable MC carbide in to surrounding γ matrix takes place during prolonged thermal exposure, creating a favorable condition for the formation of more stable lower-order $M_{23}C_6$ carbides on the MC/ γ interface. The MC carbides serve as a carbon source and γ matrix as a chromium reservoir for the

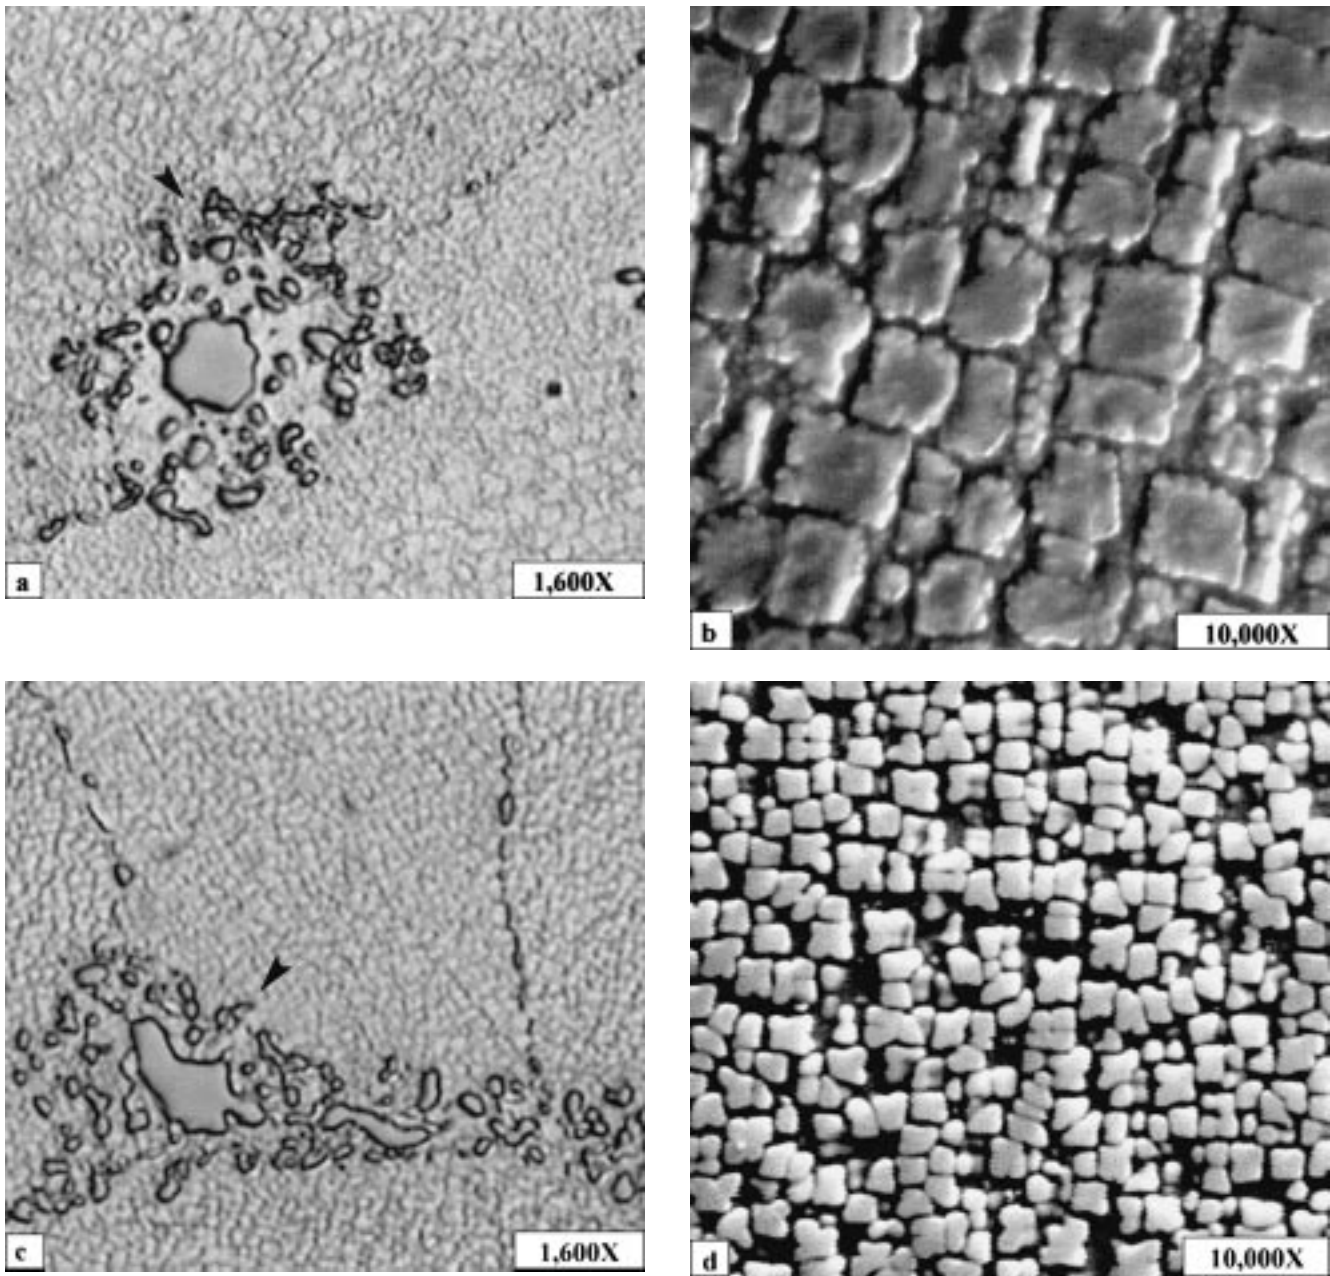
Fig. 6 Micrographs of the (a) and (b) Blade 1 and (c) and (d) Blade 2 leading-edge specimens after rejuvenation. (a) and (c) Optical micrographs and (b) and (d) SEM micrographs. Arrowheads indicate disintegrated primary MC carbides (etchants: (a) and (c) Kalling's reagent and (b) and (d) electrolytic chromic acid)

The improvement of the material properties was a result of the restoration of the airfoil microstructure. The micrographs in Fig. 6 reveal the elimination of the excessive grain-boundary carbide precipitation and the refinement of the primary and secondary γ' particles. The morphology of the primary γ' particles is predominantly cuboidal, although not ideally. The microstructure of the rejuvenated leading edge specimens looks similar to that of the root in the as-received condition, except for primary MC carbide morphology: instead of large blocky particles, there are fragments of the original primary carbides present (Fig. 6a and c). The products of the MC carbide decomposition ($M_{23}C_6$ carbides and low-carbon degenerated portions of MC carbides) were dissolved in γ -solid solution during HIP, leaving remnants of original primary MC carbides—unaffected core surrounded with small MC fragments (Fig. 7). The EDS analysis data in Fig. 7 show lower carbon concentrations in the surrounding debris compared to that of the unaffected central part of the original MC carbides. Obviously, dissolved degenerated MC portions had even lower carbon concentration.

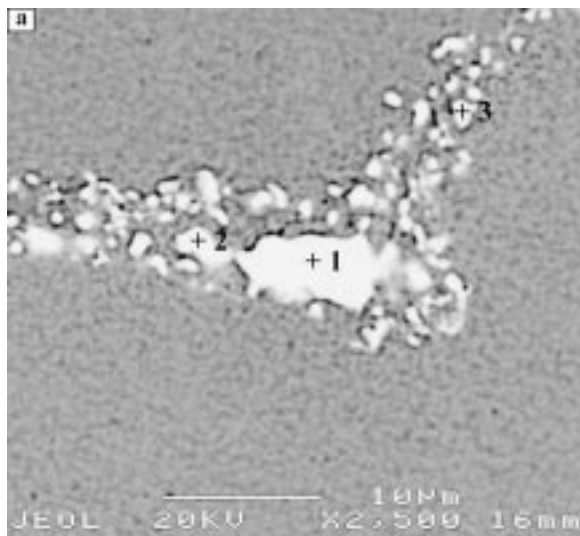
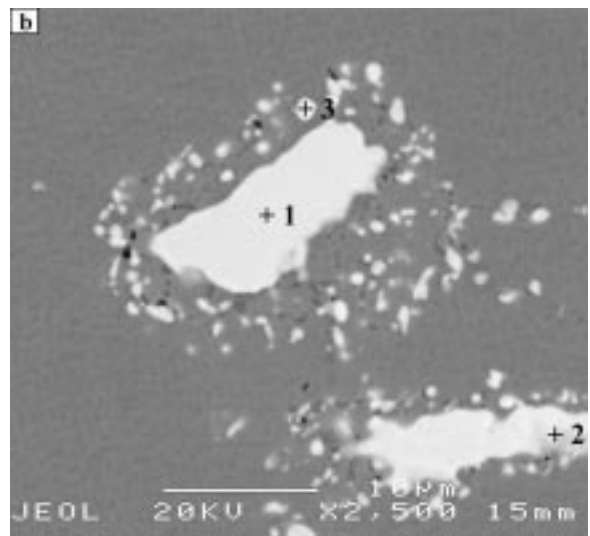
Fig. 7 SEM-BEI micrographs of the degenerated MC carbides in (a) Blade 1 and (b) Blade 2 leading after rejuvenation. EDS analysis results from marked locations are shown in the respective tables (as-polished)

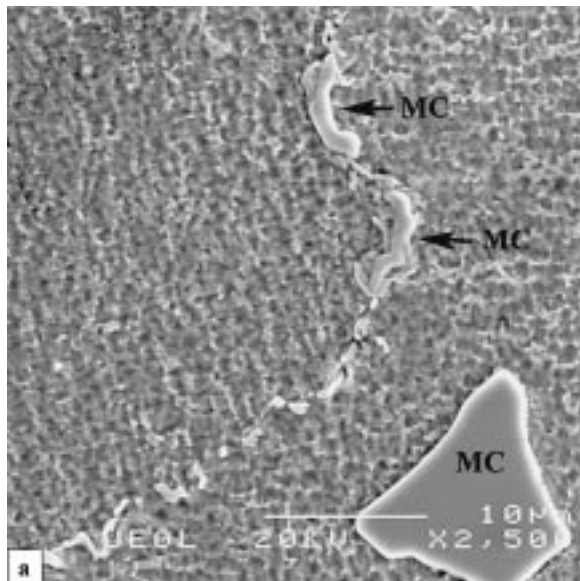
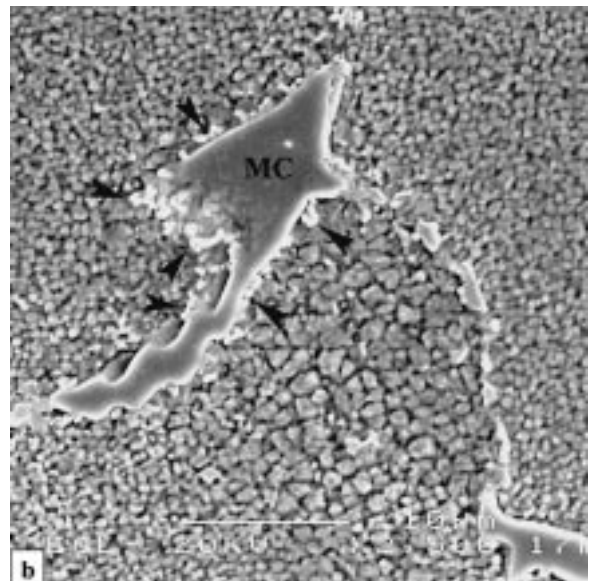
Fig. 8 SEM micrographs of rejuvenated (a) Blade 1 and (b) Blade 2 root specimens after 1000 h aging at 815 °C. Arrowheads indicated fine $M_{23}C_6$ precipitates at MC carbide edges: (a) BEI (as-polished) and (b) SEI (etchant—Kalling's reagent)

The comparison of the rejuvenated Blade 2 root and the leading edge microstructures after aging shows that they demonstrate a similar tendency, although the aged root specimen reveals a presence of early stages of MC decomposition: the SEM secondary electron image. Figure 8(b) shows a number of very fine globular $M_{23}C_6$ carbides formed around primary MC carbides. The microstructure of the rejuvenated and aged Blade 2 leading edge is typically overaged with the grain boundaries overloaded by $M_{23}C_6$ carbides and coarsened and coalesced γ' (Fig. 9c and d and Fig. 10b). The SEM backscattered electron micrograph in Fig. 9(d) shows gradually changing MC carbide contrast due to additional decomposition of the previously degenerated MC carbides.

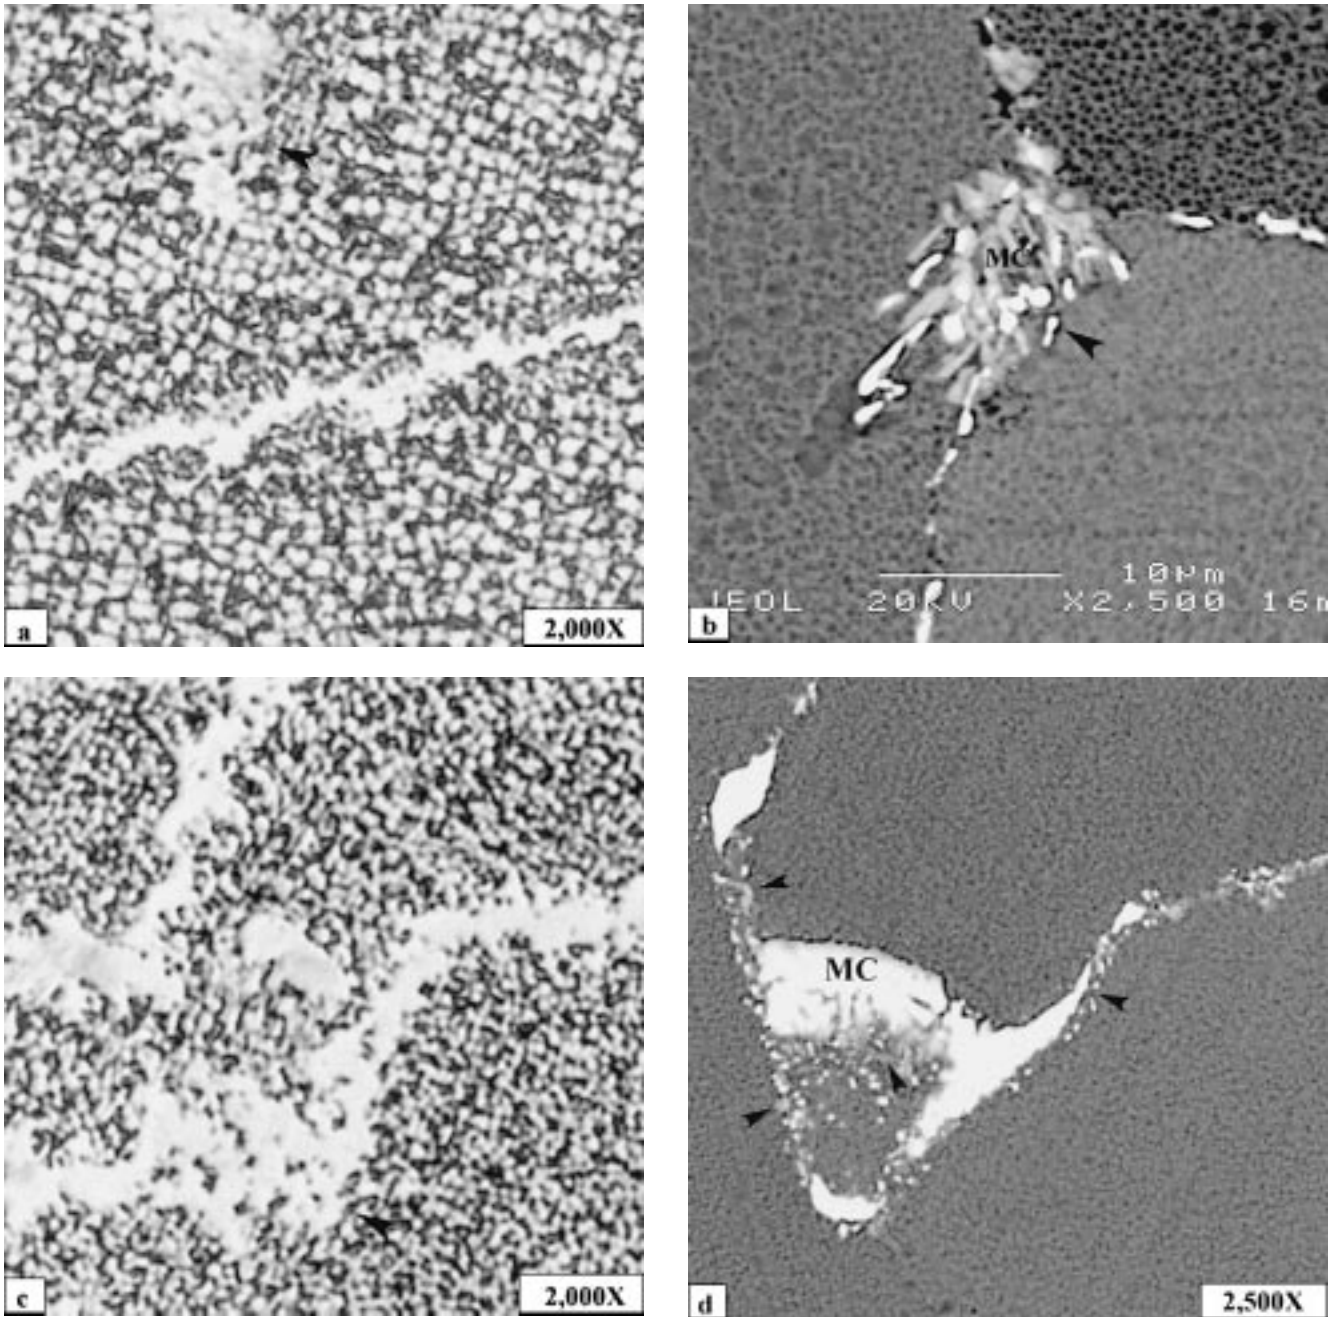
Fig. 9 Micrographs of rejuvenated (a) and (b) Blade 1 and (c) and (d) Blade 2 leading-edge specimens after 1000 h aging at 815 °C. Arrowheads indicate previously degenerated MC carbides continuing to deteriorate during aging. (a) and (c) Optical micrographs (etchant—electrolytic chromic acid) and (b) and (d) SEM-BEI micrograph (as-polished)

The effect of aging on the microstructure of the rejuvenated airfoils was compared to that of the root, since the root material showed no primary MC carbide decomposition during service. The micrographs of the rejuvenated root and leading edge specimens after 1000 h aging at 845 °C are presented in Fig. 8 to 10; they reveal a significant acceleration of the aging process in the leading edge compared to the root. While the microstructure of the rejuvenated Blade 1 root is similar to that in the “as-received” condition (practically as new material, Fig. 8a), the Blade 1 leading edge microstructure demonstrates characteristic signs of overaging: excessive secondary carbide precipitation on the grain boundaries and γ' coarsening (Fig. 9a and 10a). The SEM backscattered electron image in Fig. 9(b) shows a change of the contrast of the MC fragments, that is, a previously degenerated MC carbide readily decomposed during aging.

blades. The aging process has evidently accelerated in the mid-airfoil in comparison to the root. The cause of this appears to be the release of additional amounts of carbon into γ -solid solution from dissolution of the MC carbide decomposition products during rejuvenating HIP or solution annealing. The aging acceleration can be expected to be higher when service-induced microstructural deterioration is more advanced, as happens often in modern machines with firing temperatures above 1250 °C, despite the use of protective coatings. In order to extend the blade's life, it seems to be prudent to avoid the extensive primary MC carbide decomposition by reducing the periods between rejuvenations.

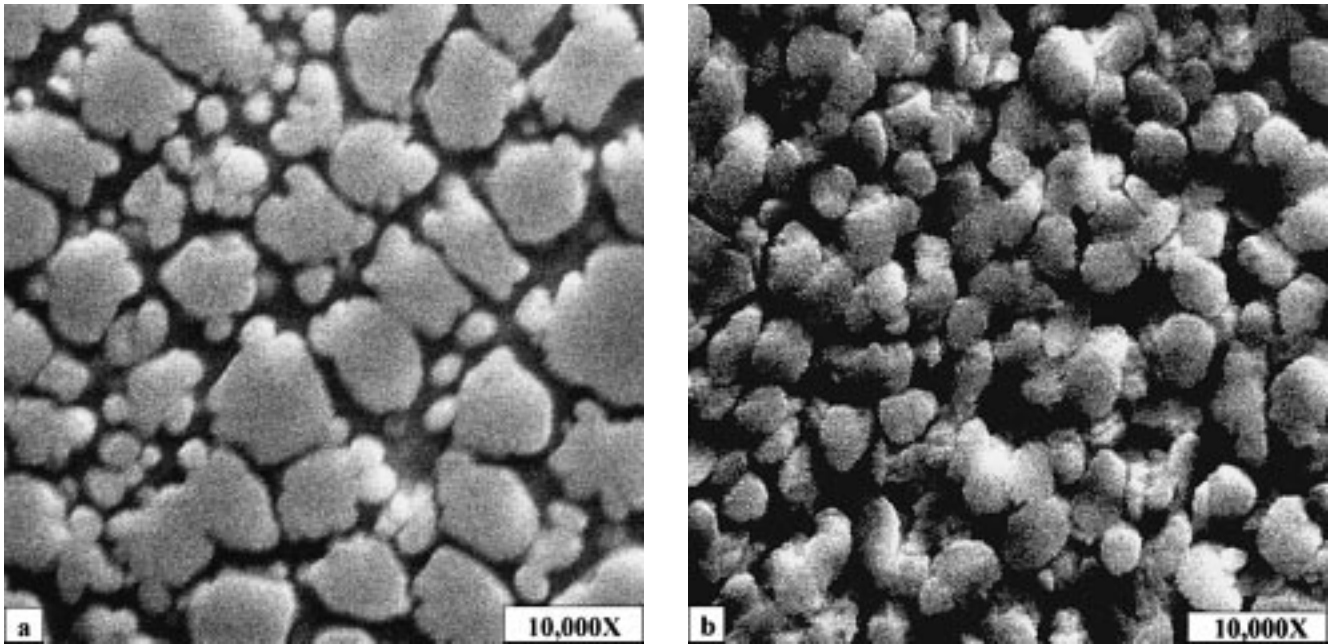
Fig. 10 SEM micrographs of γ' phase in rejuvenated (a) Blade 1 and (b) Blade 2 leading-edge specimens after 1000 h aging at 815 °C (etchants—electrolytic chromic acid)

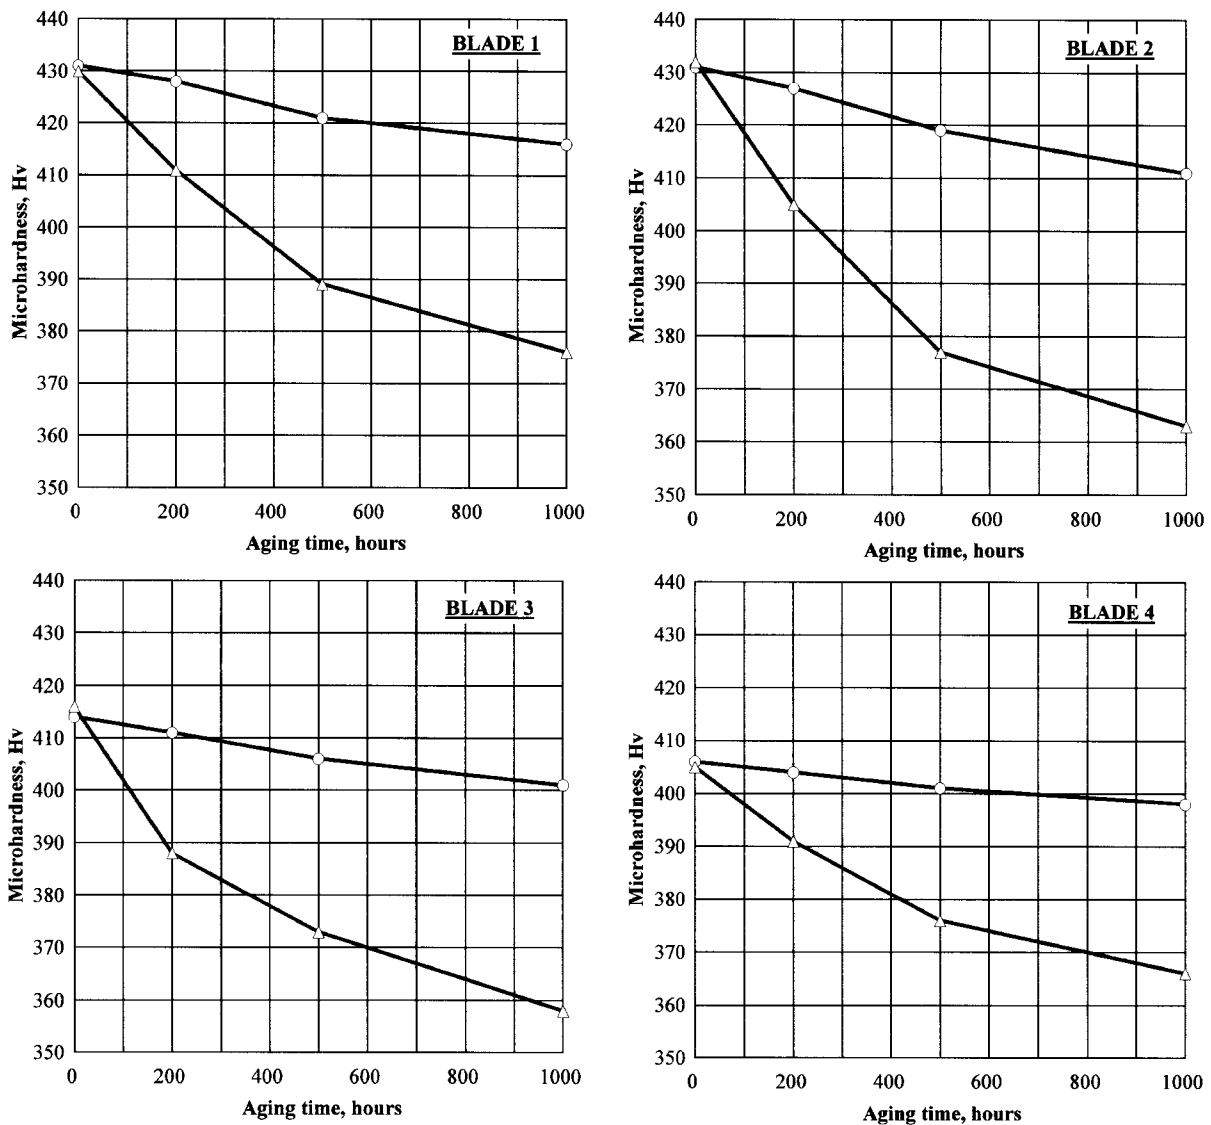
Fig. 11 Influence of aging at 815 °C on the microhardness of rejuvenated blades: ○—root; △—leading edge

microhardness: while the root microhardness decreases slightly, the reduction of the leading edge microhardness is substantial (Fig. 11). The results of the short-term stress-rupture tests also display the difference between rejuvenated and aged root and mid-airfoil behavior. The acceleration of the aging process in the rejuvenated airfoil caused a noticeable reduction of its stress-rupture life and plasticity compared to that of the root (Fig. 12). A comparison of the SEM micrographs of the root and airfoil fracture surfaces illustrates the difference of the fracture mode (Fig. 13). The root specimen from the rejuvenated and aged Blade 4 demonstrates predominantly transgranular ductile fracture, while the fracture surface of the mid-airfoil specimen shows distinct interdendritic-intergranular fracture with a formation of the grain-boundary cavities caused by a heavy secondary carbide precipitation.

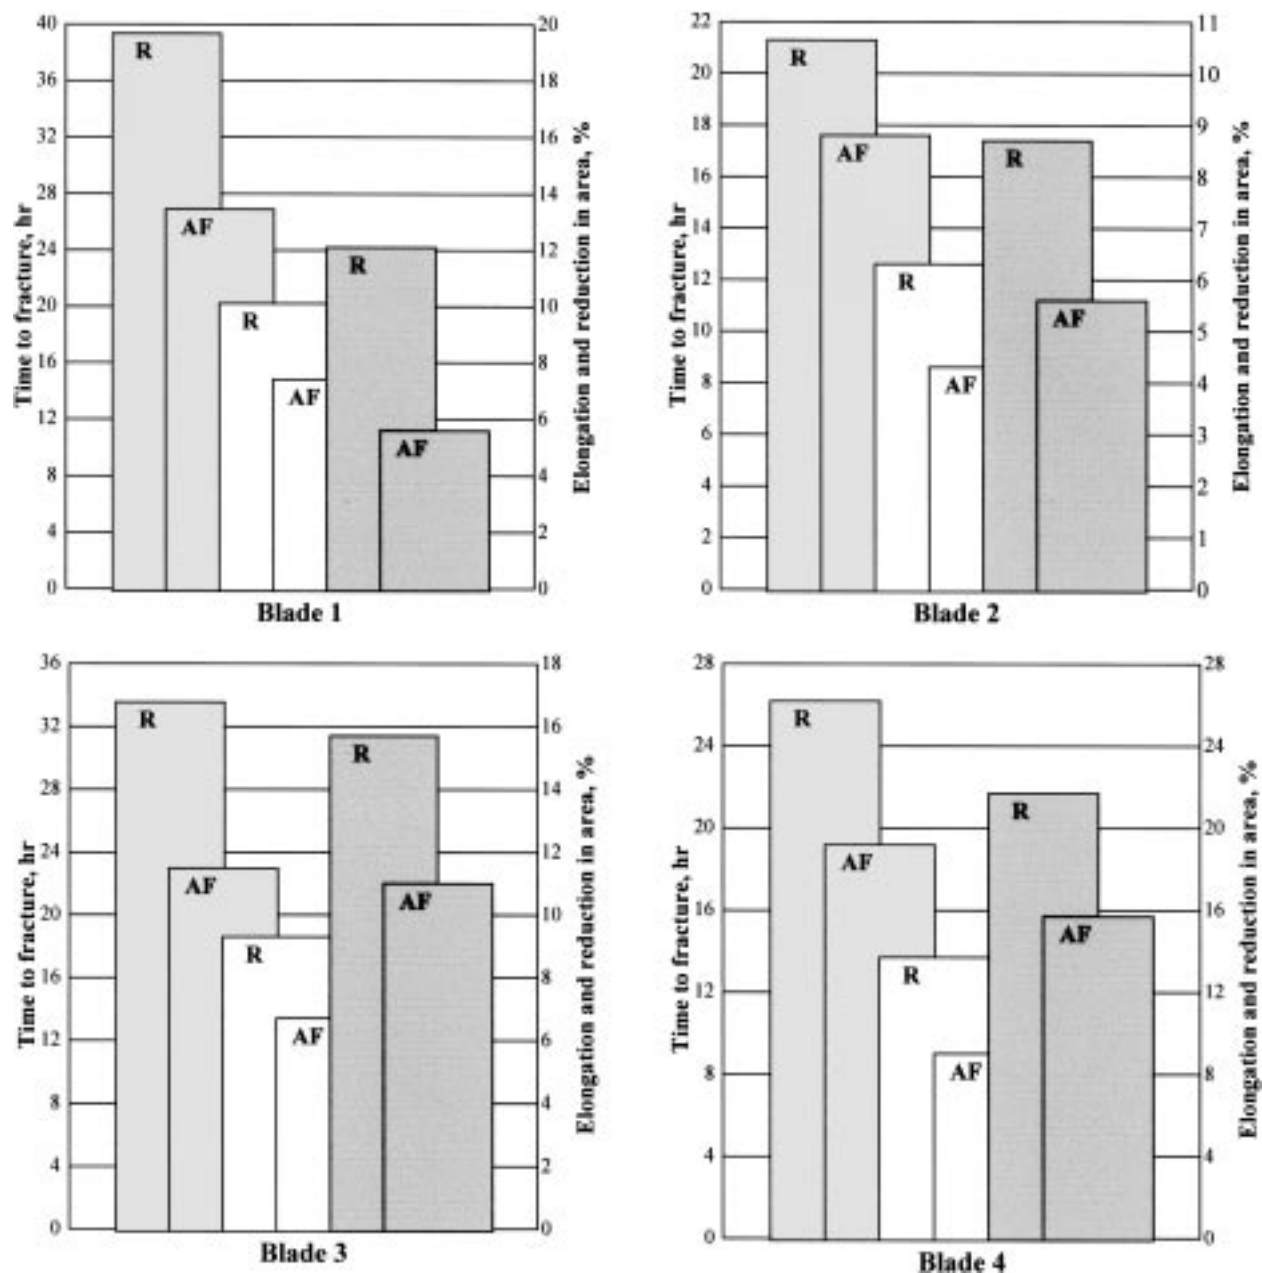
Fig. 12 Results of short-term stress-rupture tests of the rejuvenated blades after 1000 h aging at 815 °C: R—root specimen and AF—airfoil specimen. □—time to fracture, h □—elongation, % ■ reduction in area, %

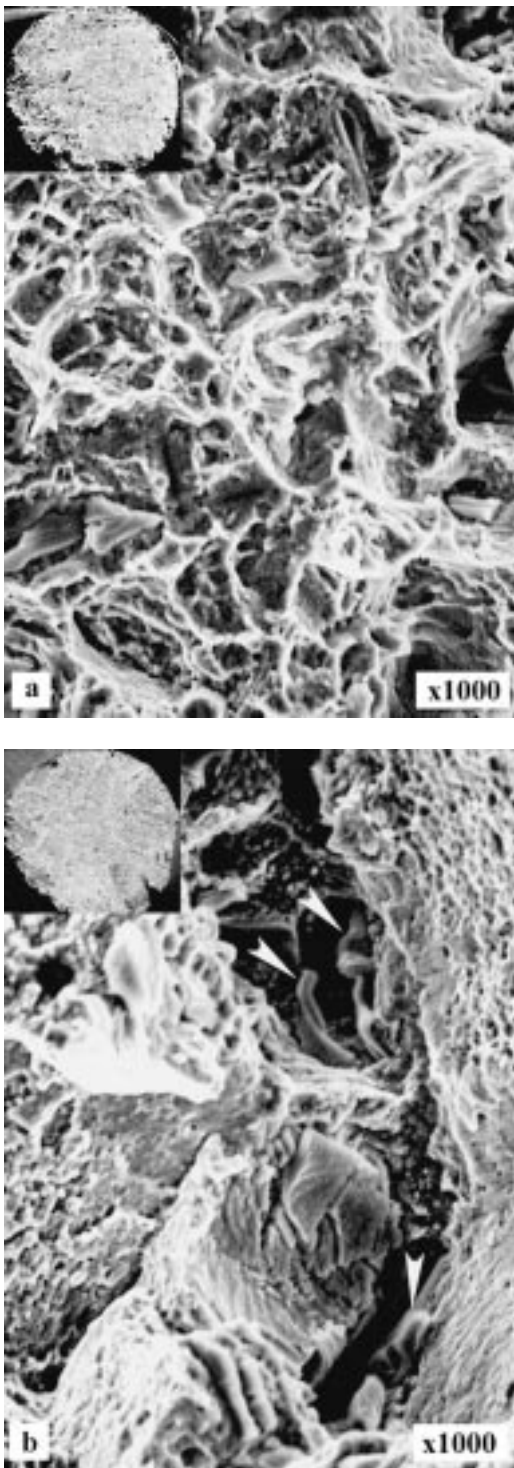
Fig. 13 SEM-micrographs of the fracture surfaces of rejuvenated and aged Blade 4 (a) and (b) root and (c) and (d) airfoil specimens. Arrowheads indicate grain-boundary cavities formed due to heavy $M_{23}C_6$ carbide precipitation
