# In Situ Repair Welding of Steam Turbine Shroud for Replacing a Cracked Blade

S.K. Albert, C.R. Das, V. Ramasubbu, A.K. Bhaduri, S.K. Ray, and Baldev Raj

A root-cracked blade in a high-pressure steam turbine of a nuclear power plant had to be replaced with a new blade by cutting the shroud to remove the cracked blade. This necessitated in situ welding of a new shroud piece with the existing shroud after the blade replacement. The in situ welding of the shroud, a 12%Cr martensitic stainless steel with tempered martensite microstructure, was carried out using gas-tungsten arc welding and 316L austenitic stainless steel filler metal followed by localized postweld heat treatment at 873 K for 1 h using a specially designed electrical resistance-heating furnace. Mock-up trials were carried out to ensure that sound welds could be made under the constraints present during the in situ repair welding operation. In situ metallography of the repair weld after postweld heat treatment confirmed the adequate tempering of the martensitic structure in the heat-affected zone. Metallurgical investigations carried out in the laboratory on a shroud test-piece that had been welded using the same proc

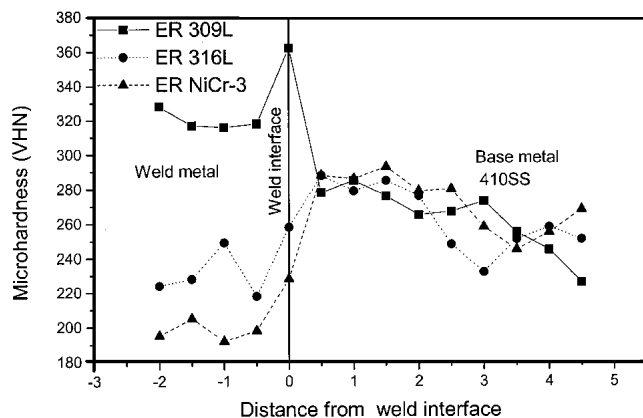
**Fig. 1** Variation of hardness across the weld interface for the weldment made with three different austenitic filler wires after 873 K/1 h PWHT

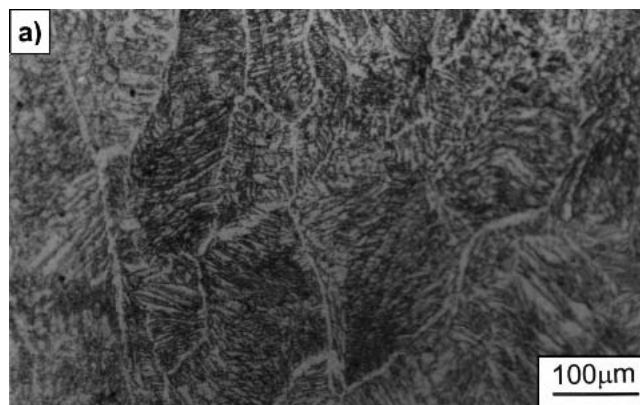
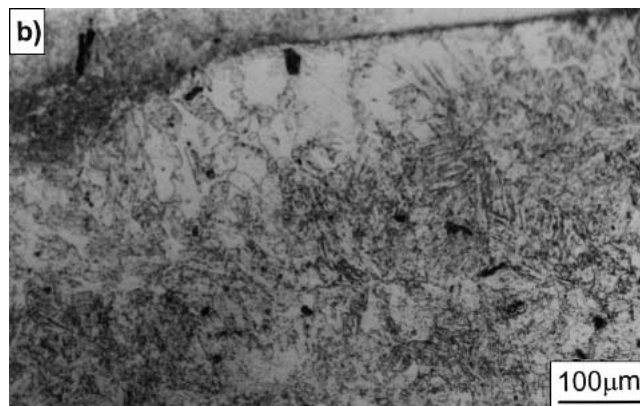
**Fig. 2** In situ metallographs of the microstructures of the repair weldments after 2 years of service (repair executed in 1998): (a) fusion zone in a IV-stage LP-turbine blade; and (b) HAZ near the fusion line in a III-stage HP-turbine shroud

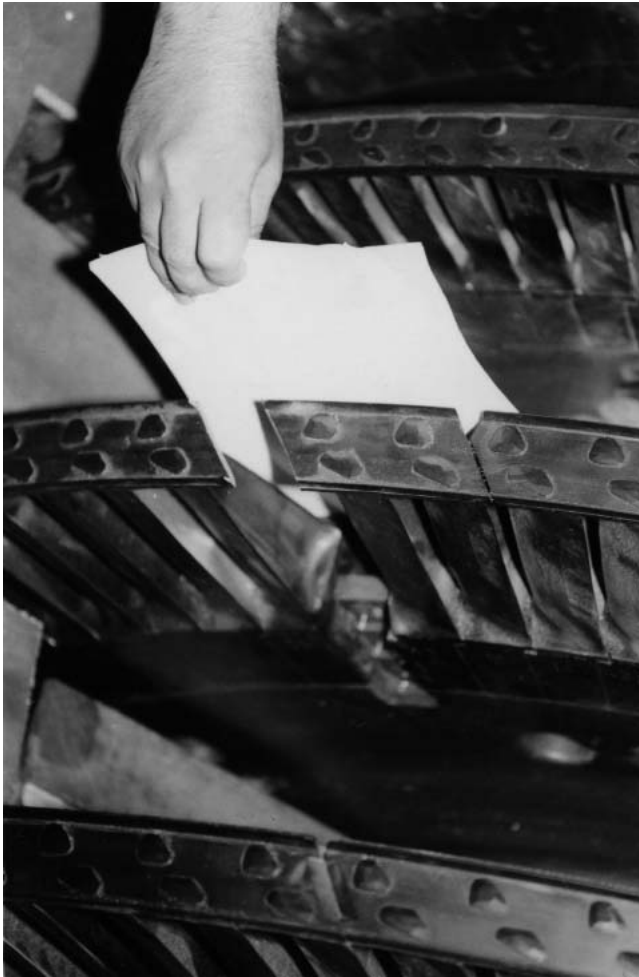
**Fig. 3** The III-stage HP turbine shroud after the cutting and removal of the cracked blade

procedure on the mock-up assembly. While cutting the shroud piece above the cracked blade, it was ensured that the cutting operation was carried out at an angle of about  $45^\circ$  to the plane of the shroud so that the adjacent blades were not damaged during the cutting and subsequent repair welding operations. Both of the cut edges of the original shroud were then prepared for welding by grinding them at an angle of about  $35^\circ$ . After edge preparation, LPT was carried out on the edges, and no defects were observed.

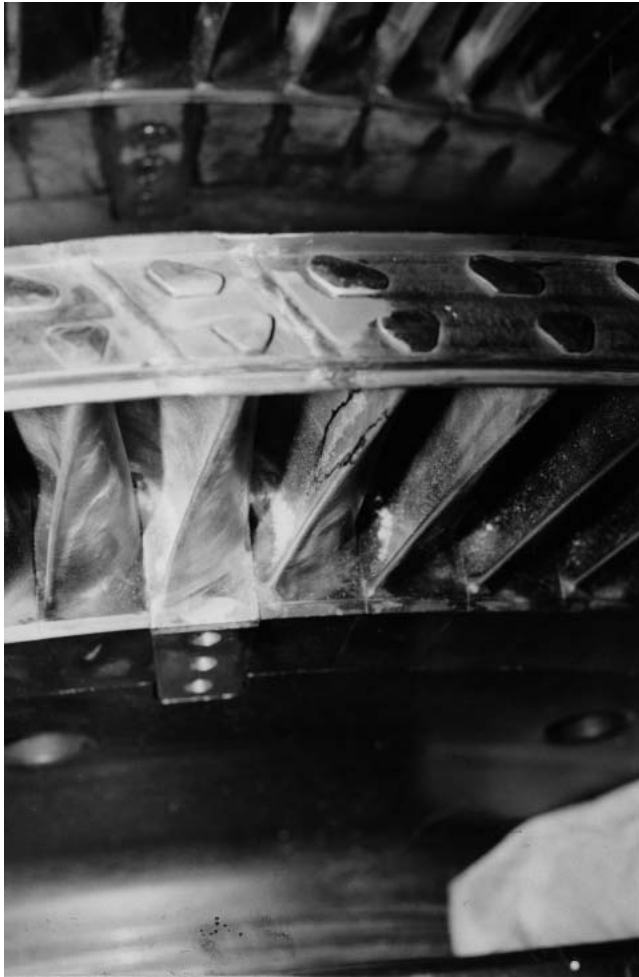
**Fig. 5** The III-stage HP turbine shroud after in situ repair welding

existing shroud by grinding. After completion of the welding, the joints were subjected to inspection by LPT and were found to be free of defects. Figure 5 shows the shroud after the repair.

During the welding operation, the new blade and the shroud piece were held in position but without riveting the tenons to the shroud piece. The welding was carried out in the vertical down (1G) position by the GTAW process, using ultra-high-purity argon as the shielding gas and ER 316L filler wires, and adopting the procedure developed and approved earlier,<sup>[5]</sup> and the technique was finalized using the mock-up assembly. As the new shroud piece had to be welded on either side to the existing shroud, and as these two weld joint locations were very close to each other, each layer of weld metal was deposited successively at both locations to minimize distortion during welding. The root (first) weld pass was deposited using a welding speed of  $\sim 1.5$  mm/s. After depositing the first pass on both the joints, the misalignment between the existing shroud and the new shroud piece, due to the minor dimensional differences between them, were machined. Subsequently, three more weld passes were deposited in each weld joint using welding speeds of 2.0 and 1.0 mm/s, respectively, for the second and the remaining passes. A welding voltage and current of 10-12 V and 80-85 A, respectively, were employed for all the passes.

After the completion of welding from the top side, the turbine was rotated by  $90^\circ$  to access the underside of the joints in the horizontal position for grinding the weld root and a final dressing pass was made at the weld root. Subsequently, the root of the weld was made flush with the shroud by grinding. Finally, ridges were built up on the new shroud piece by weld depositions, which were then made flush with the

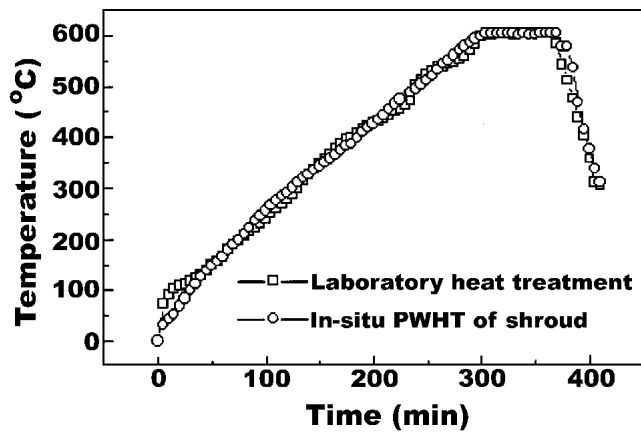
During the PWHT, the weldments were slowly heated to 873 K over 5 h, and after holding at this temperature for 1 h, the furnace was switched off and the weldments were allowed to slowly cool down to 573 K. Subsequently, the furnace was removed and the joint was allowed to cool in air. Heating was done slowly to minimize the chances for the failure of the heating elements by overheating and to improve the heat transfer from the elements to the weldments. Figure 7 shows the actual heating and cooling cycle achieved during the in situ PWHT of the repair-welded shroud, along with the heating and cooling cycle achieved during PWHT of the welded shroud material used in subsequent laboratory investigations.

Fig. 7 Actual heating and cooling cycle achieved during localized PWHT of the repair-welded shroud at the site and in the laboratory

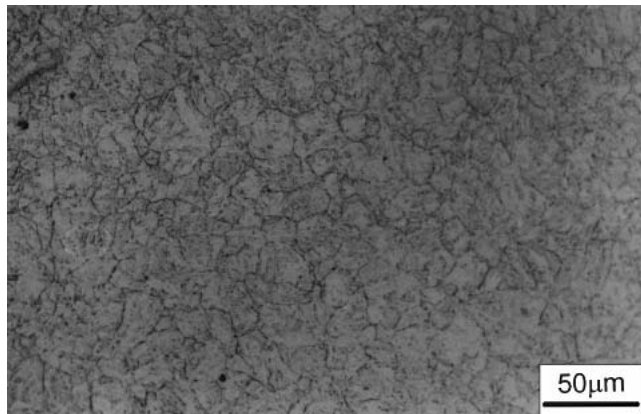
After successful PWHT, the LPT and wet florescent magnetic particle technique (WFMPT) were performed on the weldments, and no defect was found. WFMPT was also carried out after subsequent riveting of the tenons of the new blade to the new shroud piece (now welded to the original shroud). Finally, in situ metallography was carried out after PWHT, using a portable polishing unit, an etching unit, and a microscope, for which the martensitic stainless steel shroud material was etched with Vilella's reagent and the 316L austenitic stainless steel weld metal was electrolytically etched with 10% ammonium persulphate solution. The in situ metallography microstructure of the HAZ, shown in Fig. 8, indicated successful and adequate tempering of the martensite structure of HAZ during PWHT.

Fig. 8 In situ metallograph of the microstructure of the HAZ in the repair-welded shroud after localized PWHT at 873 K for 1 h

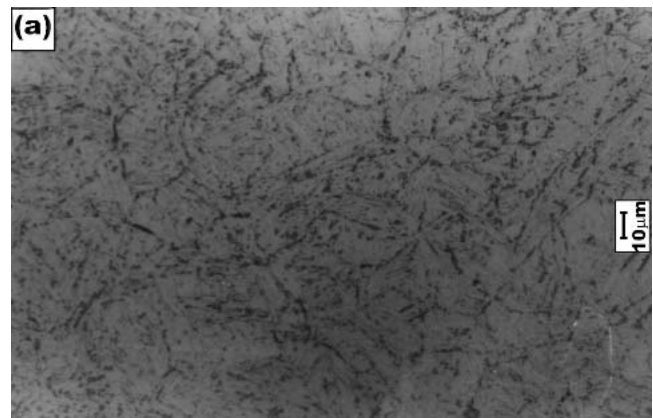
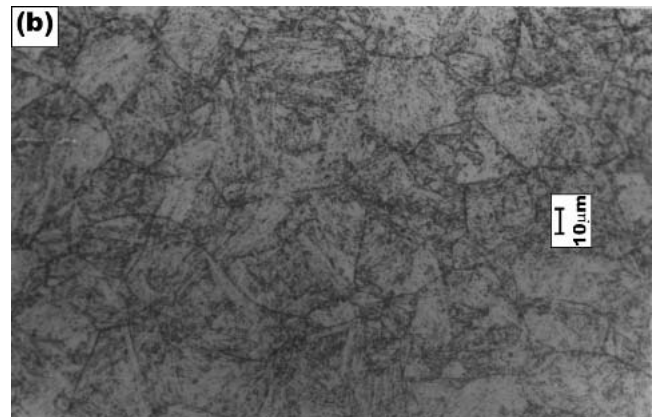
Fig. 9 Microstructures of HAZ of the welded III-stage HP turbine shroud material investigated in the laboratory (a) in the as-welded condition, and (b) after 873 K/1 h PWHT

observed in the in situ metallographs of the actual repair-welded shroud (Fig. 8). The microhardness profile across the weldment before and after PWHT (Fig. 10) shows that the hardness of the HAZ decreased from >450 (VHN) Vickers Hardness Number in the as-welded condition to about 300 VHN after 873 K/1 h PWHT, thereby confirming the adequacy of the PWHT carried out on the repair-welded shroud.

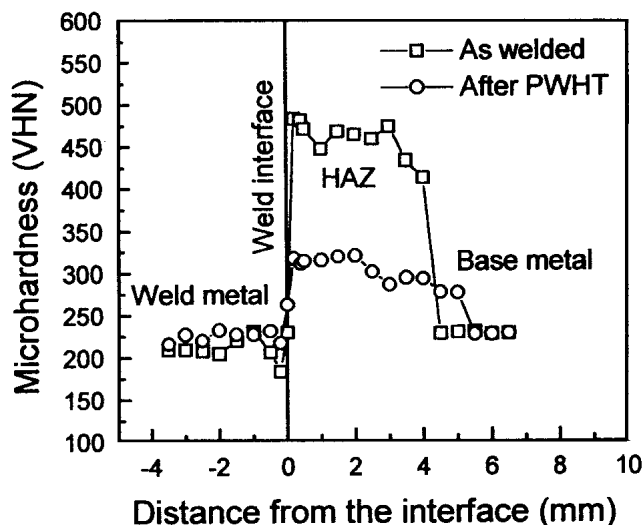
Fig. 10 Microhardness profiles across welded III-stage HP turbine shroud material before and after PWHT at 873 K for 1 h
