Carbon Segregation and Inclusions Effects on Surface Fracture Morphology of a 12% Chromium Stainless Steel

N. Souami, D. Saidi, M. Negache, and A. Ati

Keywords inclusions, segregation, stainless steel, surface fracture

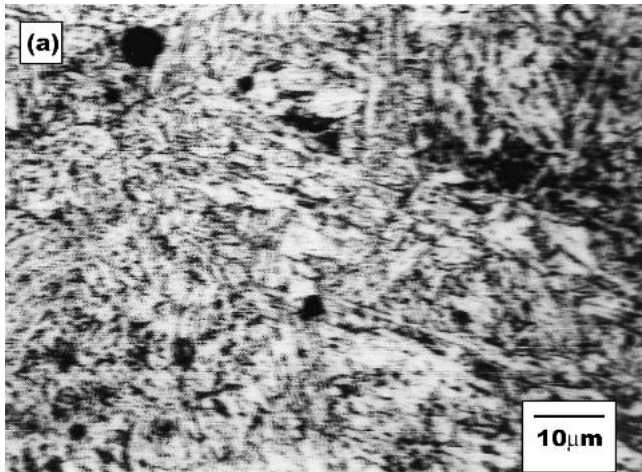
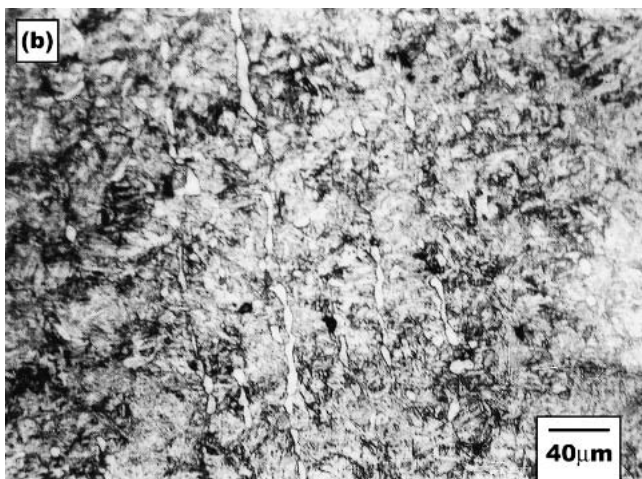
Fig. 1 Microstructure obtained after: (a) heat treatment at 625 °C; (b) 100 000 h service: apparition of aligned ferritic areas

Figure 1(a) shows the material structure after heat treatment before use. It exhibits a martensite structure with the presence of chromium carbide particles of type $M_{23}C_6$ localized at the austenite grain boundaries and between the martensite lathes. After service (type 2), the ferritic areas dispersed in the martensitic structure become apparent. These areas, generally aligned in the stress direction during service (Fig. 1b), arise from the evolution of the martensite structure, under the effect of cyclic mechanical stress. The material undergoes hardening by transformation, which generates new hardened ferritic phases. These develop generally from non-metallic inclusions and on carbides too.^[10]

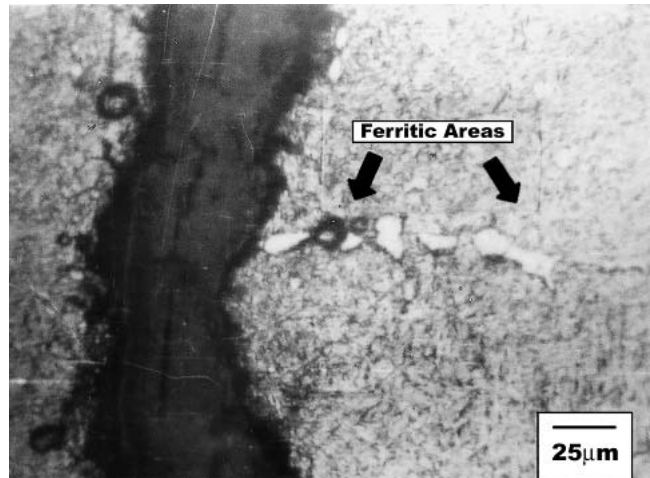
Fig. 2 Cross sectional view of splitting occurring perpendicularly to the aligned of ferritic areas

3.2.1 Crack Examination. After a 100 000 h service, some blades develop cracking. Metallographic observation of the cracking regions shows that their direction is normal to the direction of ferritic areas (Fig. 2). Furthermore, it is known that ferritic areas embedded in martensite represent the most ductile phase, which accommodates in a first step the plastic deformation. The work of Degallaix et al.^[10] on a martensitic stainless steel 12 Cr-Mo-V shows that the plastic deformation starts at the first cycle in the ferrite before it reaches martensite. Consequently, ferrite might be the start of the initiation of crack. On the other hand, Knutsen and Hutchings^[11] observed that fatigue cracks in 12% chromium stainless steel propagate at ferrite grain boundaries.

We observed that cracks do not propagate along and between the ferritic areas; this suggests that their initiation and propagation is related to some other phenomena. On the other

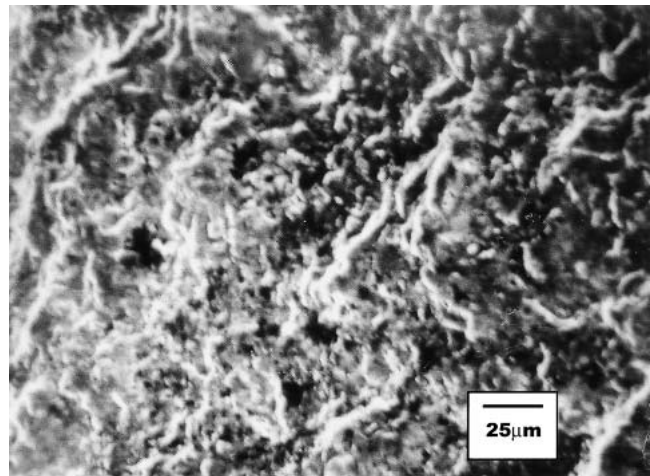
Fig. 3 Scanning electron fractograph showing fracture surface of splitting

hand, cracks propagate along rich silicon area. The examination of crack areas shows a transgranular mode associated to some intergranular mode (Fig. 3).

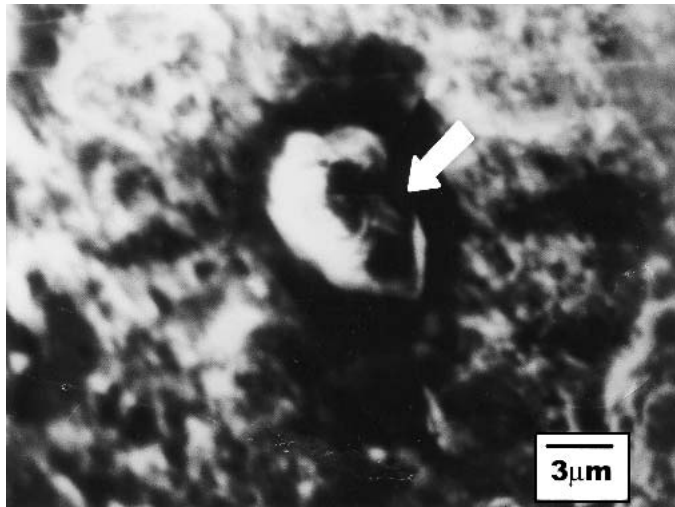
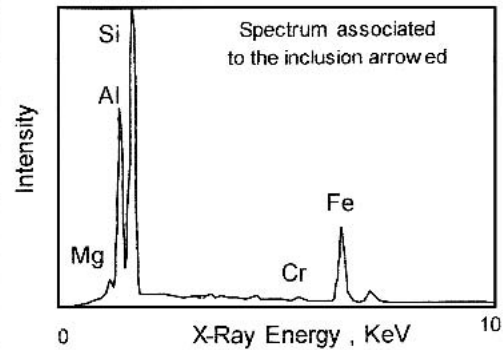
Fig. 4 Scanning electron fractograph showing a silicon-based complex inclusion

The micrograph on Fig. 4 shows the presence of angular inclusions on fracture surface, which are identified by EDS as silicon-based complex inclusions combined with aluminium and iron. This seems to be the origin of crack initiation, and certainly facilitates the crack propagation. The angular form of these inclusions facilitates more the decohesion of the matrix-inclusion interface which can be the source of crack initiation. The stress field is certainly highly modified around these hard inclusions, which facilitates crack initiation when it is located in a region of high stress. An inclusion harder than the matrix with a high young modulus lowers the macroscopic stress for initiation, even though situated at several microns below the surface.^[4]

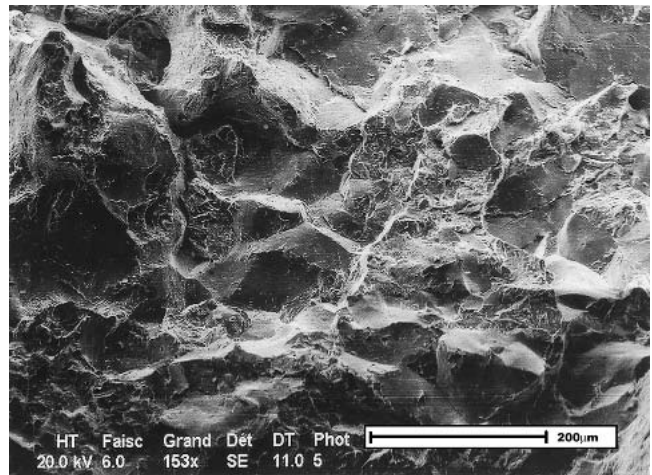
3.2.2 In-Situ Fracture. After in-situ fracture, the heat-treated steel presents a brittle fracture of the intergranular type with ductile areas. The intergranular mode is characterized by a smooth grain surface (Fig. 5). Inclusions such as manganese oxide and aluminium- and silicon-based complex inclusions were observed on the fractured surface. Figure 6 shows the microcrack initiation at the interface of a spherical silicon-based inclusion and the matrix at the grain boundary. This observation shows the negative effect of this type of inclusion on crack initiation and on the intergranular mode of fracture. Besides other cited types of inclusions, these contribute to the crack propagation along the grain boundaries.

Fig. 5 Fracture surface micrograph of the heat-treated material (steel)

appearance of the fracture surface was predominantly smooth (Fig. 5). A noticeable carbon and chromium enrichment in the grains boundaries was detected. The typical line-Auger spectrum of such a surface, as shown in Fig. 9 and Fig. 10, represents the evolution of the Auger signals for C and Cr as a function of distance on one of the fractured surface. In addition, AES survey scans from 0-1000 eV were conducted to detect the presence of impurities with Auger peaks in this energy region. Only traces of sulphur were detected by Auger peak localized at 152 eV with sulphur ones at the same proportion in all areas of the exposed surface. Furthermore, the spectra showed only low intensity Auger signals for carbon (C) and chromium (Cr) at 270 and 490 eV inside the grain structure for steel 1 (Fig. 11). Significant changes in the intensity of the Auger peaks for C and Cr were observed in the grain boundary zone (Fig. 12). The AES intensity peak height related to the $dN(E)/dE$ spectra was measured on steel 1 and steel 2 and used to estimate the concentration ratio of C and Cr between the grain center and the grain boundary regions. The computed results indicate that the grain boundary in steel 1 is considerably richer in carbon and chromium than in the grain, with a proportionality factor equal to 0.84 and 0.61, respectively, for C and Cr (Table 2). The partly high oxygen enrichment at the intergranular area of the fracture specimen is probably because some grain boundaries were sufficiently separated to provide a connection path to the atmosphere.

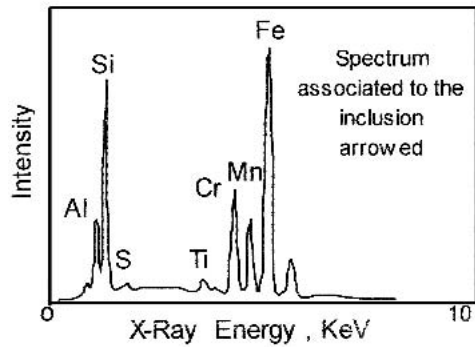
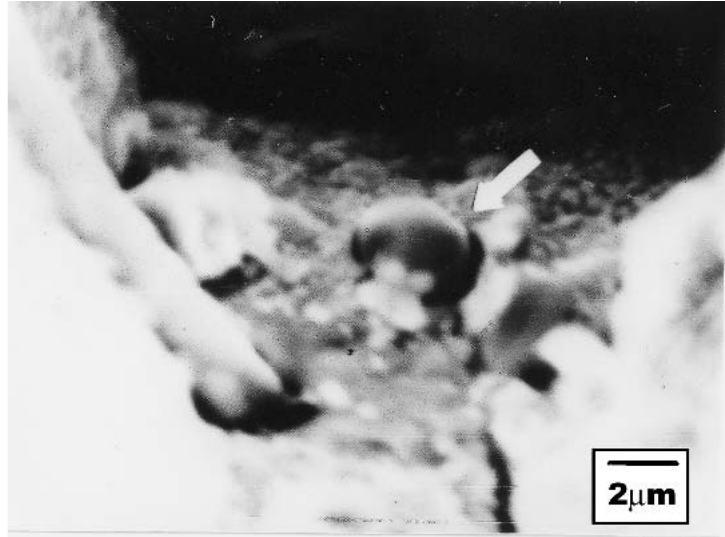
Fig. 6 Scanning micrograph showing microcrack initiation at a silicon-based complex inclusion

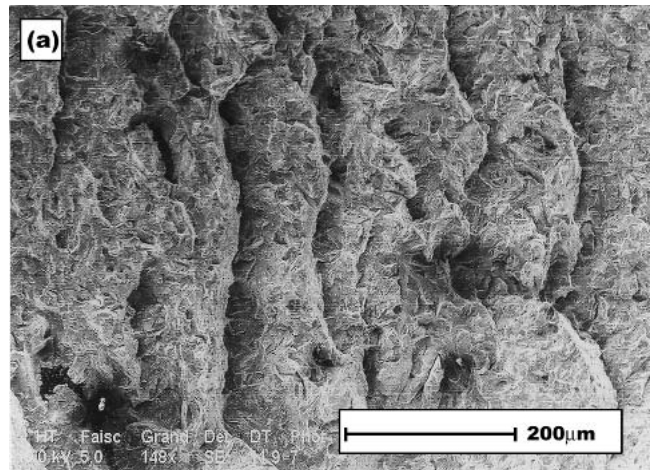
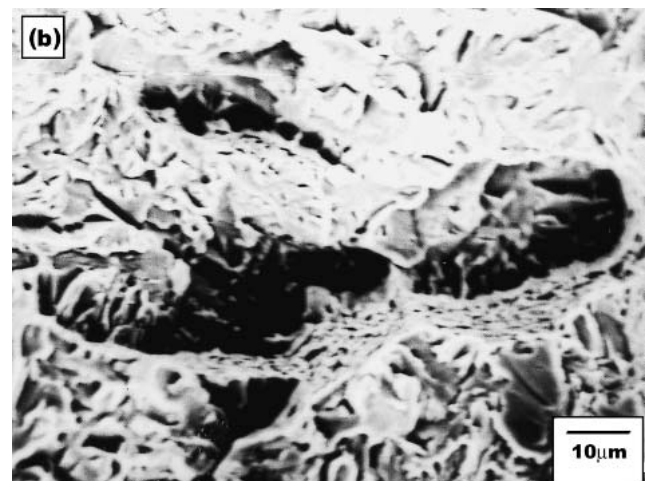
On the other hand, samples of type 2 show dimpled structure characteristic of a ductile fracture with a predominantly transgranular mode with some intergranular mode (Fig. 7a). The magnification of grain boundary (Fig. 7b) shows the presence of small cavities, which can be the mark of a previous localization of $M_{23}C_6$ carbides. The intergranular mode observed can be linked to the decohesion of the carbide from the matrix.

3.3.2 Steel 2. The same Auger analysis was carried out for steel 2. The appearance of the fracture surface of steel 2 was different from that of steel 1; whereas steel 1 was predominantly smooth, steel 2 was characterized by a dimpled structure. The fractographic observation of Fig. 7(a) reveals a number of facets and cavities typically associated with a transgranular structure with the presence of brittle areas. The Auger line profile (Fig. 10) and the punctual Auger analysis (Fig. 12) reveals a significant increase of chromium and a pronounced decrease in the concentration of carbon in the grain boundary region compared with that within the grain with an average ratio of 0.68 and 1.78.

Fig. 7 Fracture surface of steel 2: (a) predominantly transgranular mode fracture, (b) presence of microvoids at grains boundaries

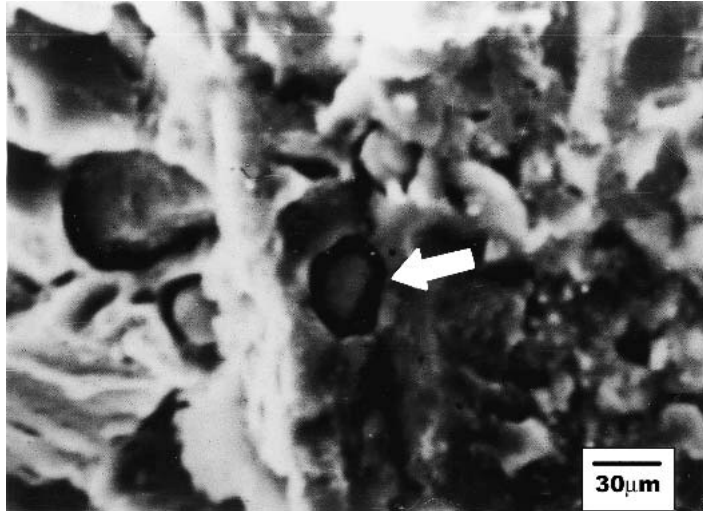
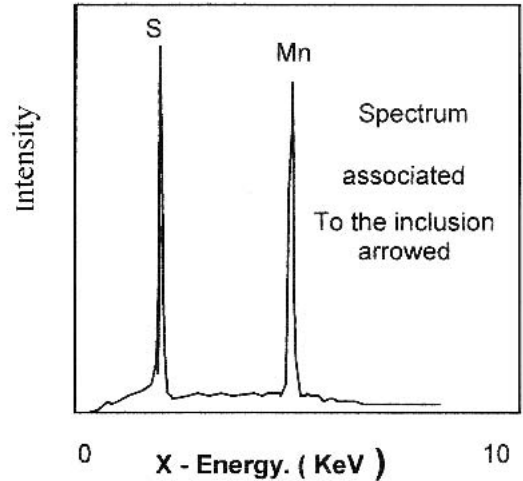
The crack surface area examination revealed only MnS type inclusions at grain boundary with microcrack initiation all around (Fig. 8). These suggest that MnS inclusions might origi-

nate from secondary crack initiation. Moreover, they contradict the conclusions of some authors who consider that these inclusions only facilitate propagation in the case of notched samples in which there is a reduced bulk and no oxide.^[4] On the other hand, this result is in agreement with the result of Mayes and Baker^[9] who concluded that MnS inclusions are responsible for fatigue microcrack initiation, which develops inside the crack stress field at the head of the major crack. Also, Horn et al.^[2] showed that microcracks are always initiated at MnS inclusions and the propagation of intergranular cracks are accelerated by weakening elements such as phosphorus near these inclusions, and particularly at the matrix-inclusions interface. This explains to some extent the microcrack initiation at the MnS/matrix interface, which we observed.

Fig. 8 Manganese sulphide inclusion exposed at grains boundary

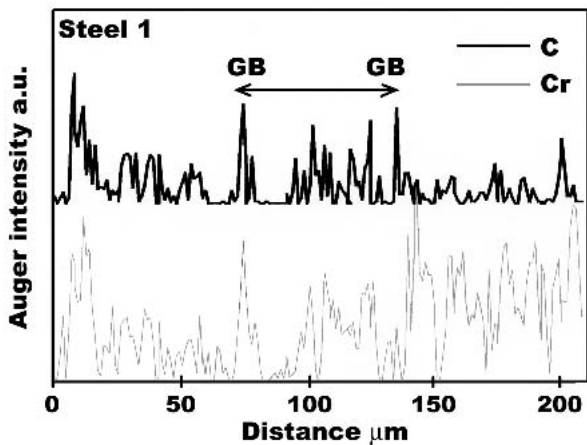
Fig. 9 AES line profile of carbon and chromium as a function of distance on the intergranular surface fracture (steel 1)

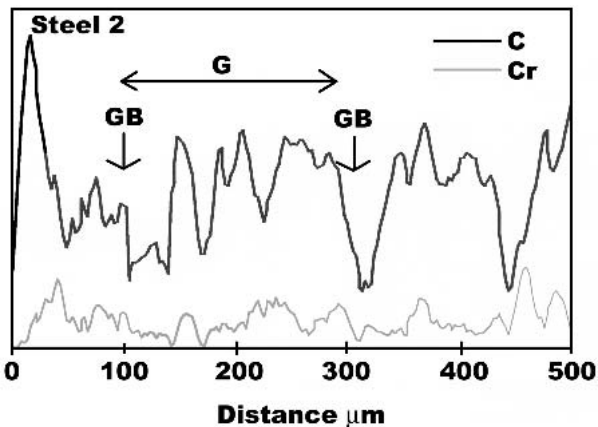
Fig. 10 AES line profile of carbon and chromium as a function of distance on the transgranular surface fracture (steel 2)

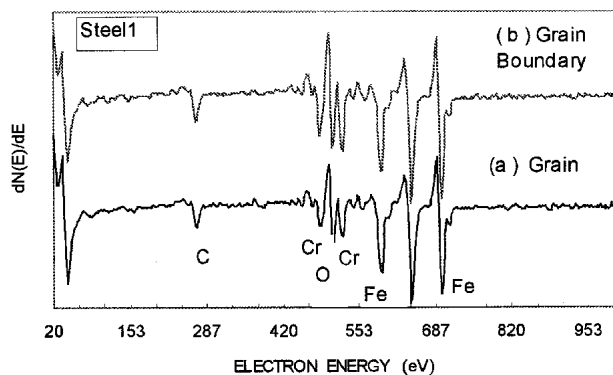
Fig. 11 AES spectra of steel 1 representing: (a) the grain, and (b) the grain boundary obtained from the intergranular fracture

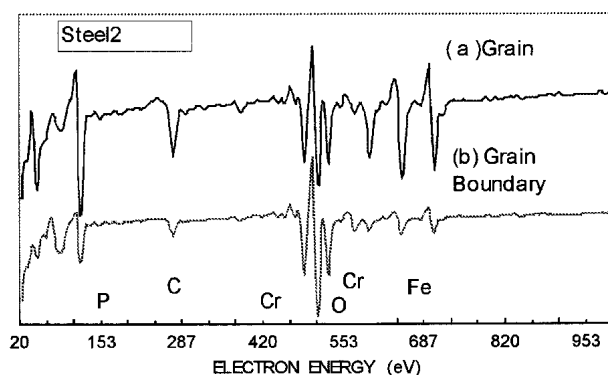
Fig. 12 AES spectra of steel 2 representing: (a) the grain, and (b) the grain boundary obtained from the transgranular fracture
