Correlation Between Molten Vanadium Salts and the Structural Degradation of HK-Type Steel Superheater Tubes

F.C. Nunes, L.H. de Almeida, and A.F. Ribeiro

(Submitted December 5, 2005; in revised form December 20, 2005)

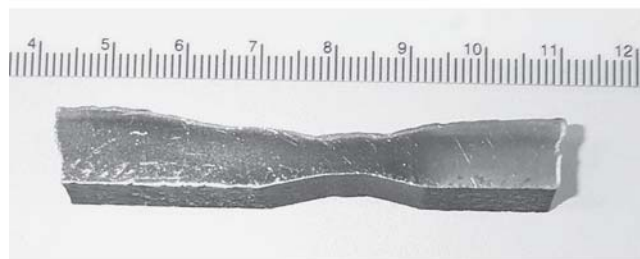
Fig. 1 (a) Schematic drawing showing where the TEM samples were obtained. (b) Visual aspect of the tube's cross section

As shown in Fig. 1(b), the external surface of the tube shows dramatic mass loss due to corrosive attack. The microstructural aspect close to the external surface can be observed in the light microscopy micrograph presented in Fig. 2. As one can observe there is a large number of chromium carbide particles, coarsened due to exposure to high temperatures. The degradation is indicated by the significant amount of dark oxide particles, which are formed due to an inward oxygen flow.

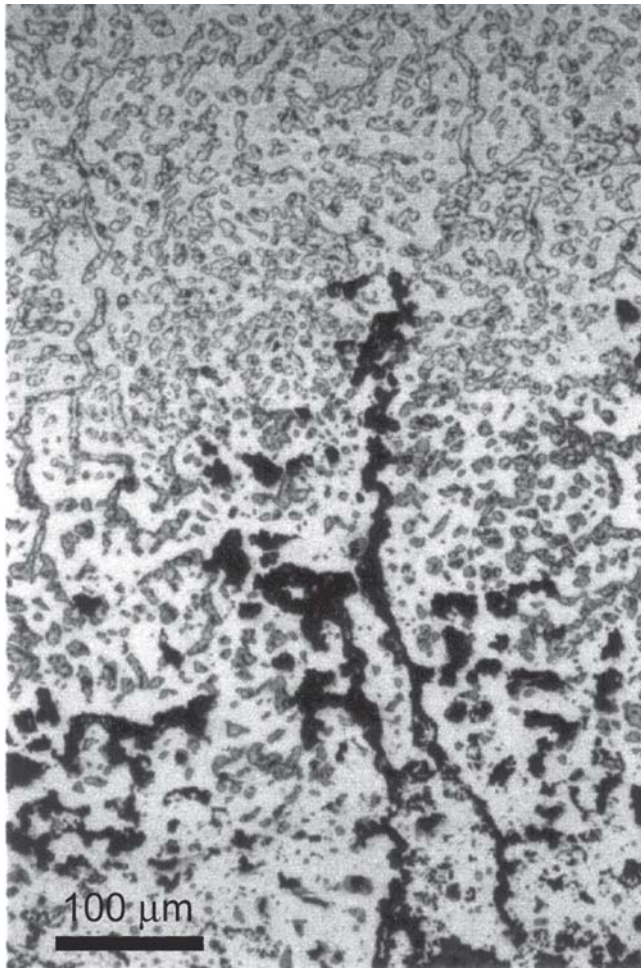
Fig. 2 Structural degradation along external surface as evidenced by the presence of dark oxide particles

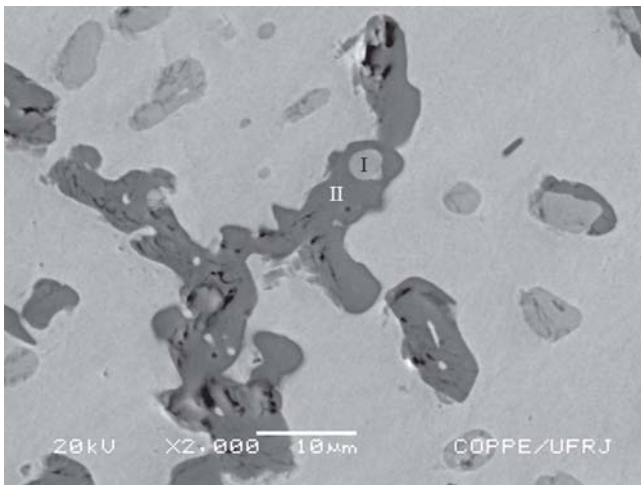
Fig. 3 SEM micrograph presenting chromium carbide particles (identified as II) next to vanadium-bearing particles (identified as I)

A higher magnification micrograph obtained near the external surface through SEM is presented in Fig. 3, where it is possible to observe chromium carbide particles in detail (iden-

tified as II), as well as small bright regions (identified as I). SEM EDS analysis (Fig. 4) shows that these bright spots contain vanadium. The vanadium-containing particles are chromium carbides with the M_7C_3 stoichiometry, as opposed to the stoichiometry of the chromium carbides far from the exposed

surface ($M_{23}C_6$). This difference in stoichiometry can be ascribed to the carburization process that takes place in the external surface. As observed in Fig. 3, these vanadium-containing particles are associated with chromium carbide particles. Yoon and Jeong (Ref 10) also pointed out the presence of vanadium in the oxidized region of HK-40 steel tubes.

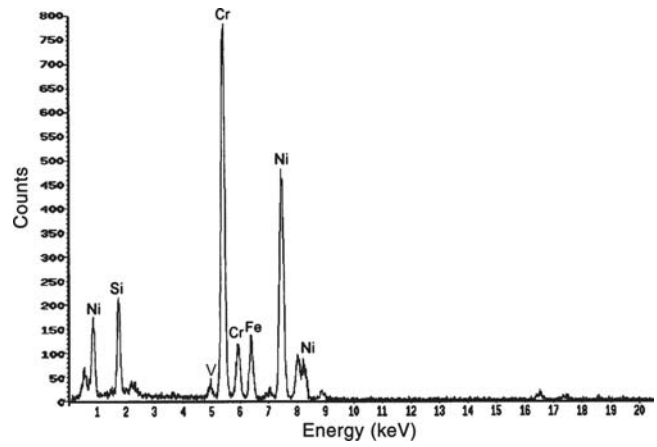
Fig. 4 EDS spectrum of the vanadium-bearing particles

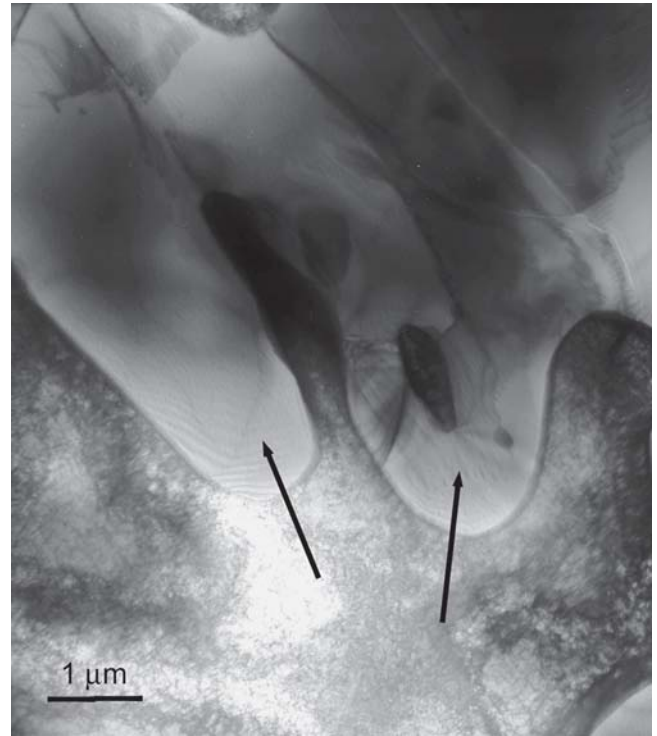
Fig. 5 Rounded chromium carbide particles in the austenitic matrix (shown by the arrows)

TEM was used to observe and identify the phases present near the external surface in more detail. Figure 5 shows massive chromium carbide particles in the austenitic matrix (shown by the arrows). The EDS analysis of these particles is presented in Fig. 6. On the other hand, EDS from the matrix (Fig. 7) also displayed strong peaks of iron, chromium, and nickel, as expected.

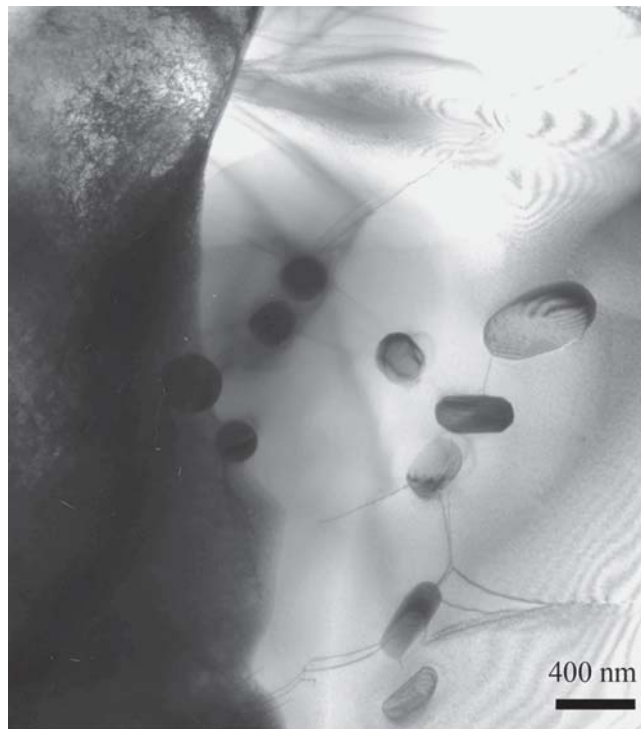
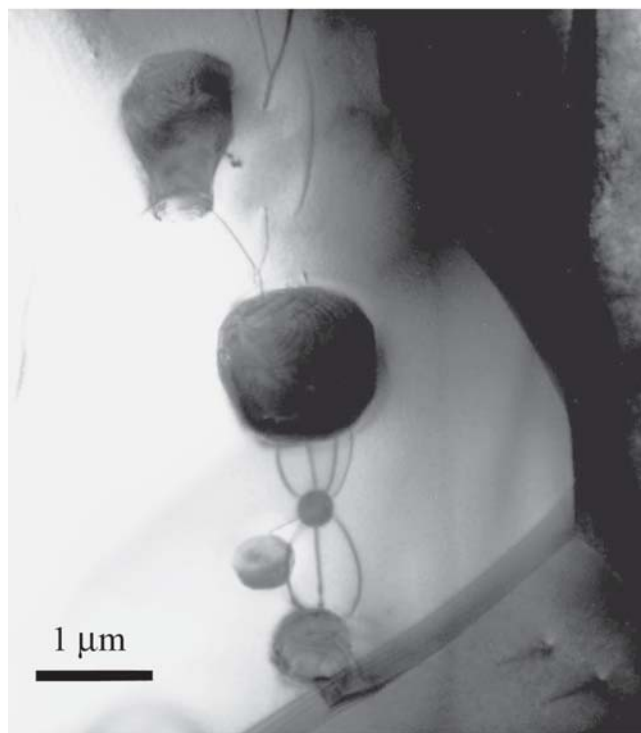
Fig. 8 (a) TEM micrograph showing vanadium-bearing particles in detail. (b) TEM micrograph showing vanadium-bearing particles in detail

Figure 8(a) and (b) show in more detail vanadium-rich regions associated with chromium carbide particles. The EDS spectrum shows vanadium peaks along with nickel, niobium, and silicon as well as chromium, as seen in Fig. 9.

cations can be seen in the TEM micrograph presented in Fig. 10 as well as in Fig. 8(b).

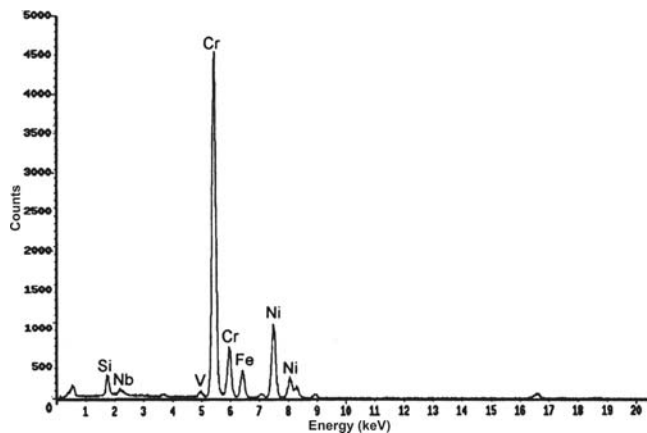
Fig. 9 EDS spectrum presenting a V peak along with strong peaks of Cr, Ni, Nb, and Si

Vanadium appears to react with Ni-Nb-Si compounds. These compounds, known as G phase, can be present in cast stainless steels modified by the addition of Nb after exposure at high temperatures over long periods of time. However, niobium can be present in small quantities in nonmodified steels as an impurity originated from the recycling of raw material, which explains the peaks presented in Fig. 9.

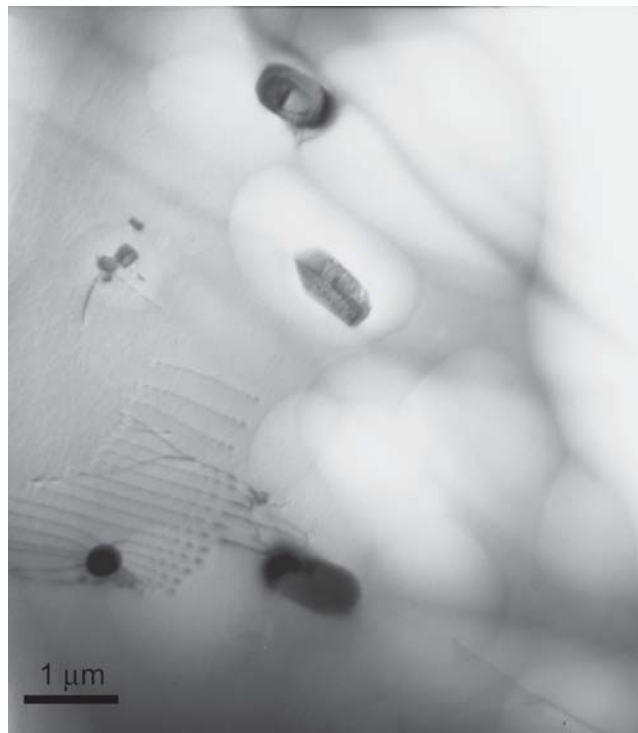
Next to these vanadium-containing particles there are accommodation dislocations due to the volume mismatch between the chromium carbide and these particles. These dislo-

Fig. 10 Accommodation dislocations next to vanadium-bearing particles
