A Comparison of Aging Kinetics of New and Rejuvenated Conventionally Cast GTD-111 Gas Turbine Blades

E. Lvova

Two industrial gas turbine blades made from a conventionally cast Ni-base superalloy GTD-111, one new and the other rejuvenated, were removed from the same machine after a particular operational cycle for an examination in order to determine the effect of rejuvenation on the material's behavior during service. It was found that service-induced changes in the microstructure, such as γ' -phase coarsening and coalescence, excessive grain-boundary secondary $M_{23}C_6$ carbides formation, and primary MC carbides decomposition, were noticeably more advanced in the rejuvenated blade. The stress-rupture life of the rejuvenated blade decreased significantly compared to that of the new blade after the same number of hours in service. The cause of this decrease appears to be related to a release of additional amounts of carbon and carbide-forming elements into the matrix during rejuvenating heat treatment as a result of the primary MC carbide decomposition.

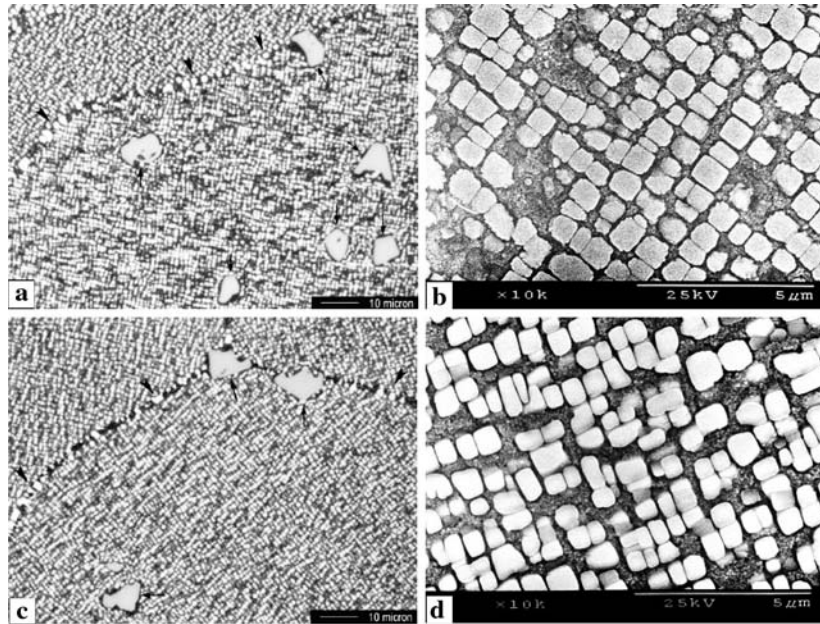
The microstructures of the Blade 1 and Blade 2 shank specimens were identical and typical of a new CC GTD-111 superalloy (Fig. 2).

Fig. 2 Optical micrographs of the shank specimens of Blade 1 (a) and Blade 2 (c); SEM micrographs of the shank specimens of Blade 1 (b) and Blade 2 (d). Arrows indicate primary MC carbides at the grain boundaries and in the grain interiors; arrowheads indicate secondary $M_{23}C_6$ carbides at the grain boundaries (Etchant—electrolytic chromic acid)

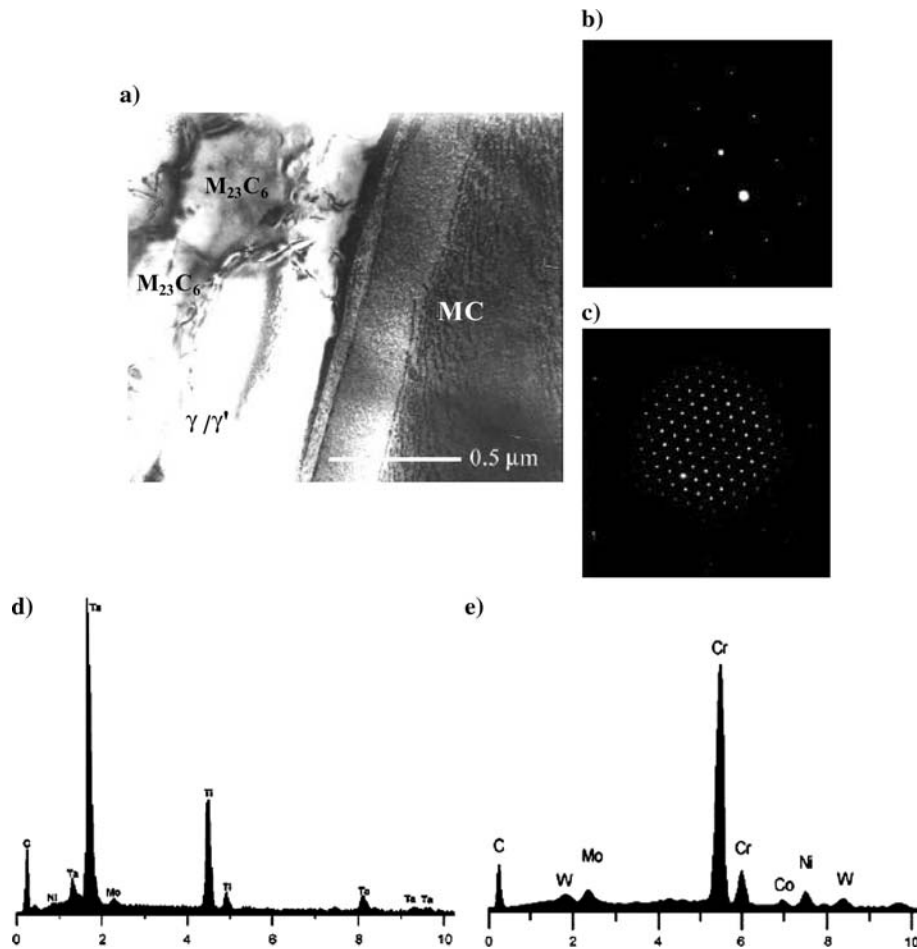
Fig. 3 Bright-field TEM micrograph of the Blade 1 shank (a); selected-area diffraction patterns (SADP) from MC (b) and $M_{23}C_6$ (c); EDS spectra from MC (d) and $M_{23}C_6$ (e)

The bright-field TEM micrograph in Fig. 3(a) showed the MC carbide situated at the grain boundary, which was decorated with small $M_{23}C_6$ carbides. Selected-area diffraction patterns from MC and $M_{23}C_6$ carbides (Fig. 3b, c, respectively) revealed no orientation relationship between them indicating their independent nucleation. $M_{23}C_6$ carbides obeyed cube-cube orientation relationship with the fcc γ matrix: $\{100\}_{M_{23}C_6} \parallel \{100\}_{\gamma}$, $\langle 100 \rangle_{M_{23}C_6} \parallel \langle 100 \rangle_{\gamma}$.

The EDS spectra demonstrated that primary MC carbides were rich in tantalum and titanium: (Ta, Ti)C (Fig. 3d), and $M_{23}C_6$ carbides were rich in chromium: $Cr_{23}C_6$ (Fig. 3e).

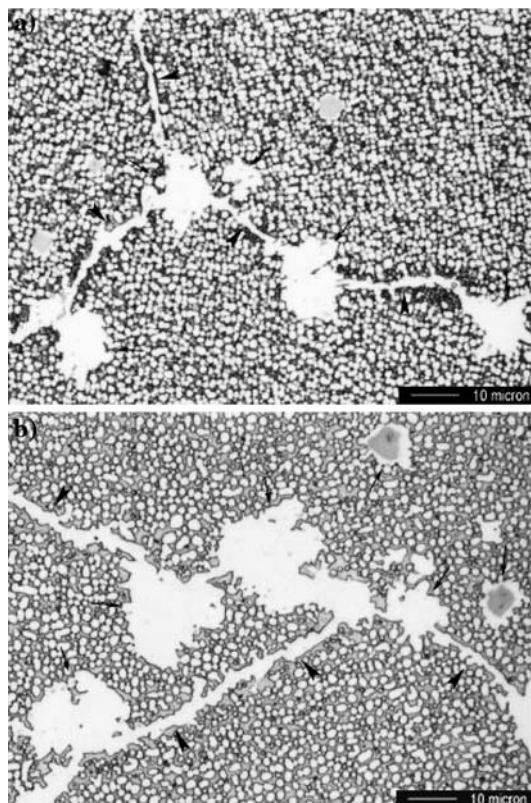
Fig. 4 Optical micrographs of the Blade 1 (a) and Blade 2 (b) leading edge specimens. Arrows indicate degenerated primary MC carbides; arrowheads indicate excessive secondary $M_{23}C_6$ carbide precipitation at the grain boundaries (Etchant—electrolytic chromic acid)

The optical micrographs of the Blade 1 and Blade 2 leading edge specimens presented in Fig. 4 displayed significant service-induced microstructural changes compared to the

The airfoil microstructures of both new Blade 1 and rejuvenated Blade 2 demonstrated features typically found in the hot section blades retired from service: excessive secondary $M_{23}C_6$ carbide precipitation at the grain boundaries, γ' particles coarsening and agglomeration, and primary MC carbides decomposition.

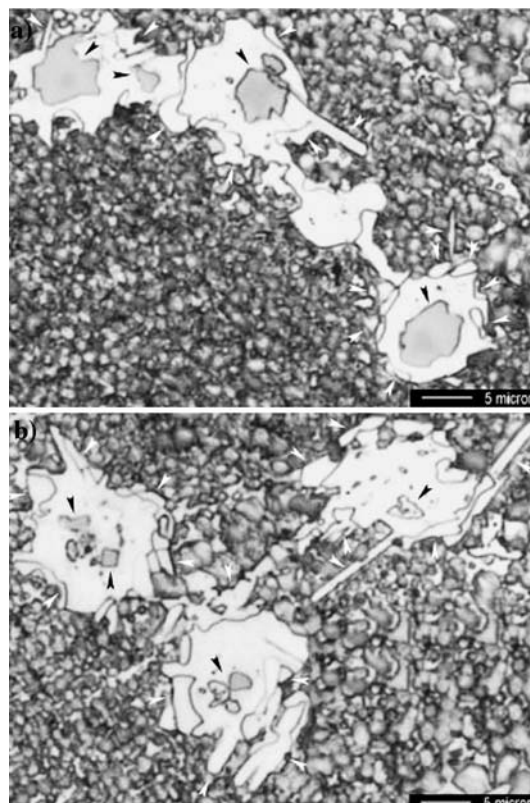
Fig. 5 Optical micrographs of the degenerated primary MC carbides in leading edge specimens of Blade 1 (a) and Blade 2 (b). Black arrowheads indicate remnants of the original MC carbides surrounded by decomposition zone. White arrowheads indicate $M_{23}C_6$ carbides formed at the periphery of decomposition zone as discrete particles and as laths (Etchant—Kalling's reagent)

In both blades MC carbide decomposition resulted in a considerable reduction of its size or in breaking down in to several pieces (Fig. 5). The disintegrated MC carbides were surrounded by a well-defined decomposition zone, with discrete $M_{23}C_6$ carbides precipitating at its periphery. The $M_{23}C_6$ carbides formed in the lath-like morphology as well, originating on the MC/ γ interface.

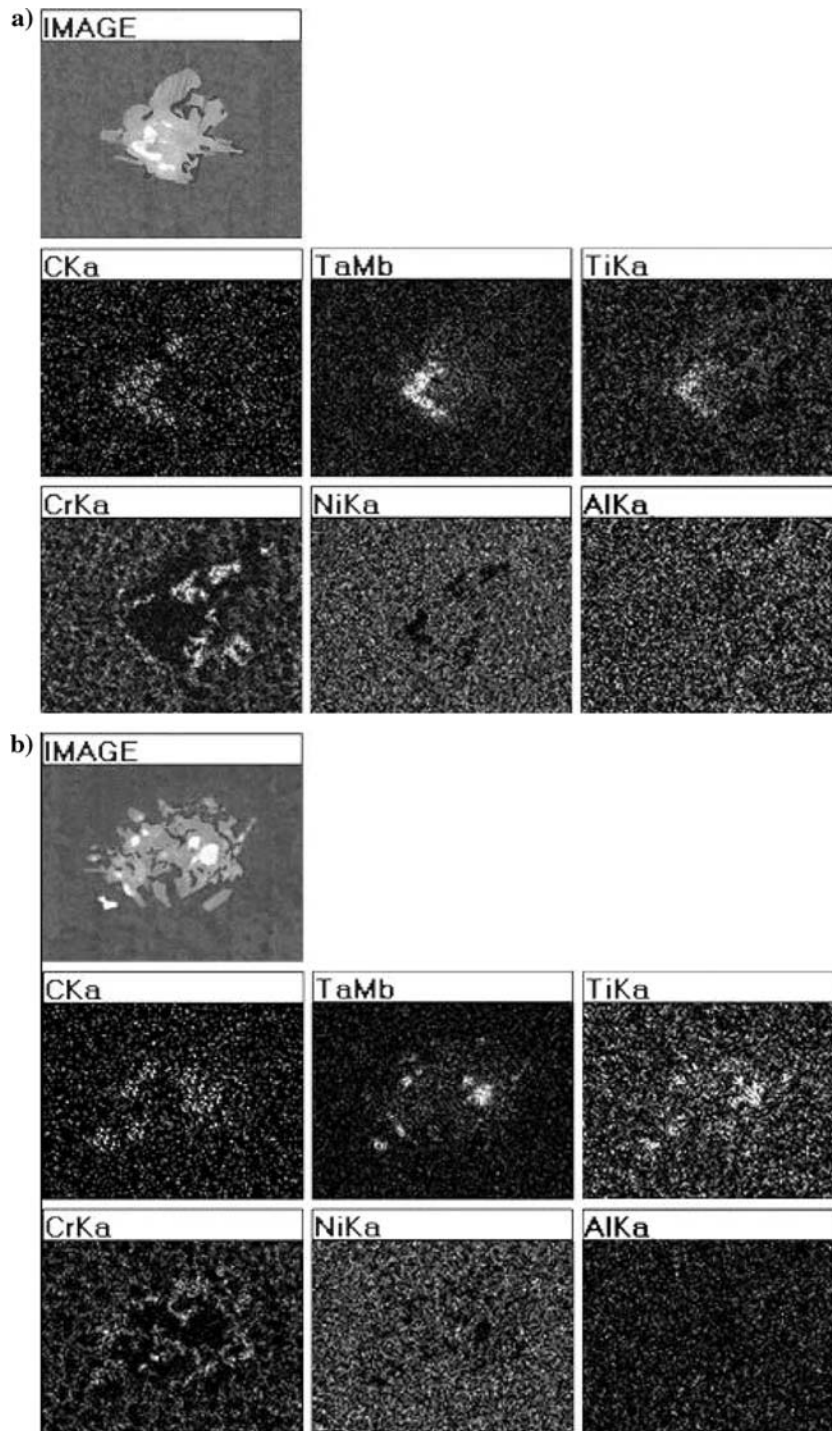
Fig. 6 X-ray maps of the primary MC carbides in the Blade 1 (a) and Blade 2 (b) leading edge specimens

The x-ray maps showed the elemental distribution in the degenerated MC carbides (Fig. 6). It can be seen that in both blades remnants of the decomposed MC carbide were rich in

Ta and Ti, as the original carbides. High concentration of chromium can be noted on the MC periphery; this fact is consistent with the $M_{23}C_6$ carbide formation as a result of MC carbide decomposition. No evidence of increased concentrations of Ni and Al in the decomposition zone was noted that would correlate with the formation of γ' -phase as a product of MC decomposition.

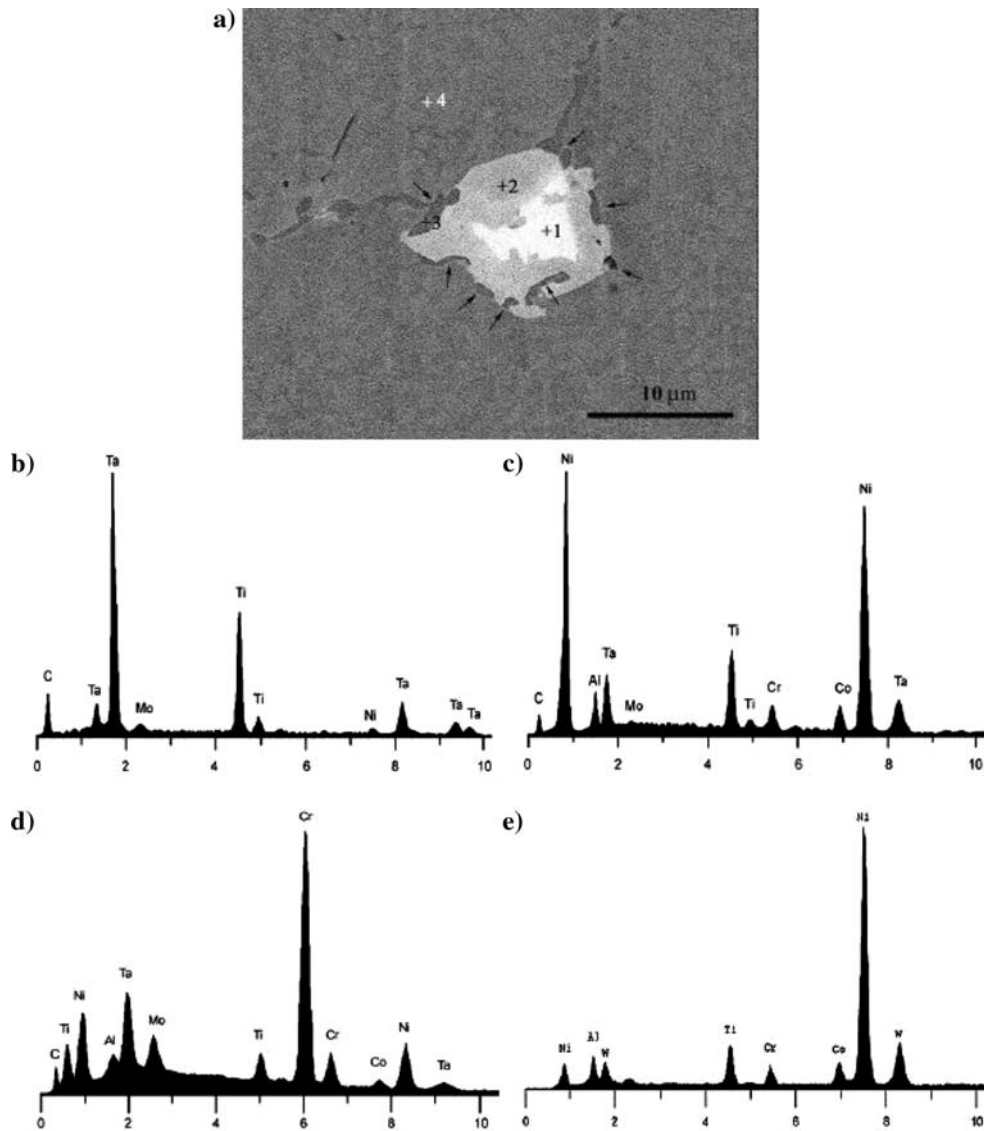
The EDS spectrum of the core of the degenerated primary MC carbide (Fig. 7) is similar to that of the original MC carbides in the shank, its composition being (Ti, Ta)C. The

Fig. 7 SEM-BEI micrograph (a) and EDS spectra (b-e) of Blade 1 leading edge specimen. Arrows in (a) indicate discrete $M_{23}C_6$ carbides formed at the periphery of MC decomposition zone. The EDS spectra from marked (+) locations in (a) are shown: 1—original MC core (b); 2—MC decomposition zone (c); 3— $M_{23}C_6$ carbide (d); 4— γ' -phase (e)

Contrary to the currently accepted reaction, the γ' -phase formation as a product of MC decomposition was not confirmed. The EDS spectra from the decomposition zone surrounding the original MC core showed the presence of a considerable amount of carbon, so that the phase from which they were taken cannot be γ' (The comparison of the spectrum from the primary γ' in Fig. 7(e) with that obtained from the decomposition zone (Fig. 7c) illustrated the difference. The spectrum of the decomposition zone was similar to that of the MC carbide (Fig. 7b), with parts of Ti and Ta replaced with Ni, Co, and Cr.

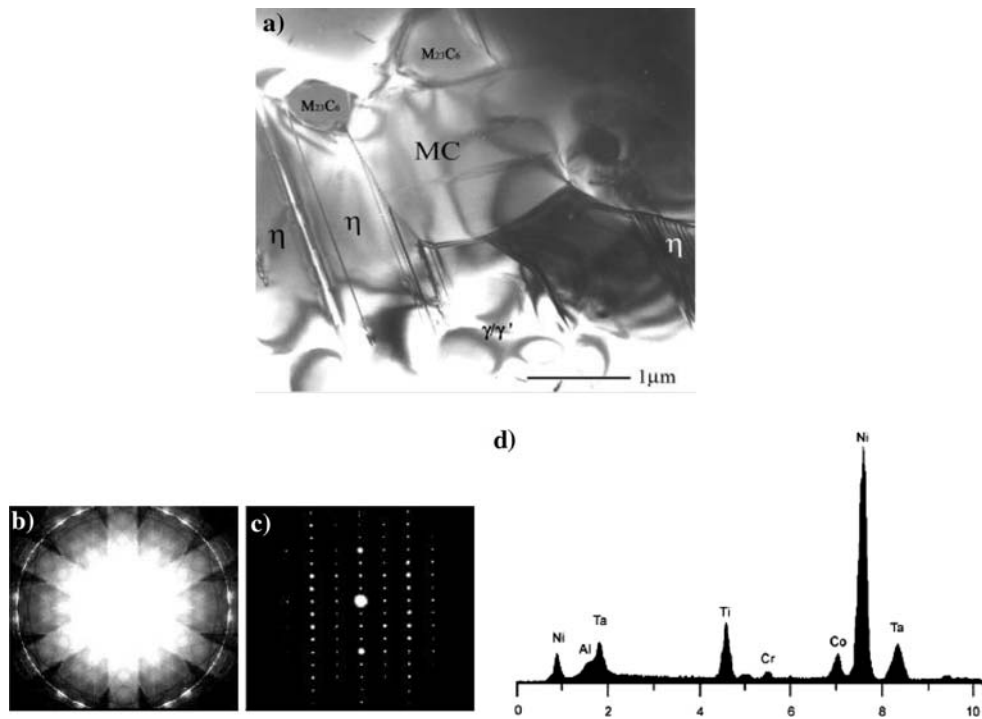
The TEM study also confirmed the absence of γ' -phase in the MC decomposition zone (Fig. 8). A phase other than γ' , containing high amounts of Ni, as was established by EDS, was observed at the periphery of the MC decomposition zone in both blades (Fig. 8a). A TEM analysis revealed the presence of

the hexagonal close-packed Ni_3Ti η -phase. Convergent beam electron diffraction and standard selected area electron diffraction methods were used to identify the crystal structure of this phase as $P6_3/mmc$ with lattice parameters $a \sim 0.52$ nm, $c \sim 0.82$ nm (Fig. 8b, c). The EDS analysis characterized the chemical composition of η -phase observed in both blades as $Ni_3(Ti, Ta)$ (Fig. 8d). The orientation relationship exists between this phase and the γ matrix:

Fig. 8 Bright-field TEM micrograph of the MC decomposition zone in Blade 1 leading edge specimen (a). [0001] convergent-beam diffraction pattern (b), [112̄0] SADP (c) and EDS spectrum (d) of η-phase

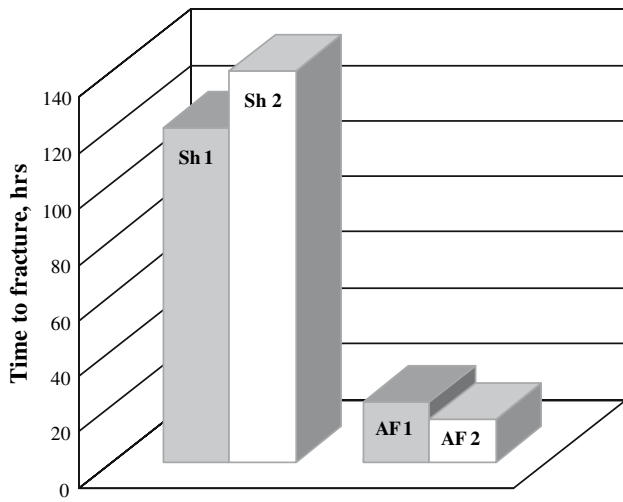
The service-induced microstructural changes in the airfoils caused a significant degradation of the material properties. The results of the stress-rupture tests of Blade 1 and Blade 2 presented in Table 2 and 3, respectively, and in Fig. 9 demonstrated a dramatic reduction of the airfoil stress-rupture life compared with those of the shank in both blades. The ductility of the airfoil specimens decreased noticeably as well.

Fig. 9 Stress-rupture test results. Sh1 and Sh2—shank specimens of Blade 1 and Blade 2, respectively. AF 1 and AF 2—airfoil specimens of Blade 1 and Blade 2, respectively

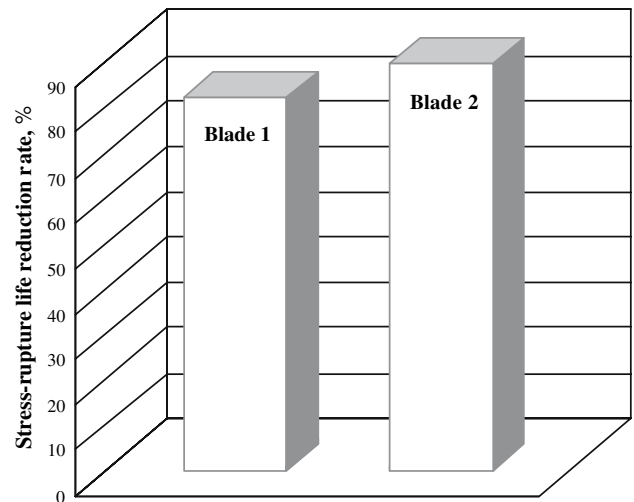
In order to make a comparison of the test data easier and to minimize the deficiency of relatively short-term tests, the stress-rupture life reduction rates for both blades were calculated as the difference between the shank time to fracture (t^{Sh}) and airfoil time to fracture (t^{Af}) relative to the shank time to fracture, $(t^{Sh} - t^{Af}) * 100 / t^{Sh}$ (Fig. 11).

Fig. 11 Stress-rupture life reduction rate calculated as the difference between the shank time to fracture (t^{Sh}) and airfoil time to fracture (t^{Af}) relative to the shank time to fracture, $(t^{Sh} - t^{Af}) * 100 / t^{Sh}$

microhardness of the rejuvenated Blade 2 was considerably more advanced than that of the new Blade 1. This fact indicates that, although the processes taking place in both blades during service were similar, as has been shown earlier, there were evidently certain differences present in the resulting microstructures.

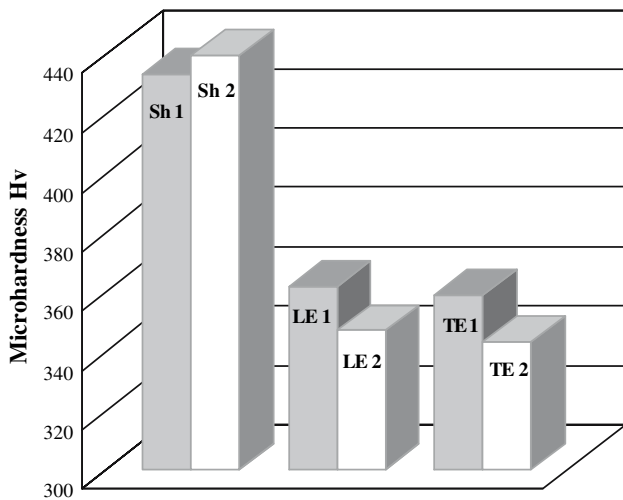
The microhardness of the γ/γ' matrix was measured in order to evaluate the degree of the solution-strengthening and the precipitation-hardening effects, which correlates with the degree of the alloy overaging. The results presented in Table 4 and Fig. 10 demonstrated a significant decrease in the airfoil microhardness compared to that of the shank in both blades.

Fig. 10 Microhardness test results. Sh1 and Sh2—shank specimens of Blade 1 and Blade 2, respectively. LE1 and LE2—leading edge specimens of Blade 1 and Blade 2, respectively. TE1 and TE2—trailing edge specimens of Blade 1 and Blade 2, respectively

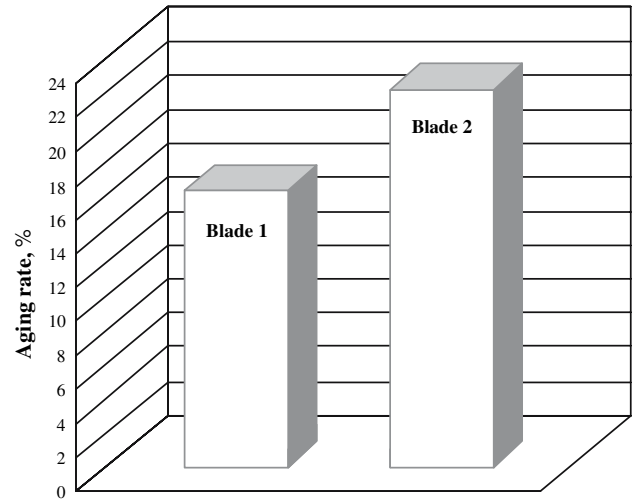
Similarly, the aging rates were calculated as the difference between microhardness values of the shank and the airfoil (as an average of the microhardness values of the leading edge and trailing edge) relative to the shank microhardness, $(H_v^{Sh} - H_v^{Af}) * 100 / H_v^{Sh}$ (Fig. 12).

Fig. 12 Aging rate calculated as the difference between the shank and airfoil microhardness relative to the shank microhardness, $(H_v^{Sh} - H_v^{Af}) * 100 / H_v^{Sh}$

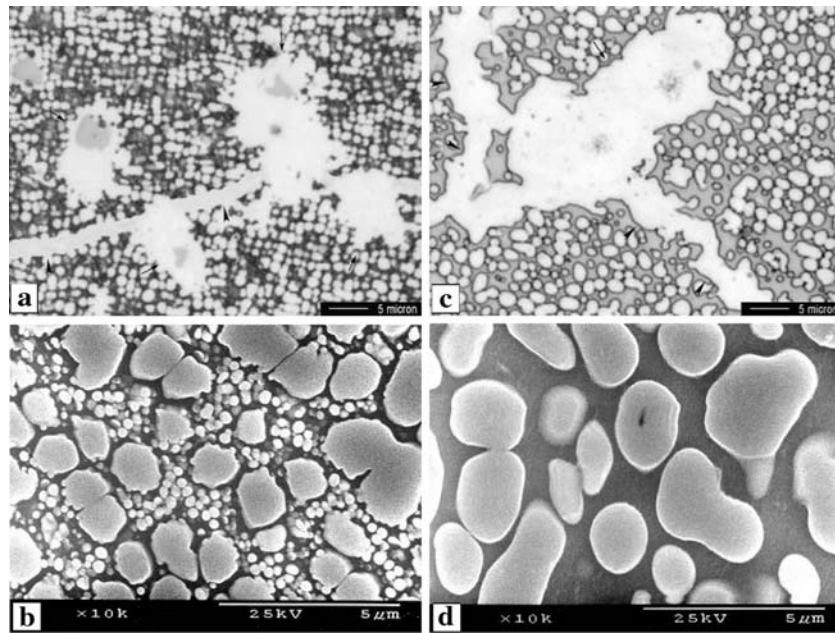
These differences are quite obvious. It can be seen that secondary $M_{23}C_6$ carbide precipitation at the grain boundaries in Blade 2 is noticeably more prominent compared to that in Blade 1 (Fig. 13a, b). The growth of primary γ' particles in Blade 2 is much more advanced than in Blade 1 (Fig. 13c, d): the average primary γ' particle diameter in Blade 1 is 1.28 μm , average γ' diameter in Blade 2 is 1.87 μm . Practically all fine secondary γ' particles were consumed by the grown primary γ' in Blade 2 (Fig. 13d).

Fig. 13 Optical (a, c) and SEM (b, d) micrographs of the Blade 1 and Blade 2 leading edge specimens. a, b—Blade 1; c, d—Blade 2 (Etchant—electrolytic chromic acid). Arrows indicate degenerated primary MC carbides; arrowheads indicate excessive secondary M₂₃C₆ carbides at the grain boundaries

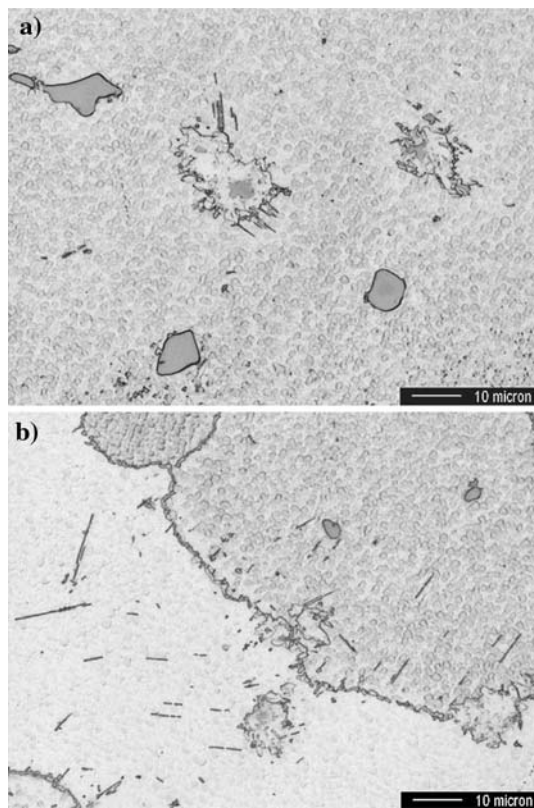
Fig. 14 Optical micrographs of the leading edge specimens of Blade 1 (a) and Blade 2 (b) (Etchant—Kalling's reagent)

fragments of the original primary MC carbides, as shown in Fig. 14. Dissolving of the degenerated parts of the primary MC carbides, η -phase, and the abundant $M_{23}C_6$ carbides formed as a result of the MC decomposition causes a release of additional amounts of carbon and carbide-forming elements, such as Ti and Ta, that were originally tied up in the primary MC carbides, into the γ -matrix. The resulting change in the elemental composition of the matrix appears to be the cause of the accelerated aging in the rejuvenated blade in the next service cycle.

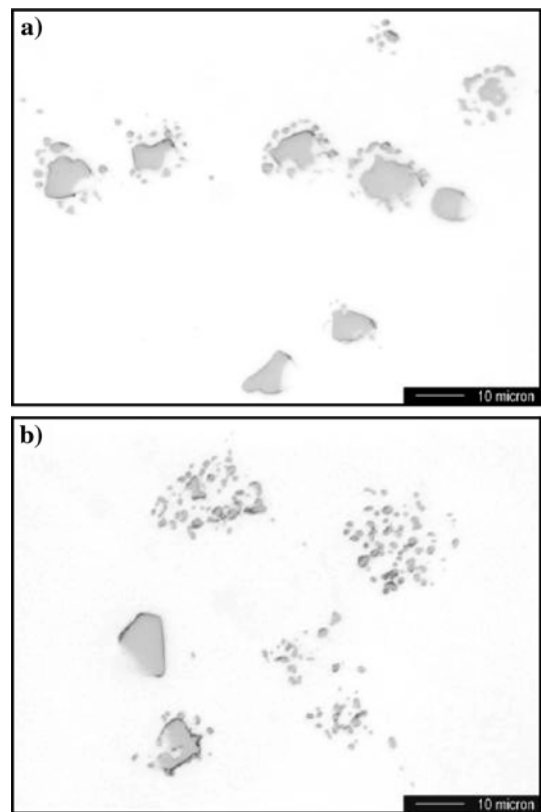
Fig. 15 Optical micrographs of the degenerated primary MC carbides in the leading edge specimens of Blade 1 (a) and Blade 2 (b) (As-polished)

Blade 2 microstructure in comparison with that of the new Blade 1. In addition, degenerated MC carbides in Blade 2 appeared much more fragmented compared with Blade 1 (Fig. 15).
