# Evaluation of Silicone Rubber Insulators used in High-Voltage Transmission Lines

Anwar Ul-Hamid, Khaled Y. Soufi, and Ibrahim Al-Hamoudi

Three long-rod silicone rubber composite insulators used in 230 kV power transmission lines were evaluated for aging affects. The insulators were obtained from various outdoor desert locations within Saudi Arabia where they had been in service for 6 years. Surface degradation associated with the aging process was analyzed by using Scanning Electron Microscopy (SEM) coupled with Energy Dispersive X-ray Spectroscopy (EDS), Fourier Transform Infra-Red Spectroscopy (FTIR), and Electron Spectroscopy for Chemical Analysis (ESCA). Electrical performance of insulators was evaluated by Rapid Flashover Voltage Tests (RFVT) and Pollution Severity Measurement Tests. Depending on their locations of service, the samples exhibited various types of pollutants at their surfaces. The analysis indicated that the insulator material showed localized surface degradation while there was no evidence of micro-cracking. Furthermore, it was noted that the electrical performance of the insulators was not significantly affected by exposure during the in-service period.

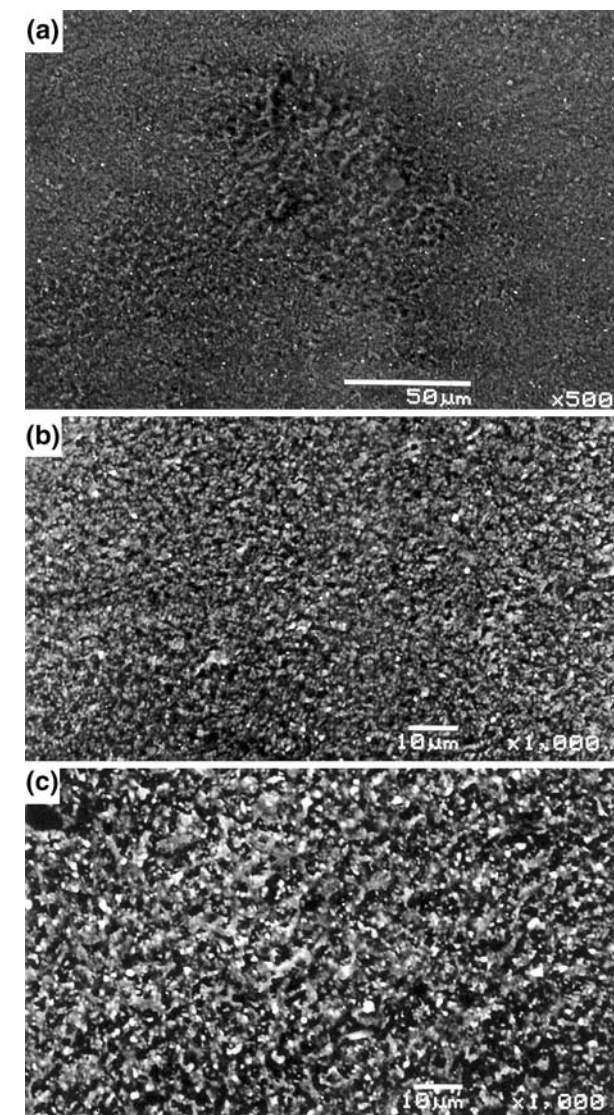
A typical insulator assembly is composed of several disc-shaped sheds attached to a long rod of fiber glass as shown in the schematic diagram and photograph of Fig. 1(a) and (b), respectively. Samples used in this study were obtained from similar insulating sheds. The surface morphology of silicone insulator obtained from sample nos. 1 and 2 appeared predominantly smooth with localized regions of roughness shown as an example in the backscattered SEM image of Fig. 2(a). The difference between the smooth and rough regions is clearly illustrated in the images obtained at a relatively high magnification and shown in Fig. 2(b) and (c), respectively. Smooth region exhibits a fine morphology while the rough region appears to possess coarse features. The roughness can result due to localized degradation of silicone rubber at these regions. Elemental EDS analysis was performed at both regions of each sample and Si:Al ratios thus obtained are shown in Table 1. The beam penetration into the sample at 3 kV will be the lowest and will increase with increasing voltage. The 3 kV beam will, therefore, provide elemental information from the top layers of the surface (Ref 5). It can be seen from Table 1 that the Si:Al ratio at 3 kV for rough region is lower than the smooth region for both samples 1 and 2. This implies that LMW polymer chains that are rich in Si and present at the surface have been consumed due to degradation at the rough areas. As a result, the underlying region with a low Si content is revealed giving off low Si:Al ratio. The depletion of LMW polymer chains allows the contamination at the surface to absorb water and form a thick water film, resulting in a lower surface resistance and higher leakage current.

The Si:Al ratios decrease with increasing beam voltages in a fairly consistent manner for both the rough and smooth regions indicating that Si content decreases in the bulk of the insulator. Micro-cracking was not observed at the samples' surface.

**Fig. 2** SEM micrographs obtained from sample #1 showing (a) an area of localized roughness, (b) smooth region, and (c) rough region

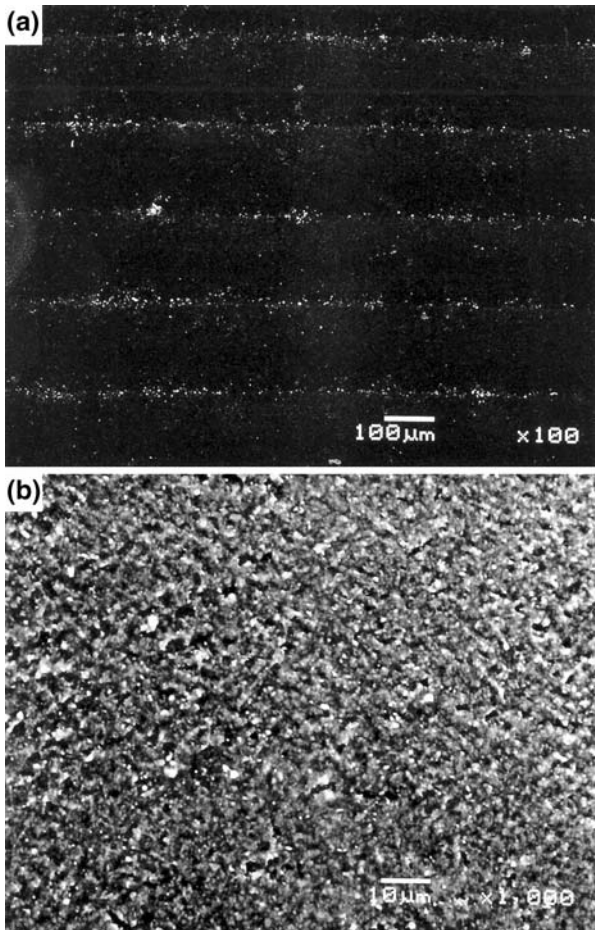
The insulator sample No. 3 is shown at a low magnification in Fig. 3(a). This sample design comprised of parallel protrusions at its surface at equal intervals. These protrusions were decorated with contaminant particles as evident in Fig. 3(a). It was difficult to remove the contaminants at these areas. The surface morphology, as shown at a higher magnification in Fig. 3(b), appeared to be smooth. Localized regions of roughness were not observed at the sample's surface. The Si:Al ratios were higher compared to sample nos. 1 and 2, especially at the top surface layer i.e., at 3 kV. Higher contamination levels at the surface are thought to have contributed to increased Si content observed. The change in Si:Al ratios was consistent and agree with the results for previously examined samples. Micro-cracking was not evident at the surface.

**Fig. 3** SEM micrographs obtained from sample #2 showing morphology of (a) smooth and (b) rough regions

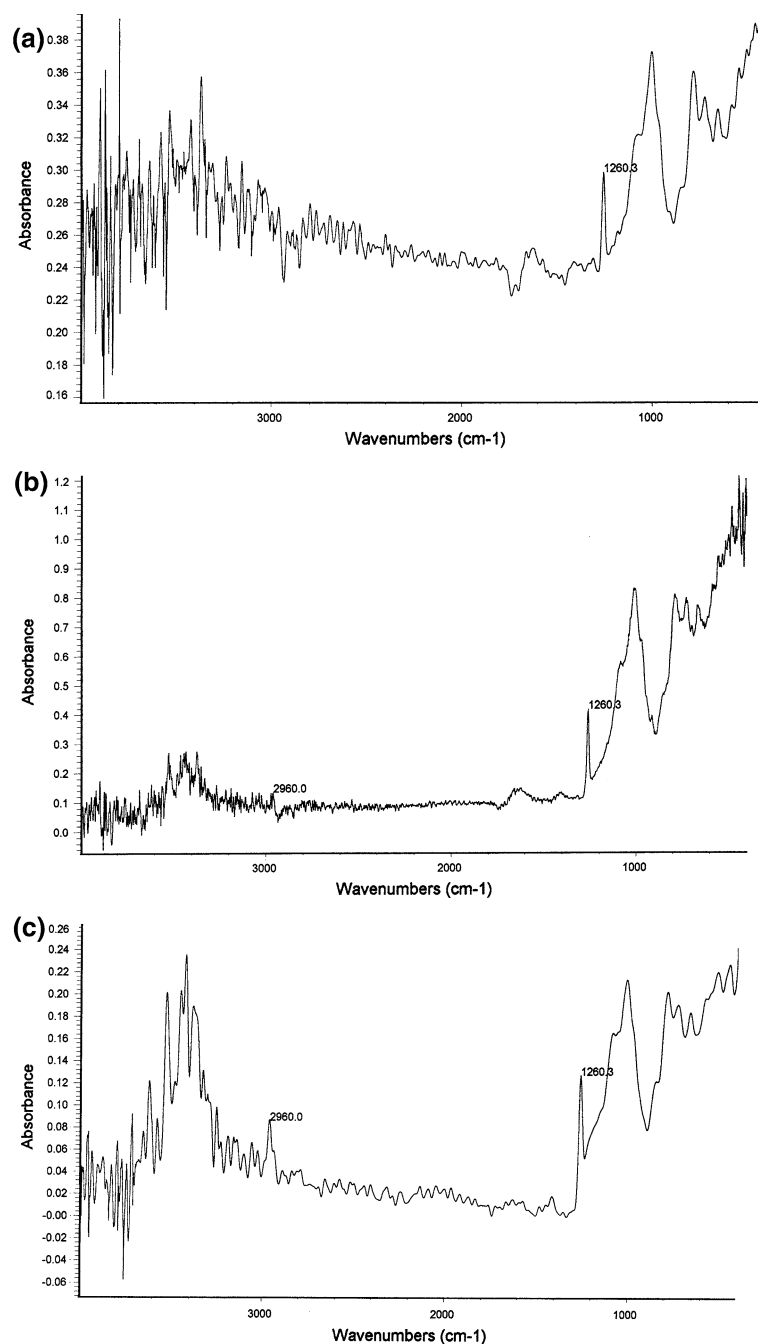
Sample #1 showed no IR band at  $2960\text{ cm}^{-1}$ . However, the bands at  $1260\text{ cm}^{-1}$  and  $1000\text{ cm}^{-1}$  were as intense as those in the virgin sample. The spectrum of this sample was quite noisy and that could have resulted to the nonobservation of the  $2960\text{ cm}^{-1}$  signal. The spectrum indicates that the sample has not deteriorated to any appreciable extent. The spectrum of this sample is shown in Fig. 4(a).

The infra-red spectrum Fig. 4(b) obtained from sample #2 showed the expected IR bands at  $2960$ ,  $1260$ , and  $1000\text{ cm}^{-1}$ . These bands when compared to those of the virgin sample indicated that there has not been any deterioration in the material. No IR bands for the Si-OH bond was observed. These observations indicated that the silicone sample had not deteriorated to any extent.

Sample #3 had been exposed to desert, marine, and industrial pollution. The spectrum for this sample showed weak signals for all the bands probably due to an oil film on the sample. The signal at  $2960\text{ cm}^{-1}$  was very weak appearing at exactly  $2955\text{ cm}^{-1}$ . The other two bands were prominent. The sample was re-analyzed after thorough cleaning. It was observed that the  $2960\text{ cm}^{-1}$  band had become more intense compared to in the un-washed condition. The FTIR spectrum is shown in Fig. 4(c).

None of the samples appear to have deteriorated to any appreciable extent. The oil film on sample #3 may serve to protect the insulator against harmful effects of UV light and oxygen.

**Fig. 4** FTIR spectra obtained from sample nos. (a) 1, (b) 2, and (c) 3

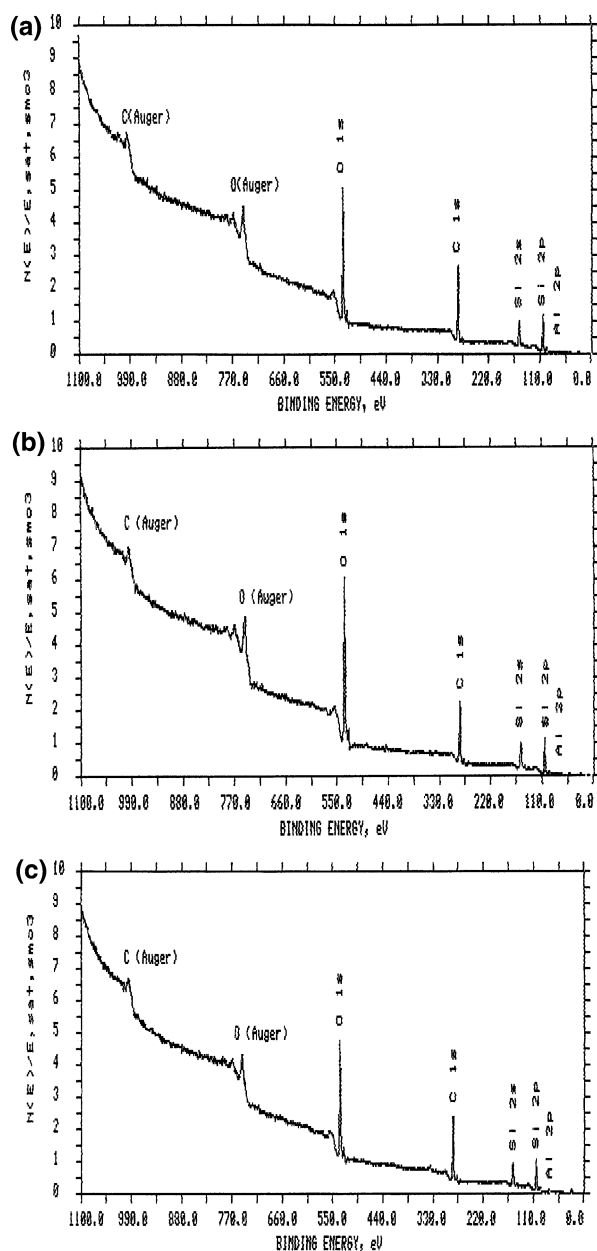
The ESCA survey spectra collected from the samples are exhibited in Fig. 5(a) to (c) and the atomic concentration values are given in Table 2. The survey spectra were not corrected for static charging. The binding energy values of the major features

in the spectra are given in Table 3. Oxygen, carbon, aluminum, and silicon were detected at the surface layer of the three-aged silicone rubber insulators.

The Si peak at a binding energy of 102.3 eV is due to the silicon in the silicone rubber. Silicon peak at slightly higher binding energy was also observed and is probably due to Si in a hydrous silicate of aluminum,  $\text{Al}_4\text{Si}_4\text{O}_{10}(\text{OH})_8$ . About 47% of the surface layer was probably hydrous silicate of aluminum and 53% silicone rubber.

As reflected in Table 2, the surface of sample #2 has the highest amount of silicon and oxygen and the lowest amount of carbon. The silicon to aluminum ratio for this sample, also shown in Table 2, falls between the other two samples. The

Fig. 5 ESCA survey spectra obtained from samples nos. (a) 1, (b) 2, and (c) 3

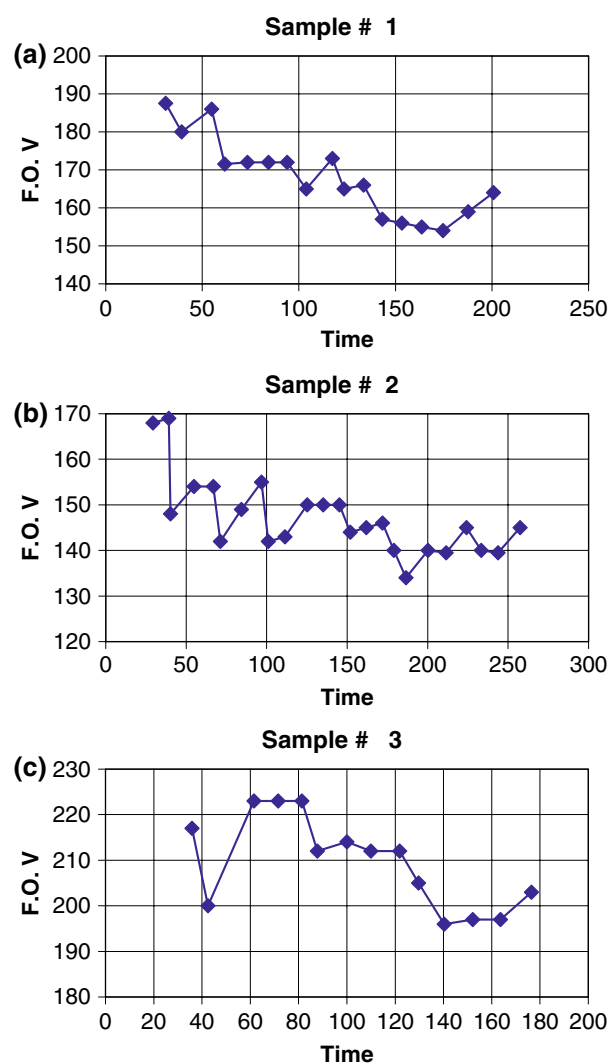
Eighteen sheds on the bottom high voltage side of sample #1 were tested at a creepage distance of 201 cm. The results are

shown in Fig. 6(a). Equivalent Salt Deposit Density (ESDD) data before and after the test is provided in Table 4. These values indicate the pollution levels at the insulator surface before and after the testing. The  $V_{\min}$  of the tested part of this insulator was 154 kV. The  $V_{\min}/\text{meter}$  of creepage distance was 76.7 kV as shown in Table 5.

Fifteen sheds on the bottom high voltage side were tested out of the sheds of sample #2. The tested creepage distance was 126 cm. Figure 6(b) presents the results of the test run on this sample. The  $V_{\min}$  of the tested part of this insulator was 134 kV. The  $V_{\min}/\text{meter}$  of creepage distance was 106.4 kV as shown in Table 5.

Twelve sheds on the bottom high voltage side of sample #3 were tested; the creepage distance was 210.5 cm. Figure 6(c) presents the results of testing sample #3. The

Fig. 6 Plots illustrating the Flashover Voltage tests carried out on naturally polluted insulator sample nos. (a) 1, (b) 2, and (c) 3

$V_{min}$  of the tested part of this insulator was measured as 196 kV. The  $V_{min}/meter$  of creepage distance was 93.12 kV as shown in Table 5.

Above results, compiled in Table 5, indicate that the electrical performance of the insulator samples was satisfactory and they were capable of withstanding high voltages.
