Metallurgical Analysis of Ball Bearing Seized During Operation

Abhay K. Jha, M. Swathi Kiranmayee, P. Ramesh Narayanan, K. Sreekumar, and P.P. Sinha

Keywords aerospace, failure analysis, metallography

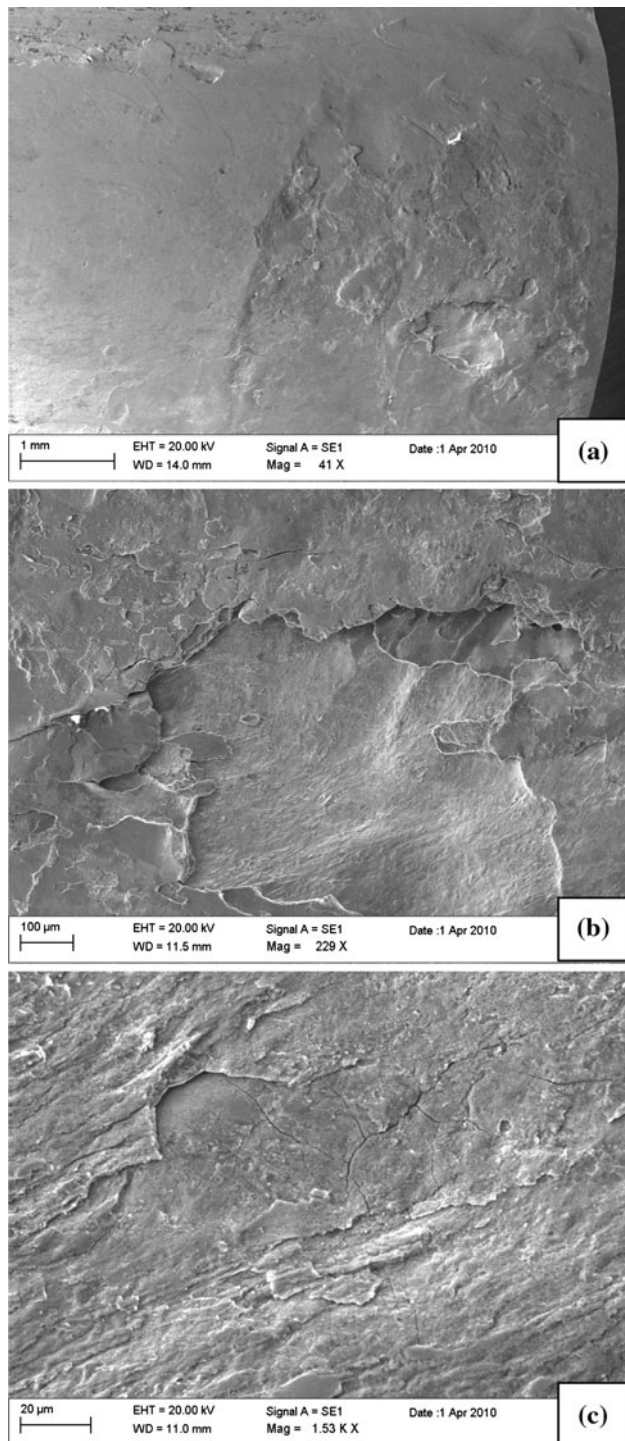
ball had undergone severe damage under mechanical loading and resulted in material spalling (Fig. 1). The outer casing also revealed similar surface rupture (Fig. 2). Dents created by the ball in contact with outer casing, under excessive mechanical loading ruptured the material adjacent to this (Fig. 2a). Isolated locations had features indicative of material exposed to very high temperature near or beyond its melting point (Fig. 2b, c). Multilayer delaminations, as shown in Fig. 2(d), indicated severe mechanical loading condition.

Fig. 1 Surface of ball seized during operation “B_s”. (a) Severe damage under mechanical loading at different locations (b, c)

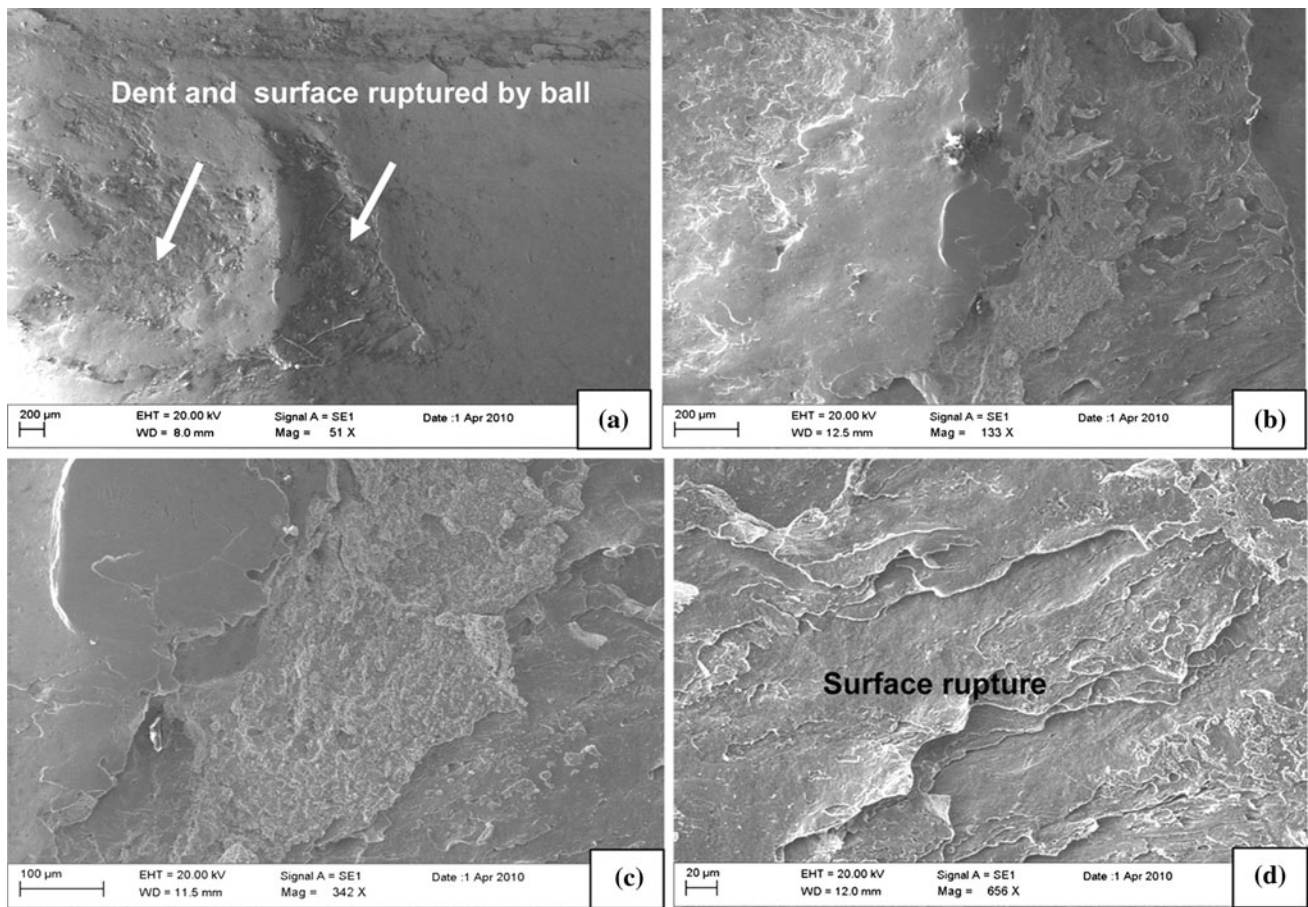
Fig. 2 Features of slotted region of case “C_s”, which was in contact with ball motion (lateral surface). (a) Dent at ball contact point; (b, c) smooth surface feature; (d) surface rupture point

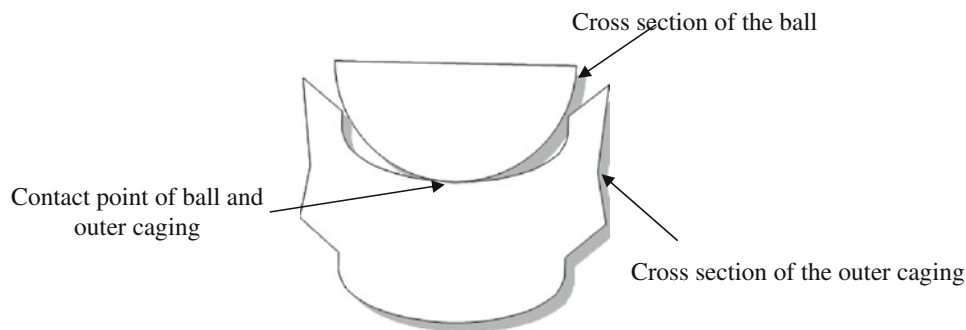
Fig. 3 Cross-section of the ball the bearing showing ball and the outer caging

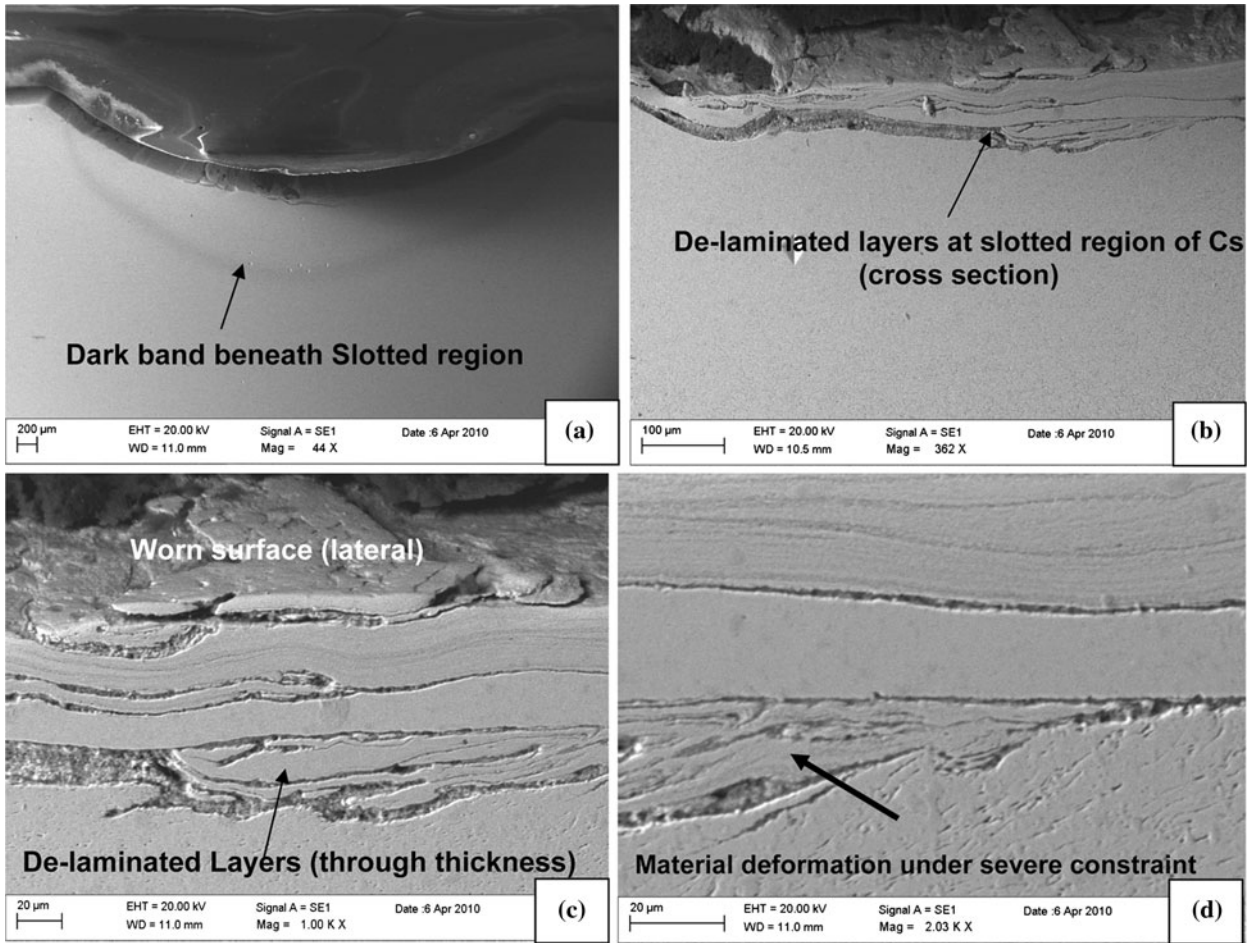
Figure 3 shows the cross section of the ball bearing. Cross section of C_s was sliced across the thickness and prepared for metallography. The prepared specimen indicated delaminated layer within 100-μm depth (Fig. 4) from the ball-outer cage contact point. Delaminated layer exhibited localized material deformation line within it (Fig. 4c, d).

Fig. 4 Features at slotted region of C_s , which was in contact with ball motion (cross section, i.e., through thickness). (a) Dark band; (b-d) de-laminated layers

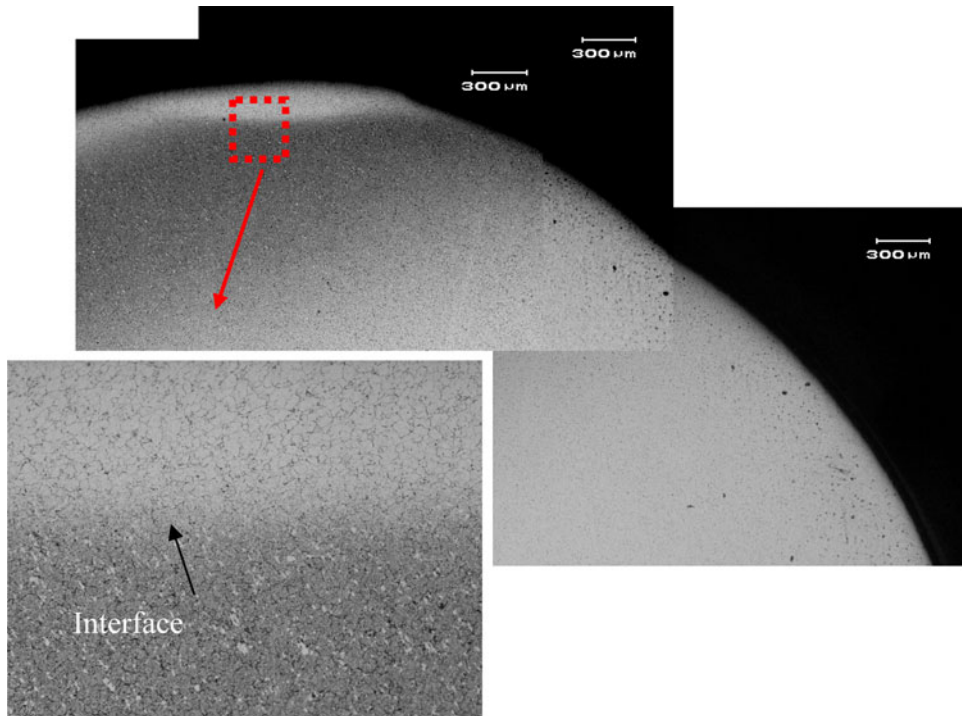
The balls B_s & B_f were cut into two halves and microstructure at the bi-sectional plane of each ball was studied. The microstructure was observed using an Olympus GX-71 inverted optical microscope. Microstructure consisted of fine-tempered secondary carbide particles in martensite (Ref 1). A narrow white band of 180-μm length was seen on peripheral region of B_s with an adjacent dark-etched region of 140-mm width (Fig. 5) with clear interface between the white narrow band at extreme periphery and dark-etched region. Dark-etched region had coarser white islands in the matrix of tempered martensite (Fig. 6). These white islands were thought to be coarser secondary carbides. Hetzner and Geertruyden (Ref 2) made similar observations and identified them to be M₇C₃ and M₂₃C₆ through X-ray diffraction. However, few isolated islands with morphological differences with that of secondary carbides were also seen, which were found to be reverted austenite. The B_f was devoid of these microstructural details (Fig. 7).

Fig. 5 Interface between the dark band and light region [*etchant*: Vilella's reagent (5 mL HCl, 1 g picric acid, and 100 mL methanol)]

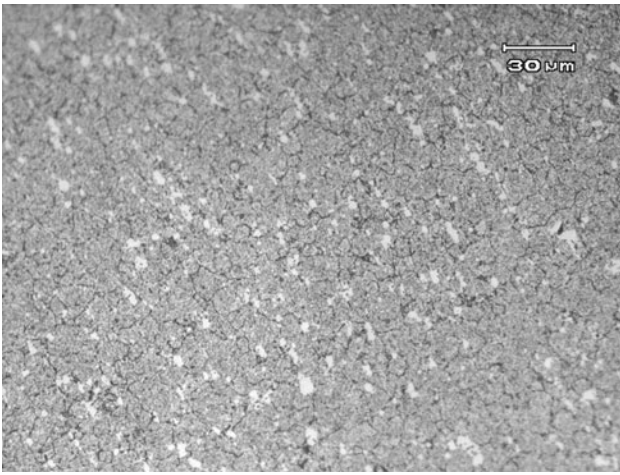
Fig. 6 Structure in the dark band region [etchant: Vilella's reagent (5 mL HCl, 1 g picric acid, and 100 mL methanol)]

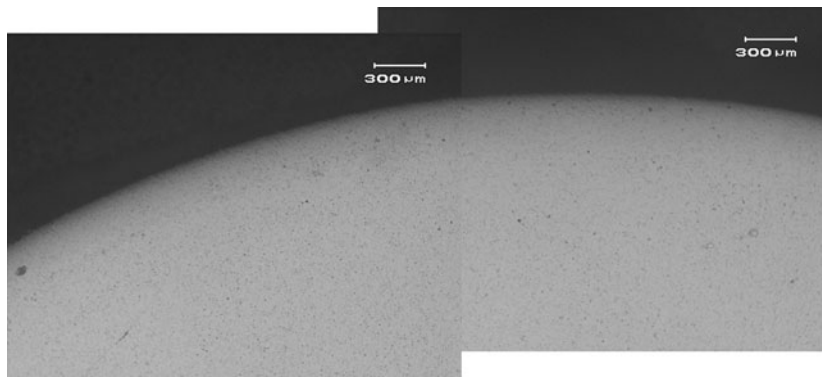
Fig. 7 Optical photomicrograph showing the absence of dark band in ball (B_f)

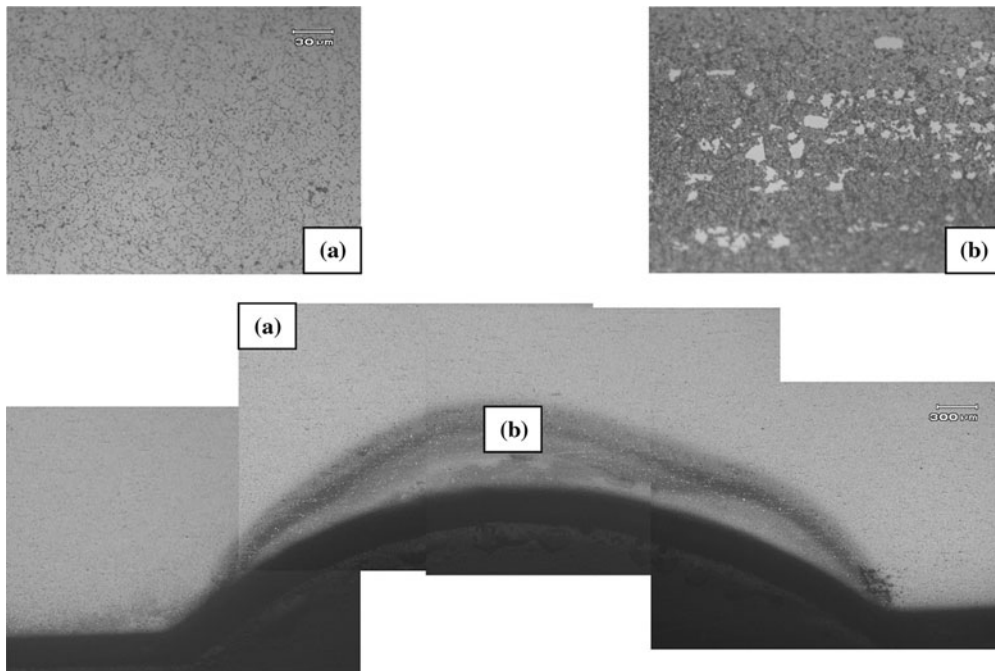
Cross section of C_s, duly polished and etched revealed similar features as seen on B_s. Dark-etched region was like necklace around the cavity of ball-cage contact region and had width of 600 μm at center and narrowing down at both the ends (Fig. 8).

Fig. 8 Optical photomicrographs of outer caging (C_s) showing dark band as necklace. (a) Core region; (b) dark-etched band region [etchant: Vilella's reagent (5 mL HCl, 1 g picric acid, and 100 mL methanol)]

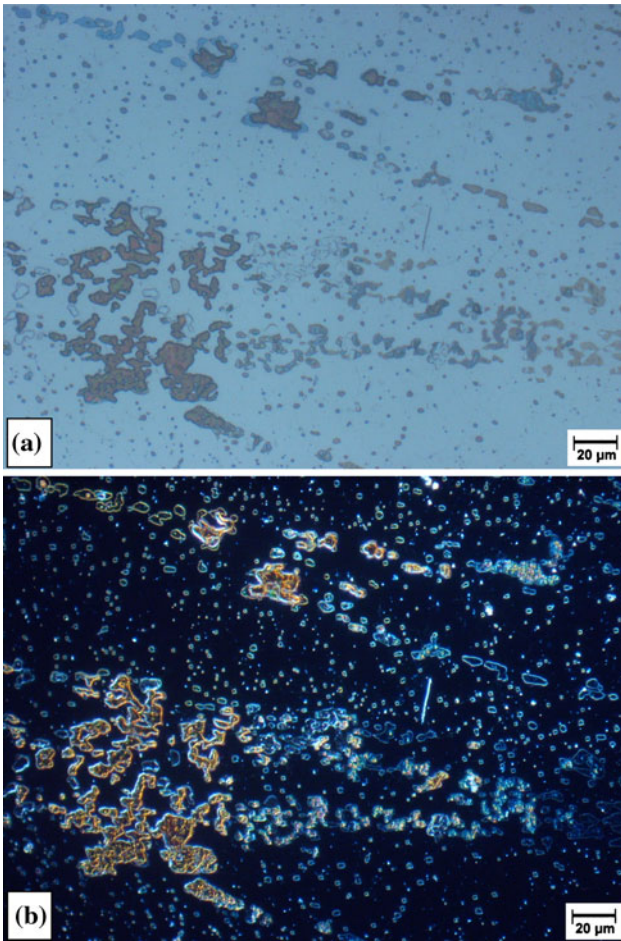
Etching with Groesbeck’s reagent gave better contrast to the microstructural details. The Fe₂MoC and M₆C were outlined and colored blue and brown, respectively (Ref 2) as seen in dark field optical images. These carbides were coarser and non-uniformly distributed within the dark-etched region (Fig. 9), while they were fine and more uniformly distributed within the remaining material of the ball (Fig. 10).

Fig. 9 Optical photomicrographs of dark etched region near outer periphery of ball 'B_f' showing carbides duly color etched: (a) bright field; (b) dark field [etchant: Groesbeck's reagent: 4 g KMnO₄ + 4 g NaOH + 100 mL H₂O at 20 °C]

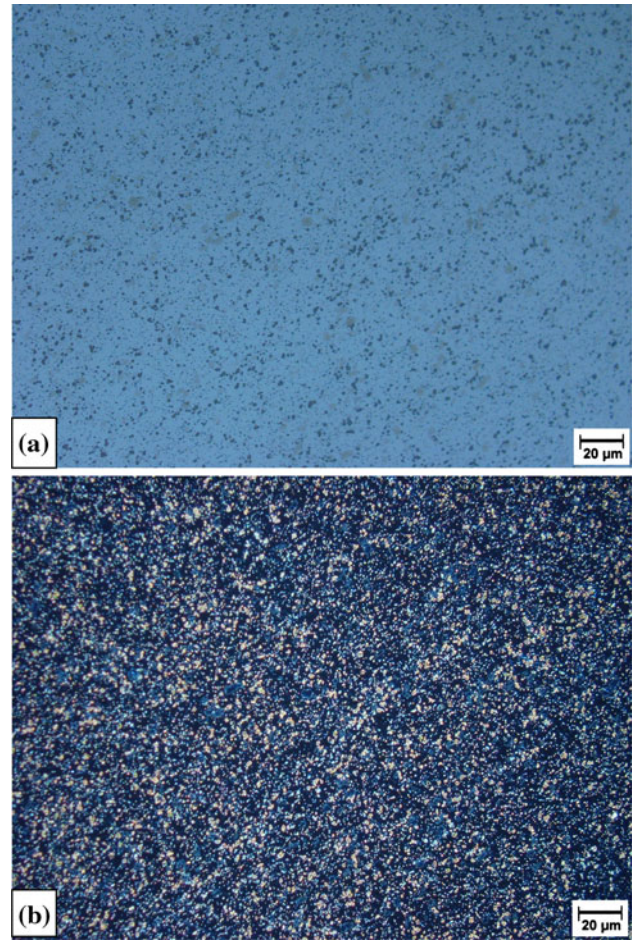
Fig. 10 Optical photomicrographs at core of ball 'B_f' showing carbides duly color etched: (a) bright field; (b) dark field [etchant: Groesbeck's reagent: 4 g KMnO₄ + 4 g NaOH + 100 mL H₂O at 20 °C]

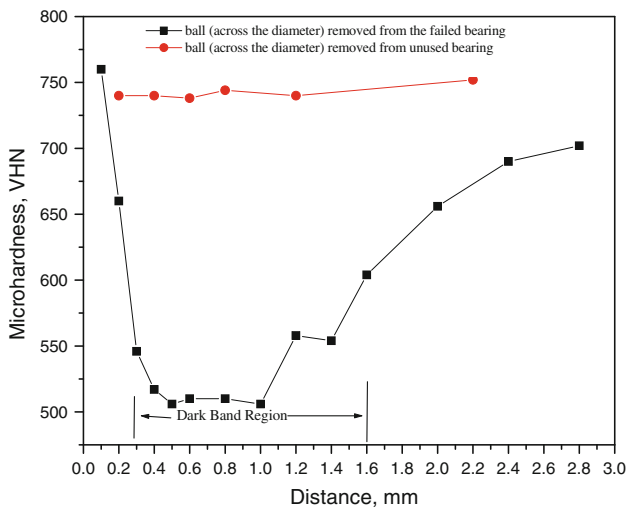
Microhardness measurements were carried out using CLE-MEX make CMT microhardness tester with 500 g load on bi-sectional plane of both the balls i.e., ball B_s and B_f. The measurements were carried out on ball (B_s) from outer periphery through dark-etched region to the core of the ball material. Hardness values were measured at various locations and plotted. X-axis represented distance in mm with zero point as outer edge. There was a distinct drop in hardness within the dark-etched region (Fig. 11), in comparison with minimum acceptable hardness value of 700 VHN at 500 g load which is equivalent to 59 HRC, while it was more or less uniform for B_s. Similar drop in hardness within dark-etched region was noticed in C_s (Fig. 12).

Fig. 11 Microhardness profile of B_s and B_f

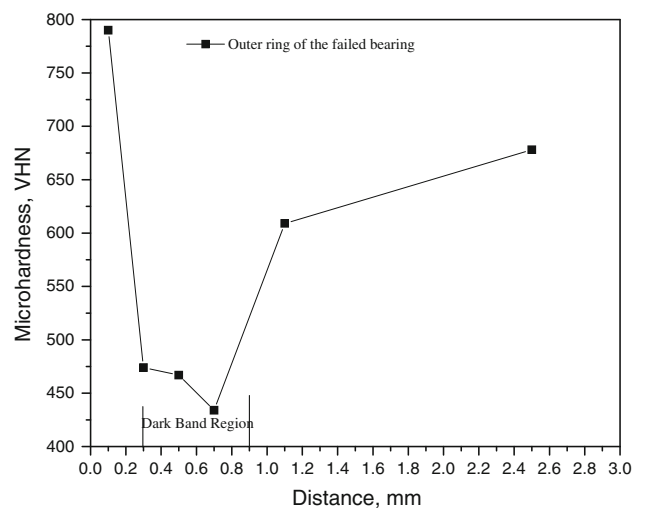
Fig. 12 Microhardness profile of C_s (cross section)

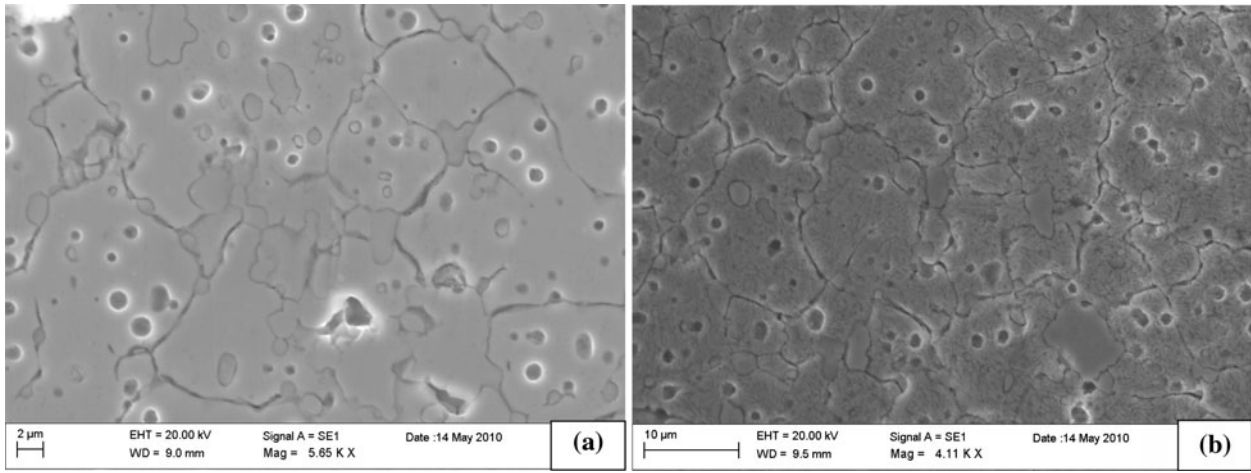
Microstructure in the core region of B_s revealed unresolved martensite (Fig. 13a) in general with fine carbide particles. Within the dark-etched band, Over tempered martensite matrix (Fig. 13b) was seen with coarse carbide particles. EDS of carbide and matrix is shown in Fig. 14. Similar observations were made on C_s.

Fig. 13 SEM photomicrographs revealing the microstructure in etched condition. (a) In the core of the ball; (b) in the dark-etched band region

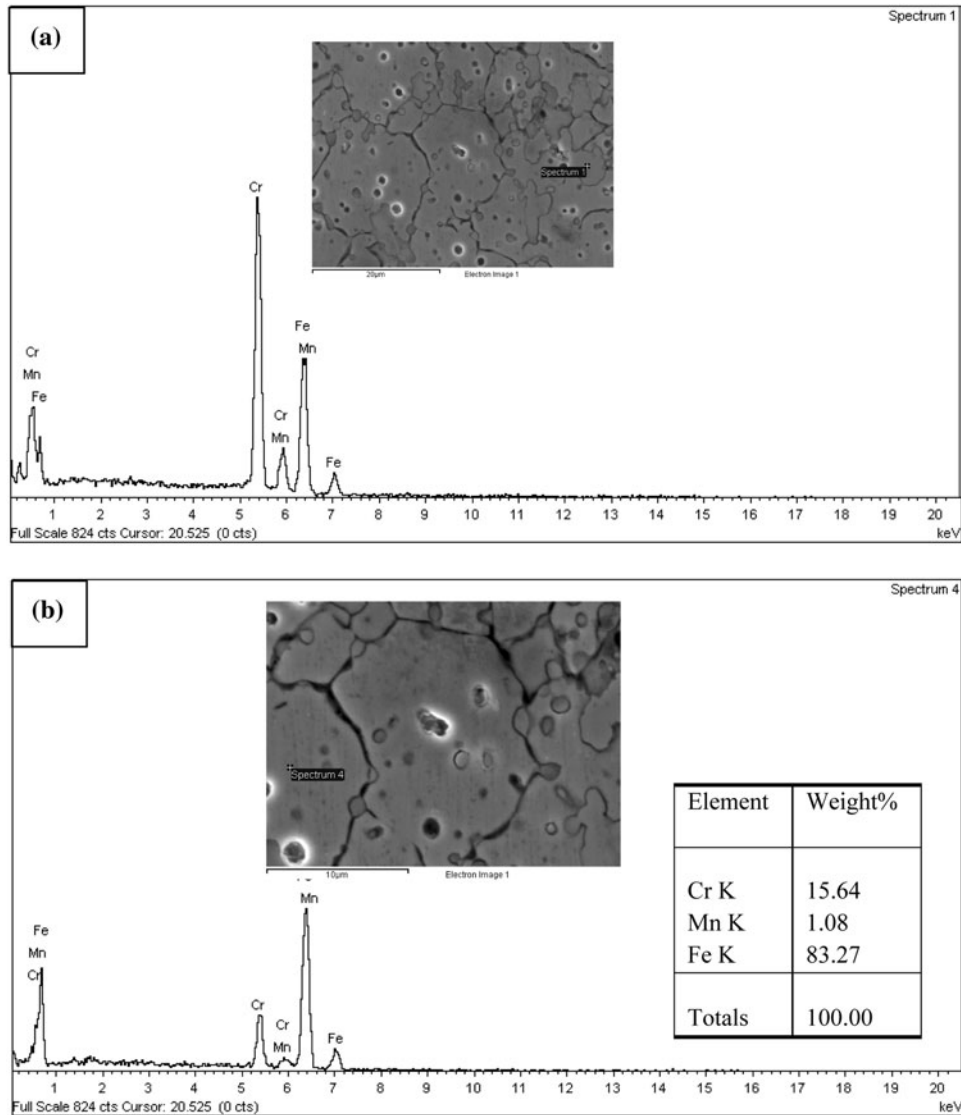
Fig. 14 EDS spectrum (a) on the chromium carbide particle; (b) on the matrix

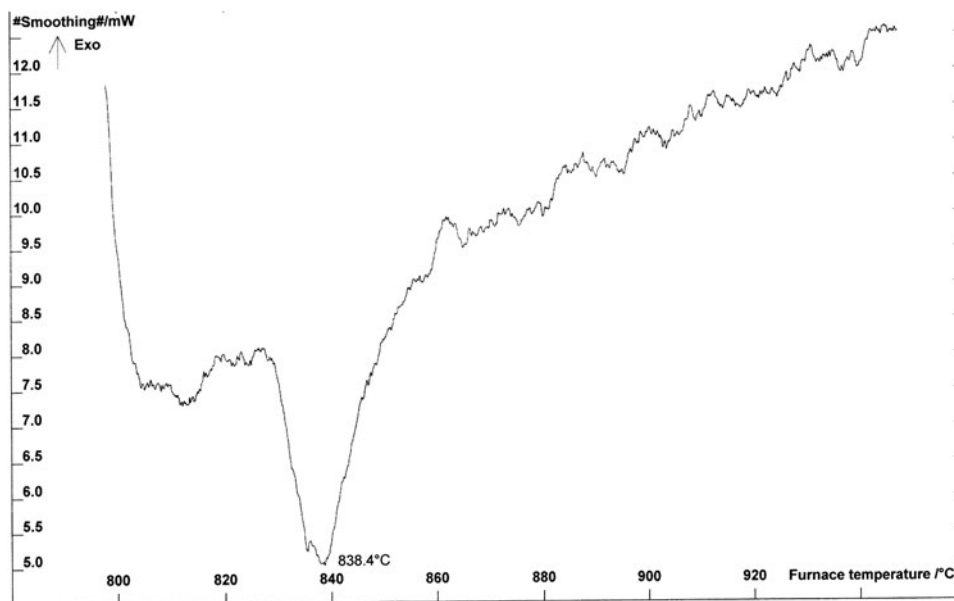
Sample of 3-mm diameter and 0.5-mm thick disc made out of C_s was subjected to DSC from RT to 800 °C with heating rate of 10 °C per min and 800-950 °C, with heating rate of 5 °C/min. Slower heating rate at elevated temperature was chosen taking into consideration 17 wt.% Cr Isopleth, Fe-Cr-C phase diagram (Fig. 15). Heating rate was kept as low as 5 °C per min during temperature range of 800-950 °C. DSC curve (Fig. 16) confirmed endothermic phase transformation (Ferrite → Austenite) at the temperature of 840 °C, which was in good agreement with Fe-Cr-C phase diagram.

Fig. 16 DSC curve showing endothermic phase transformation
