Case Study: Pitting and Stress Corrosion Cracking in Heat-Affected Zone of Welded Underground 304 Stainless Steel Pipe

H.M. Tawancy and Luai.M. Al-Hadhrami

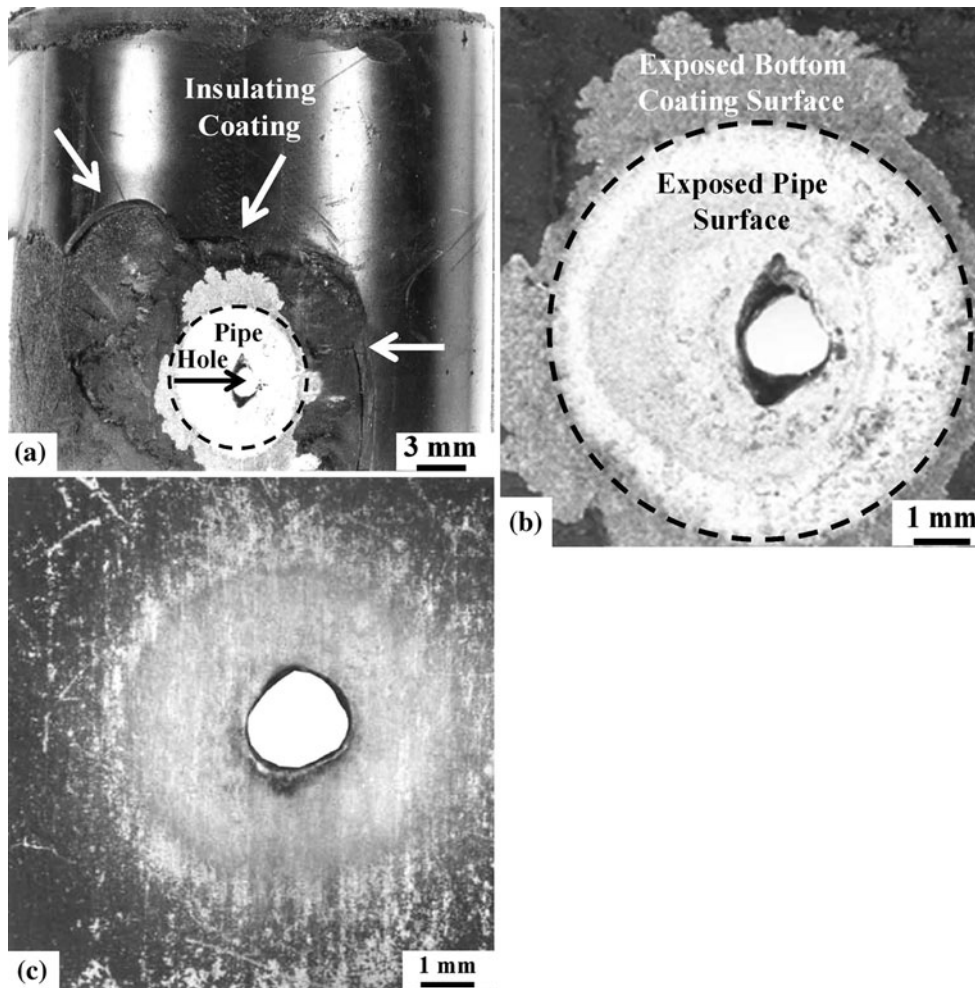
Photographs illustrating a section of the pipe where perforation occurred are shown in Fig. 1. Corrosion product was observed at the outer bottom surface in the vicinity of the perforation; however, the internal surface was relatively clean. This is further illustrated in the optical macrographs of Figure 2 indicating that the pipe was corroded by interaction between the bottom surface and the surrounding environment particularly in those regions where the insulating coating was damaged.

Fig. 1 Photographs illustrating general features of the pipe in the as-received condition. (a) An overall view of the outer surface of the bottom section of the pipe showing perforation in the region where the insulating coating was damaged. (b) A photograph showing the outer pipe surface. (c) A photograph showing the inner pipe surface

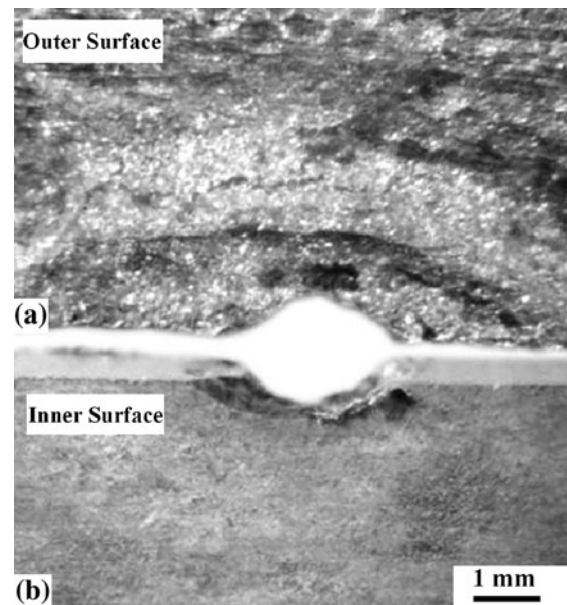
Fig. 2 Light optical macrographs of a section parallel to the surface showing macroscopic features of the outer and inner surfaces of the pipe in the vicinity of the perforation. (a) Outer surface, (b) inner surface

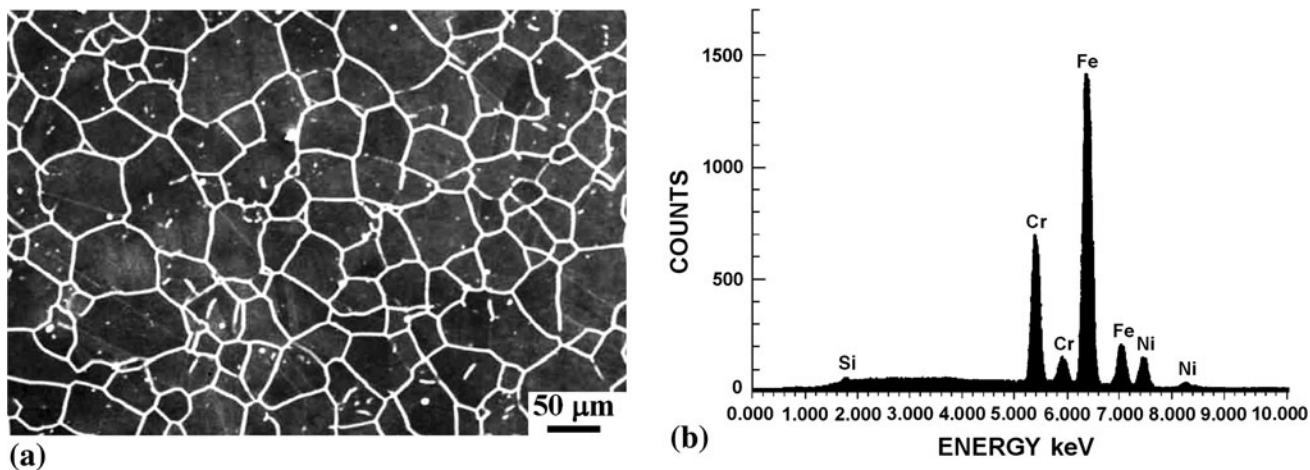
Fig. 3 Typical microstructure and composition of a sound section of the pipe. (a) Secondary electron image showing the grain structure in the etched condition; scattered carbide particles are distinguished throughout the microstructure. (b) Corresponding energy dispersive x-ray spectrum illustrating the elemental constituents of the pipe material. (c) Nominal chemical composition of 304 stainless steel in comparison with that measured by inductively coupled plasma atomic energy spectroscopy (ICP-AES)

annealed condition (Ref 10). A corresponding energy dispersive spectrum illustrating the elemental composition of the pipe is shown in Fig. 3(b) consistent with an alloy based upon the Fe-Cr-Ni system. Figure 3(c) summarizes the results of measuring the chemical composition by inductively coupled plasma atomic energy spectroscopy (ICP-AES) in comparison with the nominal composition of 304 stainless steel verifying that the pipe was manufactured according to specifications.

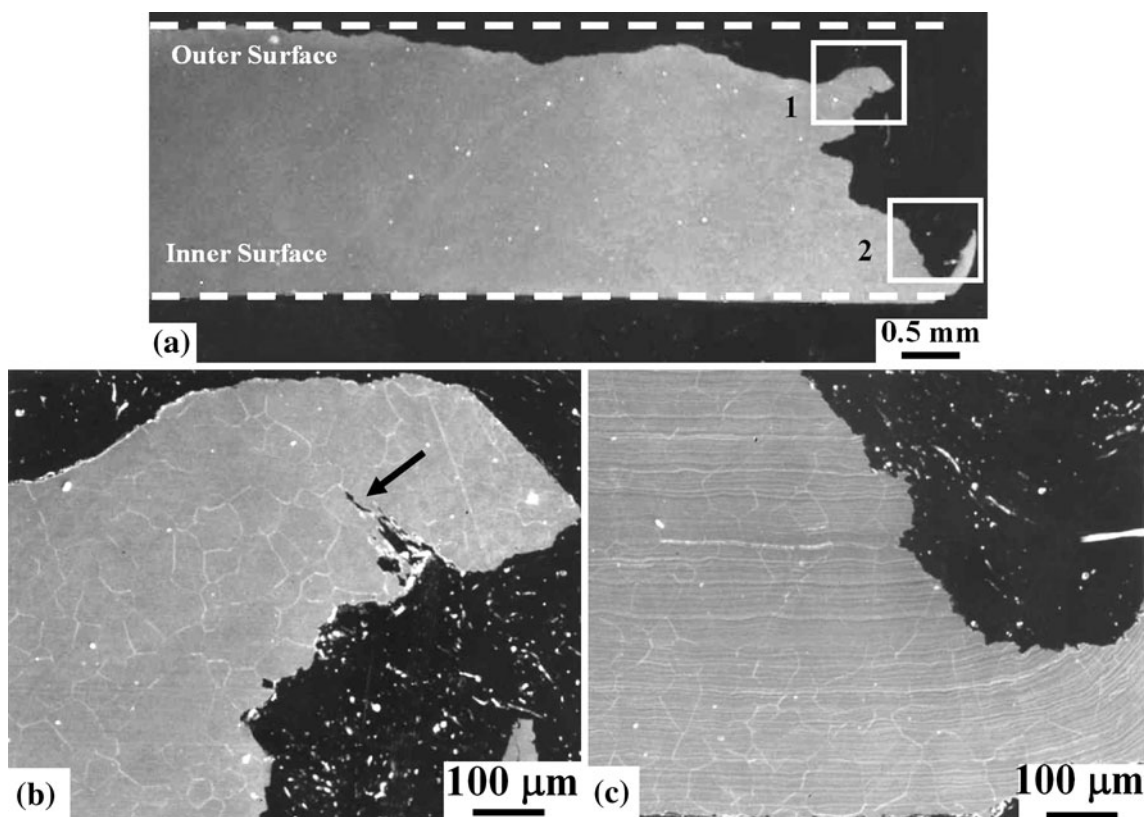
Fig. 4 Secondary electron images illustrating characteristic features of a cross section of the pipe near the perforation. (a) A macrograph indicating that tube wall thinning was initiated at the outer surface. (b) A micrograph showing the grain structure at the outer surface (region 1 in a); an intergranular crack is indicated by the arrow. (c) A micrograph showing the grain structure at the inner surface; absence of intergranular cracking is noted (region 2 in a)

Consistent with the above results, examination of a cross section of the pipe indicated that the tube wall thinning eventually leading to perforation was initiated from the outer pipe surface as demonstrated in the secondary electron image of Fig. 4(a). Evidence for intergranular cracking at the outer surface was observed in the vicinity of the perforation as shown in Fig. 4(b). In contrast, there was no evidence for such cracking at the inner surface (Fig. 4c) suggesting that the cracking was also initiated at the outer surface of the pipe.

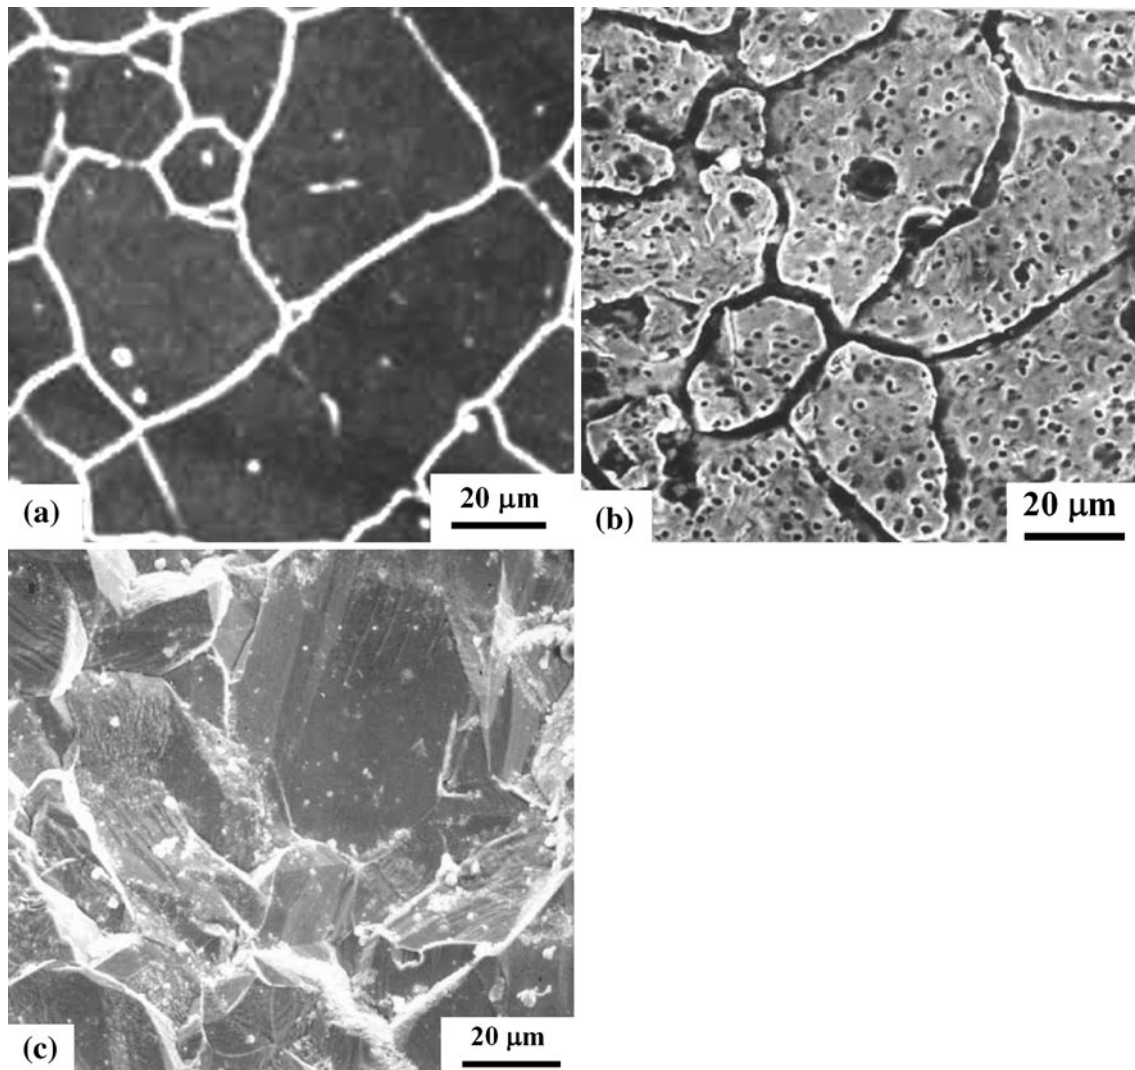
As shown in the example of Fig. 5, three types of grain structures could be distinguished throughout the pipe. A grain structure typical of annealed 304 stainless steel was observed in sound sections as demonstrated in Fig. 5(a) (specimen was polished and etched). Figure 5(b) shows a grain structure of a section subjected to corrosion attack near the perforation. Although the specimen was examined in the as-polished condition, the structure appears to be typical of a heavily etched material. Near the edges of the perforation at the outer surface, a structure such as that shown in Fig. 5(c) was observed in the as-received condition (unpolished and unetched), which typifies a fracture surface produced by intergranular separation. This observation is consistent with that of Fig. 4(b) showing intergranular cracking around the perforation at the outer pipe surface. Near the perforation, the average microhardness was measured to be HV 185, however, in far removed regions; the average microhardness was HV 162 comparable to that of annealed 304 stainless steel. Evidently,

Fig. 5 Secondary electron images illustrating the three distinct grain structures observed in the perforated pipe. (a) Grain structure of a sound section of the pipe as revealed by etching. (b) Grain structure revealed by only polishing of the outer surface near the perforation. (c) Grain structure in the as-received condition (unpolished and unetched) derived from a region of the surface exposed by the perforation

the high hardness value near the perforation could be related at least partially to residual welding stresses.

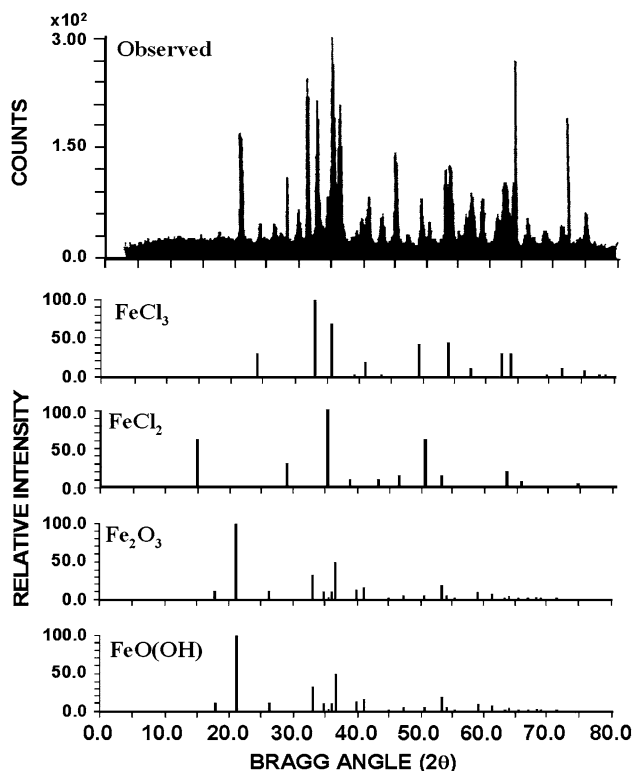
Figure 6 summarizes the result of analyzing samples of corrosion product removed from the bottom surface of the pipe

Fig. 6 An x-ray diffraction pattern derived from corrosion product collected from the outer surface of the pipe (observed) in comparison with standard ASTM patterns of FeCl₃, FeCl₂, Fe₂O₃, and FeO(OH)

using x-ray diffraction. The observed diffraction pattern is compared with standard patterns of FeCl₃, FeCl₂, Fe₂O₃, and FeO(OH). An example illustrating the result of analyzing the corrosion product by energy dispersive x-ray spectroscopy in a scanning electron microscope is shown in Fig. 7. Combining the above results could lead to the conclusion that the corrosion product consisted of mixed iron chlorides and oxides indicating that the pipe was subjected to corrosion attack by chloride ions in defective regions of the insulating coating. However, the problem was further compounded by intergranular cracking suggesting that the pipe was subjected to both pitting corrosion and stress corrosion cracking. It is known that stress corrosion cracking of austenitic stainless steels is initiated at the grain boundaries (Ref 1). As pointed out earlier, this behavior could be related to localized deformation alongside grain boundaries. In this regard, examination of the deformation substructure in the vicinity of the perforation by transmission electron microscopy revealed features typical of a material with low stacking fault energy as described below.

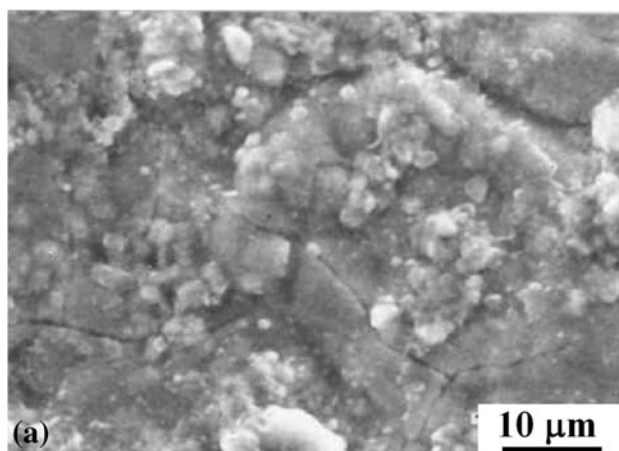
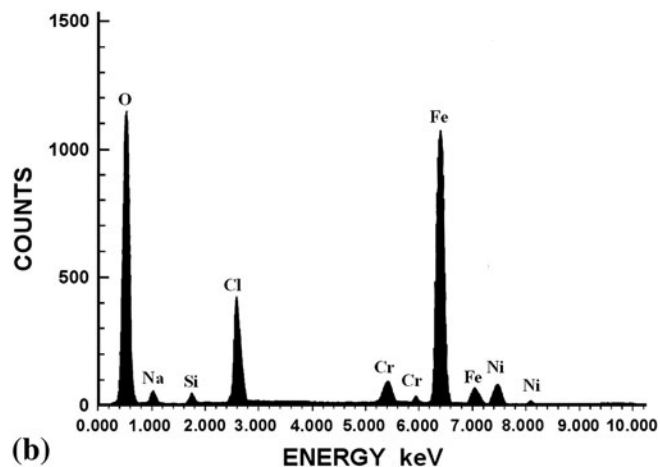
Fig. 7 An example illustrating the result of microchemical analysis of the corrosion product formed at the outer surface of the pipe by energy dispersive x-ray spectroscopy. (a) Secondary electron image showing the morphology of the corrosion product. (b) Corresponding energy dispersive spectrum illustrating the elemental composition of the corrosion product

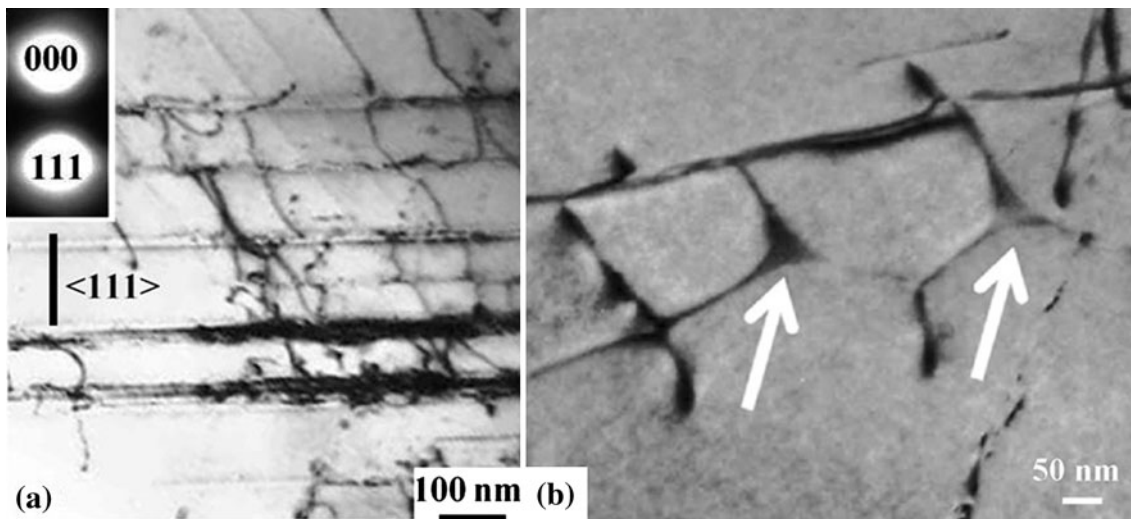
Bright-field TEM images illustrating characteristic deformation substructures in various regions in the vicinity of the perforation are shown in Fig. 8a. A common feature was the observation of slip lines (traces of {111} slip planes) with dislocations mostly confined to their original slip planes as shown in Fig. 8a. This reflects a lower tendency for cross-slip associated with low stacking fault energy. At higher magnifications, extended nodes resulting from the intersection of three partial dislocations of the type 1/6<112> were observed as shown in the example of Fig. 8b. These observations are indicative of a material with high strain hardening rate, which is expected in many austenitic stainless steels. Detailed microstructural characterization down to the scale of transmission electron microscopy showed no evidence for sensitization particularly the presence of carbide precipitates at grain boundaries. Therefore, it is possible that as a result of high strain hardening rate, the grain boundaries became weaker than the matrix leading to localized intergranular separation in the presence of chloride ions.

Fig. 8 Bright-field TEM images showing deformation substructures in the vicinity of the perforation typical of a material with low stacking fault energy. (a) Slip lines are visible with dislocations confined to their original slip planes. (b) Extended nodes resulting from interaction of three $1/6(112)$ partial dislocations
