Galvanic corrosion of an implant consisting of iron and brass

H. ZITTER and K. PAULUZZI

Institute of Chemistry, University of Mining and Metallurgy, Leoben, and the Hospital for Traumatology, Graz, Austria

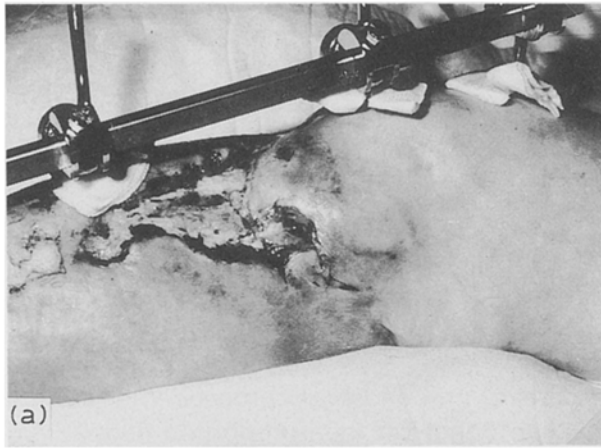
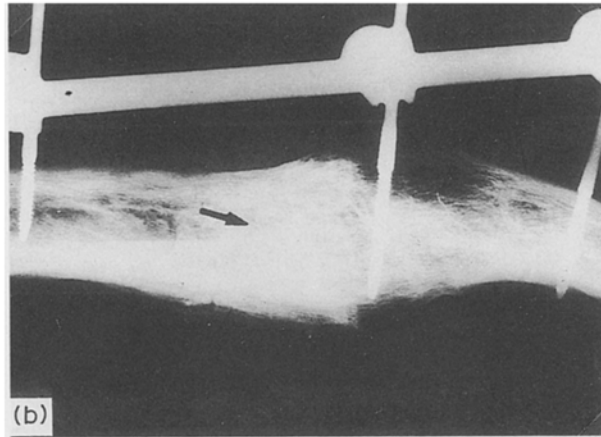
At the age of 13 years a patient developed osteomyelitis of the thigh bone without having sustained any injury to the area. Five years later his knee joint was surgically fixed by means of screws. In 1989, 53 years after the joint had been ankylosed, the patient had an accident and broke his lower leg just below the location of the arthrodesis, at a point where pus had been exuding since 1931 from fistulae in a hand-sized defect extending clear to the bone (Fig. 1a). X-ray examination of the region revealed an object in the shape of a screw (Fig. 1b).

Figure 1 (a) Condition after arthrodesis of the knee joint due to osteomyelitis and (b) location of the screw.

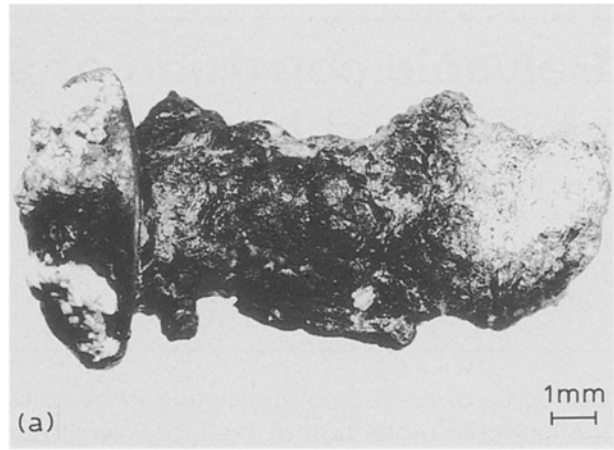
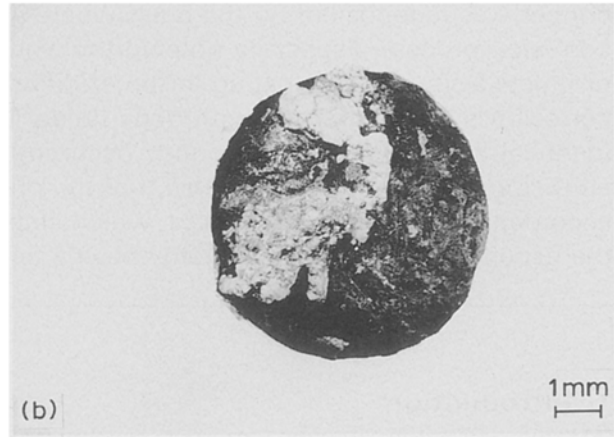
The implant, which was explanted undamaged, was shaped like a screw and was covered with solid corrosion products. A number of lighter-coloured ossifications were found around the head (Fig. 2), where bare metal also showed through in places (Fig. 2b).

Figure 2 The screw after explantation: (a) total view and (b) screw head

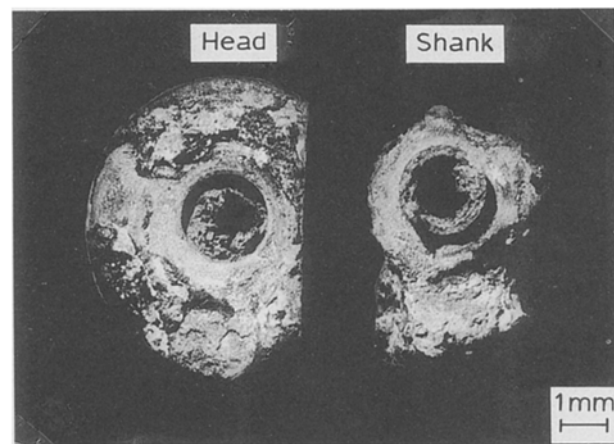
Before embedding the screw in synthetic resin, an attempt was made to cut into the protruding edge of the screw head. However, the screw broke apart at the point where the head intersected the shank, revealing that the shank had corroded all the way through. From Fig. 3, which shows the two fracture surfaces, it can be seen that the head of the screw had been hollow and that this space was now completely filled with corrosion products from the broken-off shank.

Figure 3 Fracture between head and shank of the screw.

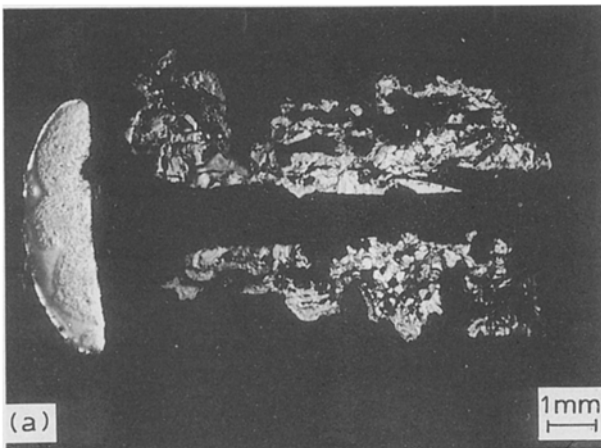
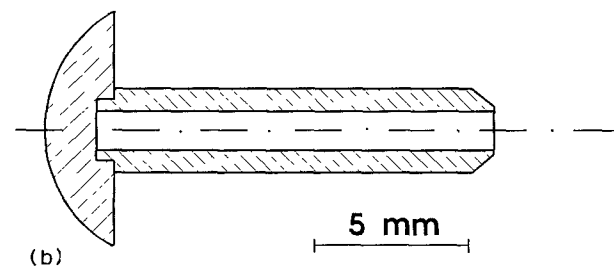
After putting the two parts into their original position, they were embedded in synthetic resin and ground along their longitudinal axis. (This type of preparation ensures that almost none of the corrosion products are lost.) The resultant longitudinal section showed that the completely corroded shank had consisted of a hollow shaft attached to the head (Fig. 4).

Figure 4 Longitudinal sections of (a) the corroded screw and (b) the presumed original implant.

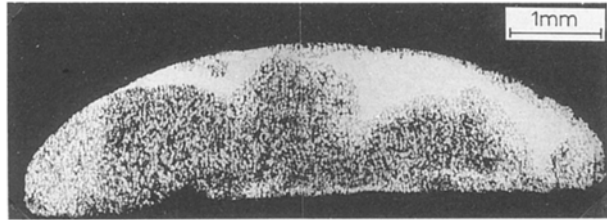
Given its colour, the brightest of the reflecting areas is easily identifiable as brass (Fig. 5), whose underside bears signs of selective corrosion. From the type of corrosion, the metal can be identified as α/β brass, whose low copper content β -phase was selectively corroded while its more copper rich, and thus more resistant, α -phase remained intact (A in Fig. 6). Pictures of the uncorroded part of the metal taken by

Figure 5 Head of the screw in longitudinal section

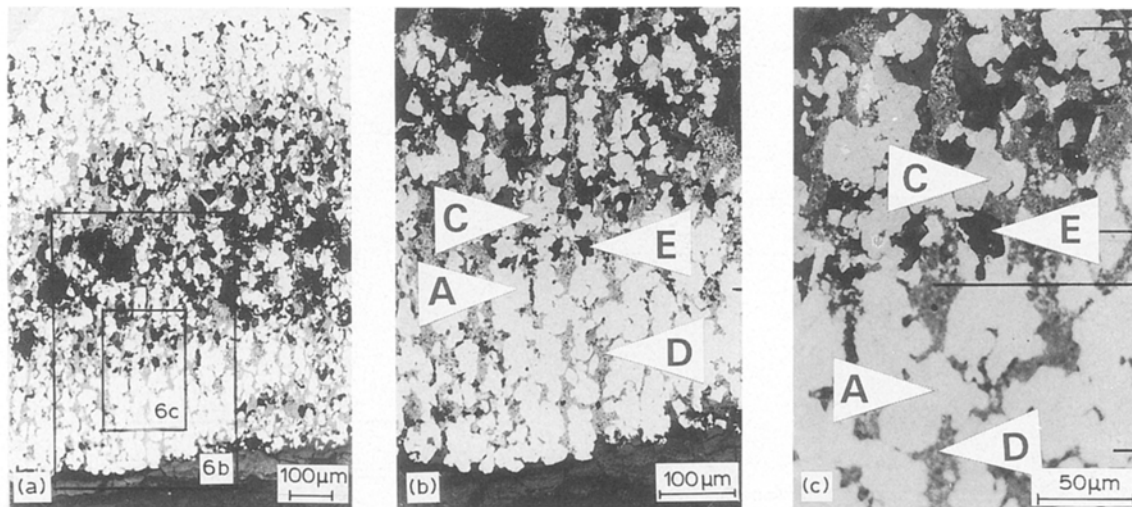
A finely precipitated phase appeared blue in the reflection, but red in the internal reflections (D in Figs 6 and 7), similar to the behavior of cuprite (a product of corrosion found in water pipes). Immediately adja-

cent, a much rarer blue phase was observed (E in Fig. 6) which, under the SEM, appeared considerably lighter than all other phases (E in Fig. 7).

The metal also had a covering of up to 50 μm corrosion products with a zoned structure (bottom of Fig. 6b) which it was not possible to reproduce photomicroscopically. SEM (Fig. 7a) revealed a lighter phase (G) on one side of the metal and a darker phase (F) on the outside.

Figure 6 Structure of the locally corroded screw head (photomicroscopic view).

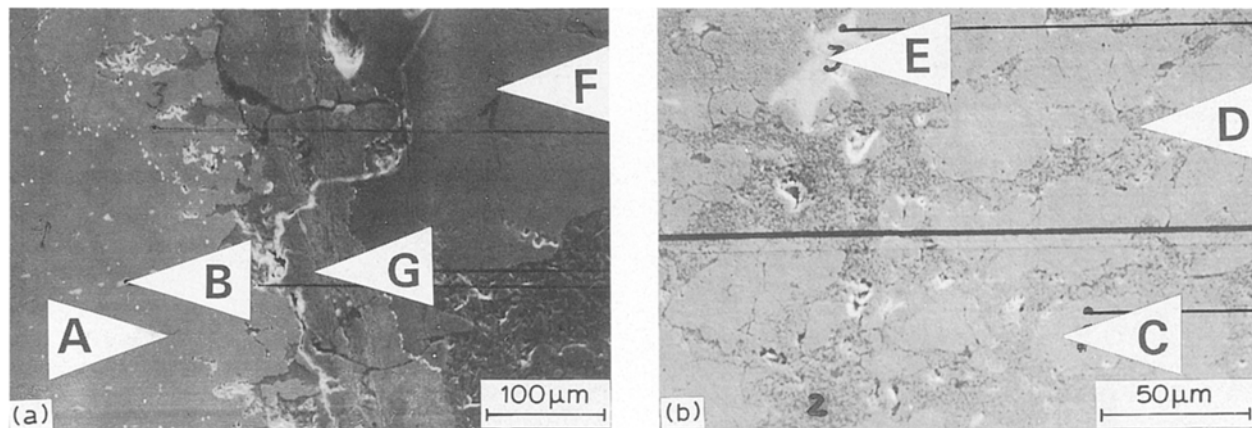
scanning electron microscopy (Fig. 7) show tiny inclusions inside the metal that, given their light colour, are likely to consist of an element with a high atomic number (B in Fig. 7). Inside the selectively corroded parts (i.e. what formerly was β -brass) several phases could be observed: the colour of the porous phase (C in Figs 6 and 7) indicated copper, such as might have precipitated in the course of the dezincification from the primary soluble products of corrosion.

Figure 7 Structure of the locally corroded screw head (SEM micrograph).

Microprobe analysis of corrosion products not visible in the micrograph sections produced the following results. Based on the spectrum shown in Fig. 9, region F in Fig. 7 consisted mainly of zinc. The analysis indicated the presence of white rust [9, 10], known to be a product of the corrosion of zinc, the chemical composition of which was identical to that of the mineral zincite (ZnO) [11]. Again based on the analysis presented in Fig. 9, region G in Fig. 7 probably contained a mixture of zinc oxide and cupric sulphide in various proportions.

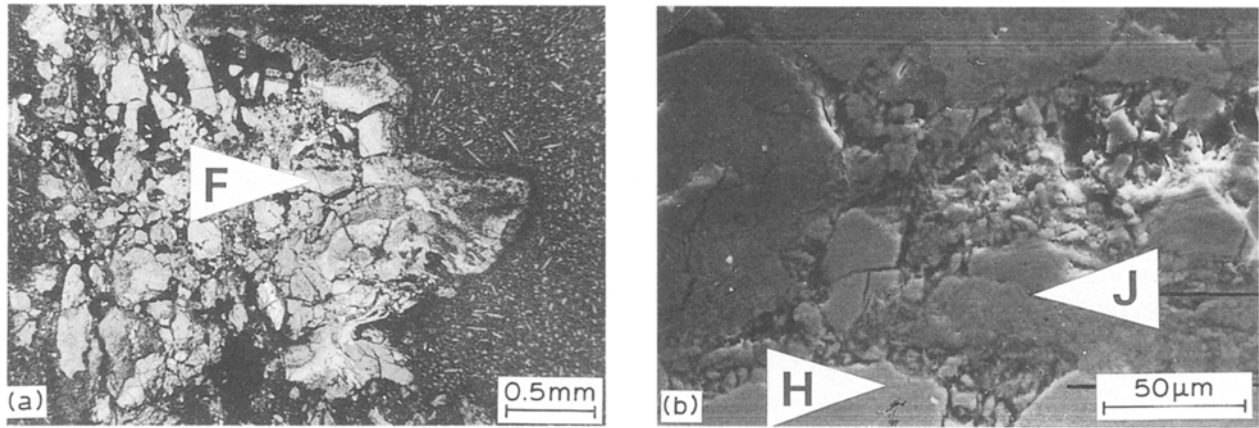
The solid corrosion products found in the hollow shaft of the screw consisted primarily of homogeneous layers that developed cracks (Fig. 8) during the course of preparation. The optical characteristics of these layers, especially their red internal reflexes, point to the presence of a hydrate of ferric oxide [$\text{FeO}(\text{OH})$] [12], better known as rust [13] (H in Fig. 8). SEM uncovered a few areas where an additional phase existed that could not be identified photomicroscopically (J in Fig. 8).

Figure 8 Corrosion products of the hollow shaft: (a) optical micrograph and (b) SEM micrograph

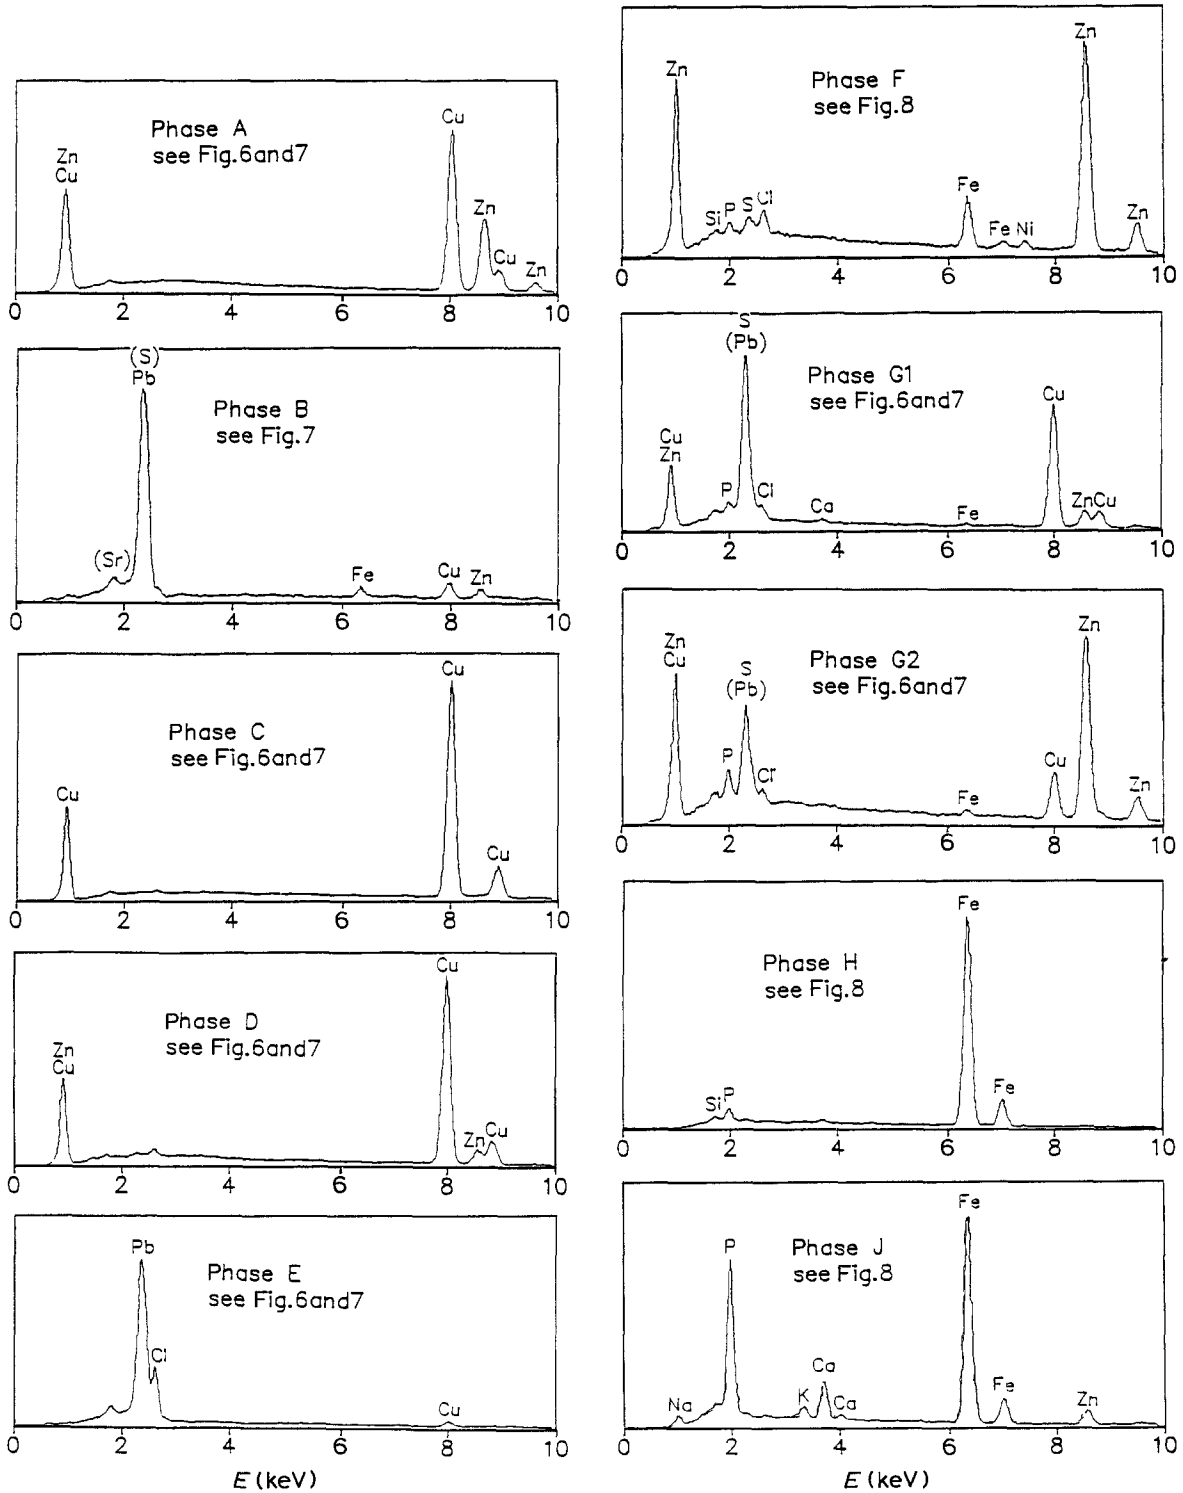
Figure 9 Electron microprobe analysis of different phases.

These spectra prove that the uncorroded matrix consisted of brass (phase A) and, as was to be expected, the red porous matter consisted entirely of copper (phase C in Fig. 6). Inclusions found in the metal (phase B in Fig. 7a) were pure lead. We therefore conclude that what we were dealing with was brass to which lead had been added by alloying in order to improve its machinability. Today such alloys are manufactured with lead contents of up to 3%, an example being CuZn36Pb3, carrying the material number 2,0375 [5]. Apart from copper, phase D (Fig. 7a) showed only minor traces of zinc, evidence that the material was largely pure cuprite [6, 7].

It was particularly surprising to find the elements Pb, Cu and Cl in the analysis of phase E. From among the possible minerals this could indicate, diaboileite mineral phase $2\text{Pb}(\text{OH})_2\text{CuCl}_2$ [8] seemed the most likely, based on the microprobe analysis and the observed optical characteristics. Subsequent comparative analysis of a sample of diaboileite from the Mamouth Mine in Tiger, Arizona, USA, the crystal structure of which was confirmed by X-ray examination, produced exactly the same intensity ratios of Pb, Cu and Cl as in Fig. 9 (phase E).

Iron was the only element found in the corrosion products of the hollow shaft, confirming the photomicroscopic result of $\text{FeO}(\text{OH})$ (Fig. 9, phase J).

The second phase (Fig. 9) that could not be identified photomicroscopically consisted mainly of iron and phosphorous. This analysis pointed to the existence of an iron phosphate, such as vivianite, $\text{Fe}_3(\text{PO}_4)_2 \cdot 8\text{H}_2\text{O}$ [14].

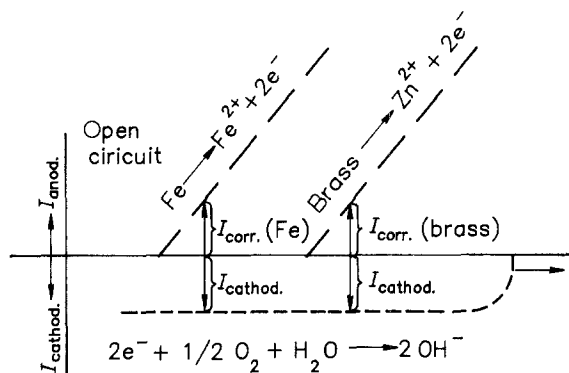
Figure 10 Electrochemical processes during corrosion of separated iron and brass.

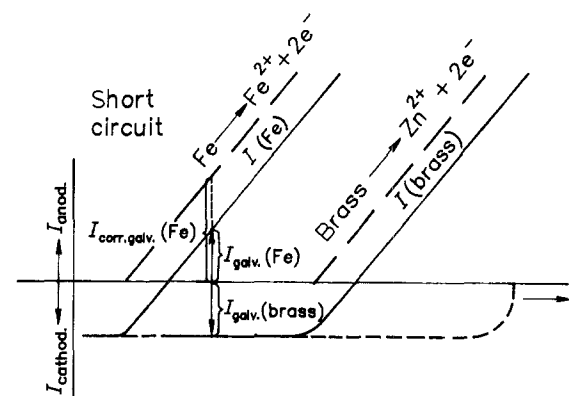
corrosion products were found directly on the surface of the brass (cf. Figs 2 and 3). There can also be no doubt that the third prerequisite, that of the capacity of the ambient medium to conduct ions, was also given. In the case of an open circuit, i.e. with separated electrodes, iron and brass would have corroded with about the same corrosion rate by reduction of oxygen as the cathodic process (Fig. 10). In the short-circuit condition a galvanic element is built up with iron as sacrificial anode, which is preferentially dissolved whereas brass is cathodically protected (Fig. 11). The galvanic current between the two metals is compensated by an equal current of ions with the surrounding electrolyte. This cathodic protection lasted as long as the shaft of iron was in conductive contact with the part of brass. Then the corrosion of brass began with the dissolution of β -grains with lower copper content. With this corrosion process copper ions were precipitated as metallic copper on the surface of the alloy, forming a local cathode which accelerated the anodic dissolution of brass.

Figure 11 Electrochemical processes during corrosion of short-circuited iron and brass. (—) Partial currents and (---) measurable currents.
