Retrieved total hip prostheses

Part II *Wear behaviour and structural changes*

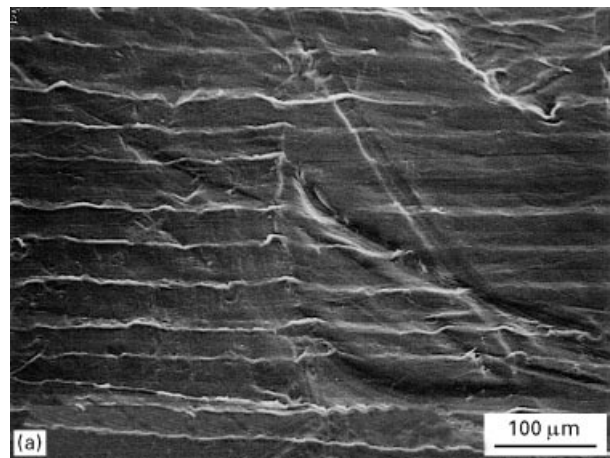
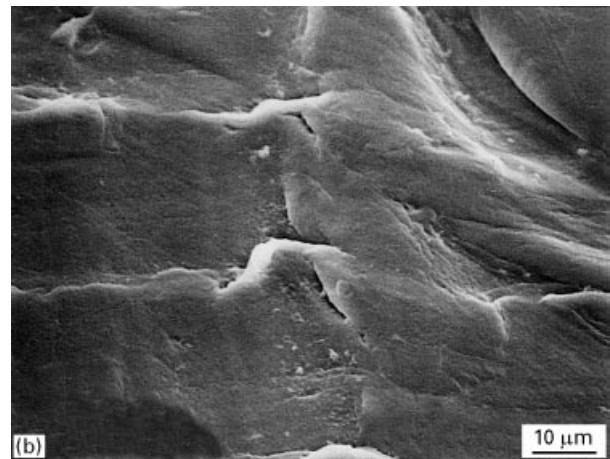
3.1.2.1. Non-weight-bearing portions. On the non-weight-bearing portions, flaws or machine marks that had been made during production were seen (Fig. 1). No abrasion was seen. Hollows, scratch lines and craters were observed. Some portions revealed an irregularly lined pattern of one to several micrometres of smooth ripples. This was taken to be the degradation in the living body (Fig. 2).

Figure 1 Non-weight-bearing portions of a polyethylene cup (by SEM).

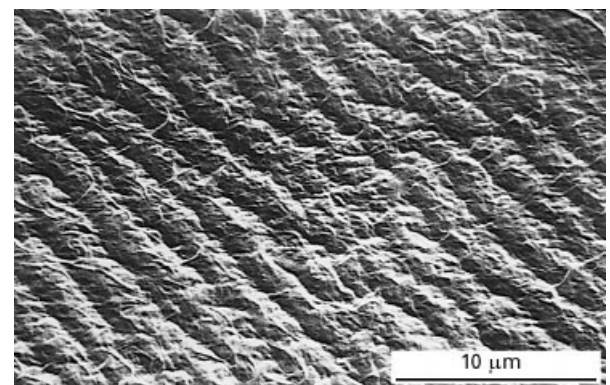
Figure 2 Degradation of the non-weight-bearing portion of a polyethylene cup (by SEM).

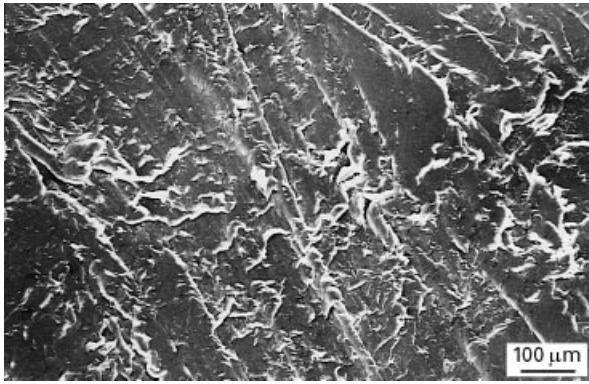
Abrasive damage and cracks were observed in many specimens (Fig. 3).

Figure 3 Non-weight-bearing portion of a polyethylene cup (by SEM).

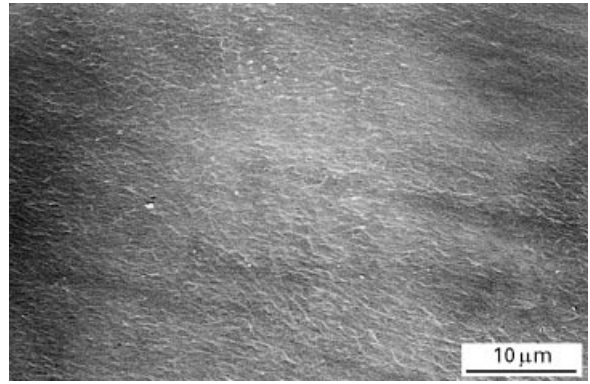
3.1.2.2. Weight-bearing portions. Surface changes on the weight-bearing areas were classified into two groups; a group with a rather smooth surface (T-28, Bioceram) (Fig. 5), the other with carpet-like conspicuous fine fibres (Charnley) (Fig. 6).

Fine, but not sharp, unevennesses were observed in the group with a smooth surface at higher magnifications (Müller, 1-T-2, 2-B-6) (Fig. 5). These differences

Figure 5 Weight-bearing area in a group with a rather smooth surface.

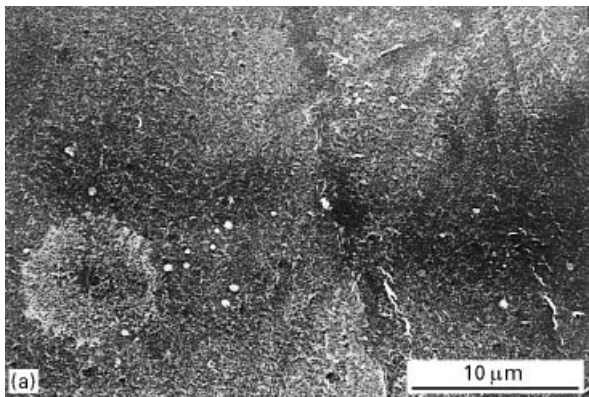
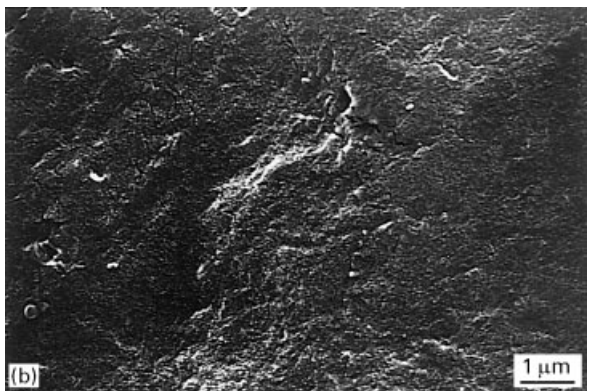
portion presented an irregularly lined pattern of smooth and low ripples of about 0.1 μm, far smaller than those of the non-gamma-irradiated polyethylene (Fig. 4a, b) [2, 3].

Figure 4 (a) Non-weight-bearing portions of a polyethylene cup with gamma irradiation of 100 Mrad. (b) Higher magnification of (a).

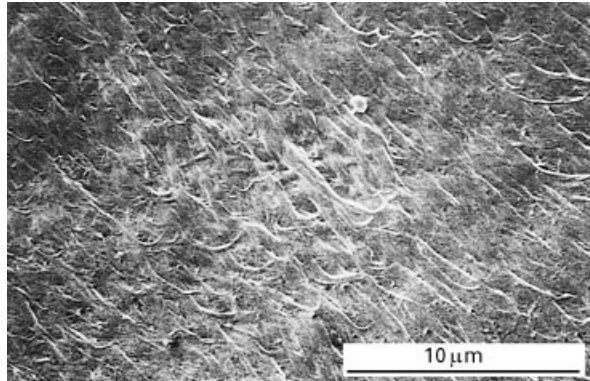
Figure 6 Weight-bearing area in a group with carpet-like conspicuous fine fibres.

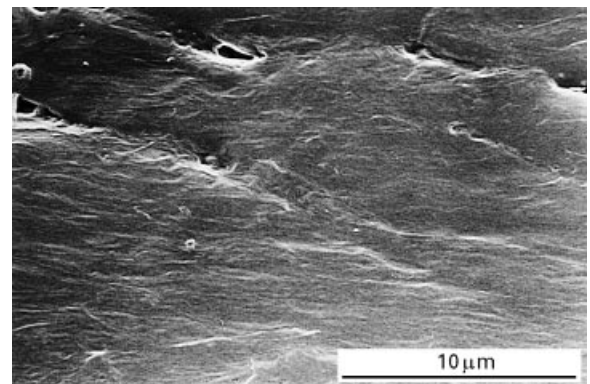
Figure 7 Fine crevices on the weight-bearing area.

Some specimens had fine crevices (Fig. 7).

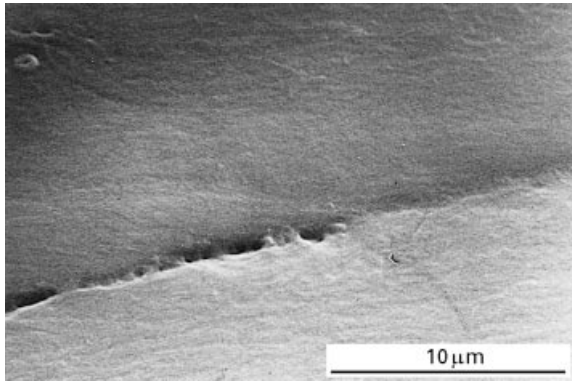
In some crevices, bridge-like fibrils were seen (Fig. 8). According to Rose *et al.* [4], the fibrils connect the boundaries of fused polyethylene particles, suggesting that the crevices were developed between fused particles. Scratches were often seen on Müller and T-28 cups. These scratches were thick and had smooth edges.

Figure 8 Bridge-like fibrils seen in the crevices.

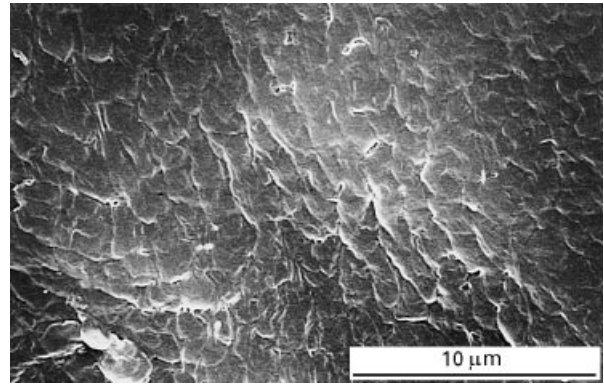
Figure 10 Scale-like defects with a rough napp on the weight-bearing area (Bioceram).

surface became scale-like with a rough napp, and fine crevices were observed (Fig. 10). There were no evident scratches.

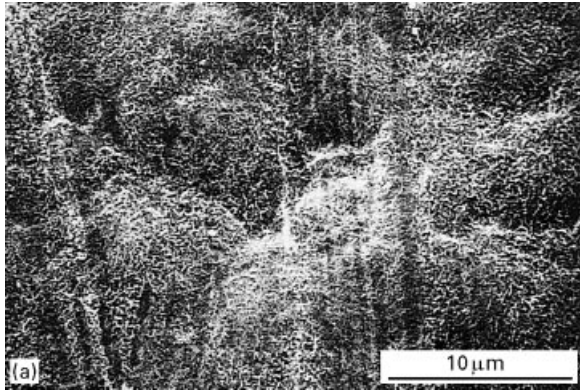
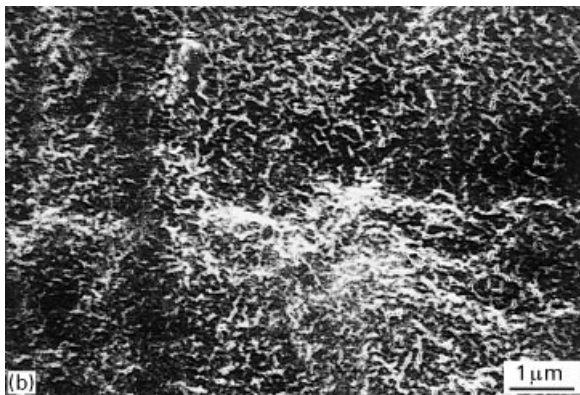
ethylene (Fig. 4a, b). The weight-bearing portion presented a more clearly outlined pattern, irregularly lined with smooth ripples of about 0.1 μm. The scratch flaking, delamination and folding phenomena, characteristic of non-gamma-irradiated polyethylene, were not observed at all. These findings indicate that wear is very small for gamma-irradiated polyethylene (Fig. 9a, b) [2, 3].

Figure 9 (a) Weight-bearing area of a polyethylene cup with gamma radiation of 100 Mrad. (b) Higher magnification of (a).

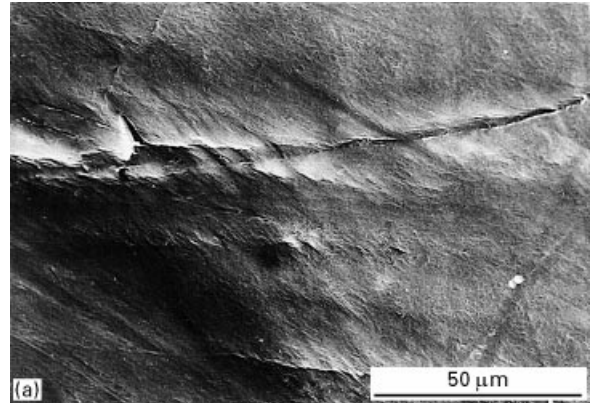
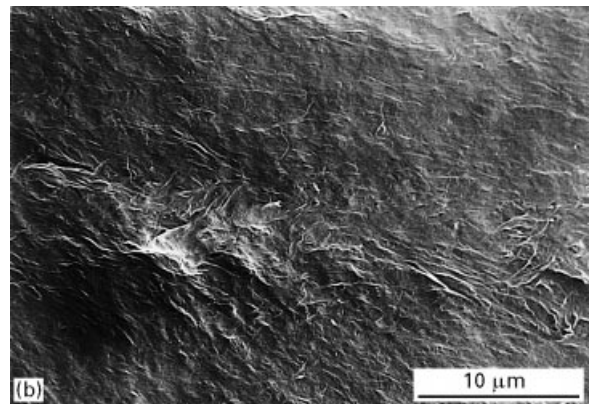
Figure 11 (a) Striate unevenness on the non-weight-bearing area. (b) Higher magnification of (a) (Charnley).

(b) *Charnley (22 mm stainless steel head)*. On the non-weight-bearing area, striate unevenness was seen (Fig. 11a, b), many fine crevices were observed overall, and their directions were not uniform. On the weight-bearing area, the surface was smooth overall; however, at higher magnification, carpet-like conspicuous fine fibres were observed (Fig. 12). Scratches and fine crevices were seen here and there. However, the crevices were rather fewer on the weight-bearing area than that on the non-weight-bearing area.

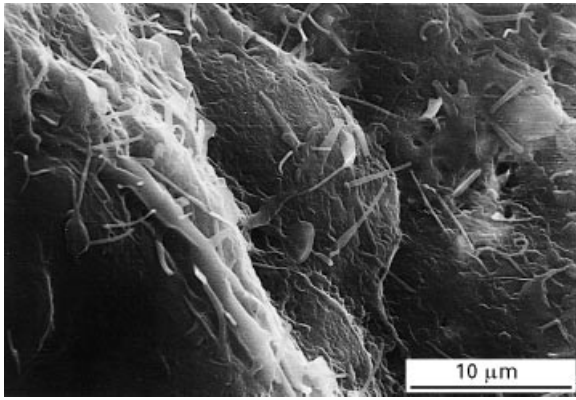
Figure 12 Carpet-like conspicuous fine fibres on the weight-bearing area (Charnley).

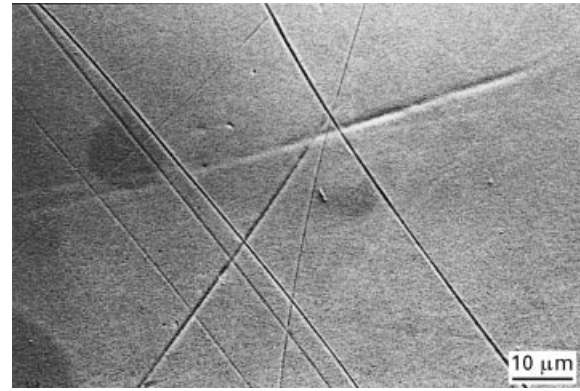
Figure 15 Weight-bearing area of the metal femoral head.

In the case of the alumina femoral heads observed by SEM, some weight-bearing areas appeared burnished in some places (Fig. 14). In contrast, readily observable burnishing and scratches were produced on the weight-bearing parts of the metal heads (Fig. 15).

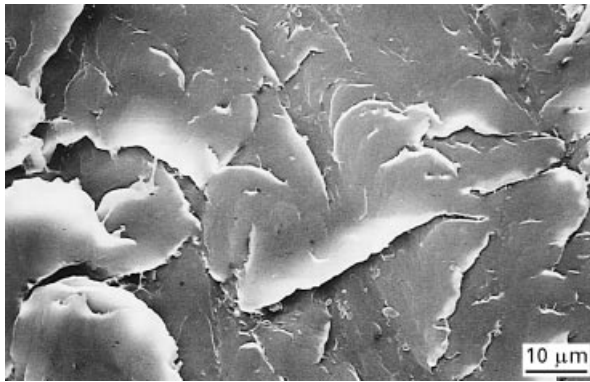
smooth overall. However, at higher magnification, scale-like structures were seen (Fig. 13). Many scratches were observed; however, few crevices were seen.

Figure 13 Scale-like structures on the weight-bearing area (Müller).

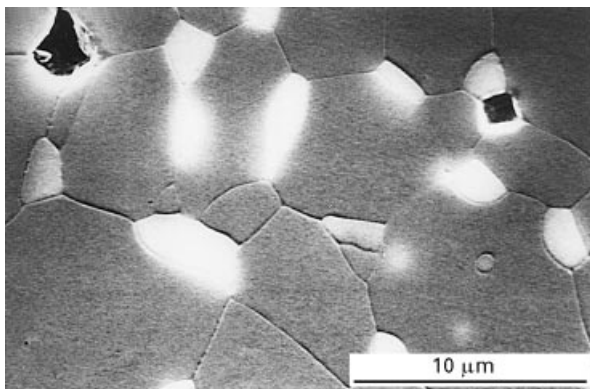
Figure 14 Weight-bearing area of the alumina femoral head.

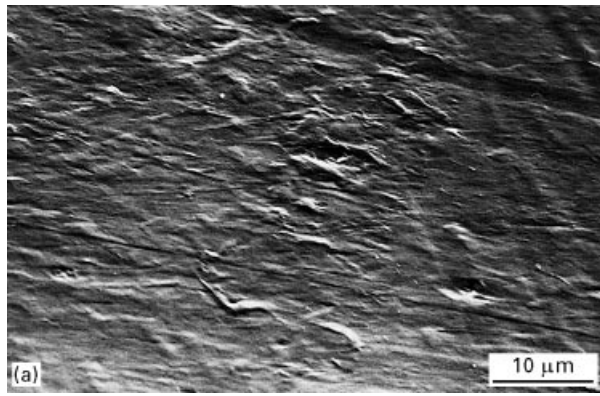
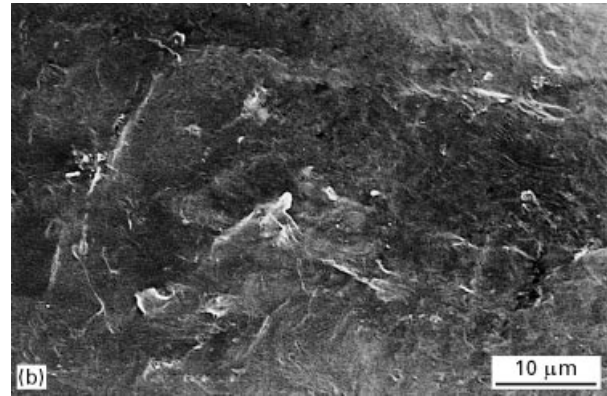
The polyethylene surface against alumina was found to have gently sloping machine marks, measuring one to several micrometres, left on the non-weight-bearing areas, while machine marks on the weight-bearing areas completely disappeared 6 years after surgery, though some remained in place at 6 months and 1 year after implantation. Overall observation revealed almost all surfaces to be smooth and burnished without scratches or pits. The polyethylene folding phenomenon, which is thought to be caused by three-body wear occurring as a result of the interposition of polyethylene wear particles between components, was also seen in places, though to a small extent. It was suspected that part of the tip of this folded polyethylene was torn into debris when a force was transmitted on to the tip from the femoral component (Fig. 16a, b).

Figure 16 Tibial plates against alumina femoral condyles taken *post-mortem* without any complications 6 years after a cementless replacement. (a) Non-weight-bearing surface of polyethylene of the tibial plate. (b) Weight-bearing surface.

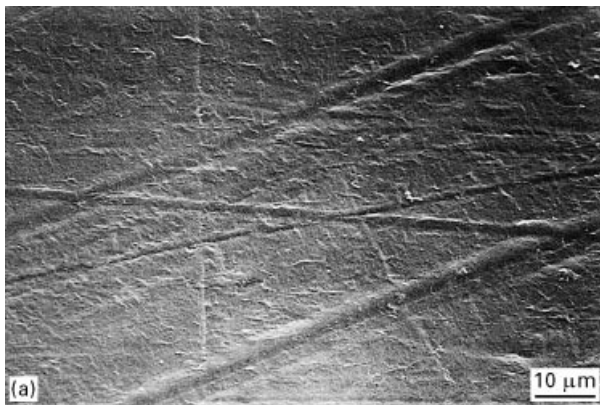
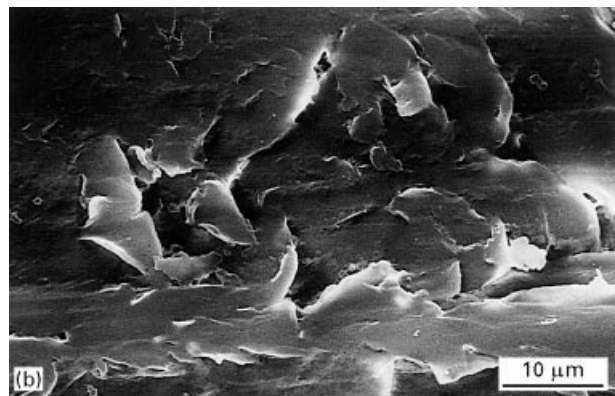
Figure 17 Tibial plates against Co–Cr–Mo alloy femoral condyles taken from a patient with late infection at the bone–tibial component 3 years after surgery. (a) Non-weight-bearing surface of polyethylene of tibial plate. (b) Weight-bearing surface.

In the case of a polyethylene surface against Co–Cr–Mo alloy, burnishing was seen in sites where the machine marks disappeared, and small scratches were observed at these sites 3 years after surgery. The folding phenomenon was observed frequently, and the folding sites mingled with scratches in many places (Fig. 17a, b) [5, 6].

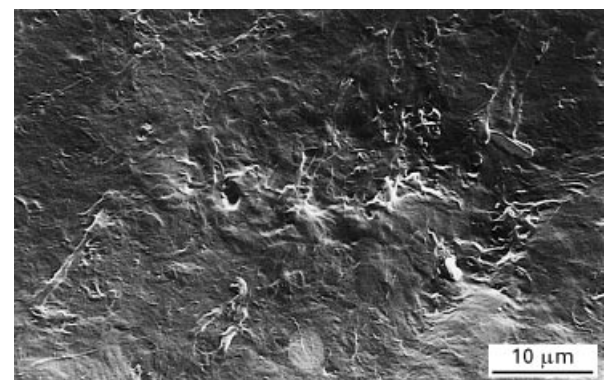
As a tibial component has a concave or flat surface while a patella component has a convex surface, their surfaces wear differently. Owing to the convex shape, and perhaps due to surgery or removal of the component, many artificial scratches were present over the surface of the patella; however, it was unclear when the scratches occurred – before use, during implantation, or at the time of removal. On the sliding areas without artificial scratches, burnishing sites mingled with folding sites. It was especially noted that there were many dimples, measuring 2–3 μm diameter. Similar changes were seen on the polyethylene articulating against Co–Cr–Mo alloy and alumina (Fig. 18).

Figure 18 Polyethylene surface of a patellar component.

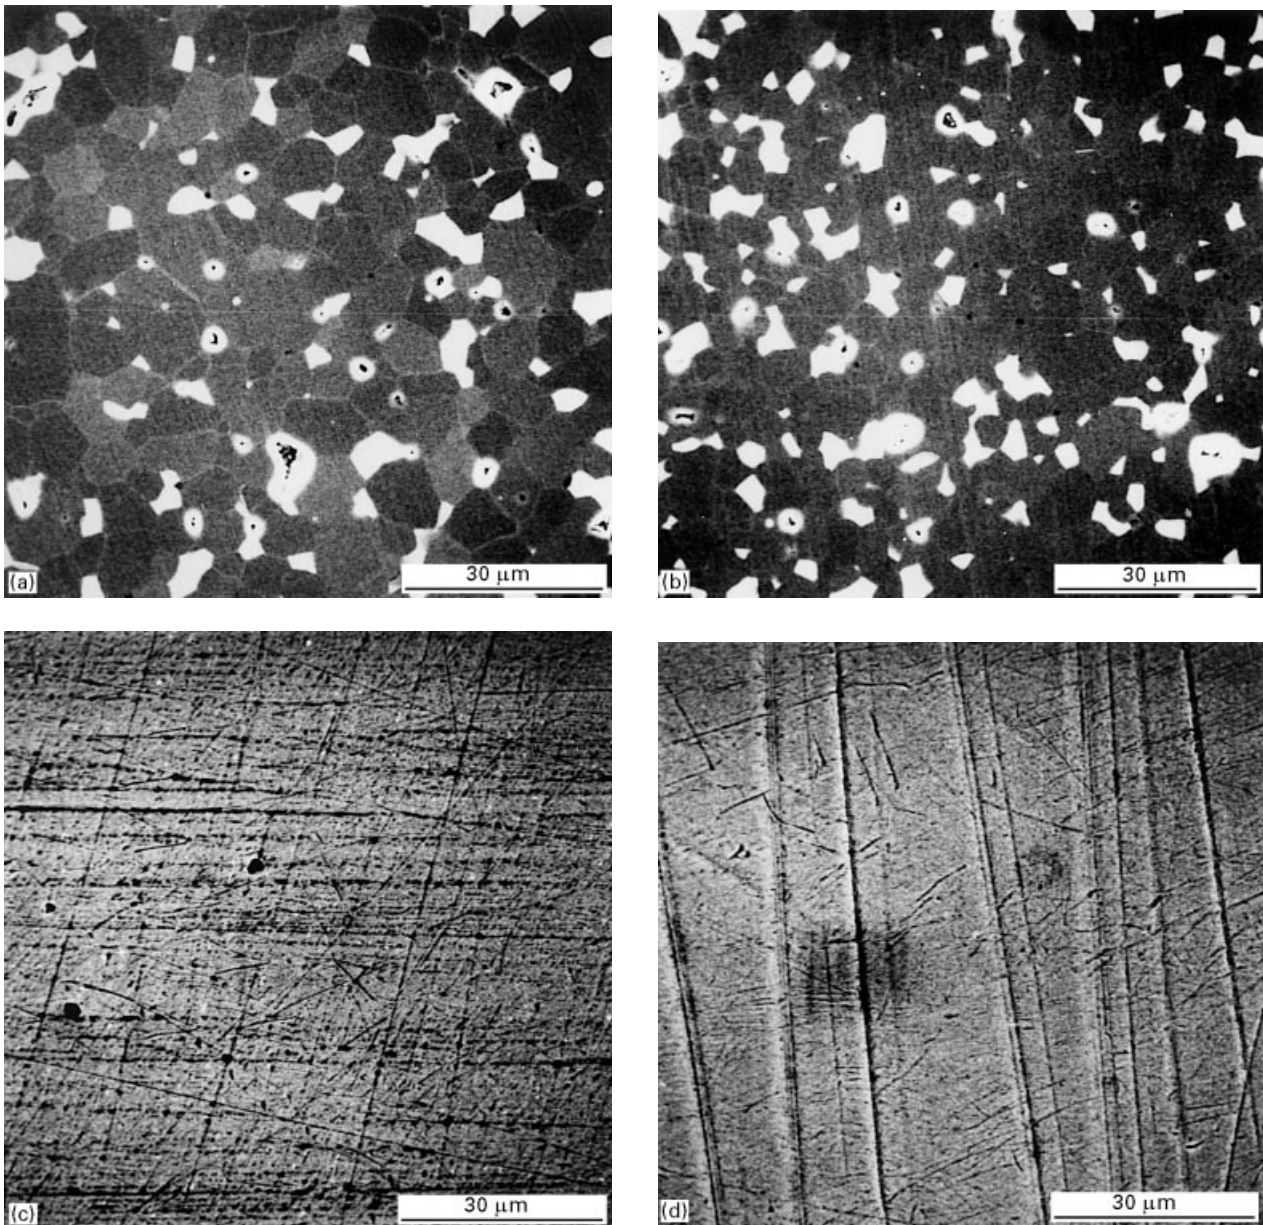
On the alumina femoral components, some sliding areas appeared burnished by SEM observation; how-

ever, no measurable change was observed by light microscopy. In contrast, observable burnishing and scratches were produced in the sliding areas of the Co–Cr–Mo alloy (Fig. 19a–d) [6].

Figure 19 (a) Non-weight-bearing area, and (b) weight-bearing area of an alumina femoral component (SEM). (c) Non-weight-bearing area, and (d) weight-bearing area of Co-Cr-Mo alloy femoral component (SEM).
