# Assessment of wear on the cones of modular stainless steel Exeter hip stems

R. P. S. CHAPLIN\*, A. J. C. LEE, R. M. HOOPER

Department of Engineering, University of Exeter, Exeter, EX4 4QF, UK

The wear on the stem cones of retrieved Exeter Universal hip stems has been assessed using scanning electron microscopy (SEM), energy-dispersive X-ray analysis (EDX) and surface profilometry. The *in-service* life of these prosthetic stems varied, up to a maximum of 7 years. A combination of SEM, EDX and visual assessment indicates that the stem cones have not suffered from any corrosion. SEM scans indicate that damage to stem cones (excluding extraction and post-removal damage) can be categorised into insertion marks and fretting marks. In some cases there are signs of material being deposited on the cone surface. Surface profilometry suggests that the levels of debris generation at the cone/internal head interface are very low relative to those that are likely to be associated with head articulation against the acetabular cup. A total of 20 stem cones underwent SEM scans. From these, 10 subsequently have undergone surface profilometry along with the corresponding internal head surfaces.

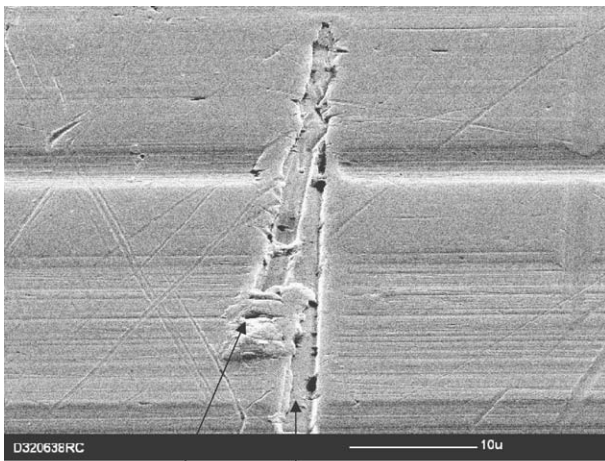
Fig. 3 is an example of surface damage that has arisen during insertion of the head onto the cone and later by extraction of the head from the cone. It is believed that a hard third body has been present, the right hand of the two marks has been made during insertion and the left hand mark during extraction. Fig. 4 also shows an insertion/extraction mark – this time the damage has been caused by a relatively soft asperity or third body. Marks on the cones are thought to be due to head insertion or extraction if they run in the direction of the taper for 1 mm or more. There is likely to be evidence of ploughing or smearing of metal. The stems that show signs of this type of damage (denoted by the letter I in Table II) are stem numbers 1, 3, 4, 7 and to a lesser extent 9, 12 and 13.

Figure 3 Insertion/extraction mark caused by the presence of a hard third body on stem cone 1.

Stem cone 1: SEM showed pronounced insertion marks thought to be caused by a hard third body. EDX analysis showed a particle with unusually high levels of Nb and C near to an insertion ‘trough’. Niobium is added to Orthinox<sup>®</sup> at levels of up to 0.8%. Its function is to stop chromium carbide precipitation at grain boundaries. This could result in hard niobium carbide particles being formed. Analysis of the insertion trough itself did not reveal anything significant.

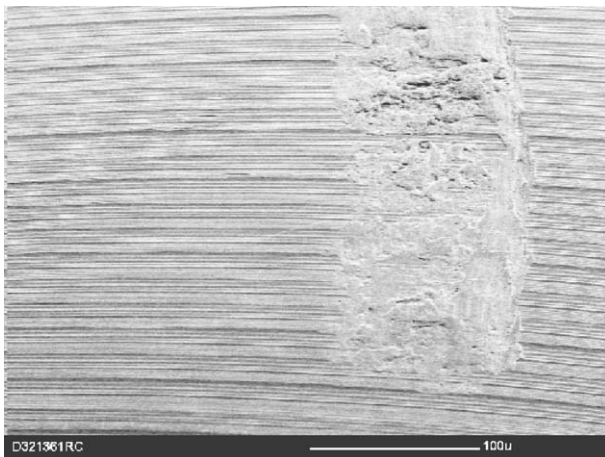
Figure 4 Insertion marks from soft third body or asperity on stem cone 4.

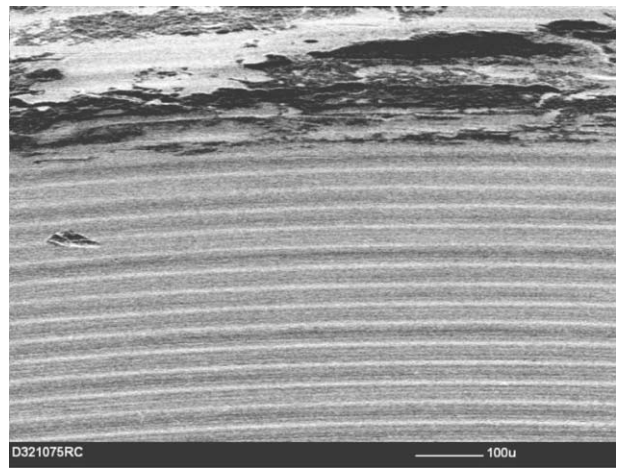
Figure 5 Surface deposit on stem cone 8.

Stem cone 8: SEM showed a dark deposit running as a ring around the wide end of the cone taper. EDX showed that this was largely carbon and also contained other constituents of body fluids.

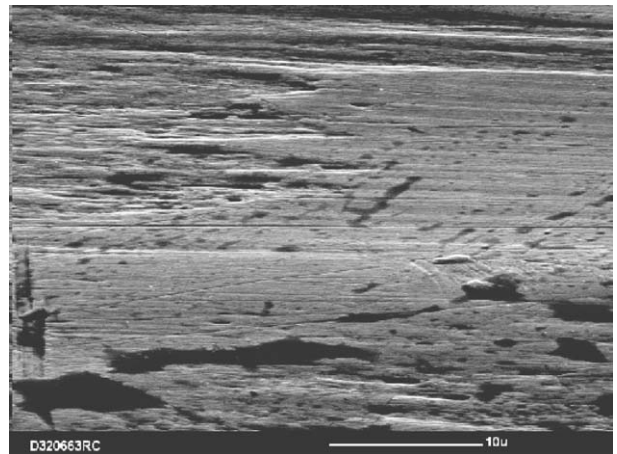
Figure 6 Heavy surface fretting leading to roughness on stem cone 2.

Stem cone 2: SEM showed signs of heavy fretting and possible signs of surface corrosion. EDX analysis suggests slightly elevated oxygen levels, but not sufficient to suggest that corrosion has occurred.

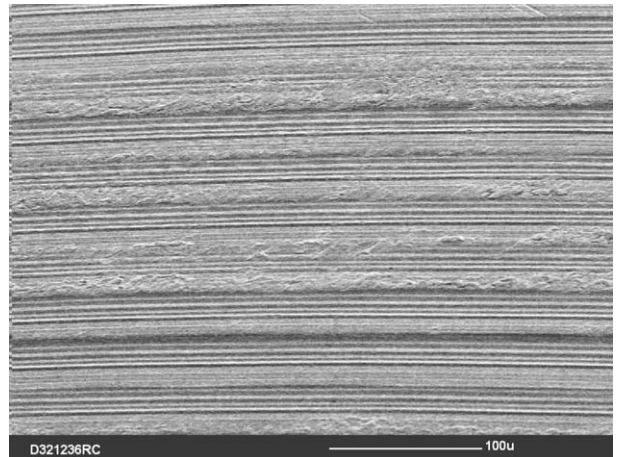
Figure 7 Surface deposit/roughness associated with fretting on stem cone 4.

Stem cone 4: SEM showed signs of deposition. EDX shows no evidence of corrosion.

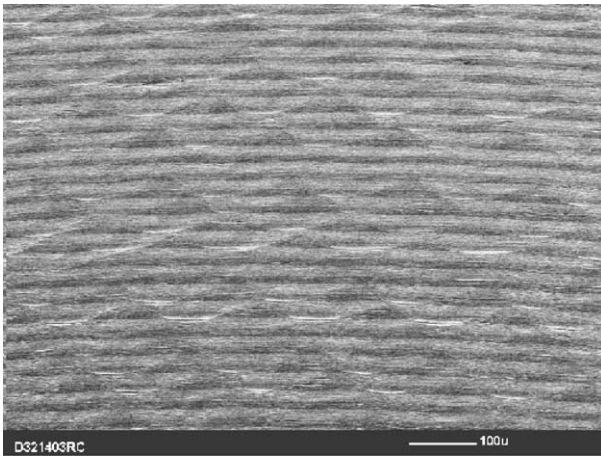
Figure 8 Fretting wear on stem cone 14.

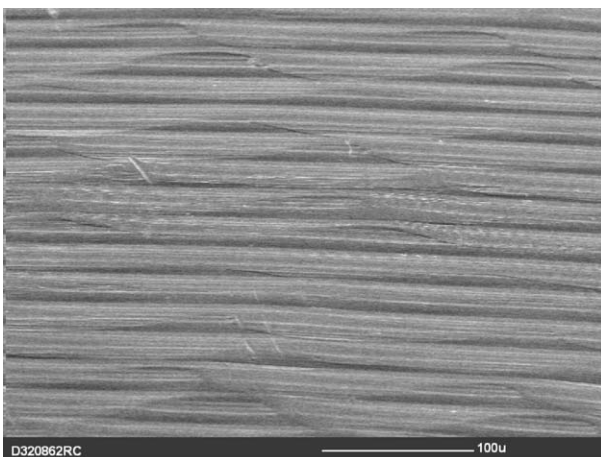
Figure 9 Fretting wear on stem cone 5.

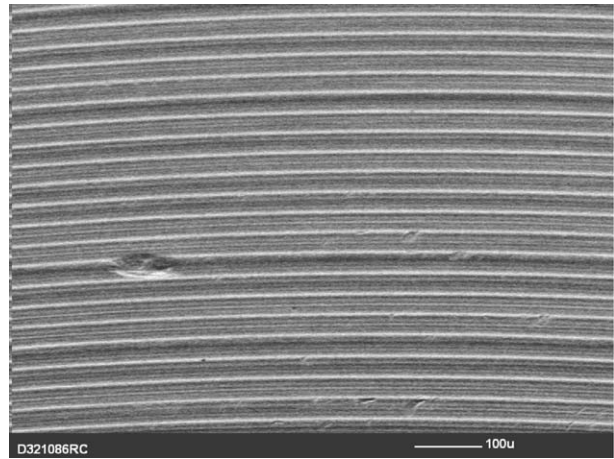
Fig. 10 is an example of what appears to be heavy machine marks.

Figure 10 Heavy machine marking.

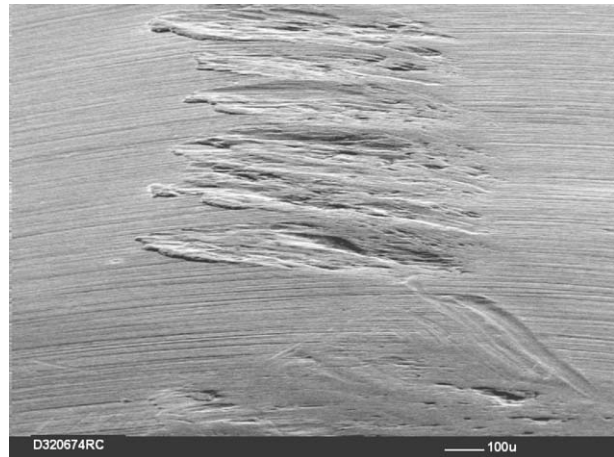
Stem cone 3: SEM showed one area, shown in Fig. 11, where either a very wide insertion mark or else an area of deposition had been made. EDX suggests the presence of a carbon-based contaminant, but not corrosion.

Figure 11 Deposit or possible insertion mark on stem cone 3.

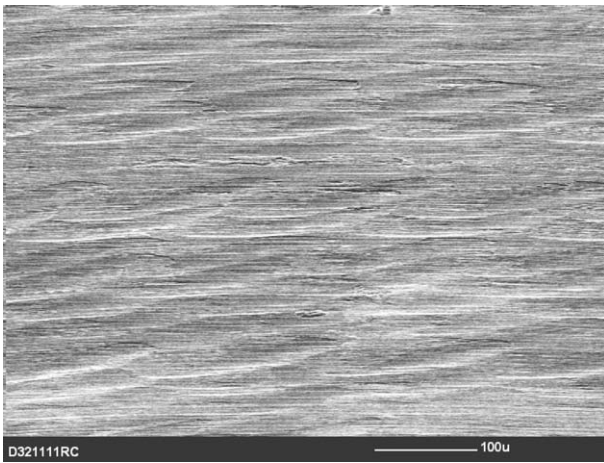
Figure 12 Signs of fretting on stem cone 9.

Stem cone 9: SEM showed signs of heavy fretting and possible signs of corrosion and deposition, shown in Fig. 12. EDX showed no significant compositional variations.

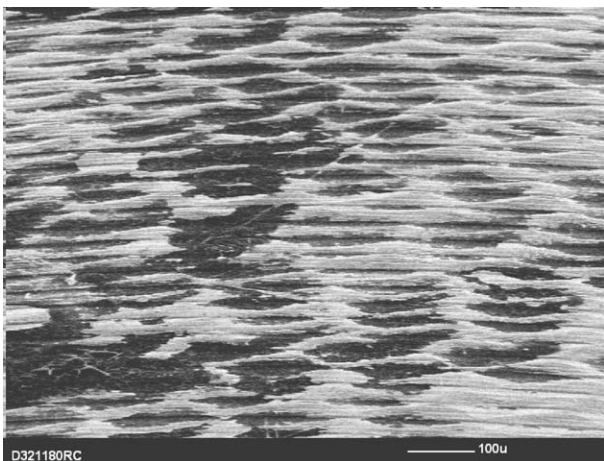
Stem cone 10: SEM showed an area that experienced differential charging under SEM, shown in Fig. 13. EDX indicated that the deposit was probably from human body fluids, being rich in Ca, Cl, K and C.

Figure 13 Differential charging shown on stem cone 10.

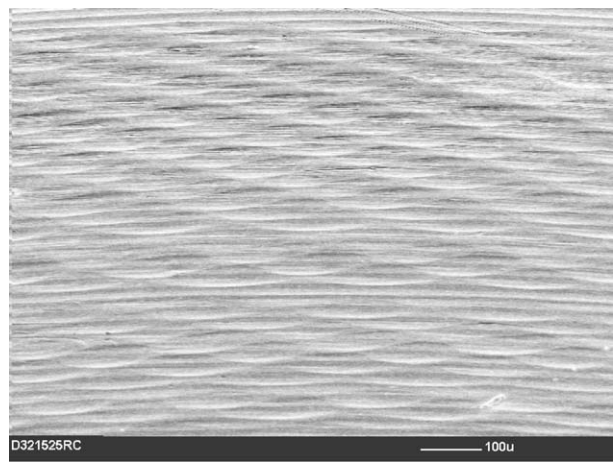
Stem cones 17 and 18: SEM indicated signs of heavy fretting and possible surface pitting, shown in Figs. 14 and 15. EDX showed no unusual compositional variations.

Figure 14 Signs of fretting on stem cone 17.

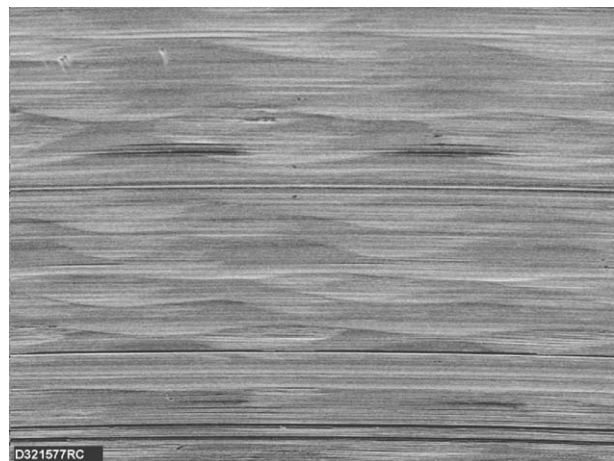
Figure 15 Signs of fretting on stem cone 18.
