Thermal fatigue damage in Borsic Al (6061) composites*

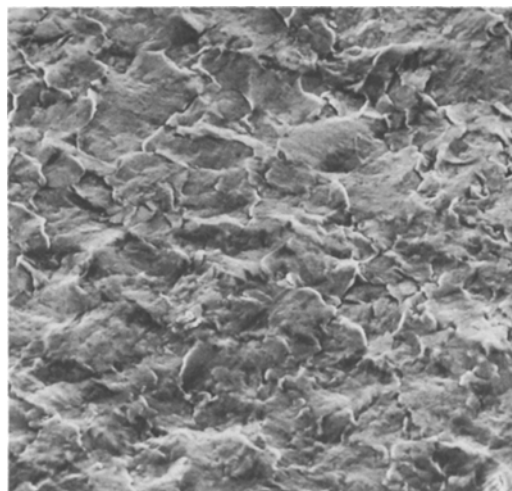
Figure 1 Grain-boundary sliding in Al matrix after 500 cycles, $\times 50$ (subsequently reduced by 30% for reproduction).

of matrix suffers grain-boundary sliding in response to the thermal stresses. Fig. 1 shows the grain-boundary sliding in Al after 500 cycles. This had been found earlier too [4]. With still further cycling, damage to boron fibres and fibre/matrix interface also sets in. Multiple cracking in boron fibre is shown in Fig. 2 while decohesion at fibre/matrix interface is shown in Fig. 3. Both of these figures

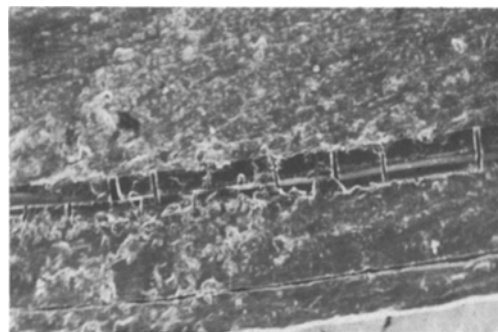
Figure 2 Multiple cracking in boron fibre after 1500 cycles, $\times 50$ (subsequently reduced by 30% for reproduction).

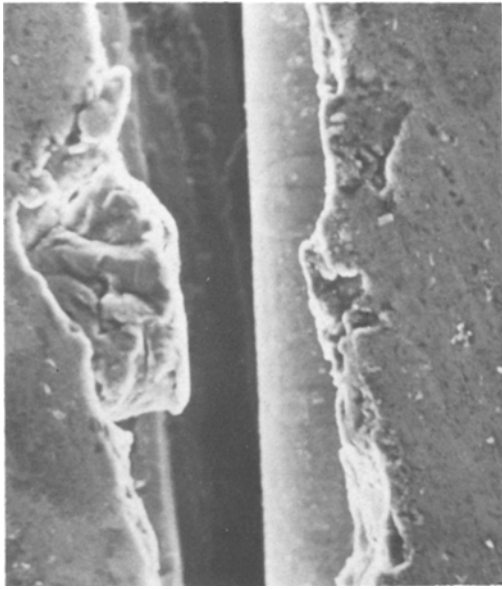
Figure 3 Decohesion at Borsic/Al interface after 1500 cycles, $\times 300$ (subsequently reduced by 20% for reproduction).

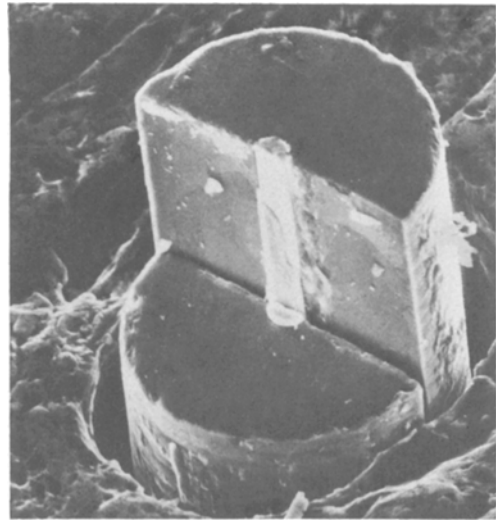
Figure 5 Diametrically split boron fibre has one part slid past another, $\times 400$ (subsequently reduced by 30% for reproduction).

each other due to the shear stresses generated. A dramatic evidence of this phenomenon is seen Fig. 5. Again, one notices that crack started at the boron/core interface. Also to be noted is the separation of the boron fibre/aluminium matrix interface. In conclusion then, all three means enumerated above operate as result of thermal fatigue involving greater than 100 cycles and lead to a much severe microstructural damage in these commercially produced Borsic*/Al composites.

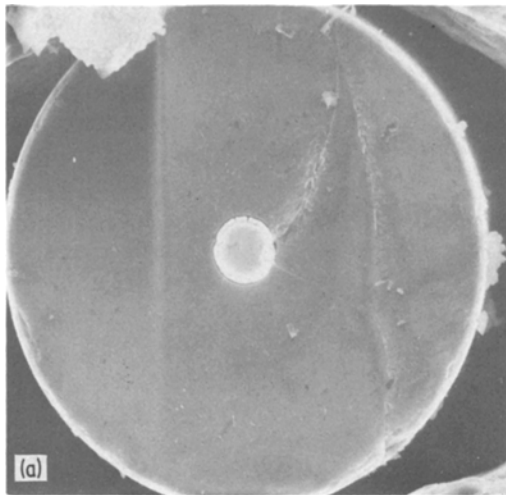
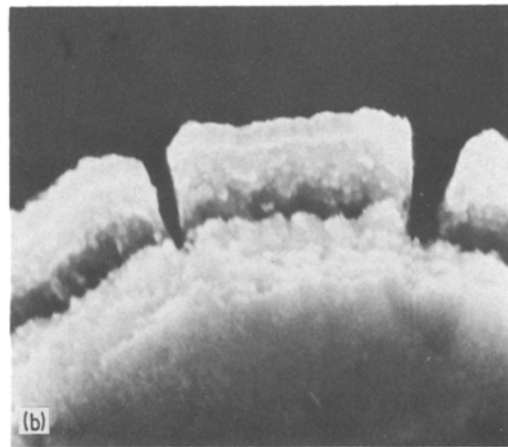
are from 0° samples after 1500 cycles. Cracking in boron fibre starts at the boron-tungsten boride core interface. This is demonstrated in Fig. 4a and b of the boron fibre after 1500 cycles. One can notice the crack starting at the boron/core interface in Fig. 4a. Fig. 4b, a higher magnification of the core region of Fig. 4a, shows vividly the microcracks present at the boron/core interface. Boron fibre can also split diametrically due to thermal stresses, and the two separated parts can slide past

Figure 4 Borsic fibre after 1500 cycles. Notice the crack nucleation at boron/core interface. (a) $\times 500$, (b) $\times 10\,000$ (both subsequently reduced by 30% for reproduction).
