Microscopy of failure mechanisms in filament-wound pipe

M. L. C. JONES, D. HULL

Department of Metallurgy and Materials Science, University of Liverpool, P.O. Box 147, Liverpool, UK

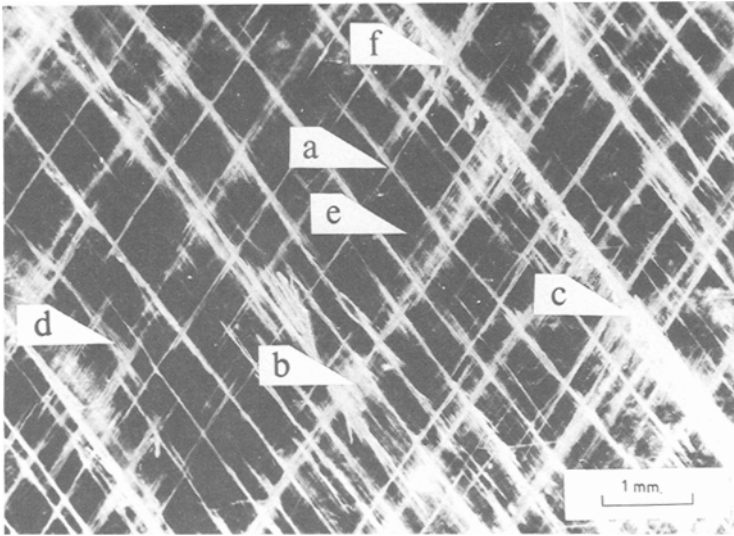
Figure 2 External appearance of 55° pipe tested to weepage in Mode 2 (see text for details).

The first signs of visible damage during this test were thin white streaks parallel to the fibre direction. As the pressure was increased the number of these streaks progressively increased and small isolated opaque patches appeared as the weepage pressure was approached. A low magnification view of the exterior of a pipe tested to weepage at a hoop stress of about 100 MN m^{-2} is shown in Fig. 2.

The different features of the whitening apparent in Fig. 2 were correlated directly with internal cracking using the sectioning and polishing techniques described above. The very fine striations shown typically at point (a) were due to transverse cracking in one lamina. Each crack is confined to the lamina in which it was initiated. Such a crack is shown in Fig. 3a. The small opaque area at point (b) in Fig. 2 is caused by cracking parallel

Interlaminar cracks associated with transverse cracks at the free surface also produced opaque patches as shown at point (c) in Fig. 2. A section through this type of crack is shown in Fig. 3d. The effect is similar to the unpeeling of the outer layers in cross-ply laminates described by Puck [8].

Transverse cracks were usually perpendicular to the lamina plane. However, sometimes in areas of low fibre density the crack travelled obliquely through the lamina as in Fig. 3b. This class of crack produced a more diffuse type of whitening which can be seen at point (d) in Fig. 2. The extremely fine striations visible at point (e) in Fig. 2 were due to the debonding of individual fibres prior to the development of transverse cracks.

The first evidence of weepage was the formation of water droplets at one or two sites along the pipe. As the pressure increased the number of transverse cracks and the extent of interlaminar cracking increased and this resulted in an increased number of weepage sites. Eventually droplets were visible all over the pipe. In some cases weepage occurred as fine jets of water. A possible weepage site is marked at point (f) in Fig. 2.

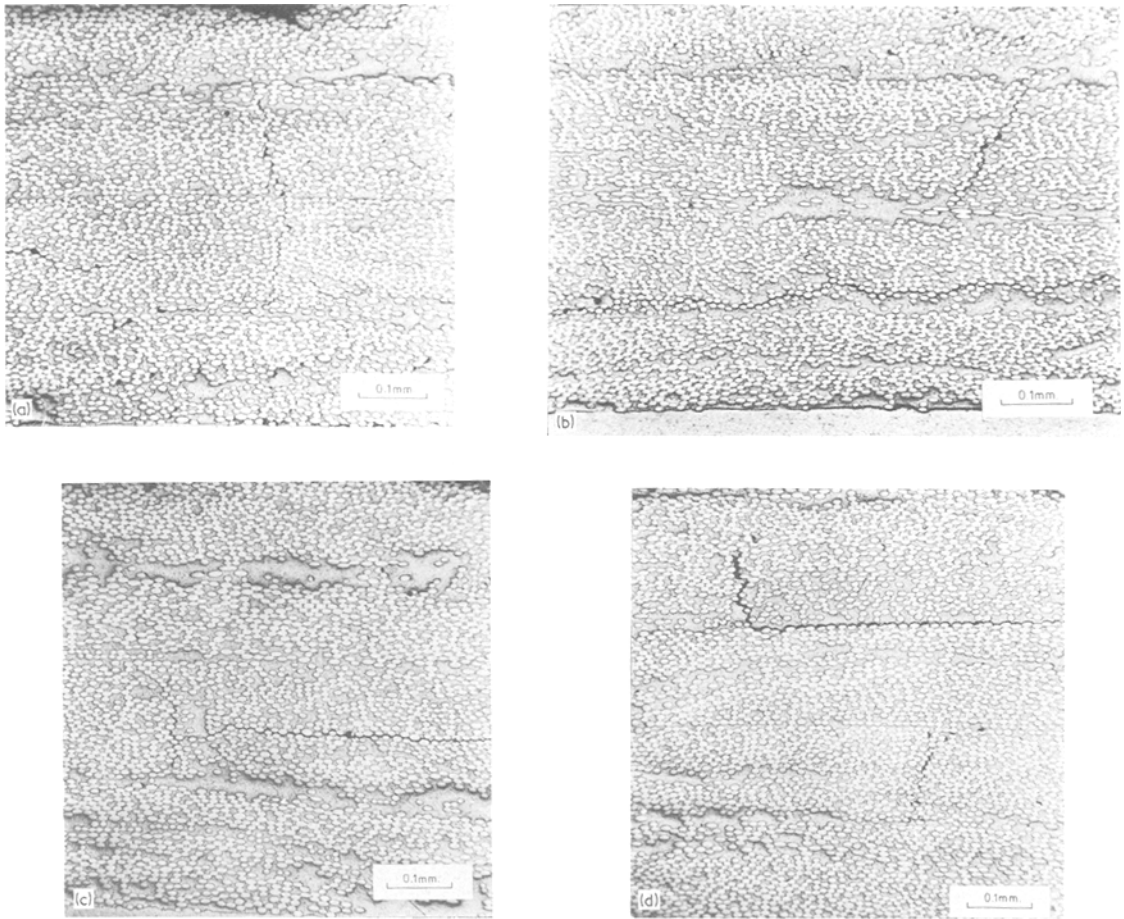
to the lamina plane. Fig. 3b shows this type of crack as well as a slightly oblique transverse crack. Cracks parallel to the lamina plane were found primarily near the interlaminar region but occasionally occurred in the interior of a lamina as shown in Fig. 3c.

Figure 3 Photo-micrographs of cross-sections of pipe shown in Fig. 2 sectioned along 11'. (a) Transverse lamina crack. (b) Interlaminar and oblique transverse crack. (c) Crack parallel to a lamina plane through the centre of the lamina. (d) Free edge delamination from tip of transverse crack.

using polarized light. At weepage $\sigma_H \approx 100 \text{ MN m}^{-2}$, the average crack spacing was approximately 0.85 mm in the centre two laminae and 2.3 mm in the inner and outer laminae. The spacing of the transverse cracks decreased with increasing pressure and at burst, $\sigma_H = 450 \text{ MN m}^{-2}$, the average spacings in the centre and outer layers were 0.5 mm and 1.2 mm respectively. The overall trends were consistent with the concepts of load transfer used in the minimum crack spacing theory [15]. In contrast interlaminar cracking became more pronounced as the pressure increased. The distribution of cracks in a section taken diametrically opposite the burst region of a failed pipe is shown in Fig. 4a. Long interlaminar cracks are connected by regularly spaced transverse cracks.

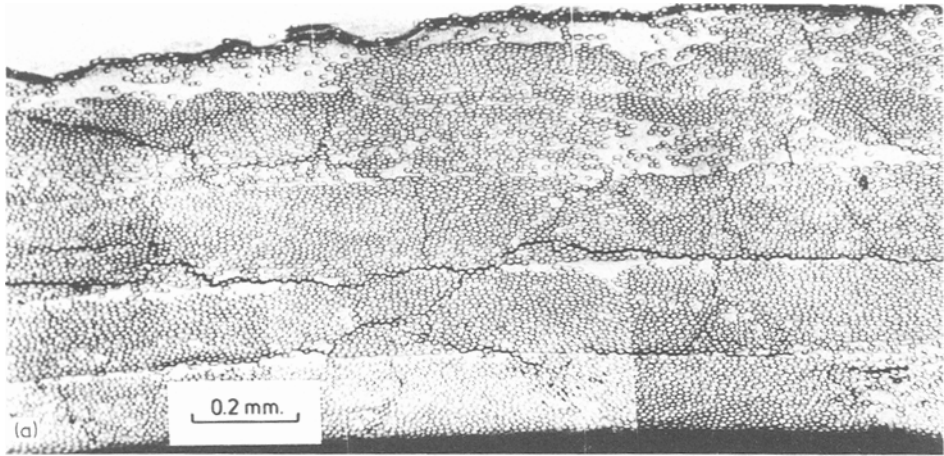
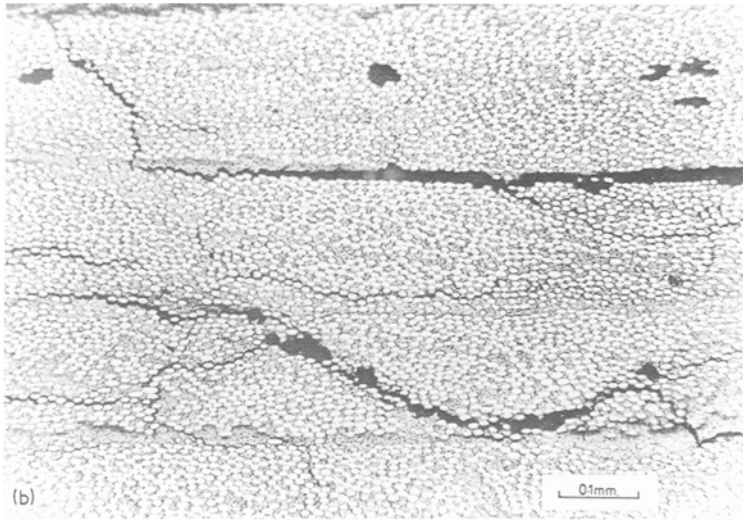
Near the burst point the interlaminar cracks were found to have opened considerably and were

connected by wide oblique transverse cracks, Fig. 4b. The perpendicular transverse cracks present remained unopened.

Figure 4 Photo-micrographs of cross-sections of a 55° pipe tested to failure in Mode 2 sectioned along 22°. (a) Opposite burst; (b) near burst.

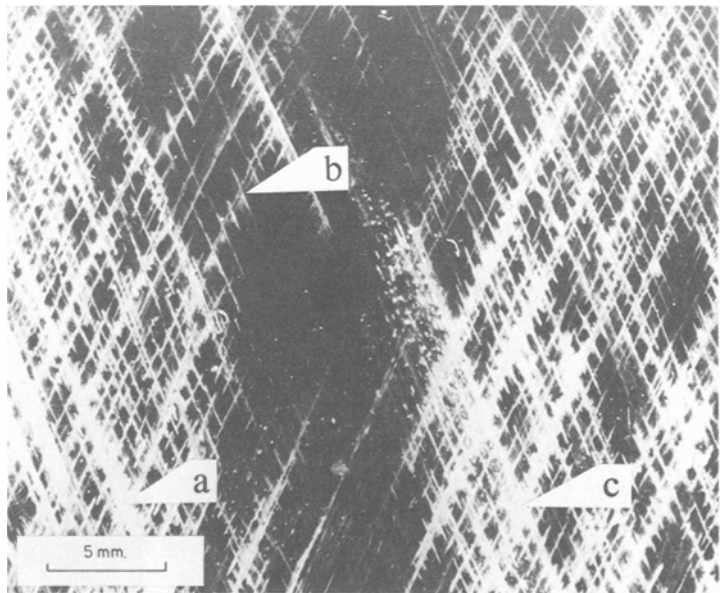
The sequence of events observed during the testing of these pipes was similar to 55° pipes, i.e. non-linearity in the stress–strain curve followed by the appearance of white striations parallel to the fibre direction followed by weepage and failure. The appearance of a pipe after testing to a hoop stress of 87 MN m^{-2} is shown in Fig. 5. Weepage occurred at $\sigma_H = 64 \text{ MN m}^{-2}$ and burst occurs at about $\sigma_H = 115 \text{ MN m}^{-2}$ at this winding angle.

Figs. 2 and 5 are similar due to the occurrence of multiple striations parallel to the fibre direction and the absence of large independent interlaminar cracks. However, the pipe in Fig. 5 has

Figure 5 External appearance of 65° pipe tested to 75% failure stress in Mode 2.

reached 75% of its burst stress, whereas the $\phi = 55^\circ$ pipe in Fig. 2 has been loaded to only 25% of the burst stress. At 75% of the burst stress the $\phi = 55^\circ$ pipe is almost opaque due to the formation of interlaminar cracks after weepage.

A cross-section of the pipe is shown in Fig. 6a. The transverse cracks, particularly in the first and fourth laminae, have opened up. There is none of the interlaminar cracking found in the 55° pipe except that associated with the transverse cracks. A good example of one of these "unpeeling" cracks can be seen at the top of Fig. 6b. Note that the mounting resin has filled in the crack. The spacing of the transverse cracks was regular with an average spacing similar to that found in the 55° pipe, i.e. 0.4 mm in the middle laminae and 1.2 mm in the inner and outer laminae. The formation of transverse cracks resulted in the initiation of minor cracks in adjacent laminae at regular intervals as shown at (b) in Fig. 5. A possible weepage site is shown at (c) in Fig. 5.

The relatively crack-free band in the centre of Fig. 5 extended round the circumference of the pipe and was repeated at regular intervals along the length. This crack-free zone coincided with the cross-over points in the pipe. These points are

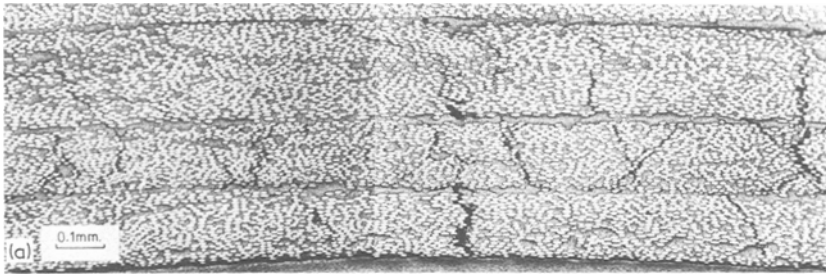
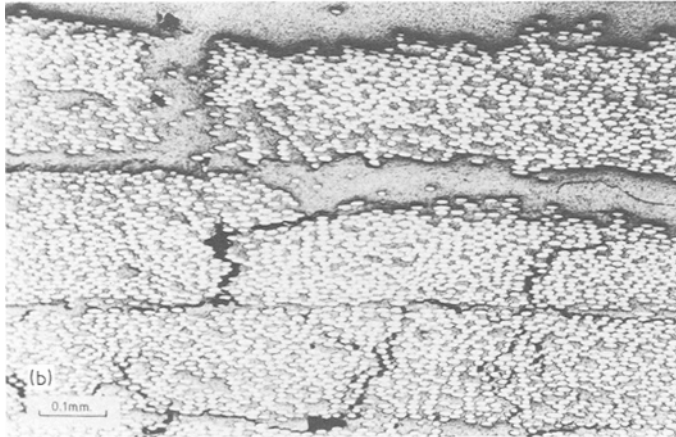
Figure 6 Photo-micrographs of cross-sections of pipe shown in Fig. 5 sectioned along 11'. (a) Multiple transverse cracks in inner laminations. (b) Transverse cracking and unpeeling of outer lamination from a transverse crack.

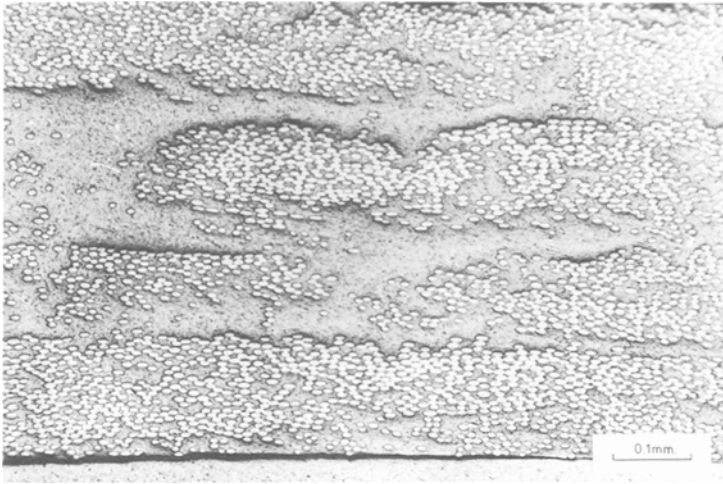
formed in helical wound pipes as illustrated in Fig. 7. The overlapping of the rovings at the cross-over points results in a local change in the fibre volume fraction. Regions of good packing alternate with regions containing pockets of resin with low fibre content as illustrated in Fig. 8.

Figure 8 Photo-micrograph of cross-section of untested 55° pipe showing fibre distribution near a cross-over point.

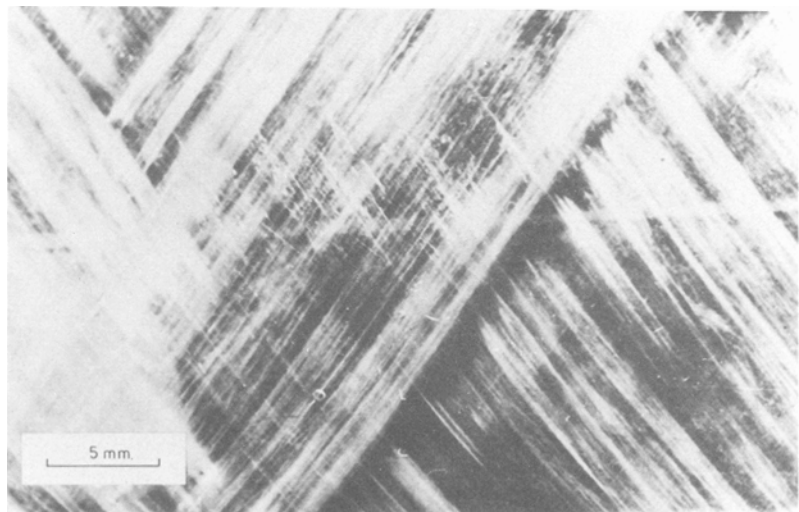
The completely different form of whitening found after testing in this mode is illustrated in Fig. 9 which shows the pipe wall of a failed pipe. The criss-crossing striations seen in pipes tested in the Mode 2 which are due to transverse cracking in adjacent laminae were not observed. The main features shown in Fig. 9 are the large opaque

patches and the fine striations parallel to the fibres which are due to delamination and fibre debonding.

Figure 9 External appearance of 55° pipe tested to failure in Mode 3.

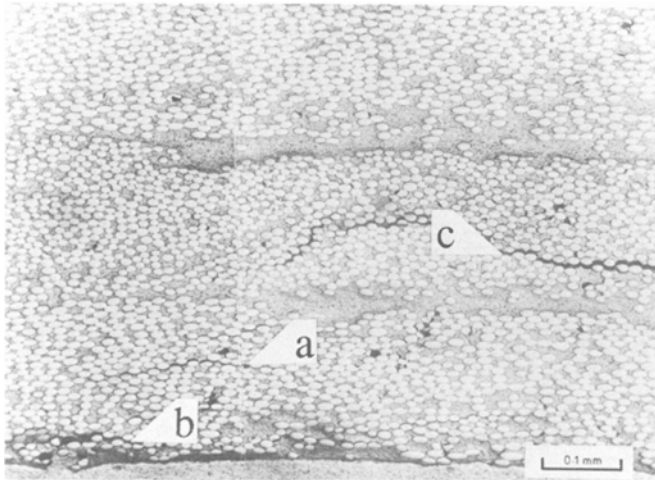
The appearance of these cracks is illustrated in Fig. 10. Discrete fibre debonding shown at point (b) usually developed in clusters near the inner pipe wall. Short intralaminar cracks and large interlaminar cracks can be seen at points (a) and (c) respectively. All the cracks occurred within the first two laminae and in most sections of the pipe the damage was confined to the inner layer.

Figure 10 Photo-micrographs of cross-section of pipe shown in Fig. 9 sectioned along 11' (see text for details).

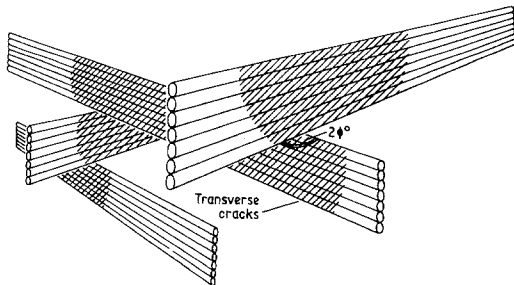
Figure 11 Schematic illustration showing formation of a weepage path through the pipe wall by the intersection of transverse cracks. The flow of liquid is restricted to the three contact points.

to take place a continuous path must exist through the pipe wall. This will only occur if a transverse crack in the innermost layer is crossed at a point by a transverse crack in the second layer and if this crack is in turn crossed by a crack in the third layer, etc. A schematic representation of this model is shown in Fig. 11 for a four-layer pipe. The transverse cracks in each layer are shaded and a continuous crack path results from the crossing of the cracks in successive layers. The occurrence of interlaminar cracking will increase the probability of achieving a continuous crack path and hence the probability of weepage by increasing the length of crack crossed by other cracks. The width of the transverse cracks is about $2\mu\text{m}$. Although the liquid is free to enter and leave the pipe wall along the whole length of the crack, the rate of flow is restricted at the three contact points, each $2\mu\text{m} \times 2\mu\text{m}$ in area. The escape of fluid appears as small droplets at high pressure. Jet weepage is a sign that interlaminar cracking is present, at least along the outermost interlaminar plane, since it is possible for fluid to escape along the whole crack length. Weepage is not possible by interlaminar cracking alone because this does not result in a continuous crack path through the wall of the pipe.

The weepage stress in Mode 2 will be increased by reducing the amount of transverse cracking. There are several ways of achieving this. Increasing the fibre spacing would make it more difficult for the cracks to propagate through a lamina and the strain concentrations would be reduced. Deliberate fibre misaligning would also inhibit crack propagation. These two methods are impractical in filament winding. Decreasing the resin shear strength would raise the minimum crack spacing but this advantage may be cancelled by the earlier appearance of interlaminar cracking in 55° pipe. Using more layers of the same thickness and spreading shear forces over more interlaminar planes would decrease the number of cracks. Some
