## Fractographic evidence of mixed mode stress corrosion cracking in stainless steel surgical implants

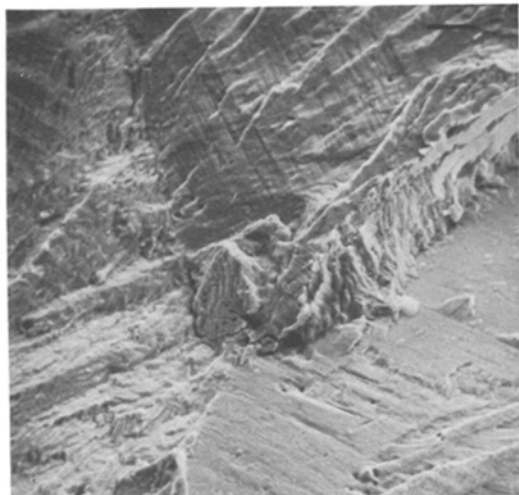
Fig. 1 presents the scanning electron micrograph showing mixed mode failure in which transgranular failure has occurred in the lower right grain. Fig. 2 presents the mixed mode failure in another part of

Figure 1 Fracture surface showing mixed mode SCC. Evidence of slip can be seen in the grain boundaries. Scale : 10  $\mu$ m.

the same fracture surface as Fig. 1. In both these figures there is evidence of slip in the grain boundaries indicating a mismatch of the grains. The fracture surface of Fig. 1 has a marked similarity with the mixed mode SCC failure reported by Neilsen ([9] Fig. 16) in an austenitic stainless steel in boiling  $MgCl_2$  solution. In Fig. 2 the transcrystalline failure shows additional features inside the grain which possibly represent crystallographic fracture along planes inclined to the main plane of fracture as was reported in the transcrystalline SCC failure of a magnesium alloy [10].

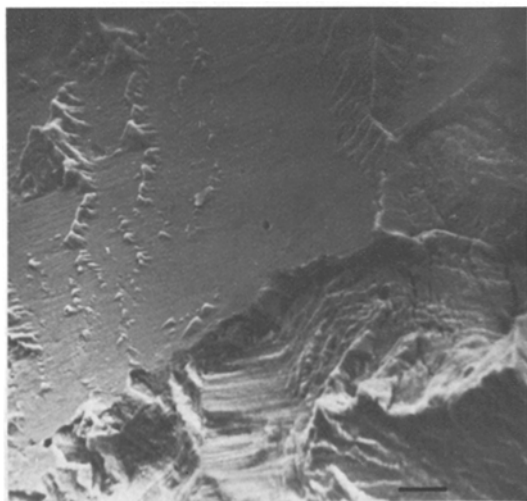
Figure 2 Another example of mixed mode fracture— the transgranular failure also showing crack propagation on planes inclined to the main plane of fracture. Scale : 10  $\mu$ m.
