Metallographic investigation of the damage caused to GRP by the combined action of electrical, mechanical and chemical environments

S. J. HARRIS*, B. NOBEL*, M. J. OWEN†

**Department of Metallurgy and Materials Science and †Department of Mechanical Engineering, University of Nottingham, Nottingham, UK*

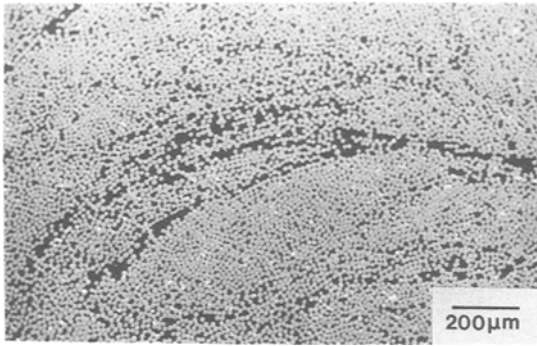
Figure 1 Resin rich areas in the pultruded rod.

The GRP rod had been fabricated by a pultrusion technique from coated E-glass fibres and an epoxy resin. This form of processing achieved high fibre fractions in the rod, i.e. approximately 80 wt%. The fibres were well aligned, but between individual fibre bundles some resin-rich regions existed, see Fig. 1. To form an insulator the rod was encapsulated in a cycloaliphatic epoxy resin incorporating crushed silica. The procedure involved a casting and curing operation to provide an outside profile which was made up of a series of sheds along the total length of the insulator (Fig. 2). The ends of the insulator were attached to a galvanized malleable iron casting to permit connection to the tower (“cold end”) and to the conductor (“hot end”).

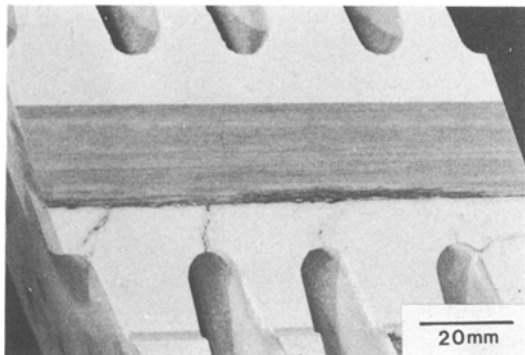
Figure 3 Electrical damage at the interface between the GRP rod and the surrounding shedding. Some of the electrical activity has punctured through the shedding.

then proceeded to varying distances along the component. Longitudinal sectioning of the insulator in the vicinity of the punctures revealed electrical damage also at the rod–shed interface and within the rod itself. As Fig. 3 shows, the damage to the rod and its surface links together the puncture holes in the shedding. Transverse sections taken within the electrically damaged region show evidence of longitudinal cracking and the formation of porous regions. Fig. 4 shows that there is a tendency for some of the damage to be associated with the resin-rich regions in the rod. Higher magnification examination of the longitudinal cracks reveal that they are not just simple mechanical cracks, but regions where resin material in the rod has been transported away (Fig. 5).

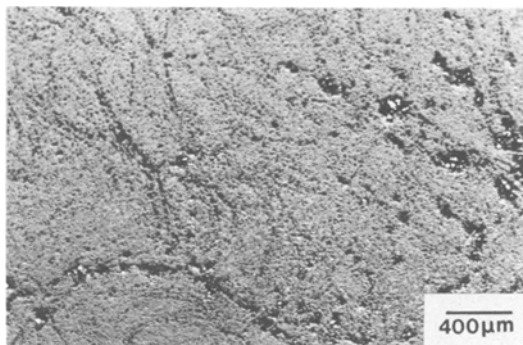
Figure 4 Electrical damage within the GRP rod. Some of the damage is associated with the resin rich regions in the rod.

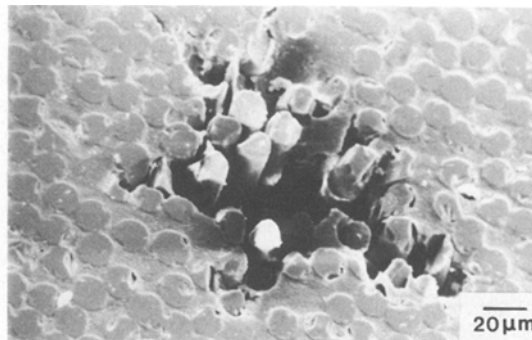
Figure 5 Electrical damage within the GRP showing the absence of resin around the glass fibres.

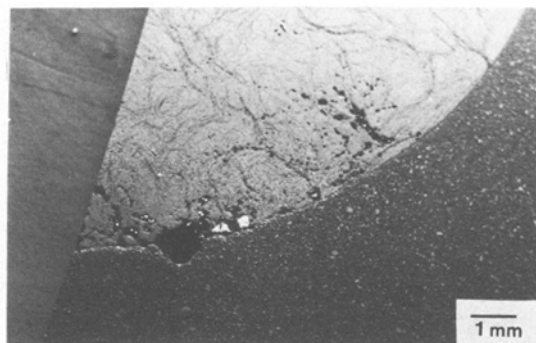
glass and resin have been transported away (Figs. 6 and 7). Higher magnification examination of the outer surface of the GRP rod in damaged regions revealed fusion and fracture of both resin and glass (Fig. 8) whilst at an adjacent position partial erosion of the fibres had occurred (Fig. 9). Characteristic honeycombing of the resin was also produced in regions of high electrical activity (Fig. 10).

Figure 6 Electrical damage at the surface of the GRP rod showing the absence of both glass fibres and resin at the interface.

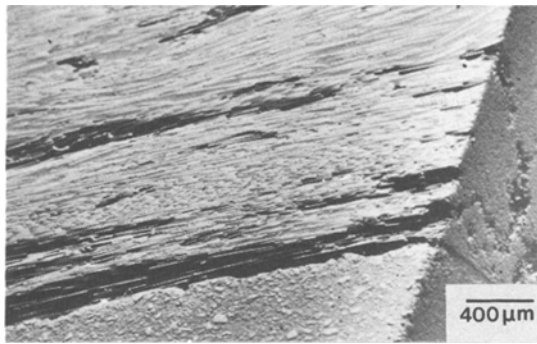
Figure 7 Longitudinal section of Fig. 6. Electrical damage has occurred along the outer surface and within the GRP rod.

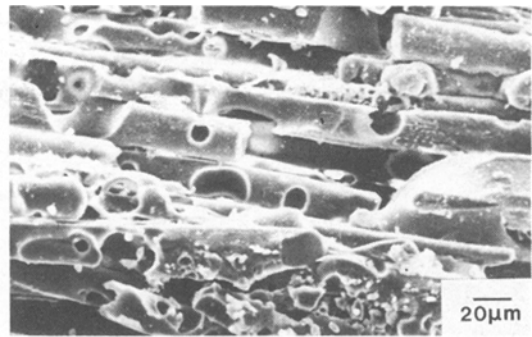
Figure 9 Electrical damage along the surface of the GRP rod showing partial erosion or puncturing of the glass fibres.

failure. The electrical damage can take the form of erosion and melting of fibres and this localized damage can then lead to cracking of fibres (Figs. 8 and 9). Cracks can also initiate inside the rod section if electrical damage has occurred adjacent to that region. However, it is difficult to understand how electrical activity on its own could account for the extremely planar nature of the fracture surface.

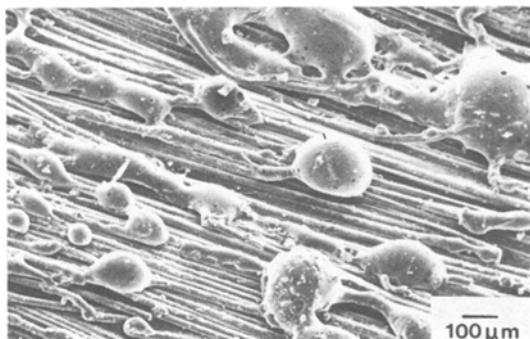
Figure 8 Electrical damage along the surface of the GRP rod showing fusion and fracture of the glass fibres.

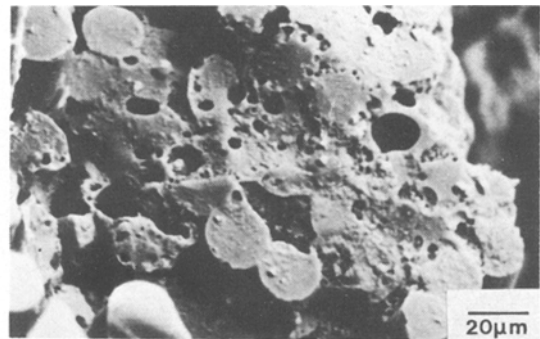
Figure 10 Electrical damage in the GRP rod showing puncturing of the resin.

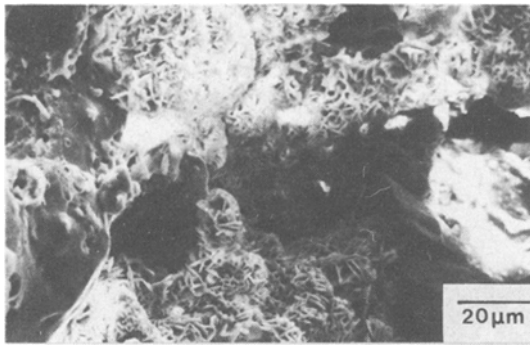
Removal of shedding from the GRP surface in electrically damaged regions sometimes revealed material different in composition to both glass and resin. A particular example of this is shown in Fig. 11, where a deposit of fine plate-like crystals can be seen. These crystals have been subjected to X-ray analysis and shown to contain appreciable quantities of zinc. Such crystals have resulted from either vapour transport or dissolution–deposition processes in aqueous solution. It is probable that they came, in the first instance, from the galvanized end fittings to the insulator and that electrical energy has assisted

both the transportation and deposition processes along the rod surface. X-ray emission studies on other parts of the GRP rod surface revealed on frequent occasions the presence of chlorine, sulphur and sodium in small quantities. The chlorine may have arisen from the resin, but the other elements are likely to have arisen from the atmosphere prior to the onset of electrical damage.

Figure 11 Debris at the surface of the GRP rod at the point of electrical breakdown. The small platelike crystals are very rich in zinc.

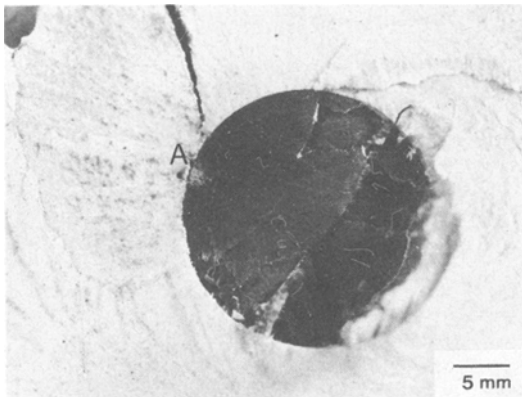
Some form of electrical activity was found on each rod that was examined, but in no case was the degree of electrical activity as severe as that observed in suspension insulators. Failure in these tests was not by electrical breakdown but by a complete mechanical break across the section of the rod, usually at the “hot end” of the insulators. The nature of this fracture is shown in Fig. 12. Fracture has initiated at the top left hand side of the rod in this picture and the crack has spread out to give a characteristic fan-like appearance. Fracture usually initiated at more than one point leading to multiple transverse cracks on the surface of the rod (Fig. 13). Crack propagation took place from one or two of these initiation points leading to a very flat type of fracture surface. Electrical damage is associated with this fracture in the form of breakdown at the GRP rod–shed interface. This can be seen in Fig. 12 at position A, i.e. close to the point of fracture initiation.

Figure 12 Brittle fracture face of GRP rod and shedding material which was subjected to the higher tensile loads in a tension insulator.

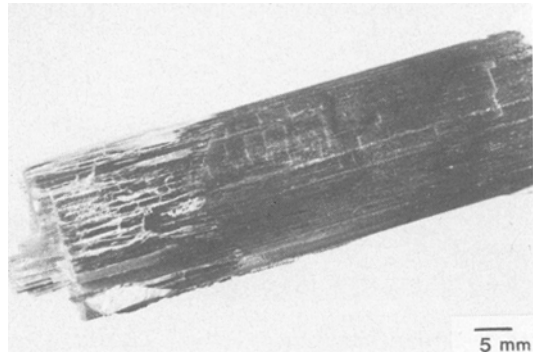
Figure 13 Multiple transverse cracks on the surface of a GRP rod (tension insulator).

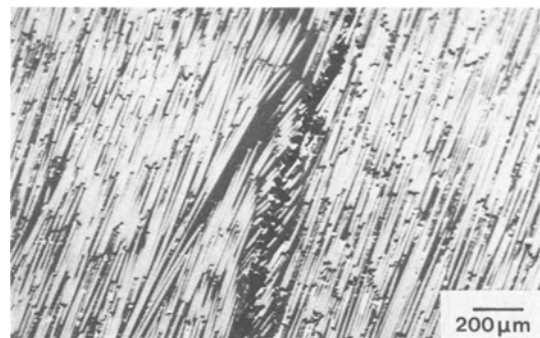
rod and shedding at a position between the hot end of the insulator and the fracture referred to above, revealed evidence of electrical damage at the interface and within the GRP rod in the form of longitudinal cracks. Many of these longitudinal cracks follow the joining line between bundles of fibres (Fig. 14). Transverse cracks were also present in the GRP rod, some running in from the surface and others from the longitudinal splits (Fig. 15).

Figure 14 Longitudinal crack, which has occurred between bundles of fibres, brought about in part by electrical tracking in the rod.

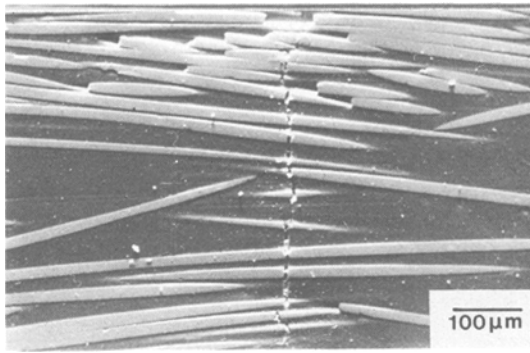
Figure 15 Transverse crack which has initiated internally in the rod from the kind of longitudinal crack shown in Fig. 14.

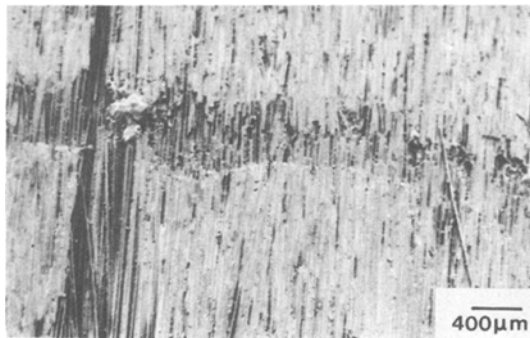
Removal of the shedding from the regions where the electrical damage and debonding had occurred at the rod–shed interface revealed evidence of erosion of the rod surface, localized melting, and brittle fracture of the glass filaments (Figs. 16 to 18).

Figure 16 Erosion of the surface of the GRP rod by electrical activity (shedding has been removed).

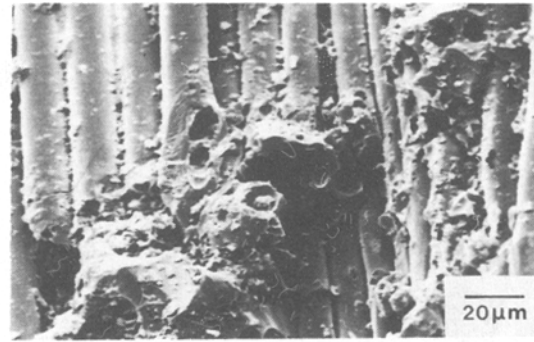
Figure 17 Puncturing of resin and glass fibre in region shown in Fig. 16.

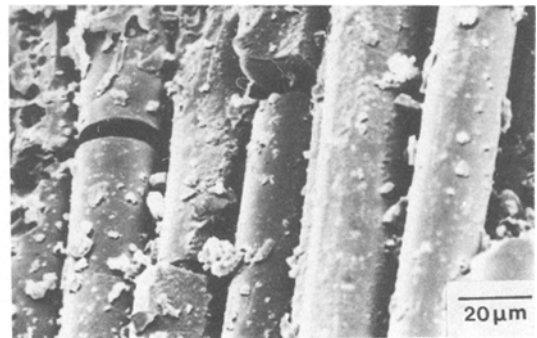
Figure 18 Higher magnification picture of transverse cracks in the surface regions of the rod shown in Fig. 16.

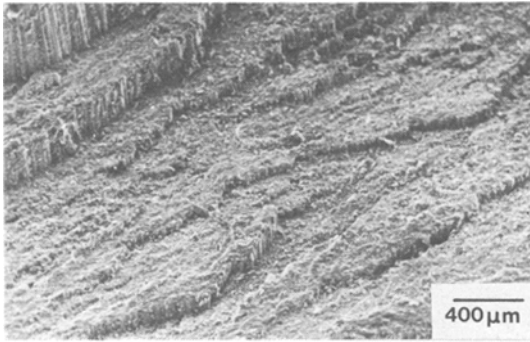
initiation can take place in several adjacent planes. However, on each plane it is quite clear that the local fracture path is extremely flat, see Fig. 19. The steps on the surface produce characteristic river markings, leading back to the point of crack initiation. Closer examination of the steps, see Fig. 20, reveals evidence of undercutting of fibres where the crack at that position has propagated at two levels. The two levels are linked by a small vertical wall or step. Thus the macroscopical flat regions of failure are made up of a series of flat regions linked by a series of microsteps which may be 50 to 100 μm in height.

Figure 19 Low magnification picture of river markings (steps) on the fractured rod surface, each of which runs towards the point of crack initiation (tension insulator).

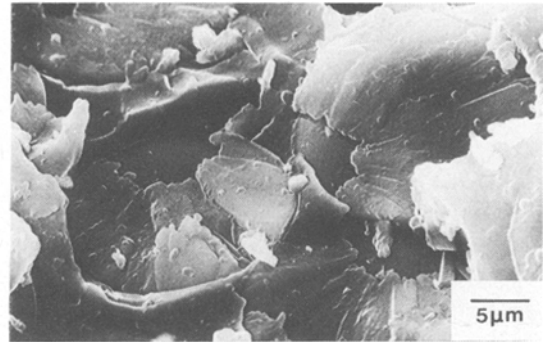
Close examination of the fracture surfaces of the individual glass fibres reveals many features. Where surfaces are relatively clean, brittle fracture of the glass appears to have taken place with the formation of a single crack propagating with a semicircular front thus forming a so-called mirror region, see Fig. 21. This has been followed by the

bifurcation of the crack in the vertical plane with the subsequent formation of “glass wedges”, see Fig. 21, some of which have remained on the fracture surface. These wedges have a comparatively rough surface and represent the so-called hackle region of failure on bulk glass. X-ray analysis on the fractured glass fibres reveals small differences in glass composition when comparison is made with fibres sectioned away from the fracture surface. The calcium and aluminium content at the fracture face is lower whilst the silicon content is increased.

Figure 21 Higher magnification picture of the fracture surface showing the existence of glass wedges on the surfaces of most of the fractured glass fibres.

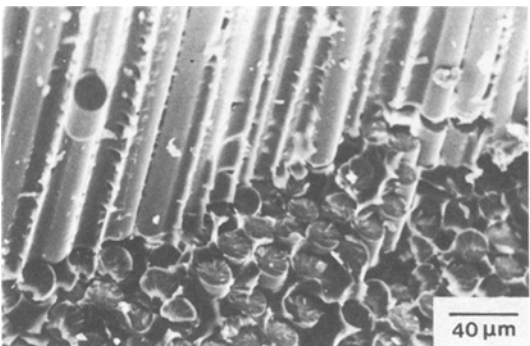
Figure 20 Detail of the steps on the fracture surface showing undercutting of the fibres at the base of the steps (tension insulator).

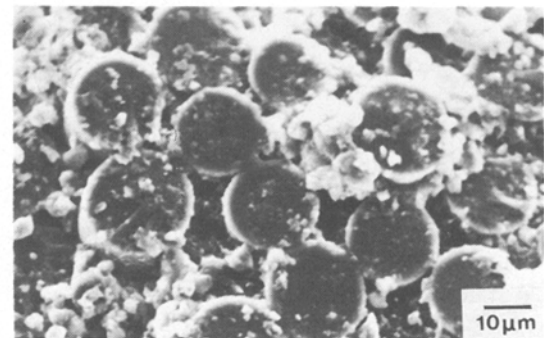
Foreign particles and glass debris were present on parts of the fracture surface, see Fig. 22. The particles have been analysed using X-ray dispersive analysis. Two groups of particulate matter could be recognised on the basis of this analysis: (a) those containing sodium, magnesium, aluminium, silicon, sulphur, chlorine, potassium and calcium; and (b) those containing aluminium, silicon and calcium. The level of calcium and silicon found

in (b) group particles was greater than in the (a) group debris.

Figure 22 Foreign particles and debris on the fracture surfaces of the GRP rod (tension insulator).

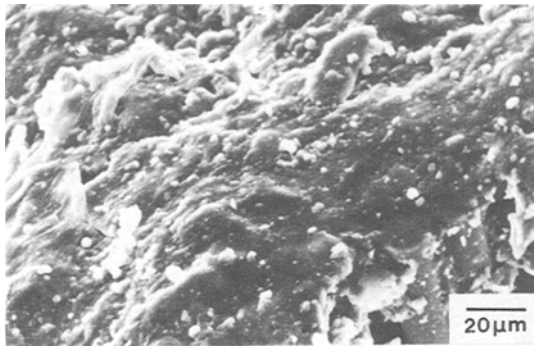
Some areas of the fracture surface are very smooth, see Fig. 23, and individual glass fibres can no longer be detected. Chemical analysis of this surface reveals similar compositions to that found in the glass wedges, with additional chlorine and sulphur. This would suggest the smooth region has either been molten or glass debris has been compacted and burnished into a continuous layer.

Figure 23 Micrograph of smooth areas observed on some fracture faces of the GRP rods (tension insulator).
