# A microscopy study of impact damage of epoxy-matrix carbon-fibre composites

D. J. BOLL, W. D. BASCOM, J. C. WEIDNER, W. J. MURRI  
*Hercules Aerospace, Bacchus Works, Magna, Utah 84044, USA*

The damage associated with the impact of quasi-isotropic epoxy-matrix carbon-fibre composites was studied by sectioning through the impact area and photographing the polished sections. Composites with a state-of-the-art low fracture-energy matrix resin (Hercules 3501-6) and a new high fracture-energy resin (Hercules X8551) were compared. Damage in the low-toughness matrix laminate was characterized by a network of interlaminar and transverse cracking that extended some distance beyond the centre of impact. A similar network of transverse and interlaminar cracking developed in the impacted tough-matrix laminate but was largely confined to a region immediately below the impact centre. This difference in the volume of impact damage could be easily attributed to the high interlaminar fracture energy of the X8551 resin compared to the 3501-6 resin. The type and distribution of impact damage are discussed in terms of energy-dissipative mechanisms and the stress patterns that develop during impact

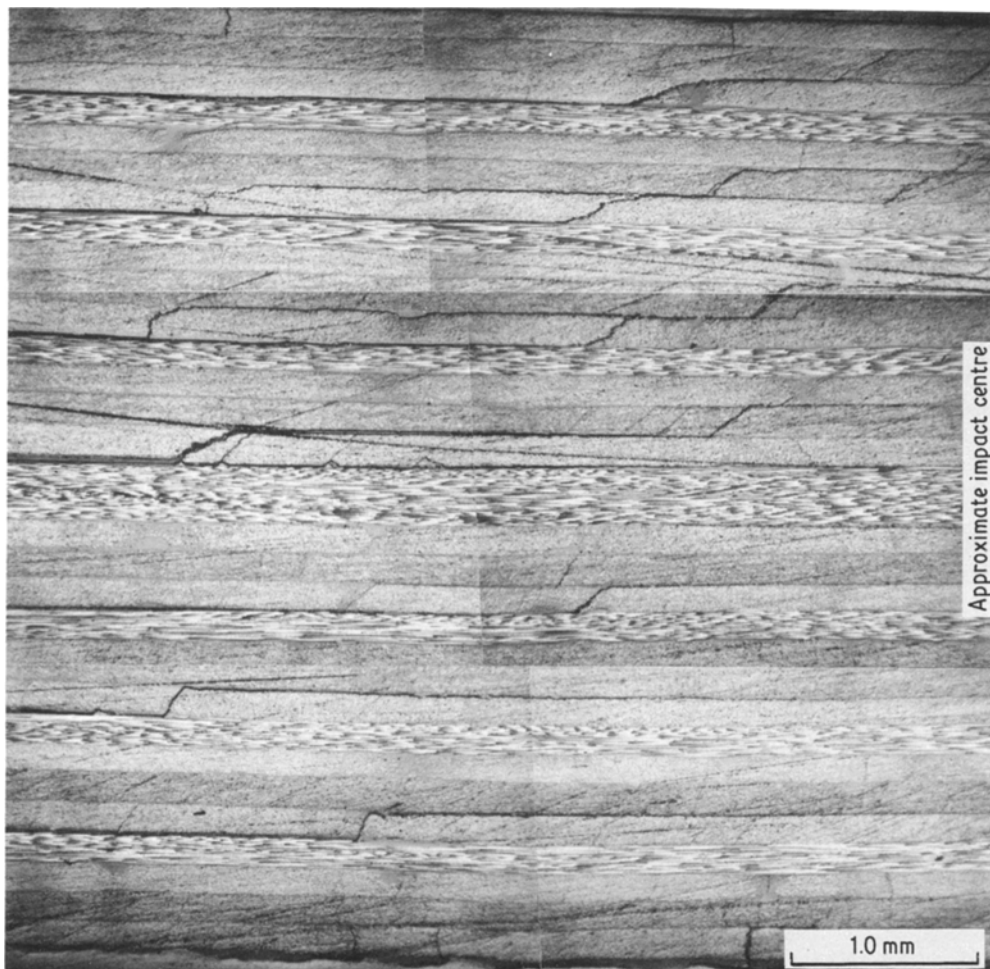
The damage observed within the 3501-6 laminates was dominated by delamination between plies connected by transverse cracks through  $90^\circ$  and  $45^\circ$  plies. This network of delamination and transverse cracking is illustrated in Fig. 4. This photograph was taken from the left-hand side of a laminate slice immediately below the centre of impact. Although it shows extensive damage, the major damage in this plate occurred below the mid-plane and away from the impact centre as shown in Fig. 5. The isometric drawing in Fig. 5 presents the outer bounds of damage in each ply without any attempt to distinguish the type of damage. However, the most predominant type of damage throughout all the indicated areas was a network of interconnecting delaminations and transverse cracks (Fig. 4). To find the outer bounds of delamination it was necessary to slice and polish sections beyond the initial 2 in. square (Fig. 2).

Figure 4 Impact damage in 3501-6/IM7G.

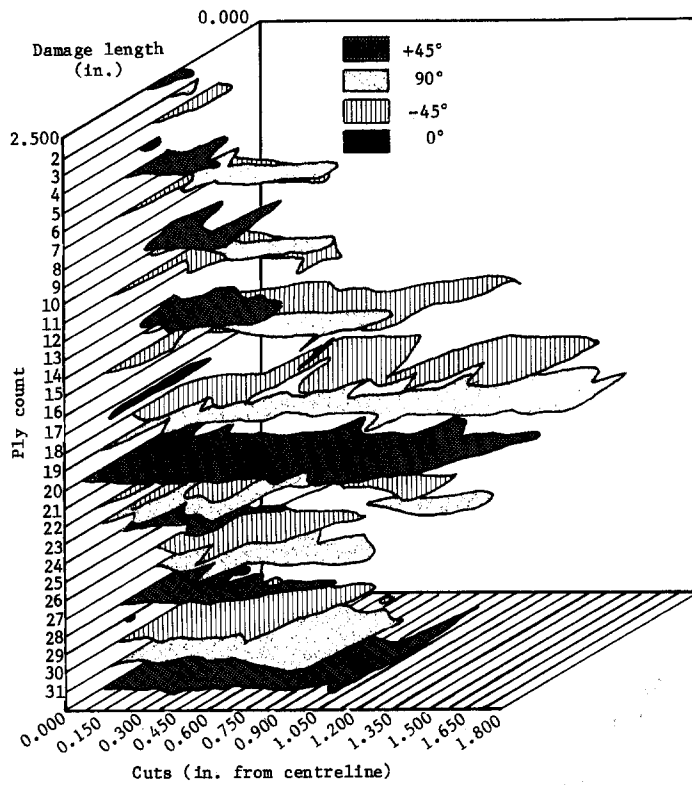
Figure 5 Damage area in 3501-6/IM7G (half section). 1 in. = 25.4 mm.

radiate from the impact centre. Areas of damage, some of which extended beyond the 2 in. square area, developed without any apparent initiation from the region of maximum damage. Similar isolated damage areas can be found on the map (Fig. 5) developed from the sectioning study. In some instances these isolated damage areas resulted from delamination

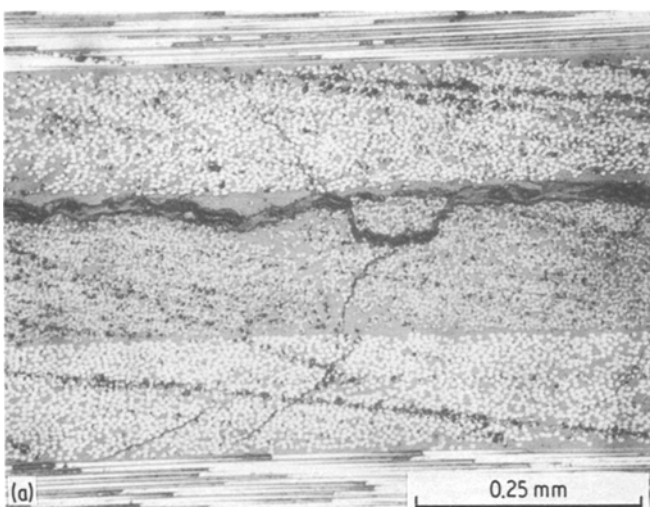
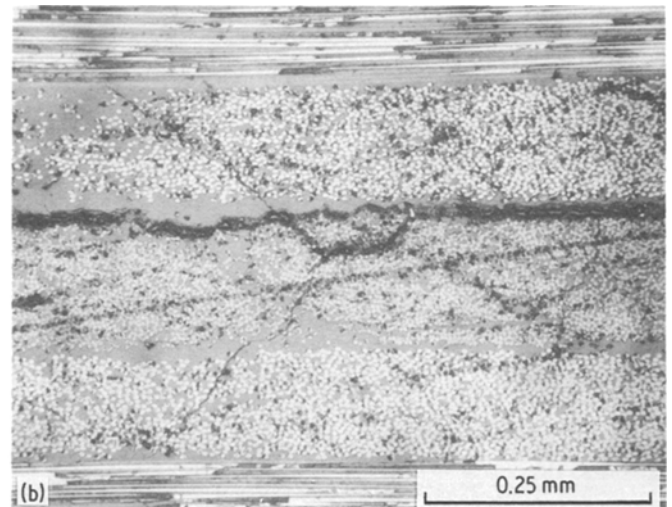
There was a strong tendency for the delamination to propagate in the resin-rich areas between plies but near the fibre-resin boundary as shown in Figs 6 and 7. It is reasonable that residual stresses in the resin near the fibres provided a low-energy path for propagation.

Figure 6 (a, b) Multiple-ply transverse cracking in 3501-6/IM7G.

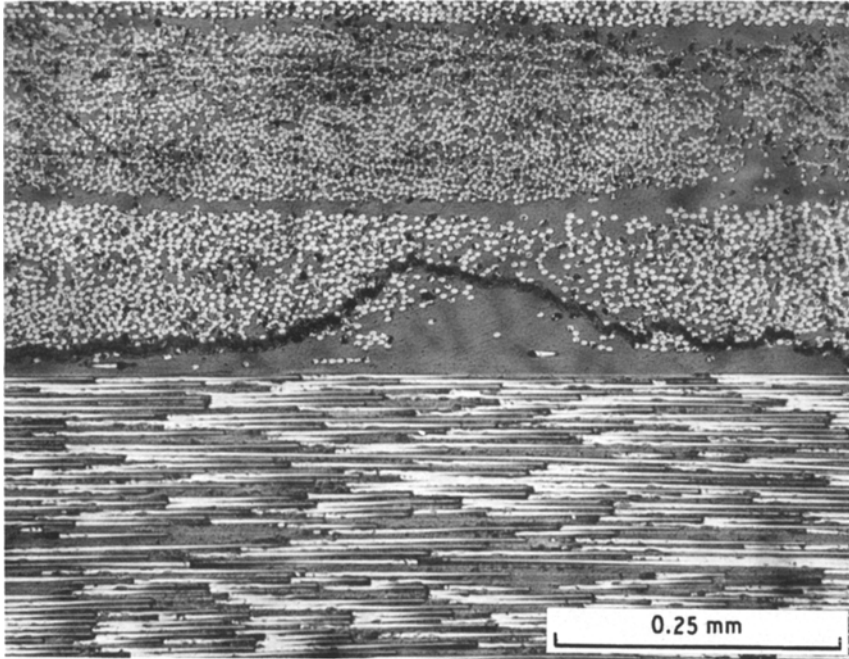
Indeed, in propagating along this boundary the delamination in Fig. 7 was almost diverted into a transverse crack.

It was not always clear what caused a delamination to divert into a transverse crack. Sometimes a resin-rich pocket (as in Fig. 7) could be identified with crack redirection. From a fracture-energy point of view, the opening mode ( $G_I$ ) for transverse cracking is greater than for delamination based on laminate tests [7]. However, the difference is small and could easily be reversed by local variations in fibre volume, resin heterogeneities etc. Moreover, these considerations are complicated by the effects of reflected stress waves and plate deflections as discussed below.

Figure 7 Propagation of a delamination at the fibre-resin boundary in 3501-6/IM7G

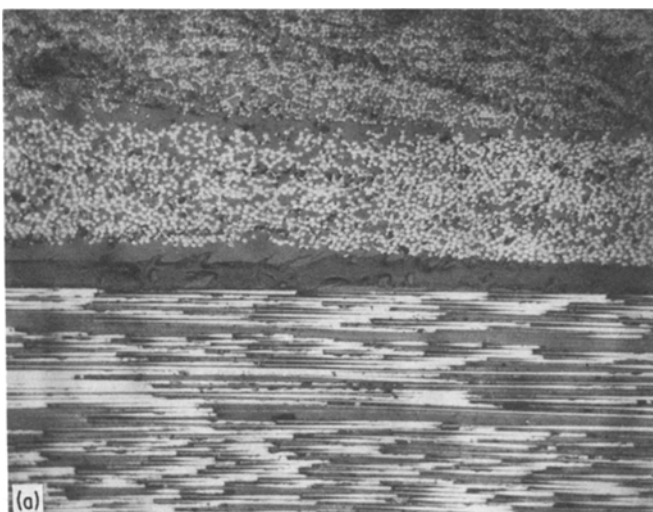
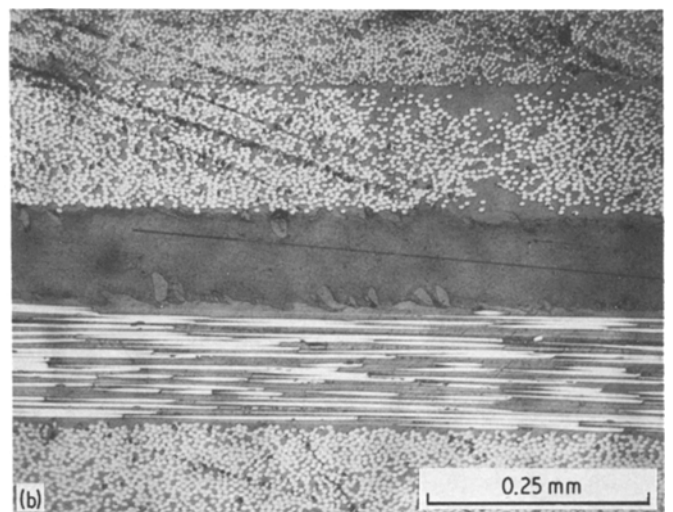
Although the delamination tended to propagate along fibre-resin boundaries the associated deformation did extend into the interply resin, as shown in Fig. 8. In these photomicrographs there are tear markings in the resin reminiscent of the hackle or chevron markings reported in fractography studies of carbon-fibre composite delaminations [8, 9].

Figure 8 (a, b) Resin tearing associated with delamination of 3501-6/IM7G.

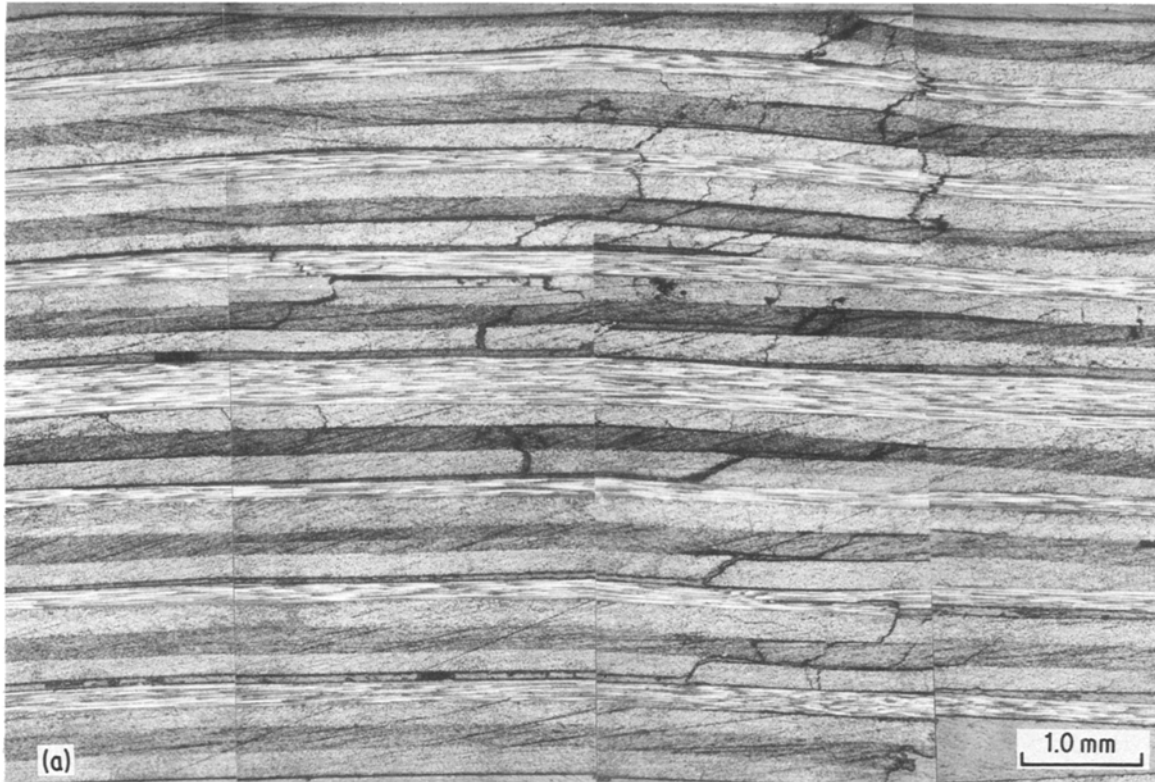
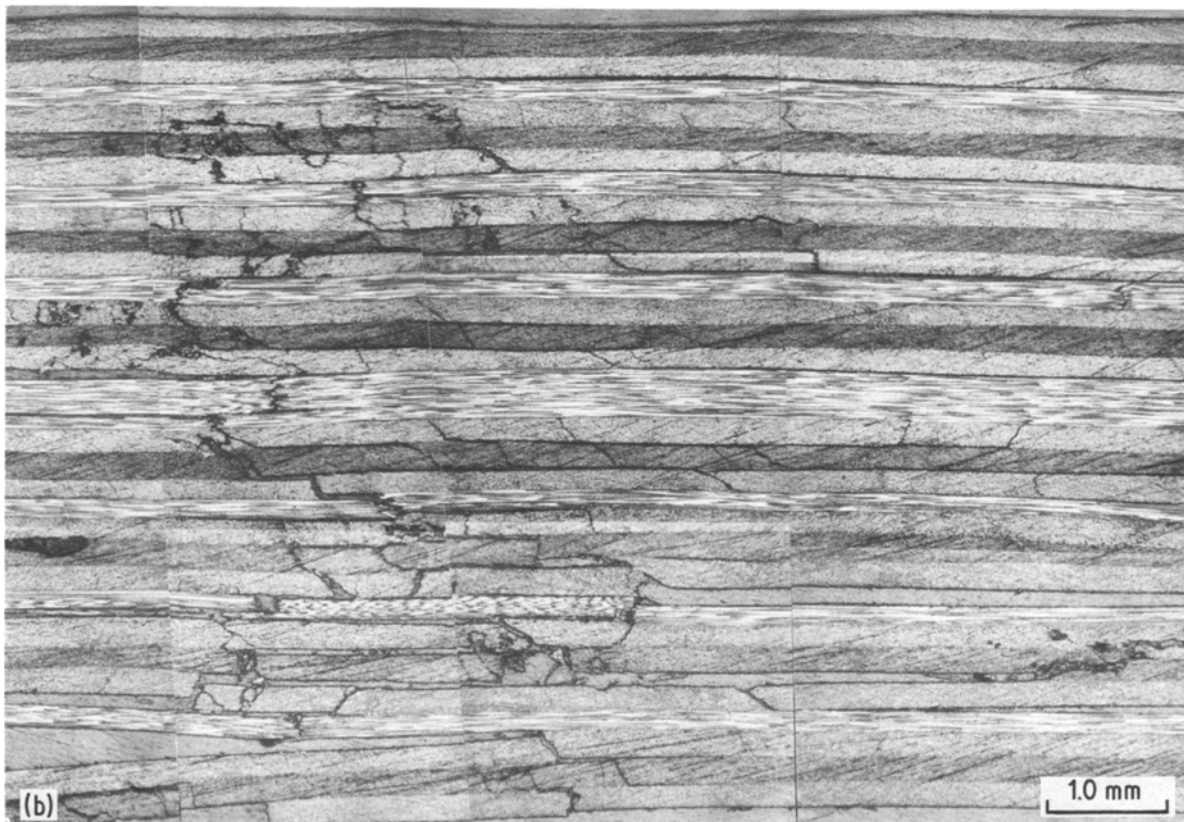
The characteristic damage of the X8551 matrix laminate included transverse cracking, delamination and fibre breakage. These features are shown in the photomicrographs in Figs 9a and b, taken from a section just below the point of impact (Fig. 9a is the left-hand side and Fig. 9b the right-hand side of the impact

centre line). The top-surface indentation had a diameter of about 0.5 in. (1.3 cm) compared to the 0.08 in. (0.2 cm) for 3501-6. Moreover, there was plastic deformation of the top ply of the X8551 matrix laminate. At the top of Figs 9a and b the 45° ply disappears near the centre of the impact zone. Visual inspection of the impact area indicated the material had been radially moved from the impact "epicentre."

Figure 9 Damage in 8551/IM7G: (a) left-hand, (b) right-hand side.

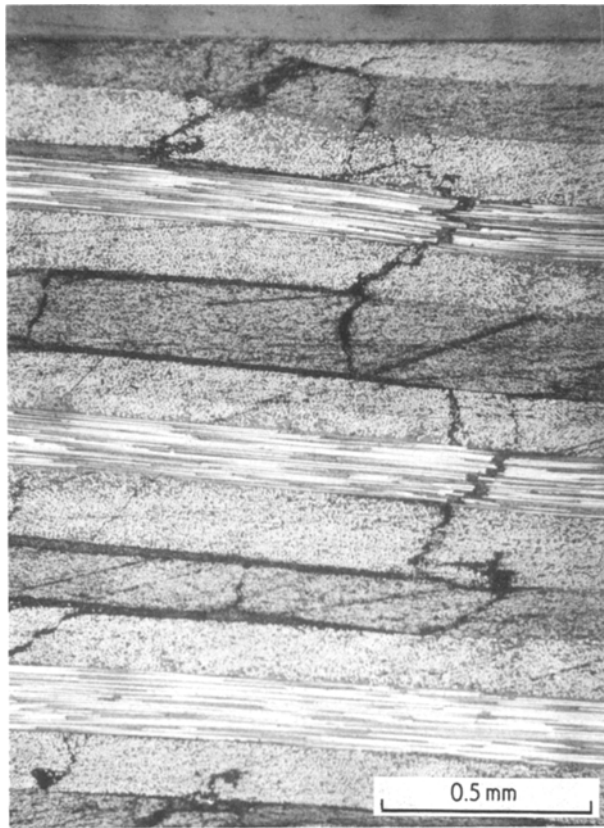
The internal damage was dominated by transverse cracking with limited delamination (Fig. 10). In many instances the transverse crack propagated through adjacent plies including fibre fracture of 0° fibres (Fig. 11). Note in Fig. 11 that fibre breakage in the 0° ply included some intra-ply delamination. Also, fracture through a 0° ply often involved wide delaminations above and below the ply fracture which terminated a short distance from the break.

Figure 10 Transverse cracking in 8551/IM7G.

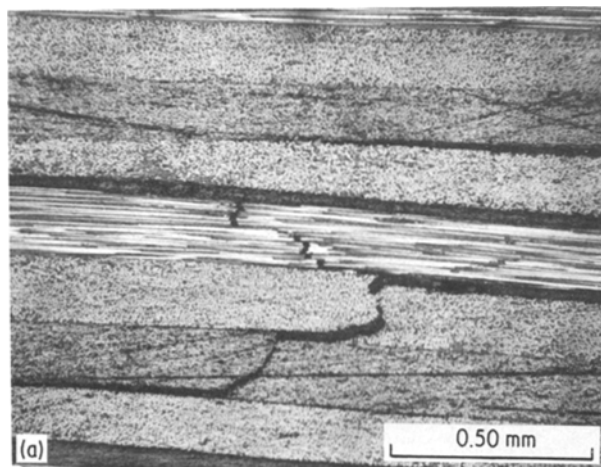
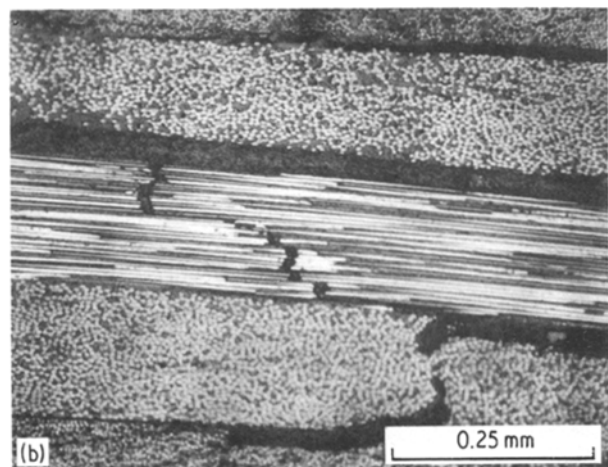
The high energy density near the centre of impact also caused fibre breakage and cracking through the  $0^\circ$  plies in the X8551 matrix laminate. It is not obvious why fibre fracture, which generally involves fracture energies two to three times greater than interlaminar fracture [11, 12] should be favoured over delamination. Fibre breakage was usually accompanied by local interply separation (Fig. 11), which suggests some competition between fibre fracture and interlaminar fracture.

Figure 11 (a, b) Transverse cracking in  $0^\circ$  plies of 8551/IM7G.

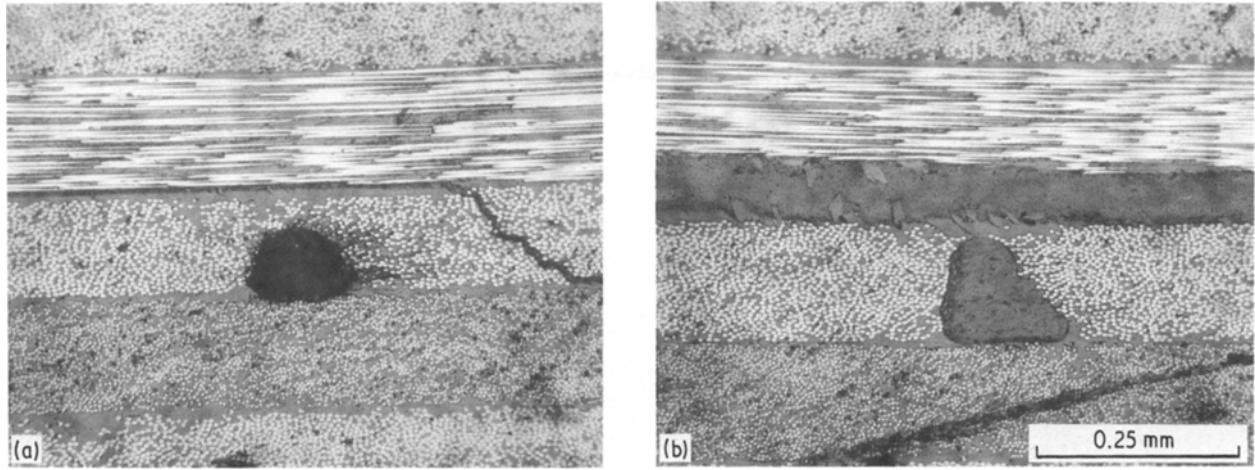
Occasionally, an air void was observed in a cut section. There was no evidence that damage initiated from these voids. In fact, Fig. 14 shows that the void had no influence on delamination propagation.

Figure 14 (a, b) Influence of voids on impact damage in 3501-6/IM7G.

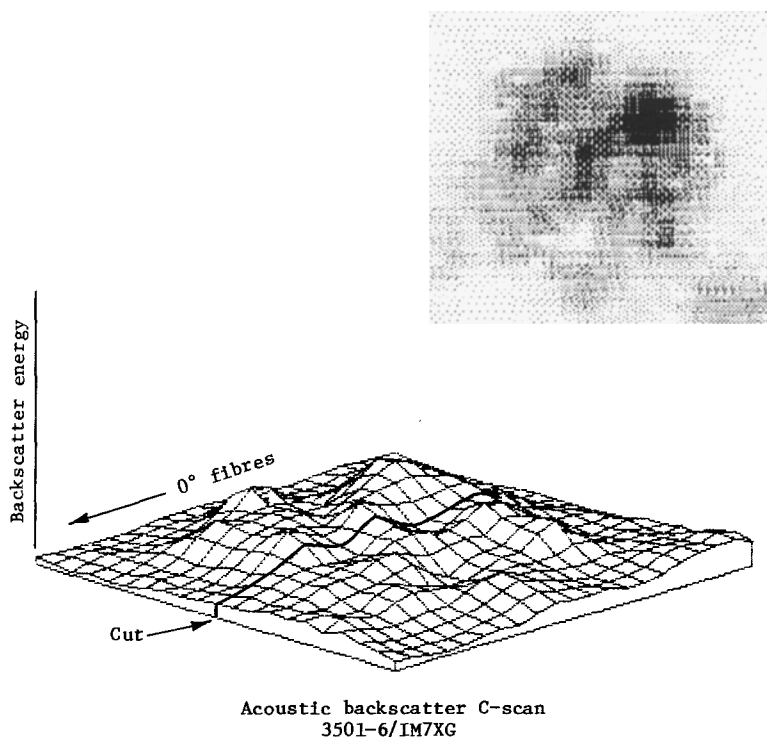
The C-scan plots indicate a number of features also revealed by microsectioning. The much larger diameter of the damaged area in the 3501-6 matrix laminate compared to the X8551 matrix laminate is evident in comparing Figs 15 and 16. The damage was most severe directly under the point of impact for the X8551 resin. The damage was most widely spread for the 3501-6 resin laminate. The maximum damage on the 3501-6 matrix plate is slightly off-centre in Fig. 15, suggesting that the impact load was not precisely normal to the plane of the laminate. Microsectioning confirmed that the damage through the laminate was not symmetrically distributed. Fig. 15 indicates that all the damage in the 3501-6 matrix laminate did not

Figure 15 Acoustic backscatter C-scan for 3501-6/IM7G. Target area is 2 in. (5.1 cm) square.

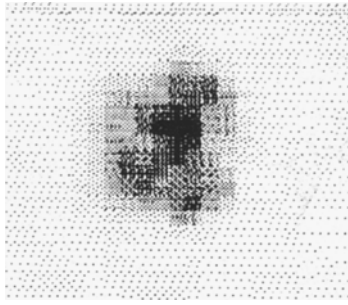
Figure 16 Acoustic backscattering C-scan for X8551/IM7G. Target area is 2 in. (5.1 cm) square.
