Causes of the formation of longitudinal surface cracks on the DC-cast 7039 aluminium alloy

C. S. WU

China Steel Corporation, Kaohsiung, Taiwan

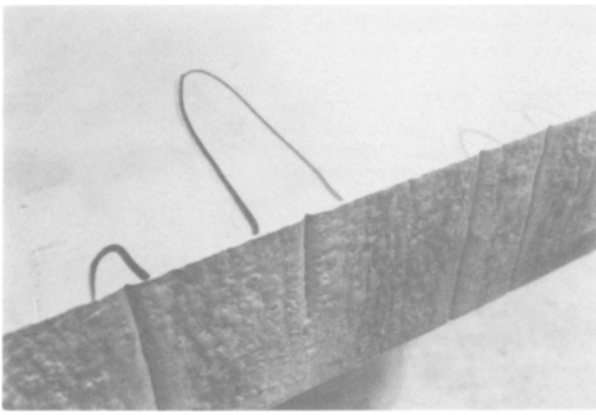
Samples were cut from the cracked ingot. The cracks showed up as a groove opening on the exterior surface and extended deeply into the interior of the ingot as shown in Fig. 1.

Figure 1 The feature of the longitudinal surface cracks.

Based on the above investigation, action was taken to improve the cooling efficiency of the mould. After that, the longitudinal surface crack was completely eliminated and perfect ingots were obtained.

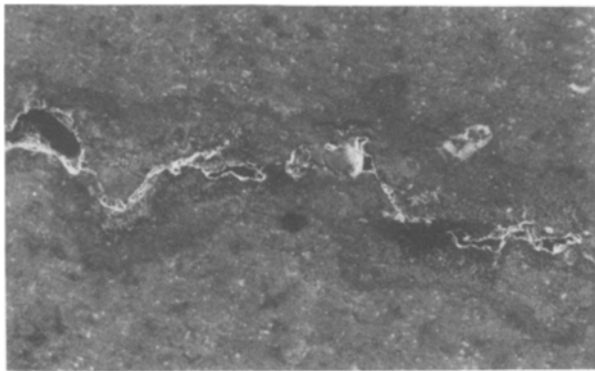
The opening of the crack is of a groove shape. Under lower magnification, the interior of the crack exhibited branching and porous structures as shown in Fig. 2. These morphologies are somewhat different from those of the thermal stress-induced cracking as yet experienced. The opening of a crack occurring in

Figure 2 The interior of a crack exhibiting branching and porous structure. $\times 32$.

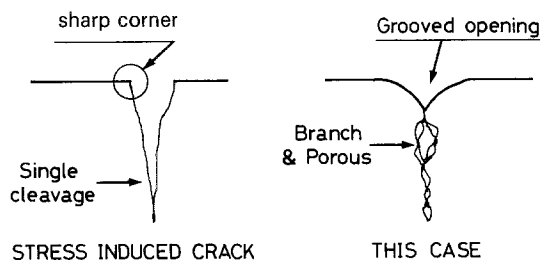
Figure 3 The appearance of the crack is different from a stress-induced crack.

the solidified shell is characterized by a sharp corner shape, and the crack is of a split cleavage inward as schematically shown in Fig. 3 for comparison. The crack characterized by the branching and porous morphology is somewhat similar to the centre-line crack or shrinkage pipe as seen in continuously cast slabs.

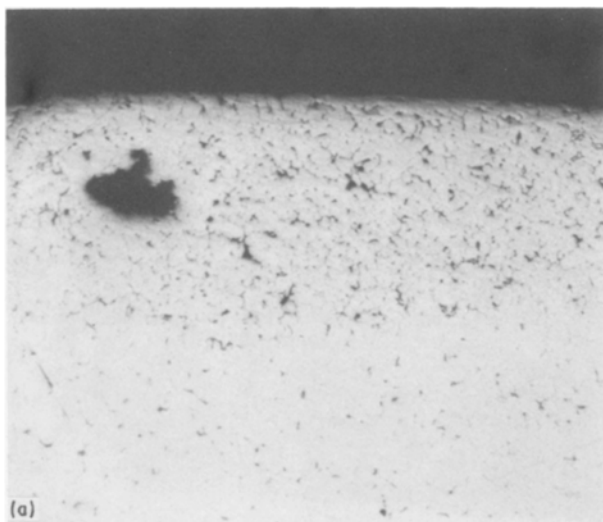
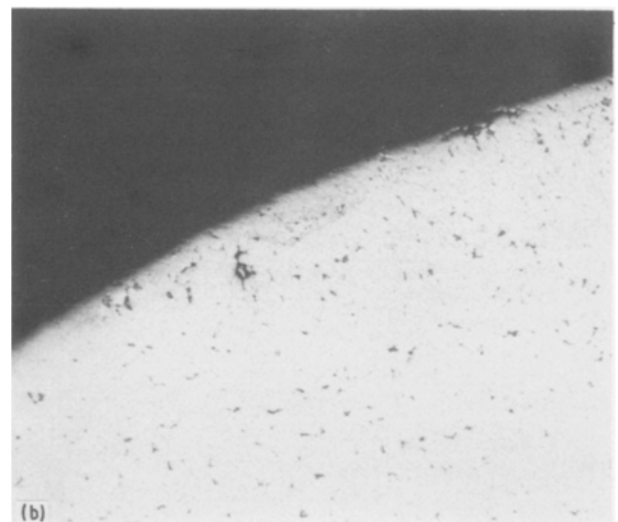
Fig. 4 shows that there was a chilled zone in the outermost area along the casting surface. The chilled layer became progressively thinner as the grooving proceeded and finally disappeared prior to the crack tip. This evidence clearly indicates that the crack opening was initially an inadequately chilled hot spot. The length of the inadequately chilled surface was estimated to be 1 to 2 mm.

Figure 4 (a) The normal surface of the ingot with a chilled layer. (b) The abnormal area around the crack opening. $\times 40$.

The fact that there was no chilled layer in the crack opening region suggests that the ingot surface suffered uneven chilling conditions. Examination of the other ingots cast with the same mould revealed that some coarse grains were found in the surface layer. This finding strongly supports the reasoning that the mould was subjected to uneven chilling conditions during the casting. Under the situation of uneven chilling, the liquid melt in front of the hot spot would be enclosed by the rapidly growing shell to form a canyon. The outer surface of the pool would then solidify and shrink to form a groove. The initial crack might occur on the tip of the groove. As the grooving surface pulled away from contact with the mould surface, the melt bridged in the canyon region would solidify at a slow cooling rate. This resulted in the cellular and dendritic structures accompanying intermetallic strings and shrinkage pores. The suggested mechanisms are schematically shown in Fig. 8.

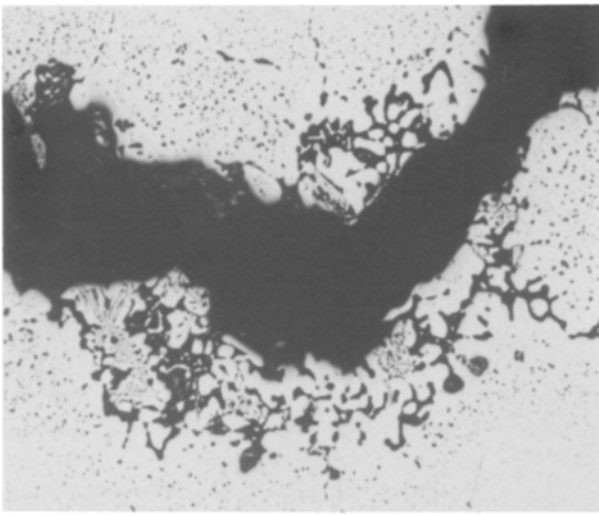
Searching along the crack "river", it was found that the "banks" were full of "foot-prints", "islands", "daisies", and "gulfs", as shown in Fig. 5. These are the solidification structures arising from the slow cooling of the constitutional melt [13]. The foot-prints and islands are the cellular structure and the daisies are the coarse dendrites in the cast structure, while the gulfs could be the shrinkage pores.

Figure 5 Microstructure of the crack interior. $\times 160$.

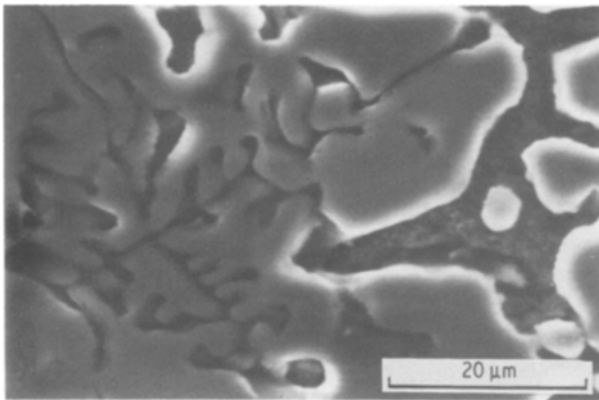
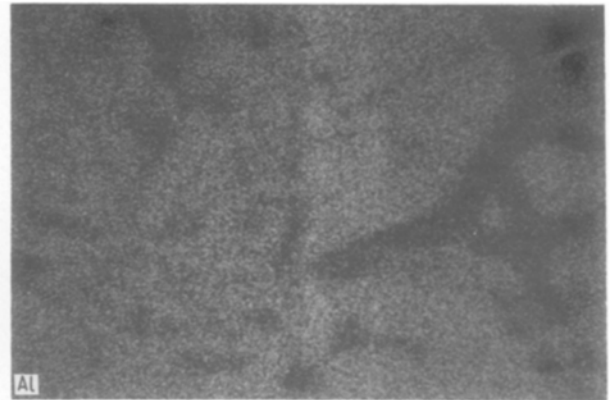
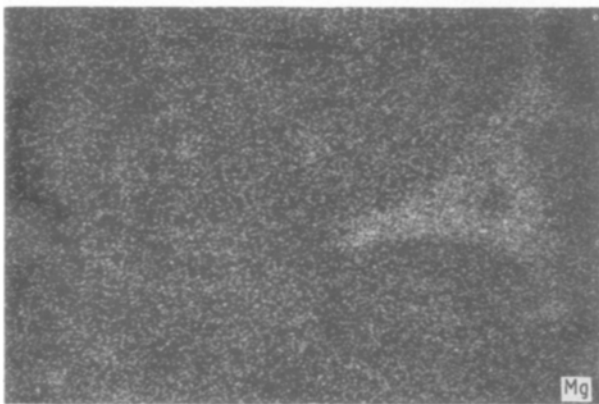
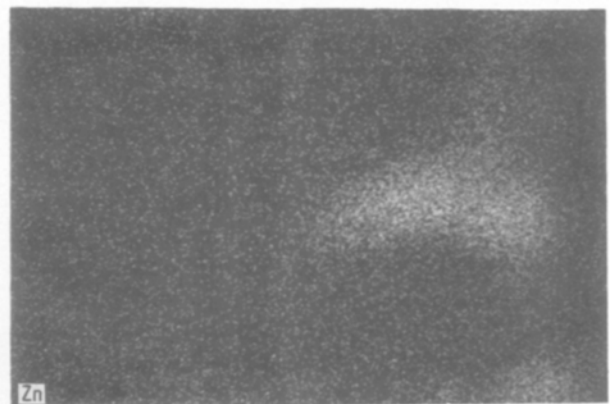
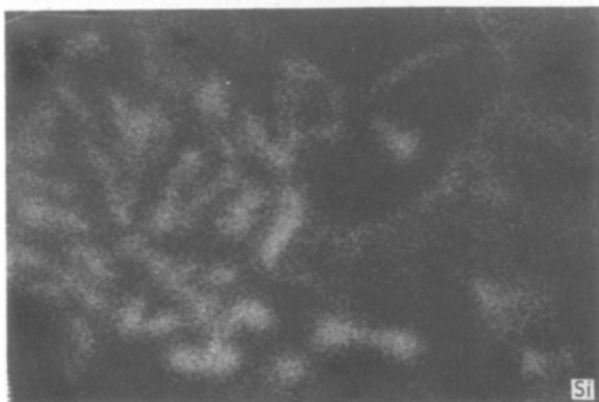
X-ray mapping of elemental distribution by EPMA indicated that intermetallic compounds were formed in these areas. The intermetallic compound in the dendrite spaces contained silicon. Another intermetallic compound containing magnesium, zinc and copper was located in the grain boundary. A small amount of aluminium was identified in these regions, as can be seen from Fig. 6.

Figure 6 X-ray mapping on the crack boundary.

Quantitative EPMA on the Mg–Zn compound area indicated that the atomic concentrations of magnesium and zinc were 27 to 32% and 20 to 26%, respectively. The concentration of copper was only 1%. Although the X-ray mapping (Fig. 6) showed that little aluminium was distributed in this region, the atomic concentration of aluminium in this region was analysed to be 40 to 50%. The atomic ratio of Mg : Zn is 1.0 to 1.5. These results suggested that the compound is predominantly in $Mg_3Zn_3Al_2$ [14]. Possible reactions involving the formation of $Mg_3Zn_3Al_2$ [14] are

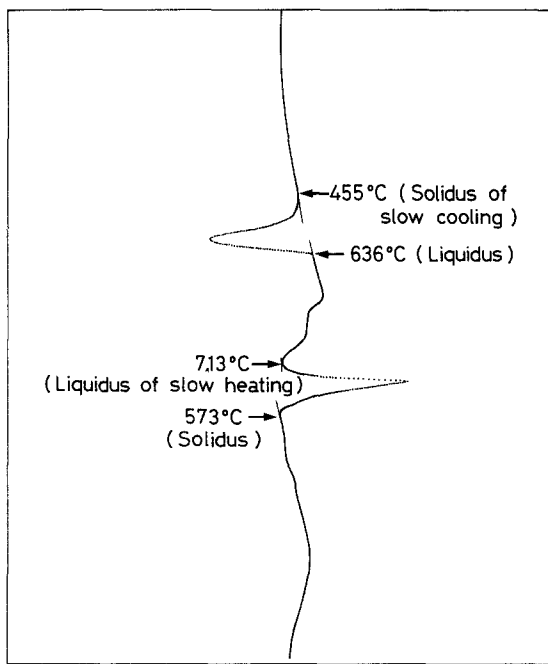
Figure 7 Differential thermal analysis of 7039 alloy.

The solidus and liquidus temperatures of 7039 alloy were measured using DTA to be 573 and 636°C, respectively, as shown in Fig. 7. The solidification range is 63°C. If the cracks arose from the formation of an air gap, the outermost opening of the crack should be of a sharp corner shape as demonstrated by the solidified shell, and even a burst feature would appear under the metallostatic pressure. If bleeding or exuding of the interdendritic substance had occurred, a secondary chilled layer would have been identified in the crack opening and the boundaries of the crack interior would have been a layer of homogeneous constitution of the compound, instead of the aluminium matrix accompanying secondary phases. None of these were found in the present work. Although some intermetallic strings were found in the crack boundaries, the matrix was of aluminium constitution. Neither inverse segregation, nor surface segregation, were found in the ingot [10].

From DTA (Fig. 7), at the extremely slow cooling rate of $10^\circ \text{C min}^{-1}$, the finishing temperature of solidification was 455°C (728 K). Therefore, Reactions 2 and 3 are more likely to occur during the solidification of the bridged liquid melt. If the cooling rate was slow enough to initiate Reaction 3, $MgZn_2$ might form coexistently with $Mg_3Zn_3Al_2$. The formation of $MgZn_2$ will enhance the formation of shrinkage cracks and pores, because its shrinkage in solidification is as high as 24% [14]. Although the existence of $MgZn_2$ could not be confirmed, formation of the Mg–Zn intermetallic compound does indicate that the solidification temperature of the bridged liquid melt was possibly extended down to the low eutectic point and may have some effect on the crack formation.

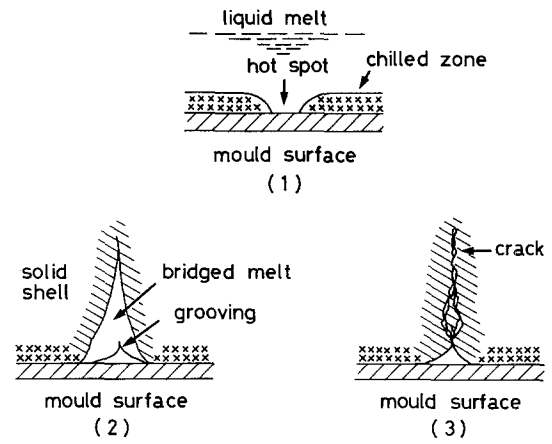
Figure 8 The suggested mechanisms of crack formation.
