# Metallographic investigations of the heat-affected zone II/parent metal interface cracking in 18Ni maraging steel welded structures

P. RAMESH NARAYANAN, K. SREEKUMAR, A. NATARAJAN, P. P. SINHA  
*Materials and Metallurgy Group, Vikram Sarabhai Space Centre, Trivandrum 695 022, India*

During the fabrication of a large diameter pressure vessel out of 18Ni maraging steel by manual TIG welding, microcracks were noticed at the heat-affected zone (HAZ)/parent metal interface. The location of these cracks was very different from those reported at the fusion zone/HAZ I interface due to "constitutional liquation". Extensive optical metallography, scanning electron microscopy and energy dispersive X-ray analyses were carried out to identify the cause for the occurrence of these cracks. It is inferred from the experimental results that the microsegregation of titanium and nickel due to repeated thermal cycling during multipass welding led to the formation of TiC/Ti(CN) and stable austenite film on the grain boundaries. Under severe thermal stresses developed during welding, microvoids generated at the interface of TiC/Ti(CN) inclusions and austenite and further propagated intergranularly

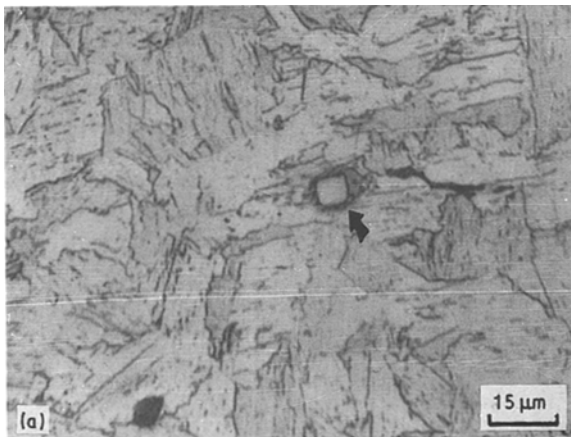
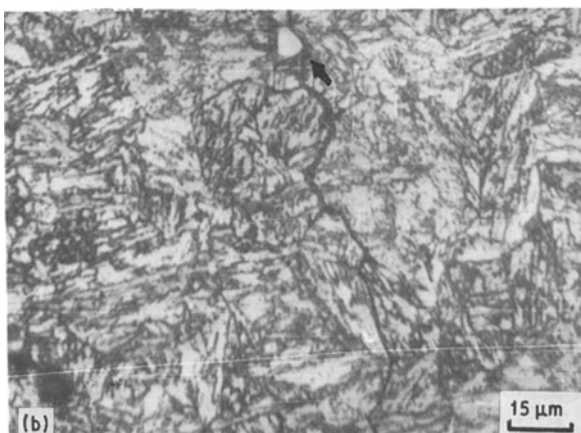
Fig. 2 shows the gross microstructural features of the weldment and the HAZ. A typical micrograph at the crack-initiating regions is given in Fig. 3. It is seen that the crack initiated at the cuboidal/angular inclusions present at the grain boundaries and further propagated intergranularly from the HAZ II to the parent metal. The microstructural variations in the areas adjacent to the cracks, as revealed by SEM, are presented in Figs 4 and 5. The high-resolution micrograph (Fig. 5) clearly indicates the presence of white etched thin austenitic films along the martensitic laths and prior austenitic grain boundaries. However, the microstructures away from the cracks are devoid of any such film (Fig. 6). A typical energy dispersive spectrum on the inclusion is shown in Fig. 7. Table II presents the chemical composition of the areas nearer to and away from the crack end obtained by Tracor Northern X-ray analyser using the spot mode. It is evident that there exists high nickel (20 to 22 wt %) and high titanium (0.5 to 0.9 wt %) concentration regions near the origin of the cracks. The effect of chemical inhomogeneity on the hardness were estimated by measuring microhardness in aged conditions. Fig. 8 shows typical microhardness indentations near the grain boundaries having austenite films (marked a) and on the matrix (marked b). The microhardness values corresponding to a and b are found to be 180 to 200 and 550 to 560 VPN, respectively.

Figure 3 Microstructure at HAZ II/parent metal interface showing (a) crack initiation at a cuboidal inclusion, and (b) crack initiation at an angular inclusion and propagation along the grain boundaries towards parent metal.

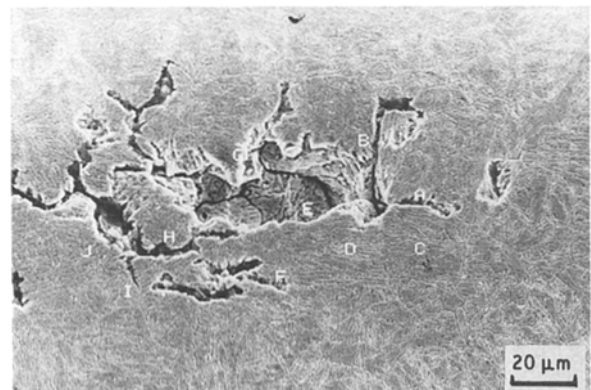
Figure 4 Scanning electron micrograph showing the topographical features of crack and identifying areas for EDAX and microstructural analysis.

TABLE II EDAX analysis of different regions identified in Fig. 4

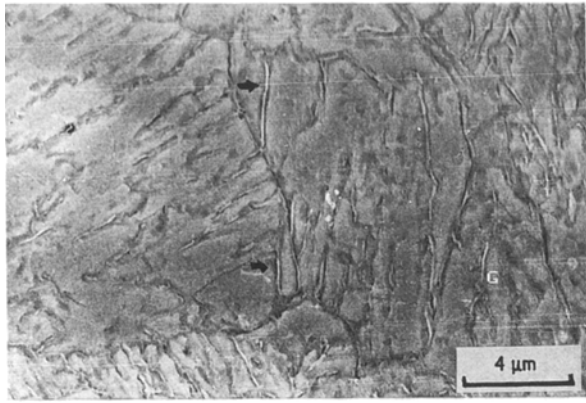
where  $\alpha'$  is the alloy-depleted martensite, and  $\gamma'$  the alloy-rich stable austenite which does not transform to martensite during subsequent cooling. The degradation of the aged hardness adjacent to the origin of the crack is attributed to the presence of austenitic film and reduction in the titanium content in the area. Similar observations on the effect of austenite present on welded and heat-affected zones have also been reported by other investigators [3, 7]. The grain-boundary inclusions, analysed as titanium-rich phases by EDAX, were identified as TiC or Ti(CN) based on their morphology and colour, following the approach of Boniszewski and Boniszewski [8] and Psioda [9].

Figure 5 Scanning electron micrograph revealing the presence of a thin austenitic film along martensitic lath and prior austenitic grain boundaries corresponding to area (d) in Fig. 4.

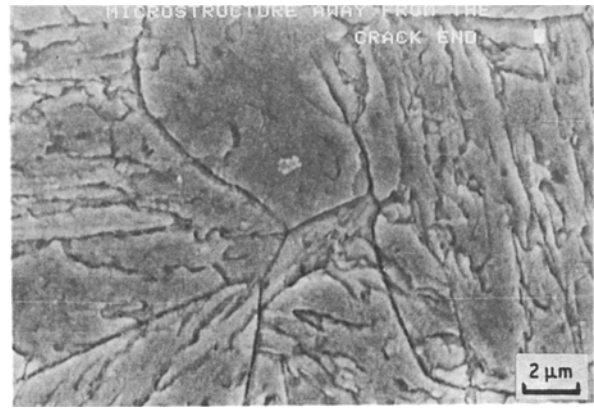
Figure 6 Microstructure (SEM) of the area away from the crack which does not show the presence of any austenitic film.

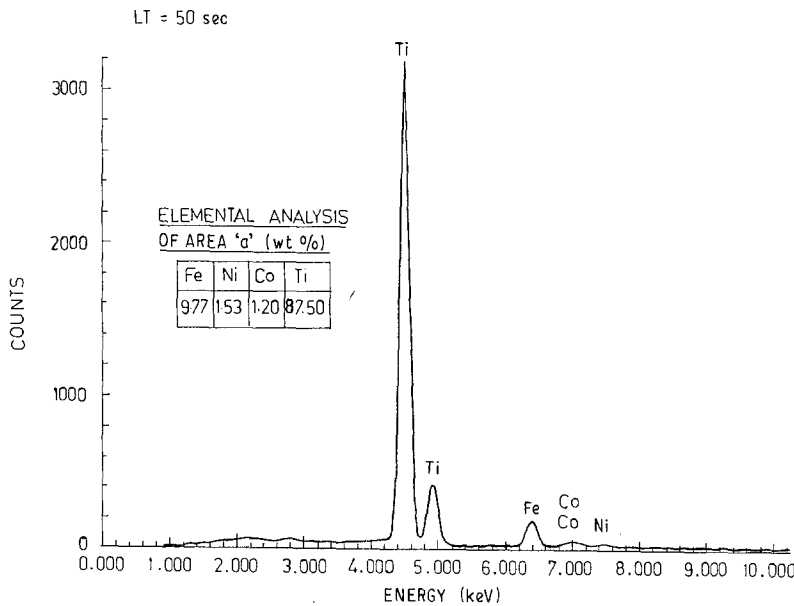
The formation of these carbides/carbonitrides was further attributed to the microsegregation of titanium at the grain boundary. Thus the experimental evidence clearly establishes that the grain-boundary segregation of titanium and nickel at the HAZ II/parent metal interface resulted in the formation of TiC/Ti(CN) inclusions and a stable austenitic film. In the presence of these adverse microstructural conditions, it is easy to hypothesize that the severe thermomechanical stresses generated during welding caused the formation of microvoids at the interfaces of TiC/Ti(CN) particles and austenitic film. Once these voids are nucleated at the grain boundaries, they are further propagated intergranularly due to the premature failure of the austenitic film. This is in accordance with Tettleman [10] who pointed out that when a softer phase is present in a harder matrix, the softer phase will reach the critical strain for fracture at an earlier stage, on loading. Consequently, this would lead to the generation of a series of microcracks even in a harder martensitic matrix.

Figure 7 Typical energy dispersive spectrum of a cuboidal inclusion showing the titanium-rich phase.

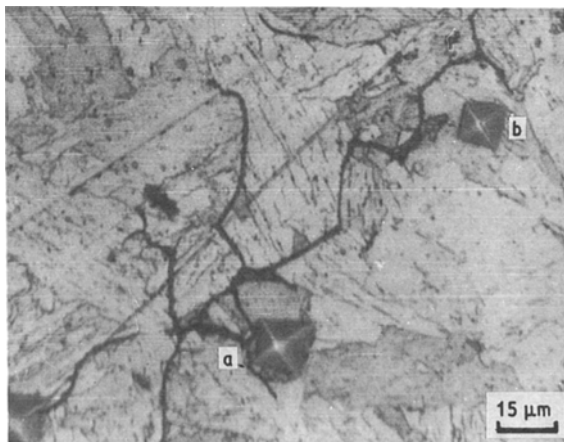
Figure 8 Micrograph showing microhardness indentation (a) near the grain boundaries having austenitic film and (b) in the martensitic matrix.
