## Failure analysis of turbine blade in atomic power plant

### Abstract

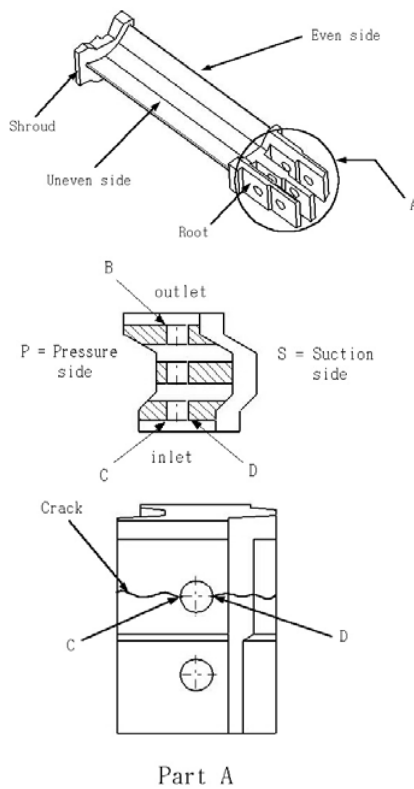
Fig. 1. Crack initiation and growth position at third stage of LP turbine.

Fig. 1 shows the crack and its growth location around the front blade root. The crack starts from Point C or D around the upper pin hole, where stress is concentrated, and grows along the circumference of rotor parallel to the lone extended from CD. The phenomenon has frequently occurred in the blades provided by GE (General Electronics), whose appearance is similar to the illustration [5].

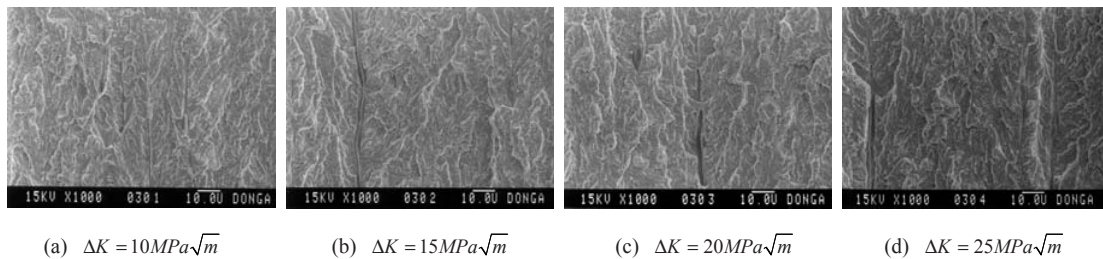
Fig. 6. SEM fractography for 12% Cr steel at  $\Delta P = 7.6kN$ .

stress intensity factor. When the crack growth rate increased with the increase of the load range for the same stress intensity factor, the material was considerably affected by the load range. Fig. 6 shows the fatigue fracture surface within the range of each stress intensity factor for 7.6kN of the same load range by using a scanning probe microscope. A typical ductile striation is not shown in the figure; instead, a small crack is repetitively formed in the direction of depth of fracture appearance perpendicular to the crack growth direction.

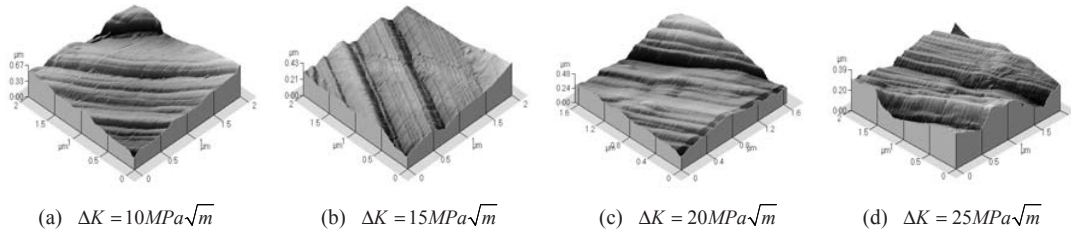
Fig. 9. AFM fractography for fatigue fracture surface at  $\Delta P = 7.6kN$ .

was formed was observed by an atomic force microscope. However, the cross-sectional characteristics of the striation observed by the atomic force microscope did not rely on the load range.

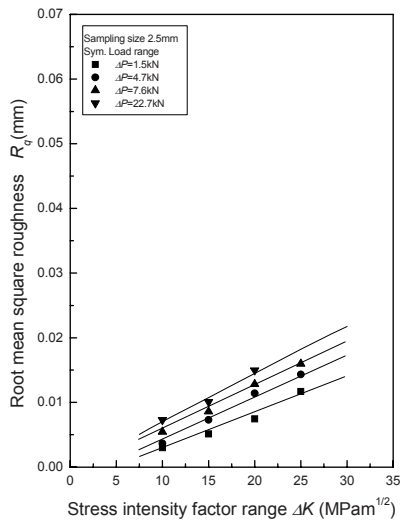
The distribution of the root mean square roughness calculated from the failure of the turbine blade exists in the range of the root mean square roughness calculated by the fatigue test of the CT test specimen. Fig. 11 shows that the slope of the root mean square roughness curve for the range of the stress intensity factor is almost uniform, regardless of the load range, while the root mean square roughness curve for the range of the stress intensity factor moves positively in

Fig. 11. Relation between  $\Delta K$  and  $R_q$  in 12% Cr steel.

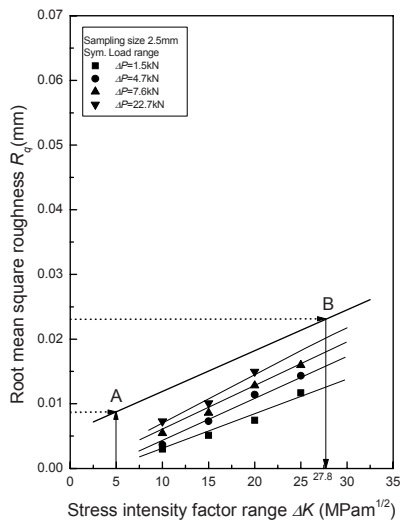
Fig. 12. Relation between  $R_q$  and gradient of  $R_q$  to  $\Delta K$ .

range for each load range, in which the dotted line shows the distribution of the root mean square roughness for the pin hole of the failure turbine blade. Point A is the cross point of one point where the stress intensity factor is  $5.0\text{ MPa}\sqrt{m}$  and the root mean square roughness from the start point of a pin hole of failure turbine blade, and Point A is the start point of the fatigue crack growth. From the above, it could be found that after drawing the average slope of the root mean square roughness for the stress intensity factor range calculated in each fatigue test at Point A, the point where the last point of the failure turbine blade's pin hole meets the root mean square roughness is Point B; so the maximum stress intensity factor range applied to turbine blade's pin hole would be  $27.8\text{ MPa}\sqrt{m}$ .

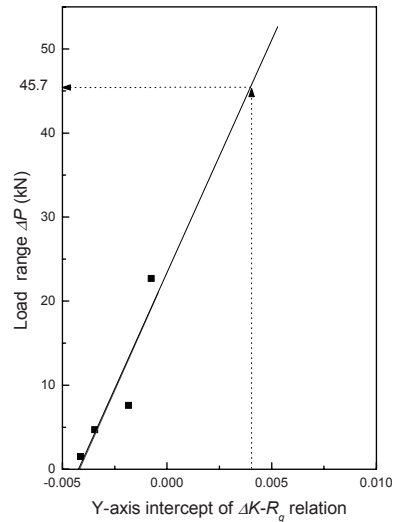
Fig. 13. Prediction of in-service load range using y-axis intercept of  $\Delta K - R_q$  relation.

Fig. 13 shows the axis intercept of the root mean square in Fig. 12 for each load range and the linear regression equation can be expressed as follows:

Therefore, the load range applied to the turbine blade can be calculated as 45.7kN by substituting the vertical axis intercept of the root mean square roughness curve for turbine blade in Fig. 11, 0.004, to Eq. (2).
