Comparison of thermal fatigue behaviour of ASTM A 213 grade T-92 base and weld tubes[†]

Abstract

Keywords: Thermal fatigue; T-92 tube; Transverse and Circumferential cracks; Failure analysis

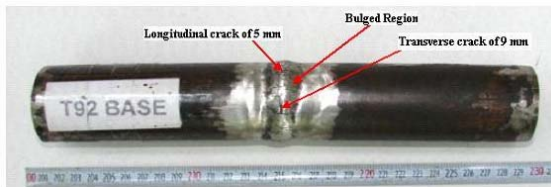
The macrograph of the failed base tube is shown in Fig. 11. Fig. 11 illustrates that a number of surface cracks were observed in the base tube subjected to thermal fatigue after 90 cycles.

The cracks shown in Fig. 11 were measured and identified. A 5 mm long longitudinal crack and a transverse crack of 9 mm were visually identified in the failed base tube at the heated zone. The tube is bulged in the heating zone, which can

Fig. 11. Visual inspection of failed base specimen after subjected to thermal fatigue.

be clearly seen in Fig. 11. The failed tube was then subjected to liquid penetrant test to identify small surface cracks.

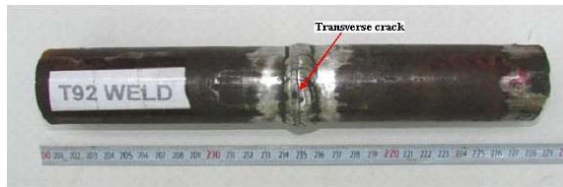
Fig. 12. Visual inspection of failed weld specimen after subjected to thermal fatigue.

The macrograph of the failed weld tube is shown in Fig. 12, which shows that numerous surface cracks were observed in the base tube subjected to thermal fatigue after 60 cycles.

As shown in Fig. 12, a transverse crack 65 mm long was visually identified in the failed weld tube at the heated zone. The failed tube was then subjected to liquid penetrant test to identify small surface cracks.

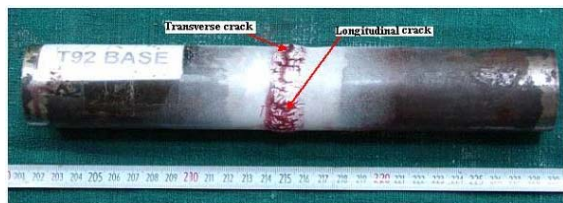
Fig. 13. Liquid penetrant examination of failed base specimen.

The macrograph of the failed base specimen subjected to liquid penetrant test is shown in Fig. 13, which clearly shows that a number of longitudinal cracks in the heated zone. Several small transverse cracks could also be identified from the longitudinal crack.

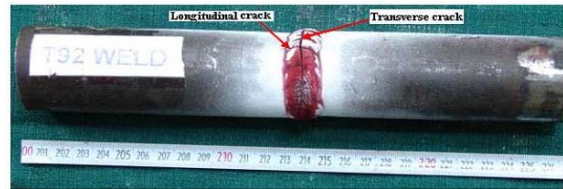
Fig. 14 shows the macrograph of the failed weld specimen subjected to liquid penetrant test. The Fig. clearly shows that

Fig. 14. Liquid penetrate examination of failed weld specimen.

numerous transverse cracks had developed in the heated zone, which traveled throughout the circumference of the weld. Small longitudinal cracks were also seen from the transverse crack, which had been invisible in the visual examination.

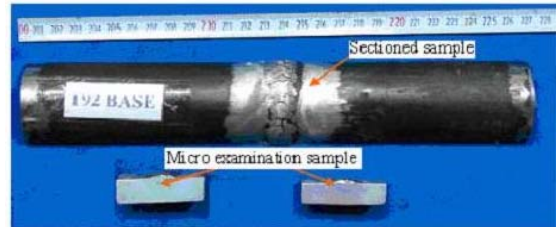
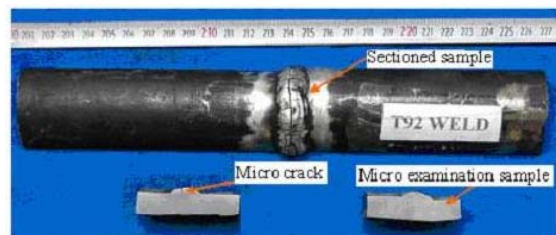
Fig. 15. Sectioned view of the failed base and weld tubes.

The sectioned views of the failed base and weld tubes are shown in Fig. 15(a and b). The failed tubes were sectioned in two halves in the longitudinal direction, and one of the halves was further divided into two sections. The projected portion from the two sides of the heating zone in the tube was also removed so that only the heated zone was taken for metallographic study. Specimens for the metallographic examinations were prepared by polishing successively in 220, 320, 400, 600, 800 emery grits, followed by a disc polishing cloth. The specimens were etched with 4% Nital solution. The specimens were then subjected to microscopic and scanning electron microscopy (SEM).

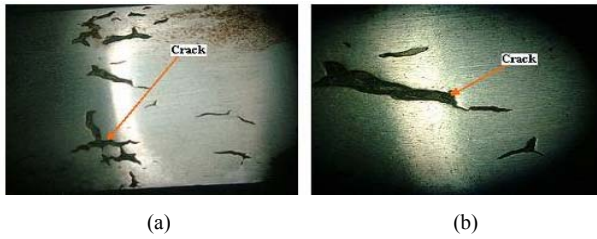
Fig. 16. Magnified view of the surface crack obtained in the failed base tube.

Fig. 16(a) shows a magnified view of the surface crack observed in the failed base tube subjected to thermal fatigue. It clearly illustrates that numerous longitudinal cracks developed in the heated zone, while numerous small transverse cracks also developed from the longitudinal crack. Fig. 16(b) shows a magnified view of the single longitudinal crack obtained in the failed base tube.

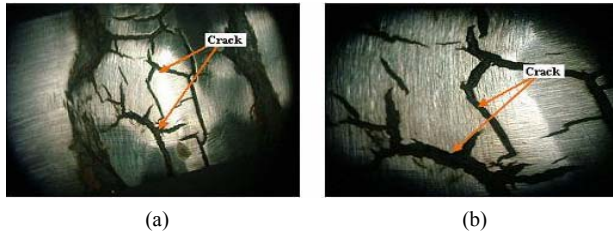
Fig. 17. Magnified view of the surface crack obtained in the failed weld tube.

Fig. 17(a) shows the magnified view of the surface crack observed in the failed weld tube subjected to thermal fatigue. It clearly shows that numerous transverse cracks developed in the heated zone, and that small longitudinal cracks also developed in the transverse crack. Fig. 17(b) shows the magnified view of the surface crack observed in the failed weld tube.

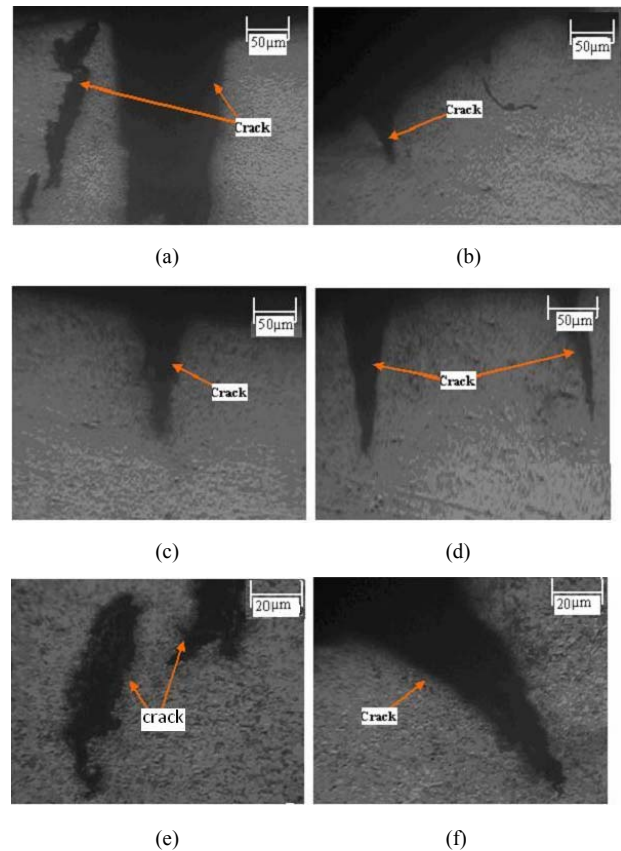
Fig. 19. Cracks identified in the failed base tube.

The defect surfaces in the T-92 base tube were identified through optical microscope, as presented in Figs. 19(a-f). The figures clearly illustrate a large number of cracks in the failed base tube. The cracks developed from the heating surface (outer surface) of the tube and traveled towards the inner surface. Oxide-filled blunt-tipped parallel cracks were also observed, which appear to have similar characteristics as the thermal fatigue failure. Decarburization of the grains nearer to the crack edges was also observed. Cracks observed in the failed base tube closely resembled the cracks observed in the failed tubes [8].

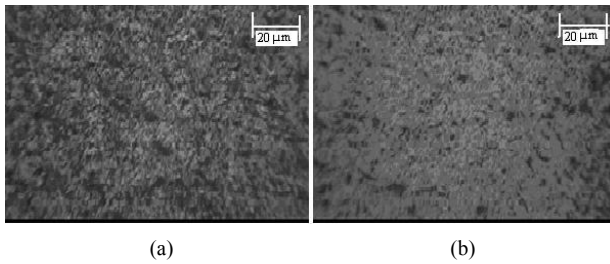
Fig. 20. Microstructure of base and weld region in defect free areas.

The microstructures of the base and weld surfaces taken from the defect-free portion of the welded tube are shown in Fig. 20(a and b). The grains were coarser than the base metal because the cooling rate of the heat affected zone [HAZ] in welding was much higher than that during the manufacture of the metal. The high cooling rate resulted in irregularly shaped grains and decreased strength since the amount of carbides formed was less due to low rate of precipitation. The microstructure showed irregular grains and the formation of martensite due to high cooling rate. Since the grains were coarser, they have a higher tendency towards cracking.

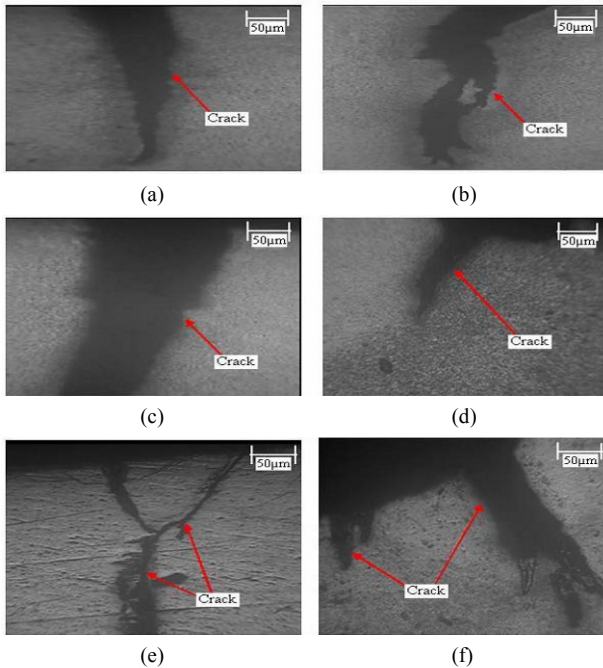
Fig. 21. Cracks identified in the failed weld tube.

The defect surfaces in the T-92 weld tube were identified through optical microscope, as presented in Fig. 21. The figures clearly illustrate a large number of cracks present in the failed weld tube. The cracks developed from the heating surface (outer surface) of the tube and propagated towards the inner surface. Oxide-filled blunt-tipped parallel cracks were also observed, which appear to have similar characteristics as with that of thermal fatigue failure. Decarburization of the grains nearer to the crack edges was also observed. The cracks observed in the weld tube closely resembled the cracks ob-

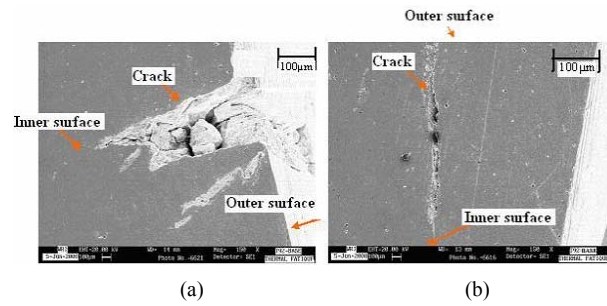
Fig. 22. Crack propagation in the failed base tube.

The cracks observed in the SEM examination of the failed base tube are shown in Fig. 22(a and b). Figs. 22(a and b) show that the cracks developed from the outer surface of the

tube and propagated towards the inner surface. Similarly, the cracks traveled in the circumference of tube-heated region. When they were compared to the cracks obtained in the failed weld tube, the width and depth of the cracks were less. This is clearly shown in Figs. 22(a and b). Crack formation was observed inside the cracked surface at higher magnification. Upon further magnification of the cracked surface, grain boundary cracks were clearly seen, as shown in Fig. 22. Figs. 22(a and b) clearly identify that the position of the crack width was initially high, which then moved towards the inner surface. The crack growth rate increased due to the temperature difference and rate of cooling, which are the reasons for the development of the cracks.

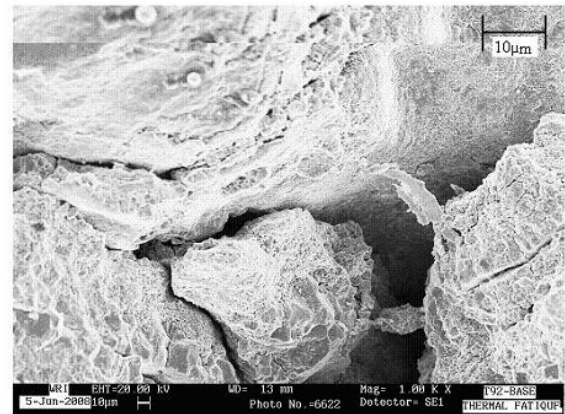
Fig. 23. Cracking along the grain boundaries.

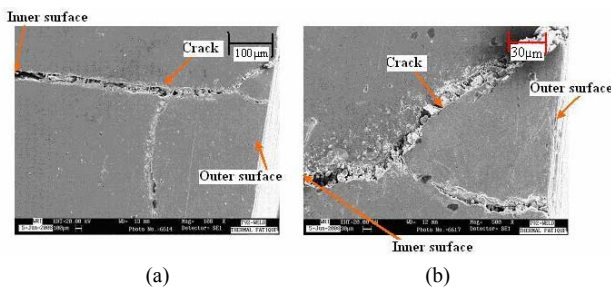
Fig. 25. Crack propagation in the failed welded tube.

Fig. 24 shows the microstructure taken in the unaffected region of the failed weld tube. The defects present in the failed weld tube are shown in Figs. 25(a and b). Figs. 25(a and b) clearly show that the cracks developed from the outer surface of the tube, which then traveled towards the inner surface. Similarly, it traveled in the circumference of tube's heated region. When compared to the base cracks, the cracks obtained in the weld were larger. Crack formation was observed inside the cracked surface at higher magnification. Upon further magnification, grain boundary cracks were clearly seen, as shown in Fig. 25. Figures 26 (a and b) show the position of the crack width was initially high; the crack growth rate increased as it moved towards the inner surface due to the temperature difference and rate of cooling.

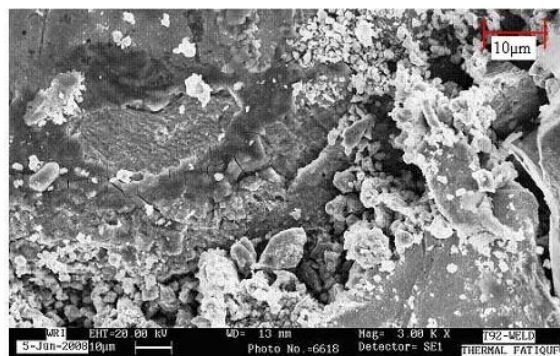
Fig. 26. Cracking along the grain boundaries.
