Characterization of corroded metallic uranium fuel plates

T.C. Totemeier^{*}, R.G. Pahl, S.L. Hayes, S.M. Frank

Argonne National Laboratory, P.O. Box 2528, Idaho Falls, ID 83403, USA

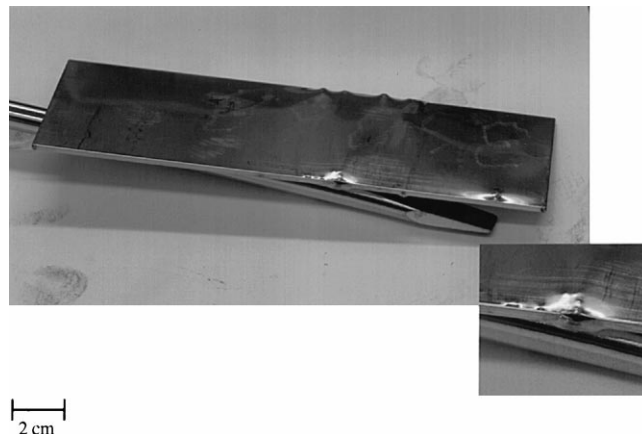
Corrosion of the U coupons manifested itself in the clad plates as extensive bulging of the cladding. Fig. 2 shows a single plate (3606) with extensive cladding deformation along the two long edges of the plate. The inset close-up in Fig. 2 shows a significant breach which has resulted from excessive cladding deformation. The bulges were most commonly found along the edges of the cladding, rather than in the center. Severe localized corrosion attack was correspondingly found to initiate along the edges of the uranium coupons, as described below. The cladding itself showed no sign of corrosion attack; breaching of the cladding appears to have been solely due to the volume expansion of the corrosion product relative to the parent metal. For transformation of U metal to UO_2 a minimum expansion of 72% occurs. A wide range of cladding bulging was observed. Some plates showed very little sign of bulging, while others were grossly deformed with more than one cladding breach.

Fig. 2. Bulged ZPPR plate (3606); inset shows close-up of cladding breach.

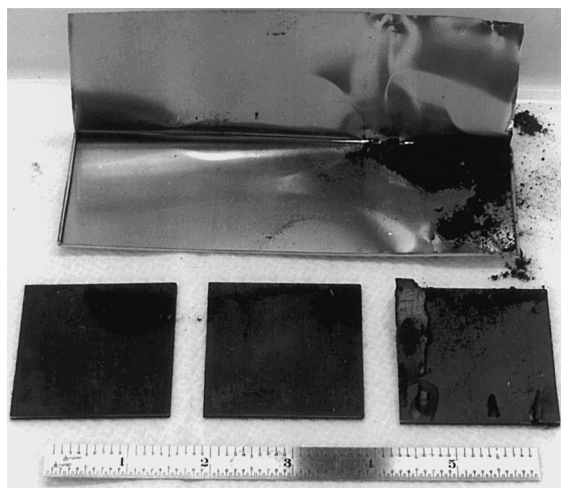
The severe corrosion of the U coupons was clearly observed upon de-cladding of the plates. Loose powder and dust quickly spread throughout the glovebox during the decladding operation. Figs. 3 and 4 show coupons immediately following cladding removal. Fig. 3 is an archival photo from 1985, and Fig. 4 is a recent photo showing coupons from the bulged plate of Fig. 2. A clear difference between the two sets of coupons was the extent of general corrosion. The coupons in Fig. 4 showed a large amount of general corrosion which was manifest in the form of gray flakes and fine dust. Much of the gross corrosion product was removed from these coupons before they were photographed. In contrast, little general corrosion was observed for the coupons in Fig. 3; especially for the two coupons on the left side.

Fig. 3. Dechlor ZPPR plate showing localized corrosion of right coupon (1985 examination).

A second form of corrosion observed was more severe and localized. This type of corrosion is clearly shown on the right hand coupon in Fig. 3 and the top coupon in Fig. 4. This form of corrosion had several notable characteristics. First, localized corrosion was almost always observed on only a single coupon for each plate (a plate contains two or three coupons). The corrosion appeared to have initiated at the transverse edges of the coupons, and often took the form of blistering or transverse cracking. The right hand coupon in Fig. 3 shows lifting of metal due to sub-surface cracking and attack. Cracking and blistering were most commonly observed at early stages of corrosion (judging on

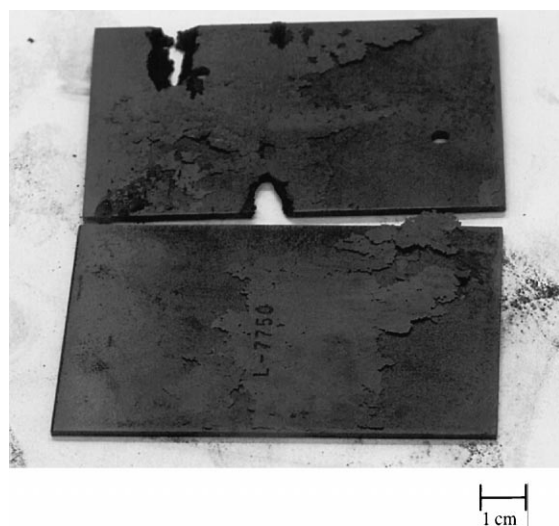
Fig. 4. Coupons from plate in Fig. 2 showing severe local and general corrosion.

the basis of overall attack). For more severely corroded coupons the localized attack consumed large areas of the coupon. The top coupon in Fig. 4 is a good example, with large quantities of material missing from its edges. There was no consistent location of localized corrosion, i.e. it did not occur in any particular place, such as near the metal frit endplugs.

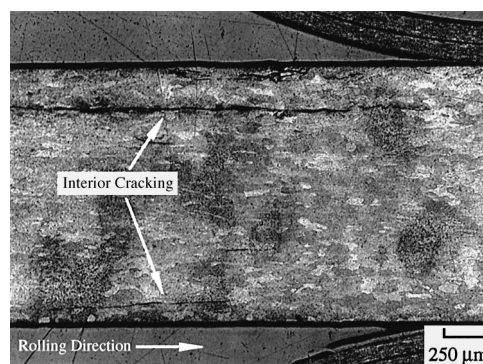
Fig. 5. Metallographic cross-section of coupon from plate 3401 showing interior cracking and equiaxed grains.

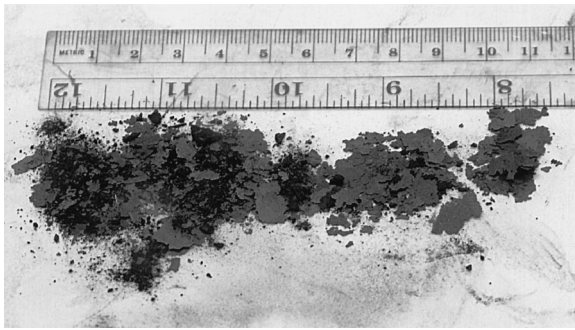
Fig. 6. Loose flake and powder corrosion product from plate shown in Fig. 2.

assumed to be oxide. The loose products were composed of two distinctly different types – a light gray, flake-like material, and a black powder. Fig. 6 is a photograph of the loose products obtained from the plate in Fig. 2. For this plate, which was considered to be relatively badly corroded, there were approximately equal amounts of flake and powder. Some of the powder was found agglomerated into fairly large chunks one or two millimeters in size. These chunks could be easily broken into powder. The quantity of powder appeared to be dependent on the extent of localized corrosion. The corrosion products from plates which did not show severe bulging and localized corrosion were composed nearly entirely of flake material.

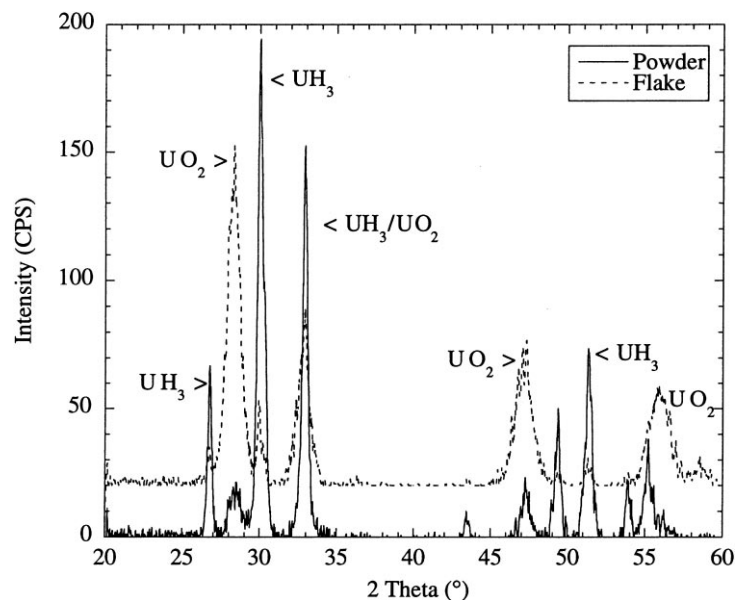
X-ray diffraction patterns from samples of flake and powder material in the 2θ range from 20° to 60° are shown in Fig. 7. The powder material was found to have strong β - UH_3 peaks, with a small peaks of either UO_2 , U_3O_7 (UO_{2+x}), or a mixture of both. Both types of uranium oxide had a good match with the diffraction pattern. Due to the width of the peaks it was not possible to differentiate between the two. In contrast, the flake material showed strong peaks from the oxide and only minor hydride peaks.

Fig. 7. XRD patterns from flake and powder corrosion products. Only major peaks are labeled; unlabeled peaks in the powder trace are from UH_3 .

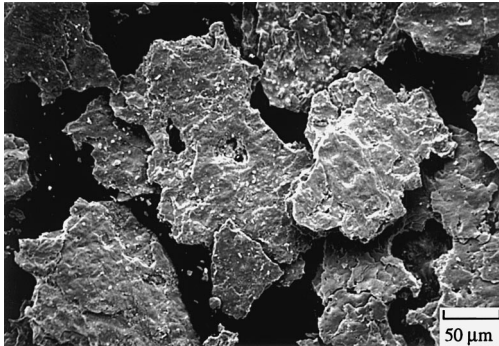
SEM examination of the loose corrosion products from plates 2249 and 2652 revealed marked differences between them. Figs. 8 and 9 show images of the products from the two plates at equivalent magnifications. The sample from plate 2249 was comprised of relatively large plate-like particles of sizes varying from nearly a millimeter to tens of microns. The platelets shown in Fig. 8 are approximately $150\ \mu\text{m}$ in size. The thickness of the platelets could not be determined. In contrast, the sample from plate 2652 was comprised of some platelets along with a considerable fraction of finer particles (Fig. 9). Fig. 10 shows a higher magnification

Fig. 8. SEM micrograph of plate 2249 corrosion product.

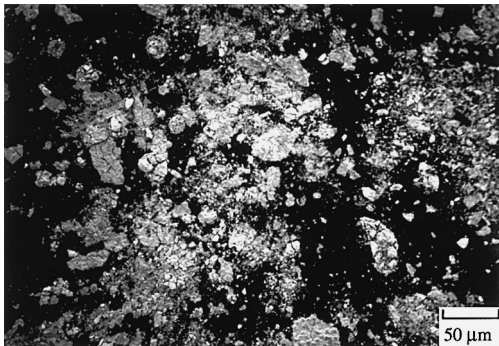
Fig. 9. SEM micrograph of plate 2652 corrosion product.

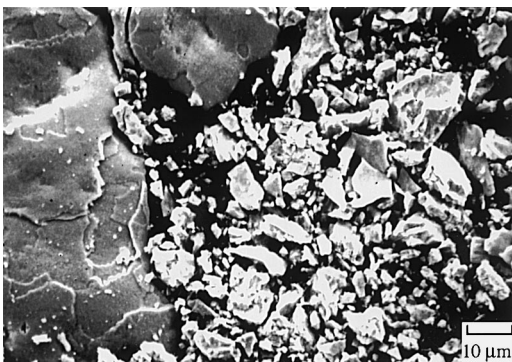
Fig. 10. Higher magnification SEM micrograph of plate 2652 corrosion product.

image of the fine particles next to a larger platelet. The sizes of the fine particles ranged from less than a micron to approximately 10 μm. The different types of product, platelets and fine particles, are believed to correspond to the flake and powder observed visually – the large plates are uranium oxide, and the fine particles are hydride. This has not been confirmed directly; the energy-dispersive X-ray spectrometer available does not permit analysis for oxygen or hydrogen.
