# Material properties and consequences on the quality of Tore supra plasma facing components

## Abstract

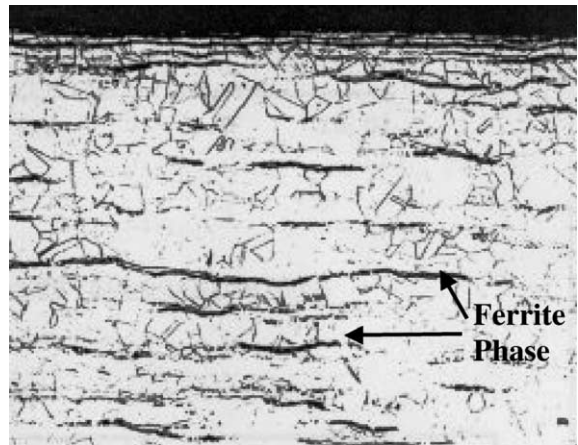
The stainless steel is only present at the rear part of the element. It was provided as a plate with low cobalt content, 20 mm thick, produced by *Fabrique de Fer de Charleroi*<sup>1</sup> (Co < 0.05 wt% because of the Co transmutation to radioactive atoms under neutron irradiation). Welding difficulties (two hot crackings) were encountered during a previous fabrication that was ending during the first year of the TPL element production [10]. They were attributed at first to possible impurities in the material. A preliminary investigation revealed an elongated second phase in the austenitic matrix (Fig. 2). This second phase was finally identified as ferrite (Table 1) by *Institut de Soudure* and *Plansee*: Cr and Mo rates are higher in the stringers whereas Ni rate is higher in the matrix. It was proved that the stringers were not of  $\sigma$ -phase. Many tests were performed in order to decide whether the material could be accepted or not. At CEA, TIG welded tube samples were done, they were burst tested under internal pressure at room and 230 °C temperatures ( $dP/dt = 138$  MPa/min), they were also creep tested at 230 °C and under 2/3 of the burst stress (creep stress 250 MPa). It was concluded that there is no influence of the ferrite phase on

Fig. 2. Presence of ferrite phase in the austenite matrix of 316L SS ( $\times 100$ ).

the mechanical properties. Plansee reaches the same conclusion doing tensile tests (Table 2), notch impact tests and rotary bending fatigue tests on TIG welded samples (no fracture or helium leakage after 10 000 cycles). Only two values were found out of the specifications: the magnetic permeability with a value of 1.10 (specified as  $\leq 1.05$ ), revealing a higher ferrite content than allowed (3%), and the rate of phosphorus 0.05 wt% (specified as  $\leq 0.03\%$ ). Although the presence of longitudinal stringers could explain the 3% hot cracks previously observed during TIG welding and that the rate of ferrite was too high a concession was given to continue the fabrication, which was suspended during about 4 months. Today about TPL 700 finger tubes have been TIG welded without any appearance of cracks.

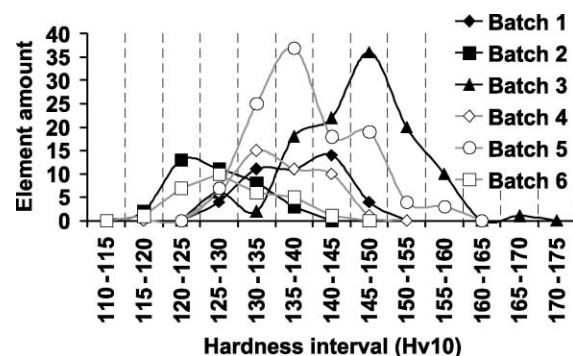
Fig. 3. Discrepancy of the hardness at reception, versus the different finger batches. For each finger a mean value of 3 measurements is calculated (they are performed 5 mm under the tile EB weld at rear, middle and front part of the element).

rial and final element. This can be explained either by a softening of the possibly cold worked material or by an overheating of elements during manufacture (see [9,12] for heat treatment and hardness). At the reception it was found an important discrepancy of the hardness suggesting that all the fingers did not see the same heat treatment (see Table 4, and Fig. 3; *Electral* 077 and 078 were mainly used for finger batches 1, 2 and 6 whereas the others were used for batches 3, 4 and 5). This was confirmed by investigations of Plansee, which showed that in a batch of 30 fingers the elements at the periphery were rather overheated whereas under heated at the core [12].

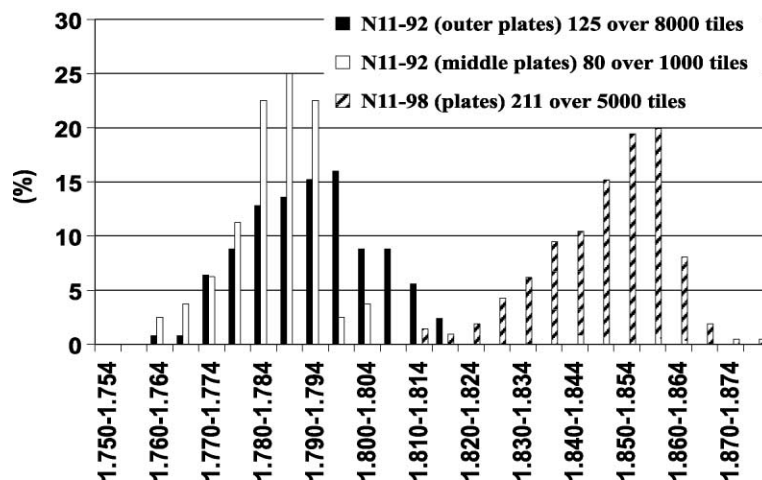
The middle plates were finally used for neutraliser elements that are situated under the limiter. The final quality of the tiles appeared to be close to 100%. The first conclusion is that the AMC<sup>®</sup> process is not compliant in regards to the CFC heterogeneity. This process was optimised for slice-segmented CFC blocks, which are more homogeneous and with a lower density in the core (Fig. 4), and did not work well for layer-segmentation. Moreover the more important rigidity of the N11-98 material leads probably to more important stresses at the edge singularity and cracks at the bond. *One can say* the results depend on porosity and rigidity of the material.

Fig. 4. Density measurements in the used CFC.
