SNS target tests at the LANSCE-WNR in 2001 – Part I [☆]

Abstract

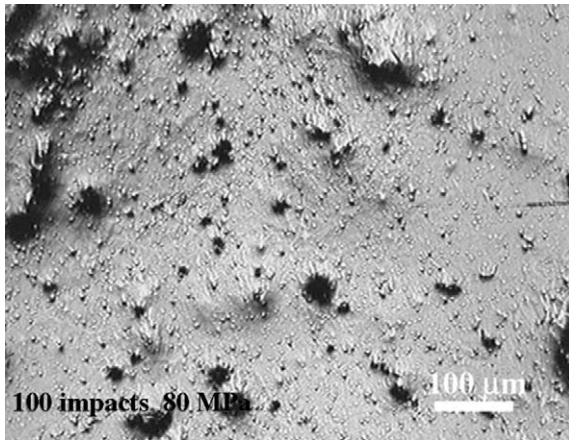
Fig. 1. Pitting damage on impact bar of SHPB with mercury test volume, by Futakawa et al. [1].

The pits seen in the JAERI SHPB tests varied in diameter from a few to tens of microns in diameter; some of the depths measured were $\sim 10 \mu\text{m}$, as well. In the hypothetical case where depth damage accumulated linearly with each successive pulse, such damage would quickly break through the SNS target window for pulsing at 60 Hz.

When compared to pits seen in the JAERI SHPB test (Fig. 1), the size and shape of these pits were found to be generally similar. This would seem to confirm, at least roughly, similar mercury pressure conditions and interaction with target walls.

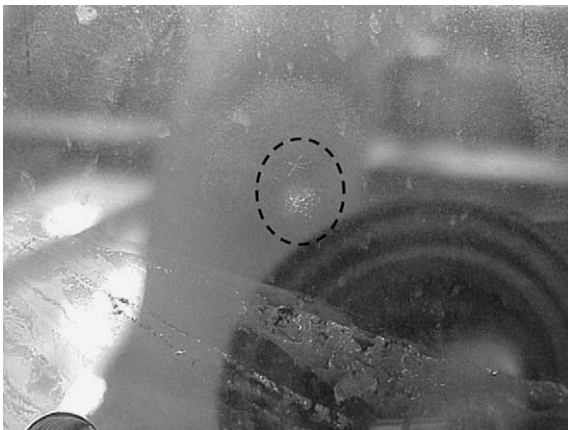
The flanges were first removed from LE3, and immediately evidence of damage could be seen by eye. Fig. 8 is a photograph of the rear flange with a damaged area circled near the center of the flange (the center is marked by a scribed 'X'). The damage area is a cluster of pits and dents about 4 mm in diameter located about 4 mm below (as oriented during irradiation) the center. Fig. 9 shows the front flange of LE3 after some initial cleaning. Here there is a cluster of pits roughly 5×3 mm in size located about 9 mm below the center. Closer to the center is another cluster more oblong in shape. The

Fig. 8. Visible damage on the rear flange of the LE3 target, before cleaning.

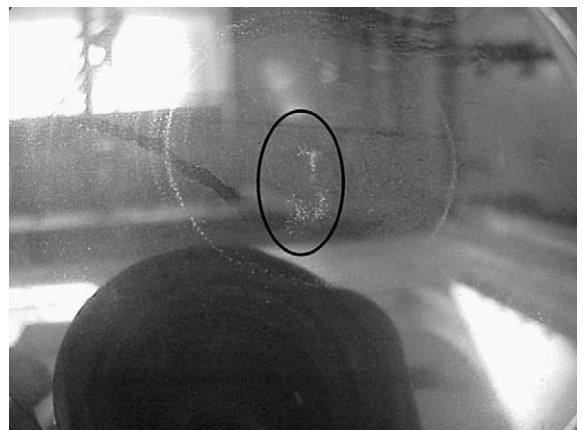
uniform circle seen at a larger radius in Fig. 9 is an artifact of flange machining.

Fig. 9. Damage near the center of the front flange of LE3.

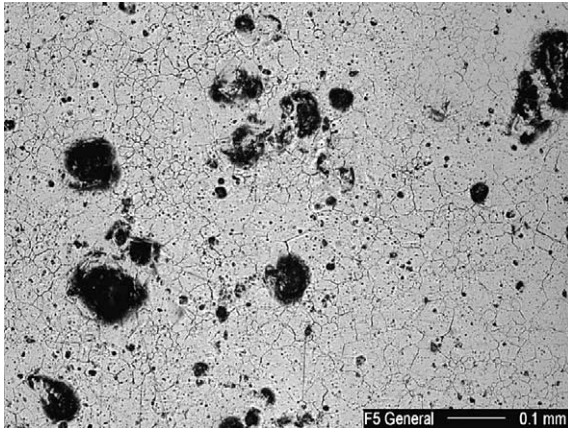
Fig. 10. Optical microscope image of damage on front flange of LE3.

characterization with a laser profilometer and activation surveys. Part II presents the microscopy in detail. An early optical micrograph of the front flange from LE3 is shown in Fig. 10. This region is within the large cluster shown in Fig. 9, and the largest pits are more than 100 μm across. Smaller pits are evident as well. Further, damage was not limited to the visible clusters. Examinations away from the center of the flanges showed numerous small pits; at 40 mm away many pits a few μm across could be found on this and the other annealed flanges.

Some of the pit sizes and depths were measured using a laser profilometer. The largest pits found were 200 μm across and 70 μm deep. The depth is alarming as it is a substantial fraction of the SNS target window minimum thickness, and occurred with only 200 pulses. Survival of the SNS target window to 200 million pulses seems unlikely under full-power conditions if this damage is truly prototypic.

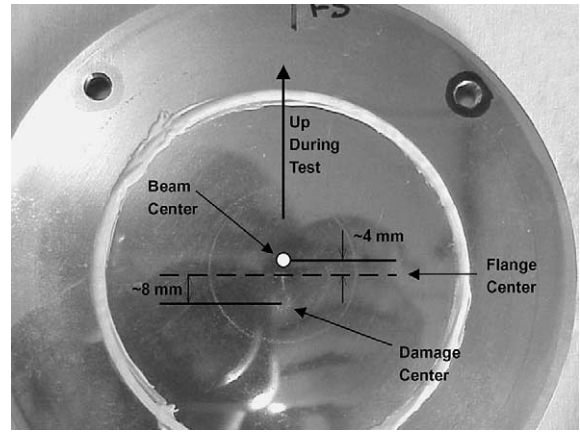
Activation surveys of the front flanges were done to determine the location of the average beam center. The alignment procedure used at the WNR has limitations and could have been off by several millimeters. The surveys indicated an offset of the beam for both LE3 and LE4, an example of which is shown in Fig. 11. For both targets the beam was 4 or 5 mm directly above the geometric center. Further, the large damage clusters on both front flanges were located below the centers by roughly twice that distance. Although activation surveys were not done on the rear flanges (beam intensity was less than 10% than at the front), damage clusters on both rear flanges were below center.

Fig. 11. Location of average beam center on front flange of LE3, as determined by activation survey.

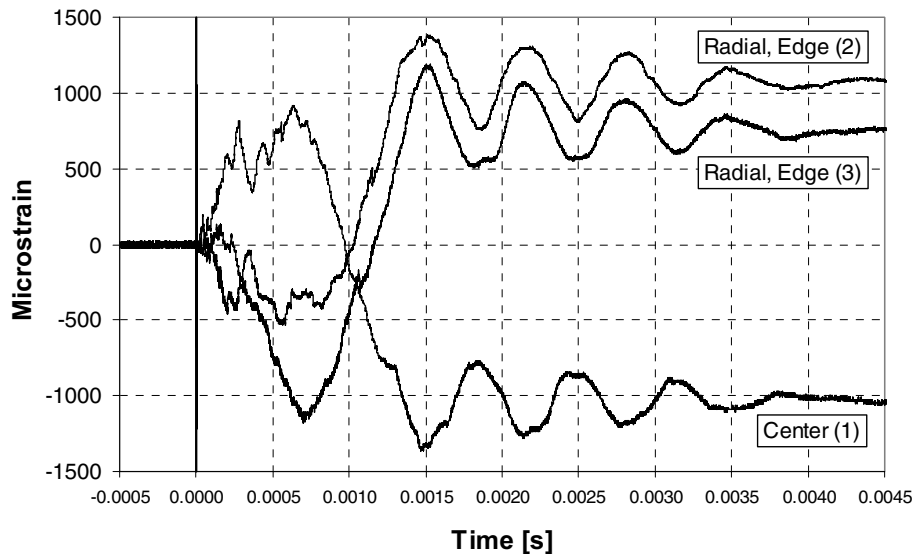
Much like previous experiments with LE targets, measured strains on the thin flanges were quite large. An example of strain data is shown in Fig. 12 from the LE4 target front flange; rear strains were similar. These are in the plastic regime for annealed stainless steel. Such large strains would not be prototypic of the SNS target.

Fig. 12. Strain from front flange of target LE4, Pulse #58.

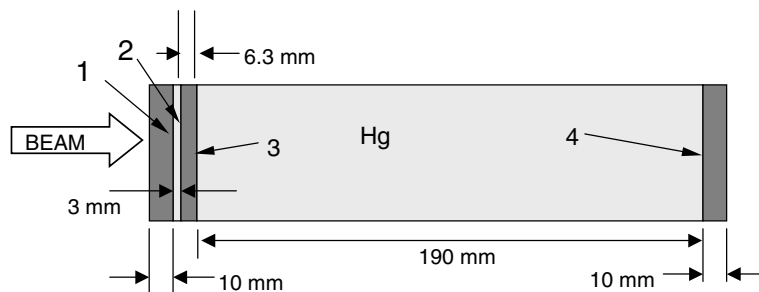
The rectangular target results were interesting as well. Fig. 14 is helpful in identifying surface locations, with surface 1 being closest to the beam and surface 4 furthest away. Large visible damage clusters were found on surfaces 1 and 2, while no visible damage was found on surfaces 3 and 4. SEM examination has identified only a few small pits on surfaces 3 and 4. This might suggest the rectangular geometry avoided the radial focusing that enhances cavitation conditions in the cylindrical targets. But how was the damage on surfaces 1 and 2 caused? One theory is that the acoustic impedance

mismatch at the air/steel interface causes rarefaction that propagates back into the first mercury layer thus leading to cavitation. The rarefaction is reduced as it travels through the intermediate window towards the bulk mercury region, or the thin cavitating mercury layer attenuates the rarefaction. Conclusions are difficult to draw at this point. If the thin mercury layer were not present, would surface 3 be damaged in a rectangular geometry? Or if the thin mercury layer were replaced by water, could damage be entirely avoided? These questions are to be addressed in 2002 target tests.

Fig. 14. RECT1 target surface locations.
