# A metallographic and fractographic study of outside-in cracking caused by power ramp tests

S. Shimada <sup>a,\*</sup>, E. Etoh <sup>a</sup>, H. Hayashi <sup>b</sup>, Y. Tukuta <sup>b</sup>

<sup>a</sup> Global Nuclear Fuel Japan Co., Ltd., 2163, Narita-cho, Oarai-machi, Higashi Ibaraki-gun, Ibaraki-ken 311-1313, Japan

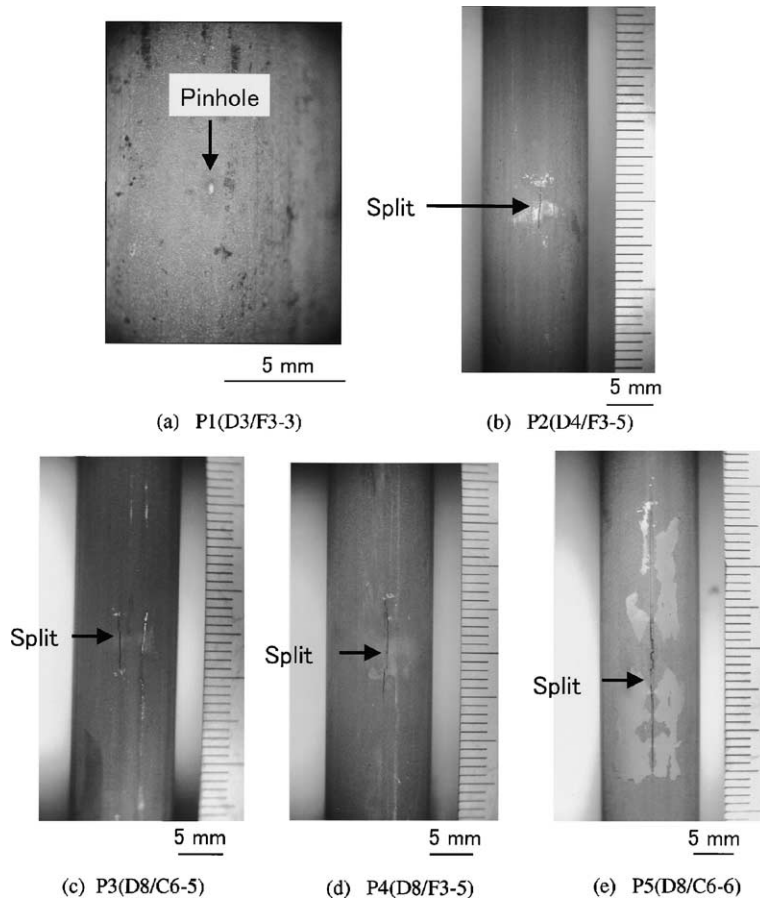
Among 25 segment rods that were subjected to power ramp tests in the Japan Material Test Reactor (JMTR), failure occurred for one rod (P1; D3/F3-3) which had experienced three cycles of base-irradiation, one rod (P2; D4/F3-5) with four cycles, and three rods (P3; D8/C6-5, P4; D8/F3-5 and P5; D8/C6-6) with five cycles. The ramp sequences included a stair case ramp mode and a single step mode [8]. The exposure and ramp test data are summarized in Table 1. The rods ramp-tested after three and four exposure cycles failed in the single mode tests. As for the rods with five cycles, two rods (P3 and P4) failed in the single mode tests and one (P5), in the stair mode. Photos showing outer surfaces of the failed rods are given in Fig. 1. The P1 rod with three exposure cycles showed a small pinhole, while rather long axial cracks were clearly visible on all other rods, P2, P3, P4 and P5, with respective crack lengths of about 4, 5, 10 and 40 mm.

Fig. 1. Visual outside appearances of failed segment rods.

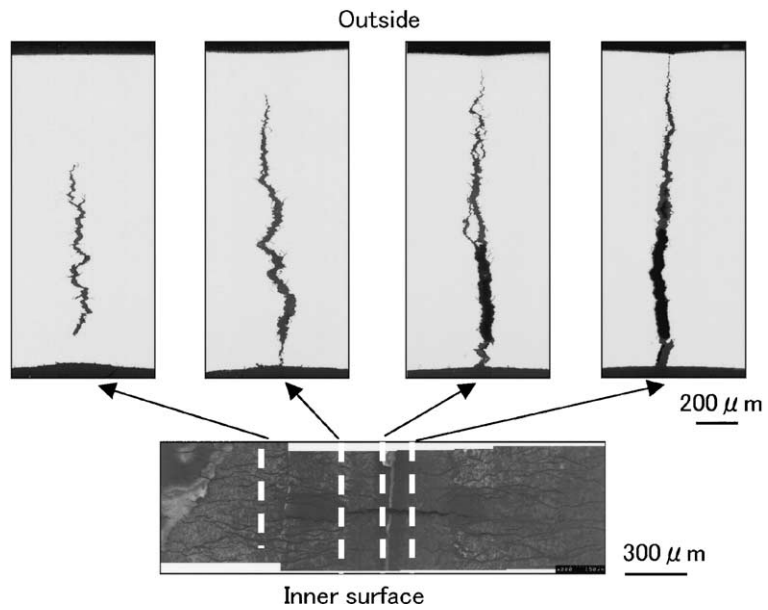
Fig. 2. Transverse views and inner surface of P1(D3/F3-3) segment rod.

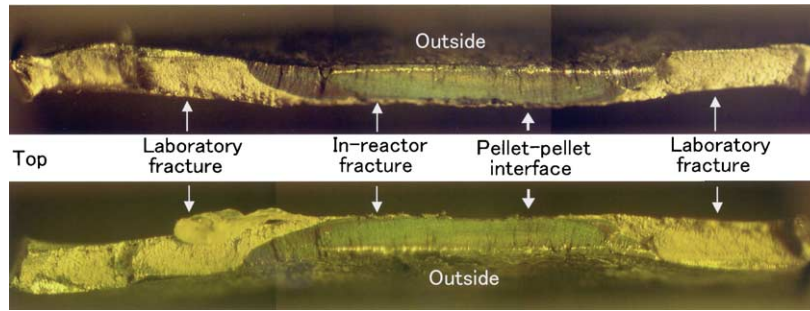
Fracture surfaces of P2, P3 and P4 segment rods were observed with a periscope to see the overall fracture surfaces and assess how damaged they were. Fig. 4 is a fracture surface pair for the P2 segment rod. The surfaces were rather clear and bluish, suggesting they were not heavily oxidized. The photos revealed that the fracture surface outline was similar to a semi-ellipse with the long axis on the outside surface. This outline shape indicated that the crack initiated outside and propagated into inwards. Furthermore, many stripe patterns that had similar outlines on the fracture surface were visible there. These patterns suggested that cracks might gradually proceed step-by-step, keeping a fair amount of similarity in the outline shape of the fracture surface.

Fig. 4. Fracture surface pair of P2(D4/F3-5) cladding tube.

Although stripe patterns are visible on the fracture surface of the P2 specimen when observed with the periscope, such patterns are not recognized on SEM

images. This result suggests that the patterns might be originated from a change in oxide thickness on the surface. It is usually recognized that a very thin oxide film on metals causes an interference color and the color varies with the thickness [13]. The fact that SEM images of fracture surfaces are almost clear and do not show any oxidized features on them seems to support the above idea.

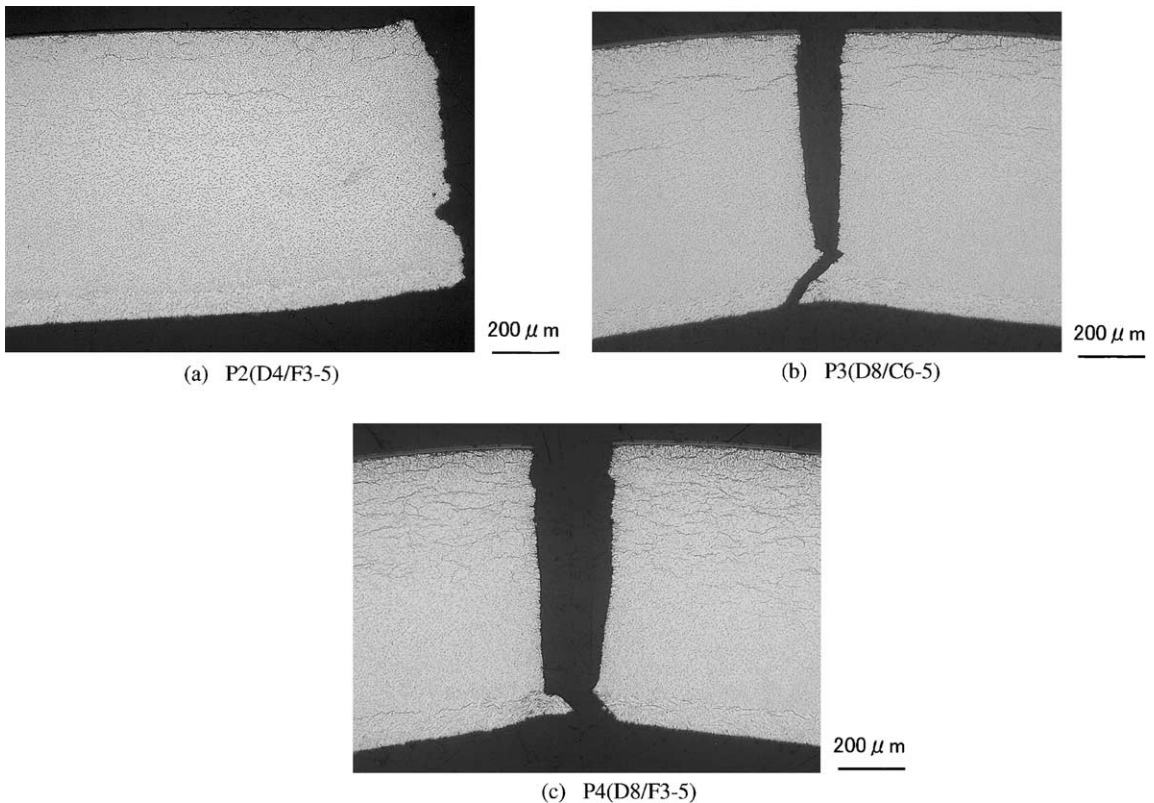
The hydride distributions around penetrated cracks in P2, P3 and P4 segment rods are given in Fig. 5. These photographs are from specimens mounted transverse to the tube axis. Tiny hydride platelets were distributed only at the outside portion of P2 specimen (Fig. 5(a)), which meant that hydrogen in the tube precipitated only in a narrow band near the outside and was in solution in the remaining areas during the ramp test. Fig. 5(a) illustrates the predominant circumferential orientation of the hydrides in the band, but some radial hydride platelets with a maximum length of about 50  $\mu\text{m}$  were also present. Radial hydrides near the outside portion were more dominant in Fig. 5(b) and (c) for P3 and P4 specimens. Many radial hydrides precipitated over the outside portion. At the same time, hydrides with circumferential orientation were still found in the area about a third of the wall thickness from the outside.

Fig. 5. Transverse views showing hydride distributions and fracture regions for P2(D4/F3-5), P3(D8/C6-5) and P4(D8/F3-5) segment rods.

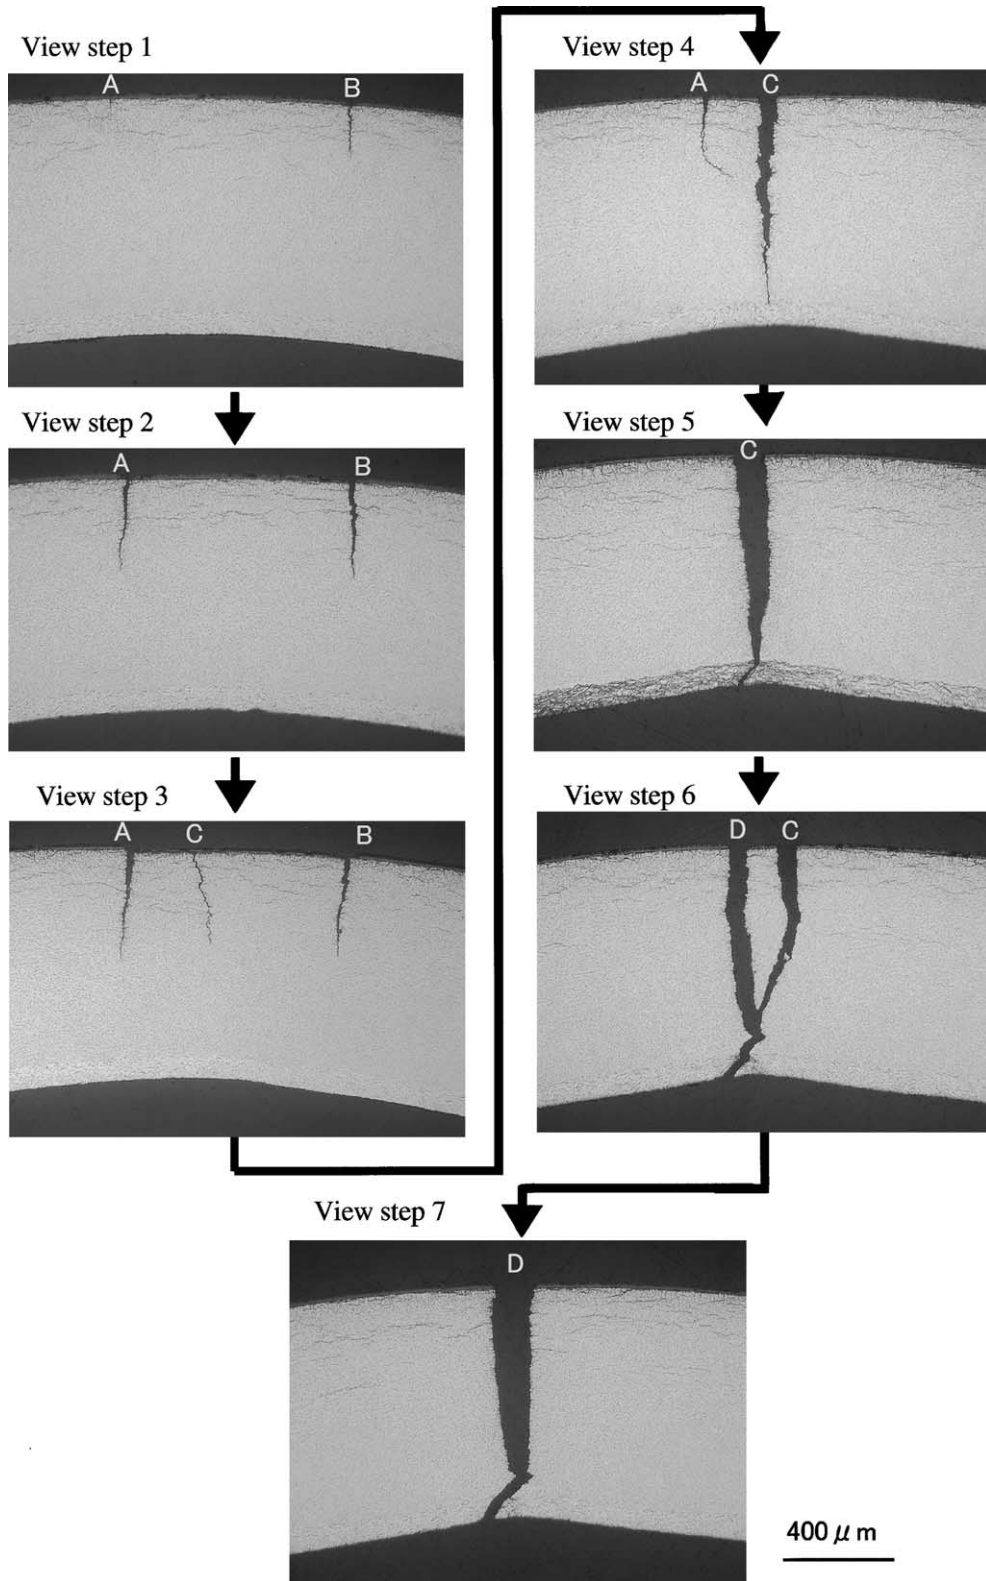
Transverse views at every step are depicted in Fig. 6. In the view step 1, two incipient cracks appeared and lengthened in views 2 and 3. Another crack C appeared in the view step 3 which grew and finally penetrated the cladding in the step 5. Although two cracks, C and D, were separate on the outer surface as shown in the step

6, they had become one by the step 7. These photographs also revealed that at the sections where the crack penetrated the cladding wall, the crack mainly proceeded in the radial direction and there was significant ductility at the Zr-layer or Zr-layer and the narrow Zry-2 portion just adjacent to the layer. Since it was

Fig. 6. Transverse views of step-by-step crack morphology in P3(D8/C6-5) specimen.

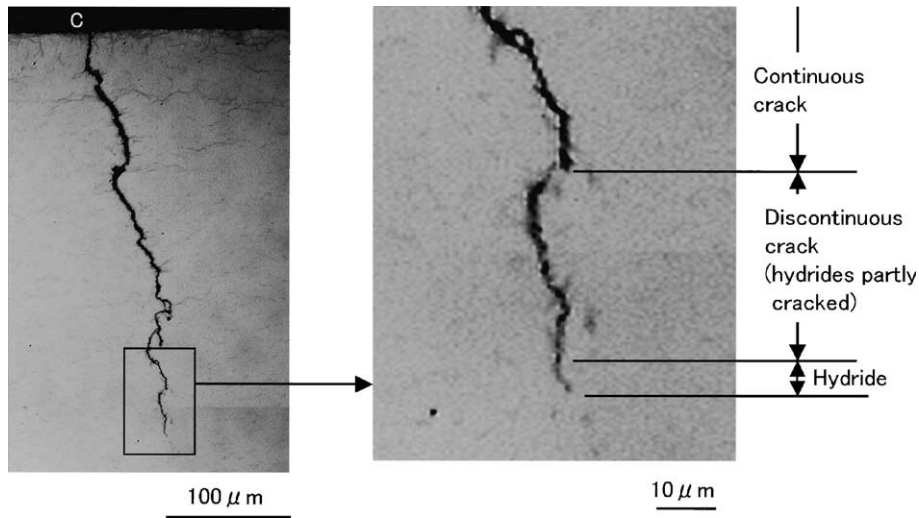
impossible to distinguish the hydrides from the crack on photographs taken from etched specimens, photographs taken from normally polished specimens were utilized for careful examination of hydride precipitation at the crack tip. A photograph of incipient crack C (in the view step 3) in a normally polished specimen was magnified and image-processed in order to distinguish the crack from hydride platelets. The image-processed photograph in Fig. 7 showed that at the crack tip, hydride platelets with partial cracks were present and hydride platelets without cracks precipitated at the bottom of the par-

Fig. 7. Detailed morphology of hydrides near crack tip in the transverse view step 3 in Fig. 6.

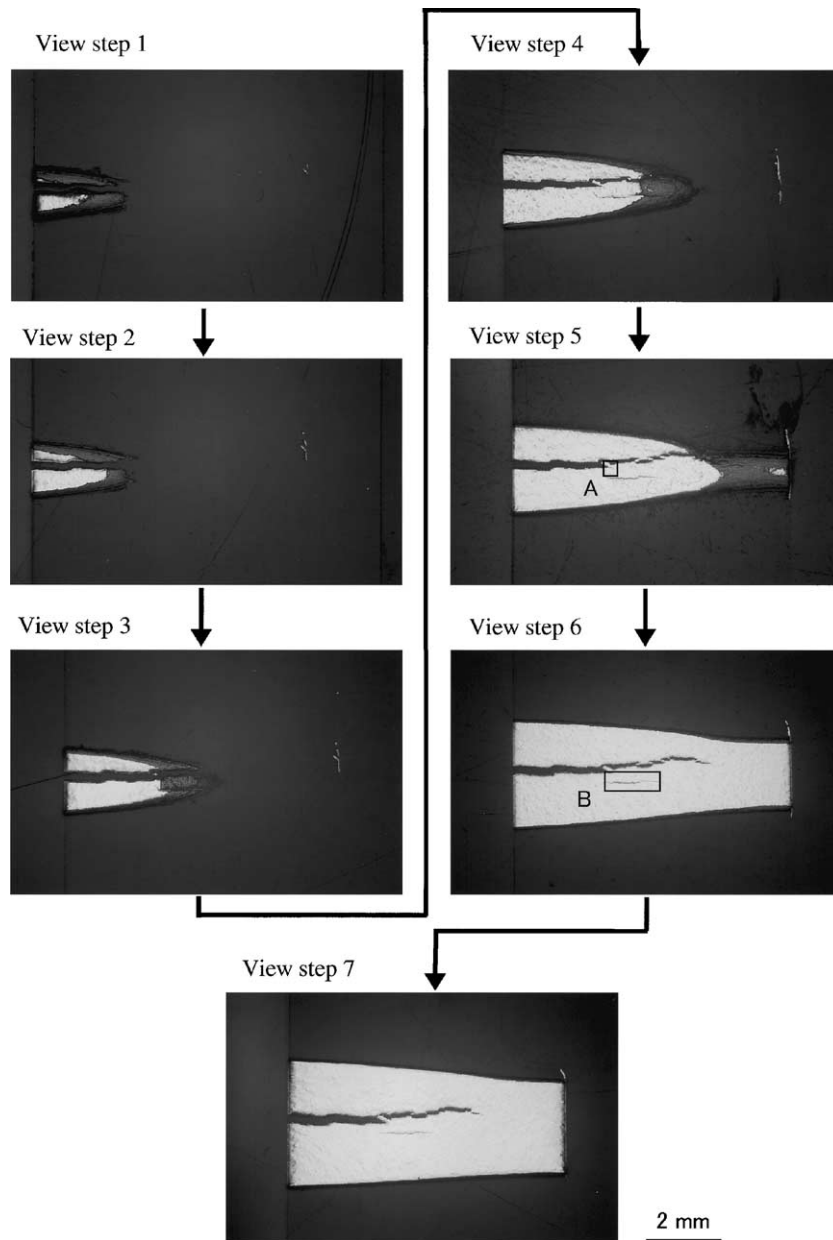
tially cracked hydrides. The image also showed that there were few hydrides platelets around the crack, except the crack front. Longitudinal views for every step in the P4 specimen are shown in Fig. 8. An interesting hydride distribution at the crack tip was observed in the view step 5, 150  $\mu\text{m}$  from the outside, as shown in Fig. 9. Hydrides platelets distributed around the crack tip, surrounding it. This distribution might be caused by stress distribution around the crack tip. Some incipient cracks in the view step 6 of Fig. 8, 190  $\mu\text{m}$  from the outside, were investigated by the image process method and illustrated in Fig. 10, which shows that the hydrides precipitated at the crack front and they partly cracked also in the longitudinal cross-section.

Fig. 8. Longitudinal views of step-by-step crack morphology in P4(D8/F3-5) specimen.

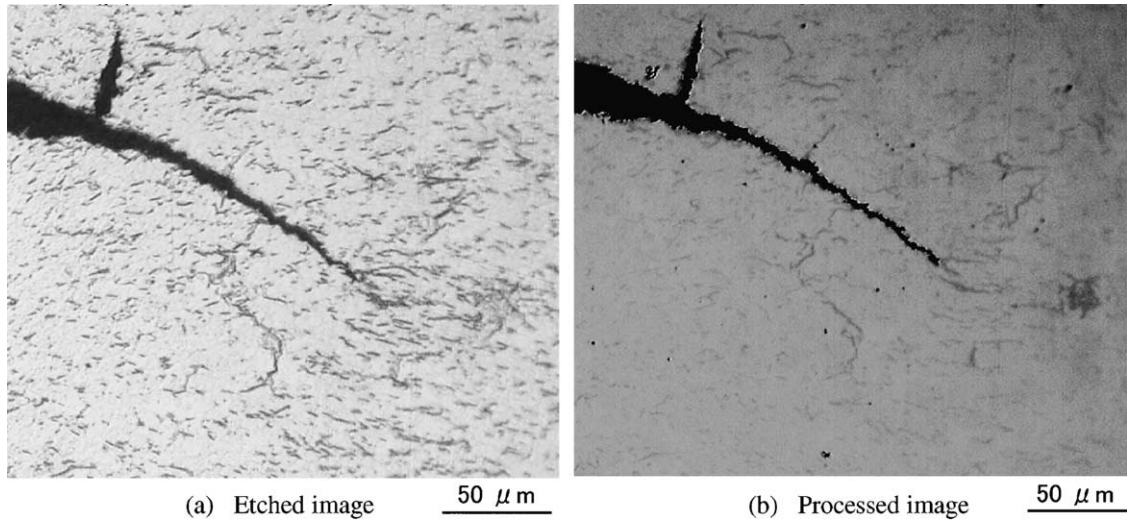
Fig. 9. Detailed morphology of hydrides near crack tip(A) in the longitudinal view step 5 in Fig. 8.

view of the tip for a comparatively shallow crack shows hydrides surrounding the crack as well as hydrides precipitated at the crack front (Fig. 9). The surrounding hydride distribution might reflect the stress field around the crack tip. However, when cracks advance and the crack tip is located where no hydrides might precipitate under ramp test conditions, as shown in Figs. 7 and 10, just the hydrides that precipitates at the front along the crack orientation are observed. Those hydride platelets are about  $2\ \mu\text{m}$  wide in general. Sometimes, the hydrides at the front are followed by partially cracked hydrides (Fig. 7). These observations suggest that the crack would propagate through the cracking of hydrides that precipitate at the crack tip. Detailed metallographic optical photos, thus, reveal that hydrides are responsible for the outside-in crack propagation.

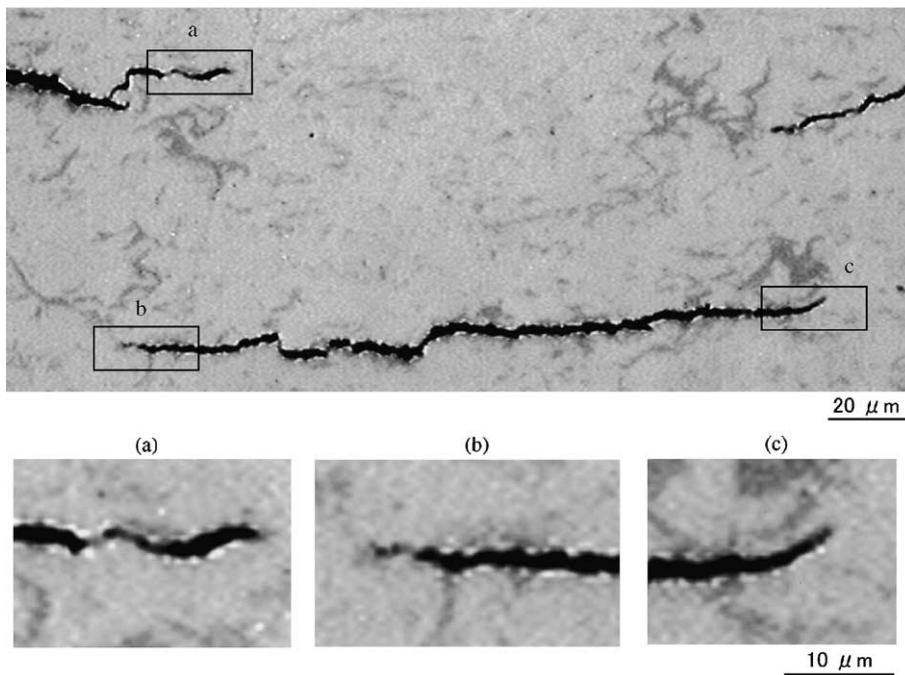
Fig. 10. Detailed morphology of hydrides near crack tip(B) in the longitudinal view step 6 (Fig. 8).

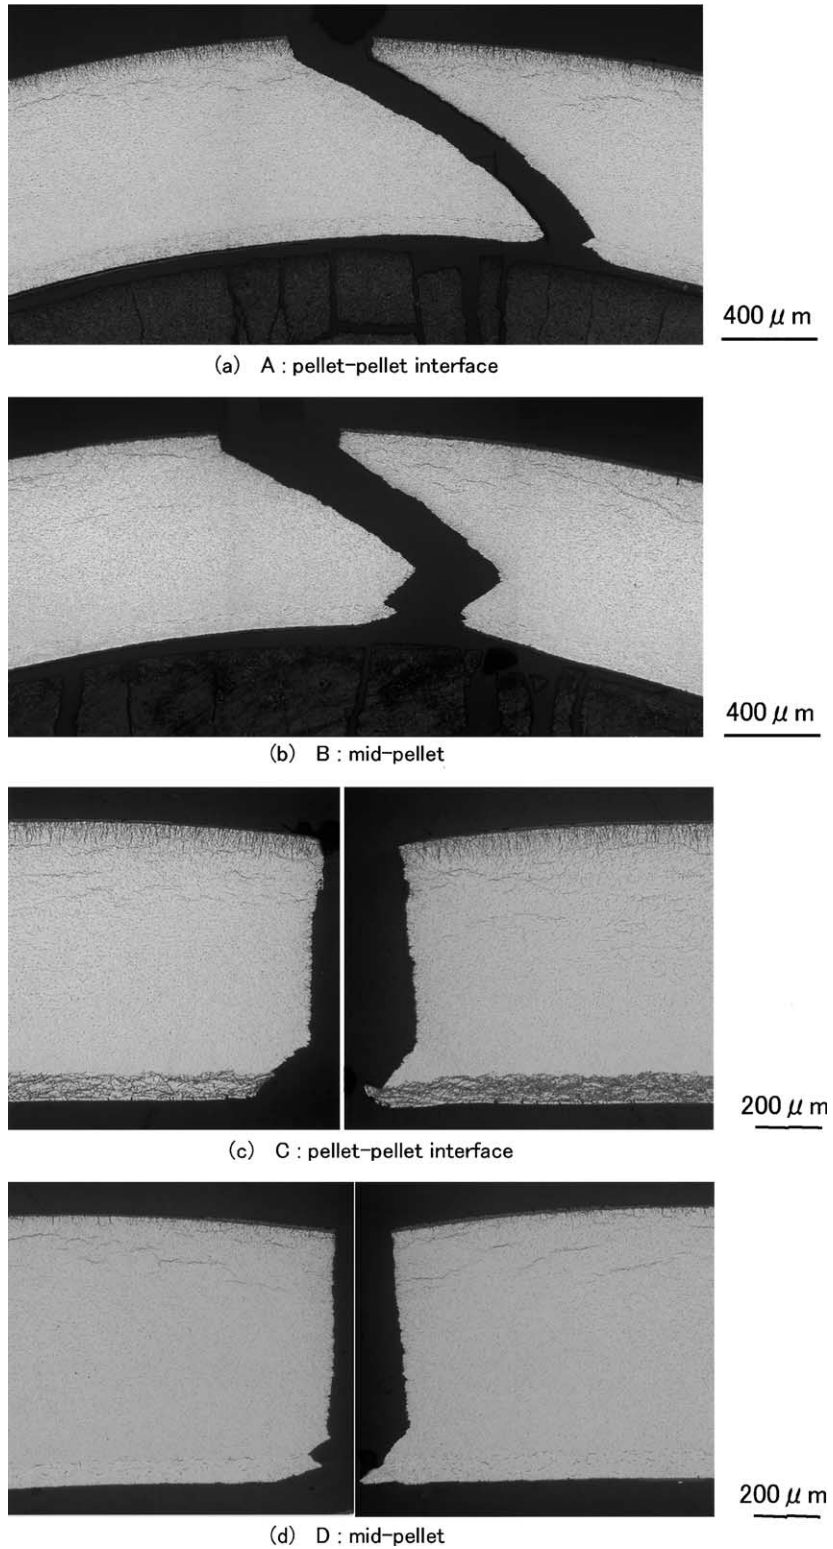
Since P5 segment rod failed with a comparatively long axial crack, four transverse sections were examined. The optical photographs in Fig. 11 revealed that the crack propagated in the radial direction about 100  $\mu\text{m}$  from outside and was followed by ductile fracture in the upper half, while, in lower the half, just like P2, P3 and P4 rods, the radial crack was predominant and ductility was retained just near the inner surface.

Optical photographs on specimens mounted transverse to the tube axis indicate that the most noticeable feature of hydride morphology in cladding tubes from ramp-tested segment rods is the existence of many radial hydrides near the outside as typically shown in Fig. 11(c). Since no radial hydrides such as observed in ramp-tested tubes are found in the claddings that experienced just base exposure (Fig. 17), it is deduced that the radial hydrides near the outside precipitated during ramp tests. Since ramp tests usually cause steep temperature gradients along the tube wall, hydrides that precipitated inside the tube before the ramp test would re-dissolve and diffuse to the outside portion, and then would re-precipitate at the outside portion at relatively lower temperatures. At the same time, hoop stress caused by pellet cladding mechanical interaction (PCMI) could help hydrides precipitate along a radial orientation [9–11]. It has been reported that radial hydrides relatively crack easily under hoop stress, especially under multi-axial stress conditions [12]. That report also notes that the radial hydride length is the most critical factor for fracture behavior. Thus, among the radial hydrides that

When the numbers of radial hydride platelet in the cladding outside at pellet–pellet interface and at mid-pellet portion are compared, more hydrides can be seen at the former as shown in Fig. 11. These relatively many radial hydrides at the outside corresponding to pellet–

Fig. 11. Transverse views showing hydride distributions and fracture regions for D8/C6-6) segment rod A, B, C and D indicate the transverse sections in Fig. 3(d).

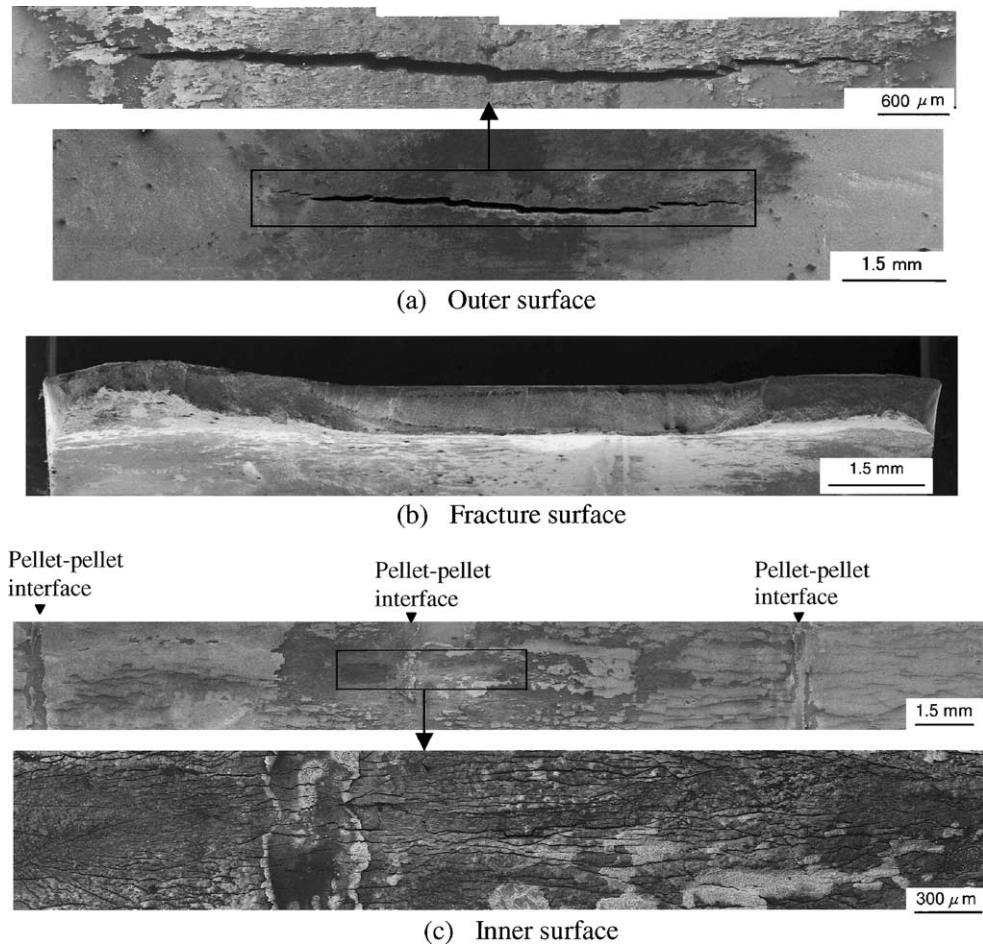
The outer and inner surfaces, and fracture surface of P2 segment rod are shown in Fig. 12. The outer surface exhibited a noticeable axial crack 'split', but only many tiny cracks appeared on the inner surface. The SEM image of the inner surface indicated that the axial crack was located near a pellet–pellet interface. Fracture surface morphology of the P4 specimens is shown in Fig. 13. Pair fracture surfaces were examined for P3 to confirm the fracture morphology (Fig. 14). Three pairs of matching fracture surfaces are compared in Fig. 15, the

Fig. 12. Overview images of outer, fracture and inner surfaces of crack in P2(D4/F3-5) segment rod.

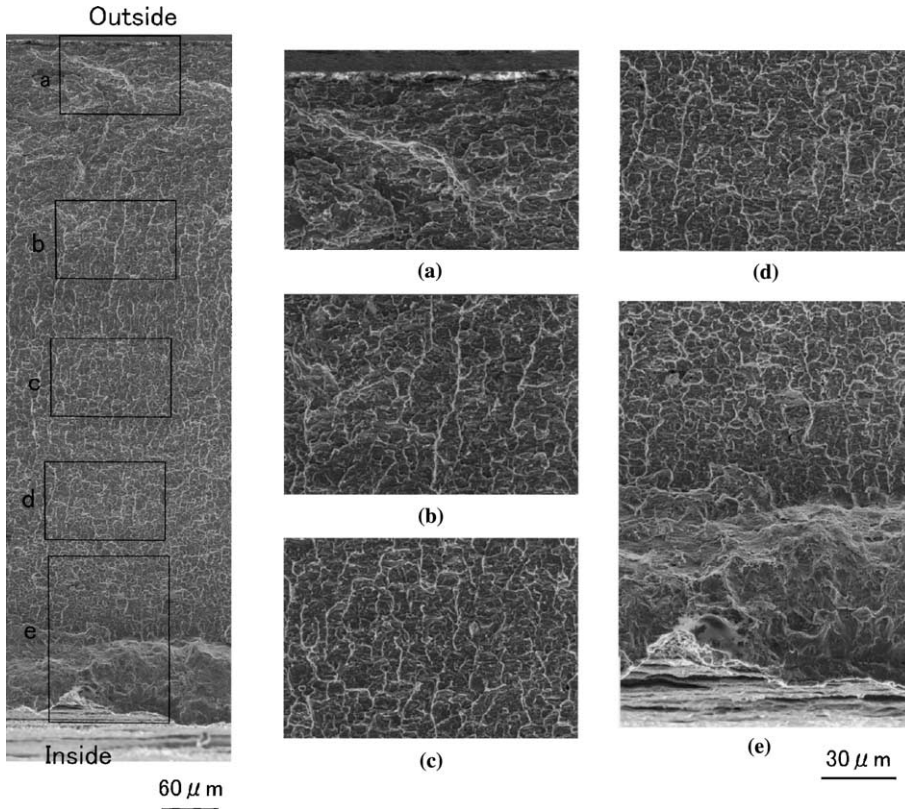
Morphology of the fracture surfaces of P2, P3, P4 and P5 specimens observed by a SEM shows the same appearance. Overall, the surfaces are rather smooth. As Figs. 13 and 16 indicate, the surfaces near the outside are most brittle and the area deeper than about  $50\text{--}100\ \mu\text{m}$  shows randomly tangled white lines that are, at a glance, similar to elongated shallow dimples. However, careful SEM observations on two opposing fracture surfaces of the P3 specimens (Fig. 15) reveal that the fracture surfaces are essentially brittle in all areas. It is deduced that the white lines, which were apparently similar to

Fig. 13. Morphology of fracture surface of P4(D8/F3-5) specimen.

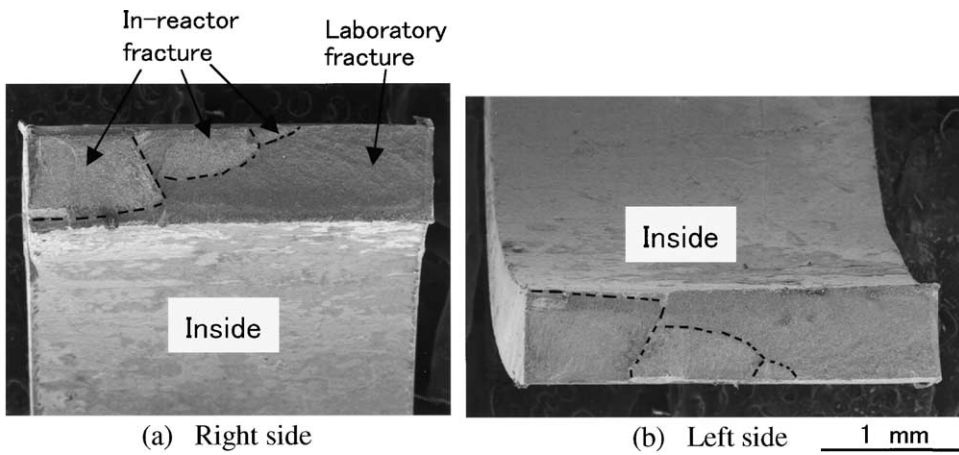
Fig. 14. A pair of P3(D8/C6-5) specimen used for SEM observation.

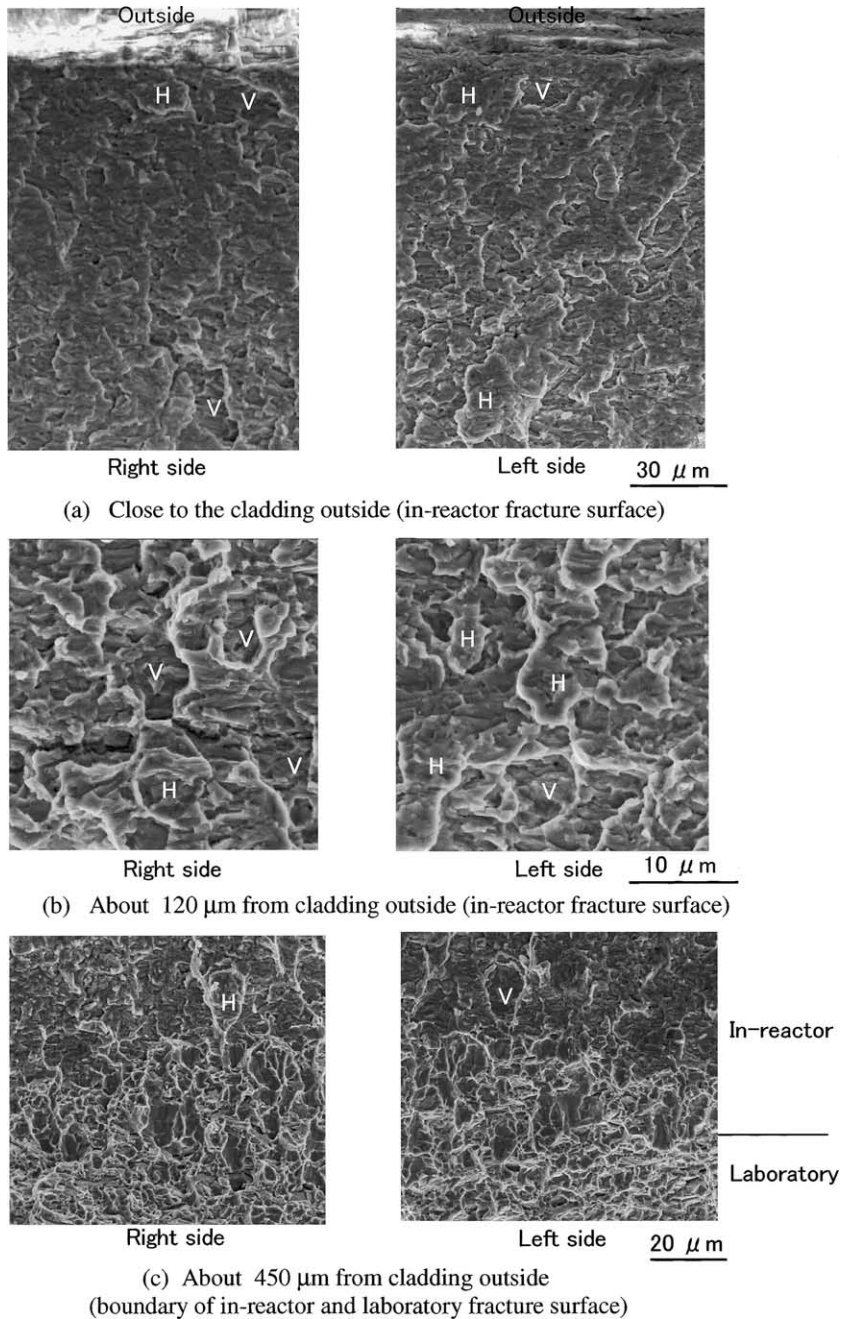
first pair shows the surfaces near the outside, the second, about 120  $\mu\text{m}$  from the outside, and the third, about 450  $\mu\text{m}$  from the outside. Comparison of the two matching fracture surfaces in each pair indicated that on a macroscopic level there was an almost perfect fit between the two sides of the crack. A 'hill (H)' on one fracture surface always corresponded to a 'valley (V)' on the matching fracture surface. The morphology of the fracture surface on P5 is shown in Fig. 16.

Fig. 15. Three pairs of SEM images of two matching fracture surfaces; H: hill, V: valley.

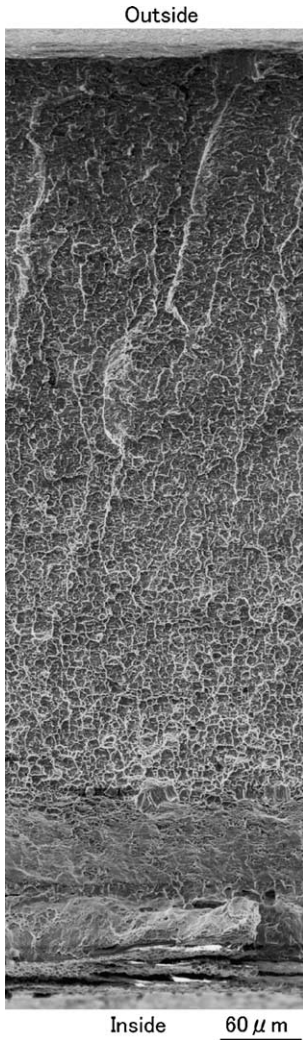
Fig. 16. Morphology of fracture surface on P5(D8/C6-6) specimen.

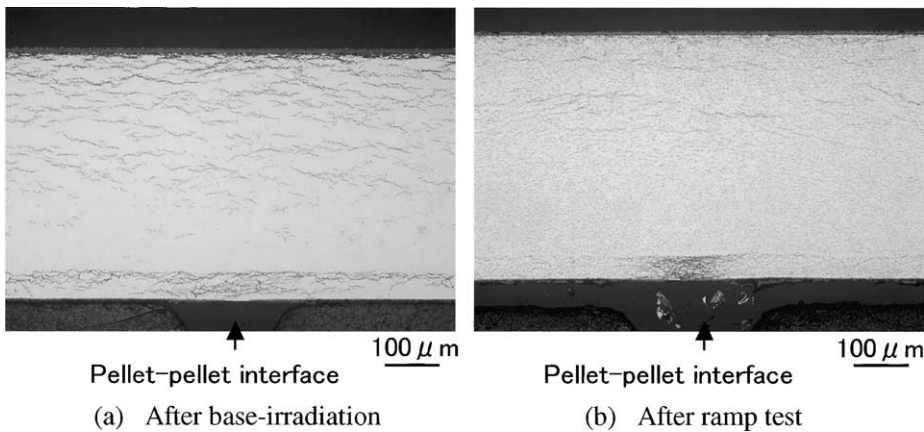
pellet interface portion might be caused by higher hydride concentration in the Zr-layer at pellet–pellet interface than at mid-pellet, as illustrated in Fig. 18. The high hydride concentration in the Zr-layer at pellet–pellet interface is observed in specimens of post-ramp tubes as well as pre-ramp ones. This hydride localization in the Zr-layer at pellet–pellet interface could be induced by slightly lower operating temperatures than those of the bulk of the cladding. Since hydrides in the Zr-layer would act as a hydrogen supplier for radial hydrides at

Fig. 18. Longitudinal views showing hydride distributions at pellet-pellet interfaces for segment rod with five irradiation cycles.

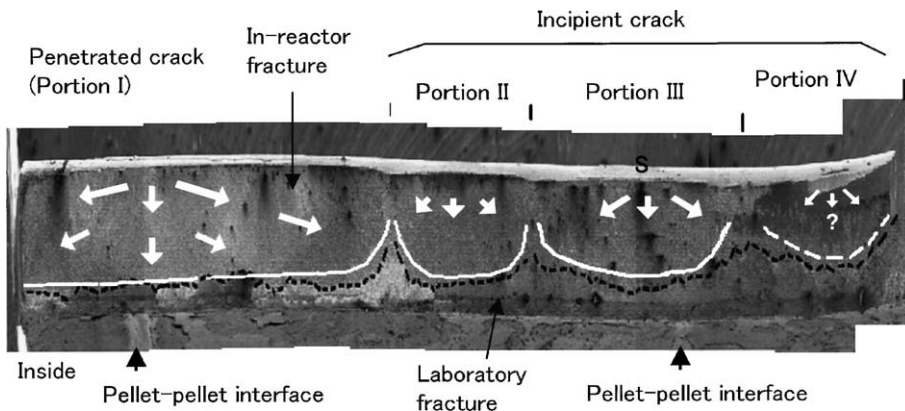
Fig. 21. Schematic of crack propagation scheme for P5(D8/C6-6) specimen analyzed by chevron patterns. The observed area is ‘SEM observation on fracture surface’ in Fig. 3(d). Black dotted lines denote the boundary of brittle and ductile fracture surfaces. White lines approximately show the outlines of four portions of in-reactor fracture surfaces.

The relatively long axial split on the P5 segment rod might be attributed to the ramp test scheme. The rod is exposed to a stair mode ramp test. That means there is a possibility that one more step power rise might be added while outside-in cracking is in progress. The extra power rise might advance the crack in both inside and axial directions, which would cause comparatively shorter time to failure (Table 1) and longer axial split (Fig. 1(e)) than those of other segment rods, P2, P3 and P4. Chevron patterns on the fracture surfaces of P5 are utilized to analyze the direction of crack propagation [6,7]. The result is schematically shown in Fig. 21, which suggests that fracture surface could be classified to four areas indicated Portions I, II, III and IV as illustrated in the Fig. 21. This figure indicates that the crack penetrates at Portion I and at other three portions, II, II and IV, it does not. The direction of crack propagation analyzed by chevron patterns on each portion is designated by white arrows. For example, the arrows show that the crack in portion III started at outside point S in Fig. 21 and propagated to both axial sides and connected with portions II and IV, finally making a long axial split.
