Preliminary results of post-irradiation examinations on LiSoR-2 test section

Y. Dai ^{*}, H. Glasbrenner, V. Boutellier, R. Bruetsch, X. Jia, F. Groeschel

Paul Scherrer Institut, 5232 Villigen PSI, Switzerland

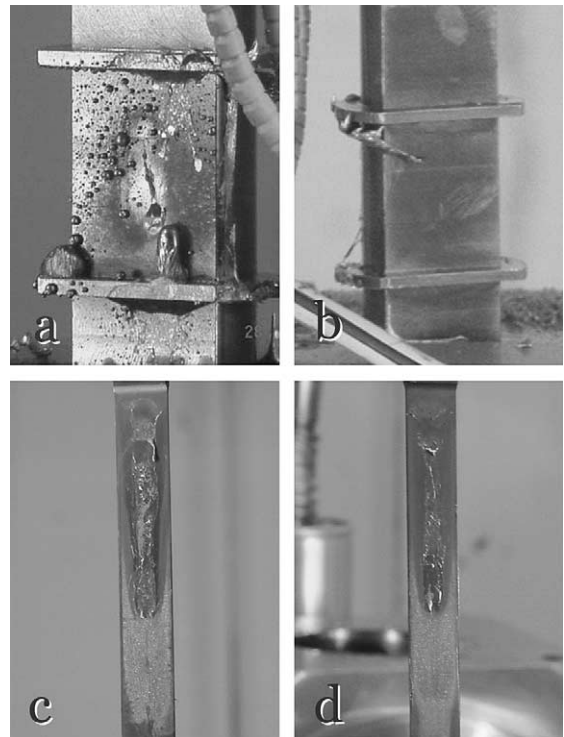
After dismantling the test section in a hot-cell, the tube and the tensile specimen were taken out. Photography was done and the four pictures in Fig. 3 illustrate the views of the front and back sides of the tube and the specimen. The photograph of the front side of the tube (Fig. 3(a)) shows clearly the proton beam footprint in the irradiation zone and also a crack existing in the irradiated zone. The black spot at the lower end of the crack is a heavy oxidized area rather than a hole (as it may appear). On the surfaces of the tensile specimen, the irradiation area can also be seen. While on the back side of the tube, no beam footprint can be seen. This indicates that the proton beam could not penetrate the

Fig. 3. Photographs showing the views of (a) the front side of the tube, (b) the back side of the tube, (c) the front side of the specimen and (d) the back side of the specimen.

whole test section which is in agreement with neutronics calculation [6].

On the surfaces of the specimen there is some Pb–Bi attached in the irradiation area and also in the region immediate above the irradiation area, where the temperature could be quite high due to the heat brought by the up-stream LBE. In the large region below the irradiation area, it looks like something deposited there.

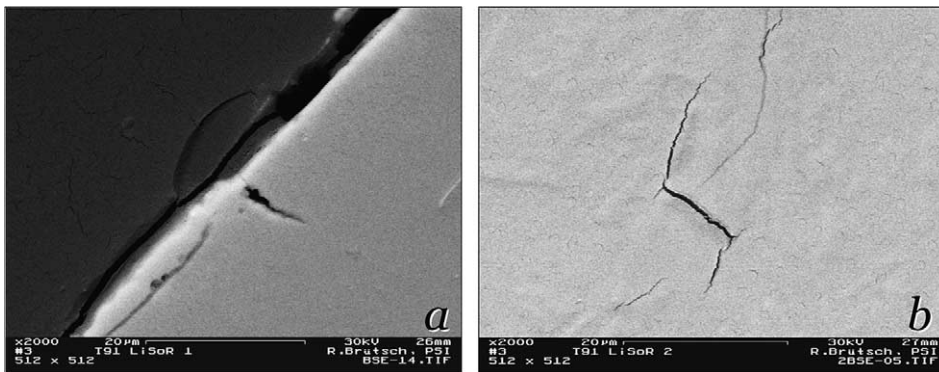
Few samples were cut from the upper part of the tube where the material was not exposed to irradiation. Fig. 4(a) and (b) shows the views of the cross-section and inner surface away from the exposed region which was slightly polished for inspection, respectively. Micro-

cracks of few tens microns long and up to ten microns deep were frequently observed. These microcracks were produced by EDM cutting rather than LBE corrosion or embrittlement. Under tension stress, such microcracks can propagate and become large cracks as observed in the irradiated area of the tube.

Fig. 4. Microcracks observed (a) at the cross-section and (b) on the inner surface at the upper part of the tube which was slightly polished for inspection.

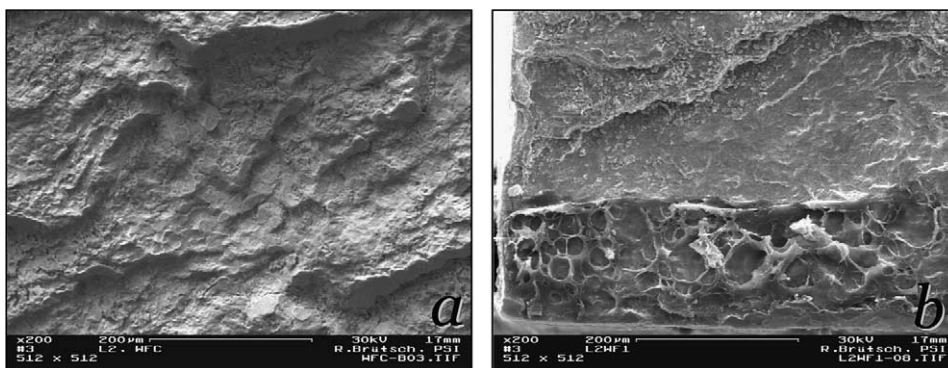
One of the main objectives of this study is to investigate the characteristics of the crack in the irradiated zone of the tube and find out where the crack initialized and how it propagated. The general feature of the crack can be characterized as brittle and ductile mixed fracture. Most of areas, particularly the central part, show brittle fracture (Fig. 5(a)). Only a small part near the outer surface and close to the upper end of the crack presents a typical ductile fracture mode (Fig. 5(b) lower part). This may indicate that the crack started at the inner surface and propagated to the outer surface. In the central part, the crack growth could be promoted by irradiation and LBE embrittlement effects, which

Fig. 5. Micrographs showing (a) brittle fracture in the central part and (b) ductile fracture in an area near the outer surface and close to the upper end of the crack.

resulted in a brittle fracture. The ductile fracture part at the upper end of the crack is less than 200 μm thick and could be broken at a relative high speed like tearing. The crack starting at the inner surface of the tube is understandable because microcracks in the surface layer were ready to propagate under high tension stress induced by the temperature gradient.

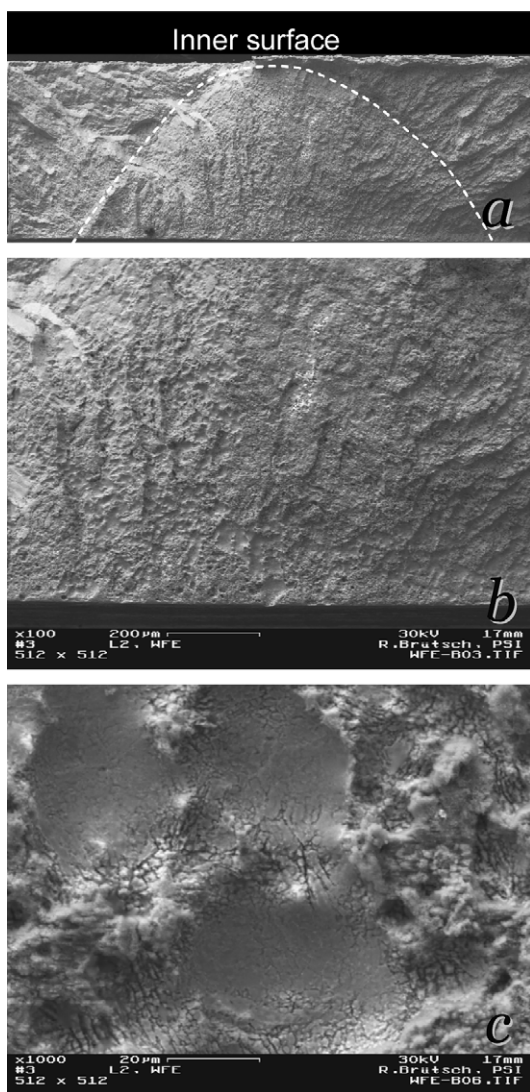
Since the inner surface was heavily oxidized by EDM cutting and also very rough, corrosion traces are not evident. While on the fracture surface there is a heavily corroded area at the lower part of the crack as can be seen in Fig. 6. The position of this area corresponds to that black spot at lower end of the crack seen in Fig. 3(a).

Fig. 6. Micrographs showing LBE corrosion in an area on the fracture surface at the lower part of the crack. (a)–(c) show the view at different magnifications.

The black spot or heavily oxidized area on the outer surface should indicate the area was once exposed to much higher temperature than the rest. This could happen when LBE seeped out through the crack, it might form drops at the lower crack end. A drop of LBE of 1–2 mm large would increase the temperature inside the wall easily to above 1000 $^{\circ}\text{C}$. At such a high temperature, corrosion effects would be significant even in a short time period of 2 h, which is the time from the leak started until the irradiation was stopped. The shape of the area under the dash line reflects also the effects of the temperature gradient.

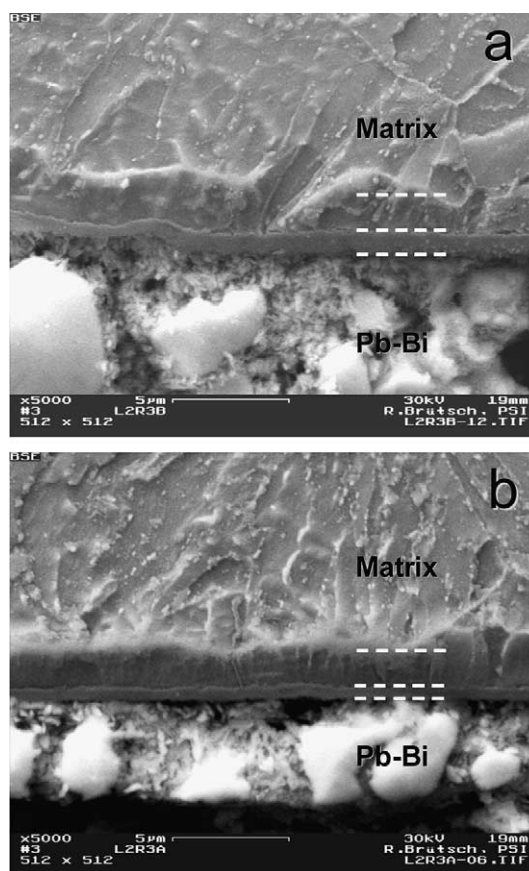
Fig. 7. Cross-sections of the tensile specimen: (a) perpendicular and (b) parallel to the tensile axis.

stress-corrosion-cracking (IASCC) is very likely to occur. However, on the cross-sections in both directions perpendicular and parallel to the tensile axis, there were no microcracks observed, as illustrated in Fig. 7. Instead of microcracks, a thin oxide layer formed on the surface. The oxide layer up to 3 μm thick was revealed only in the irradiated area. Outside the irradiated area no oxide layer was observed. In the oxide layer, two layers can be distinguished, which should be of the magnetite (outer layer) and spinel (inner layer) structure. The formation of the oxide layer is believed to be due to the high temperature experienced during irradiation.

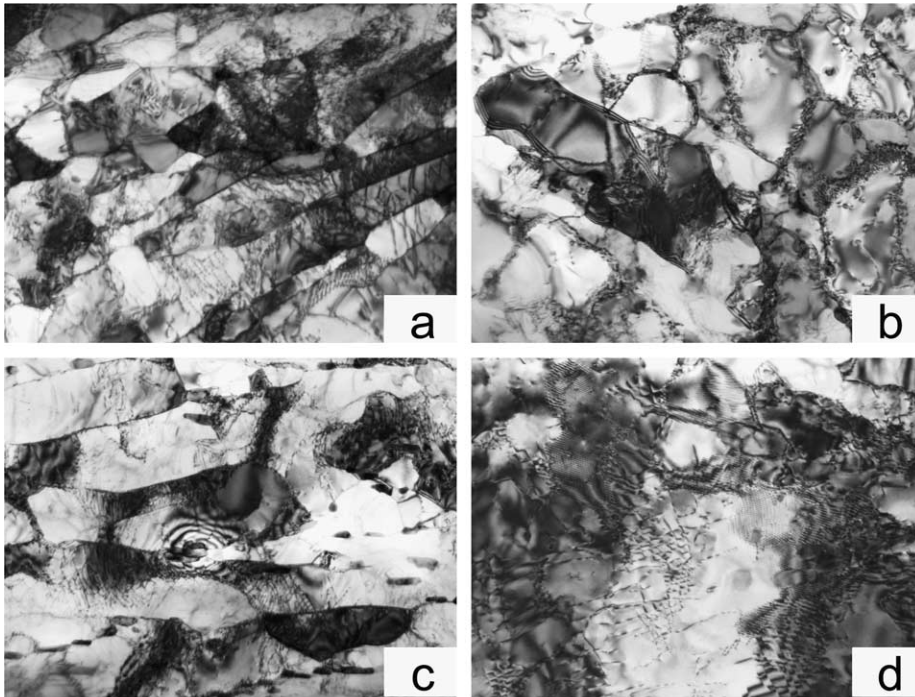
Fig. 8. Microstructure in material at positions: (a) above the irradiated area of the tube, (b) in the irradiated area of the tube, (c) below the irradiated area of the tensile specimen and (d) in the irradiated area of the tensile specimen. The scale represents 600 nm for (a), (b) and (c), but 400 nm for (d).

TEM observations have been carried out to investigate changes in the microstructure of the material after irradiation. Samples from four locations: in and above the irradiated area of the tube, in and below the irradiated area of the tensile specimen were examined. The microstructure at these four locations is presented in Fig. 8. Fig. 8(a) and (c) illustrates similar features of martensite lath structure in the original materials. While Fig. 8(b) shows that a subgrain structure has been well developed from dislocation cells, which indicates heavy

deformation of the material. Fig. 8(d) demonstrates dislocation cells formed already and subgrains were being evolved, which means that the material is also deformed.

These results give a clear explanation to the failure of the tube: high thermal stress caused by the high temperature gradient across the wall introduced significant thermal fatigue. After about 100 000 cycles, hence followed by the wobbling frequency of the beam (the leakage started at around 32 h), the crack propagated through the wall and resulted in the leakage. On the other hand, it is interesting to note that there are no microcracks observed in the irradiated area of the tensile specimen, although the material was heavily deformed by thermal fatigue. The reason could be that the total deformation was still not high enough. However, it is believed that the smooth surfaces should be also a beneficial factor. The failure in the tube should be, at least, partially attributed to the existing surface microcracks, which were ready to grow under such a stress level.
