Preliminary observations of hot spot for HT-7 long pulse discharges

M. Su, Y. Yang *, The HT-7 Team

Institute of Plasma Physics, Academy of Sciences, Division 6, P.O. Box 1126, Hefei 230031, PR China

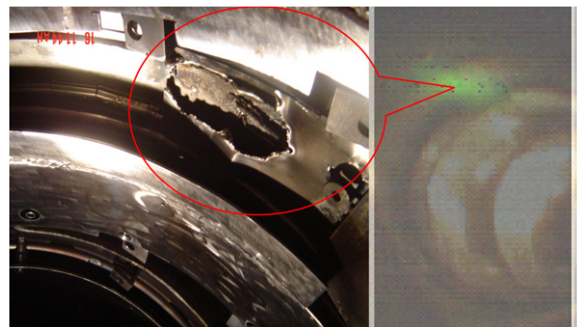
During the venting of the HT-7 tokamak device, obvious damages are observed on the inner structure. Coincidentally, there are a few positions matching to that of the hot spots observed during the discharges very well. One position is within the same cross-section as one of the PL and at the top of the vacuum chamber (Fig. 2). This position was formerly covered by the limiter. In 2004, the limiter at this part was removed. Since it is as far as 3 cm away from the last closed flux surface, it was not realized that there was possibility of PSI. This area was just covered by about 1 mm thick stainless steel (SS) patch to fix the passing thermal coupler (TC). However, during experimental run, fierce PSI was observed in this area by visible camera, frequently in disrupted plasma discharges. During the following venting period, it was found that an area of the SS patch (about 50–100 mm in diameter) was almost completely gone. The TC was melt broken in half. What was worse, the 5 mm thick SS board beneath was melted and leak was formed on the vacuum vessel. This hot spot could be related to the quench of the discharges caused by abrupt metal impurity influx.

Fig. 2. The left photo was taken during venting period, showing the melt area on the top of the vacuum chamber. The right was taken by visible camera, showing strong PSI before disruption in the corresponding position during plasma discharge.

More efforts are made on avoiding the hot spot formation. For case A, a few references (e.g. Ref. [3]) describes a probable mechanism that fast electrons accelerated by the LHW firstly are trapped due to the ripple effect, and then pushed toward the top of the vessel by the curvature and gradient drifts. On HT-7, the area is now covered by a piece of graphite board. The damage to the area is greatly mitigated. Though the quick rise of the temperature in this area was still monitored during the long pulse discharges, and damage on the protective board was still visible during the venting check, there was less frequency of discharge quenches related with the high Z impurities. Water-cooling system is under consideration for better removal of the power.

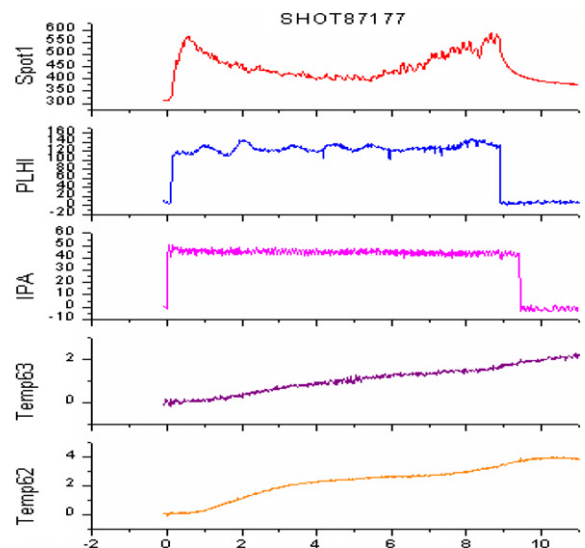
For the first position discussed in Section 3 (case A), it is observed that the temperature starts to rise soon after LHW is applied. For the 2nd position (case B), which is within the coverage of the IR camera, a few 10 s discharges are carried out for the experiment. Fig. 3 shows an example. It is arranged that the power of the LHW be switched off at about 8.9 s. It could be seen that plasma remains for another half a second before termination. Soon after the application of LHW, the visible camera observes a very bright spot at the edge of that tile. The IR camera shows that the surface temperature (T_{surf}) reaches about 500°C . Then the T_{surf} decreases by about 100°C for a few seconds possibly due to the cooling by the heat sink, and keeps increasing until the termination of the LHW. Though the horizontal or the vertical position of the plasma remains unchanged after the LHW is turned off, it is observed on the visible camera that

Fig. 3. LHW effect on the hot spot. (Waveforms from top to the bottom are surface temperature of the hot spot measured by IR camera, power of LHW, plasma current and bulk temperature of the tile at different depths measured by TC.) It should be pointed out that the surface temperature responds to the LHW very quickly, while the slow response of the bulk temperature evolution reflects that the thermal conduction between the heat sink and the tile is not good.

the bright spot disappears very soon, and IR camera shows that T_{surf} decays exponentially. This evolution shows that hot spot corresponds well to the energetic particles generated by the LHW.

For case B, it is observed that the surface and bulk temperature of the graphite tiles is very sensitive to the displacements. With a fixed position throughout the discharge, temperature of the tile contacting with the plasma could easily exceed 1000 °C, and sometimes the TC is damaged. Sweeping displacements during a discharge is effective for avoiding hot spot.

The modification on the dimensions of the tiles is proved to be useful as well. In the latest campaign, the tile in case B was changed to that with a tilted edge facing plasma to avoid the concentration of heat flux. Though the erosion was still obvious during the venting check, the PSI on this tile was observed to be mitigated during discharge.
