# Description of gasket failure in a 7 cell PEMFC stack<sup>☆</sup>

Attila Husar<sup>a,\*</sup>, Maria Serra<sup>a</sup>, Cristian Kunusch<sup>b</sup>

<sup>a</sup> Institut de Robòtica i Informàtica Industrial, Parc Tecnològic de Barcelona, Edifici U, C. Llorens i Artigas, 4-6, 2a Planta, 08028 Barcelona, Spain

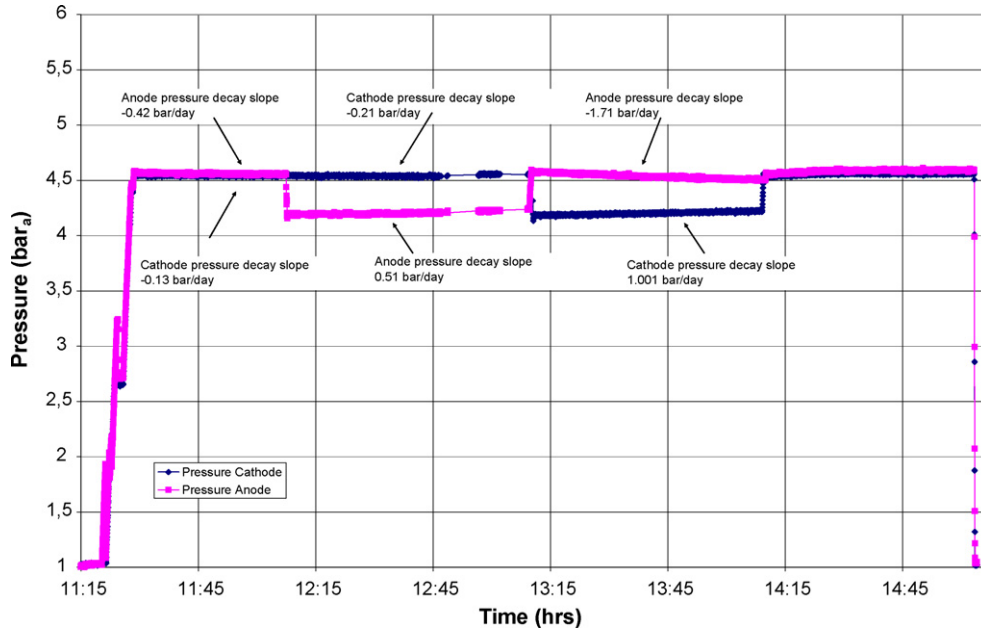
Fig. 3. Pressure decay leak check of stack at ambient temperature with air on the cathode and nitrogen on the anode.

After performing the pressure decay leak check it was decided to continue running the stack because the test did not show any overboard leaks and the crossover leak had not been identified nor quantified yet.

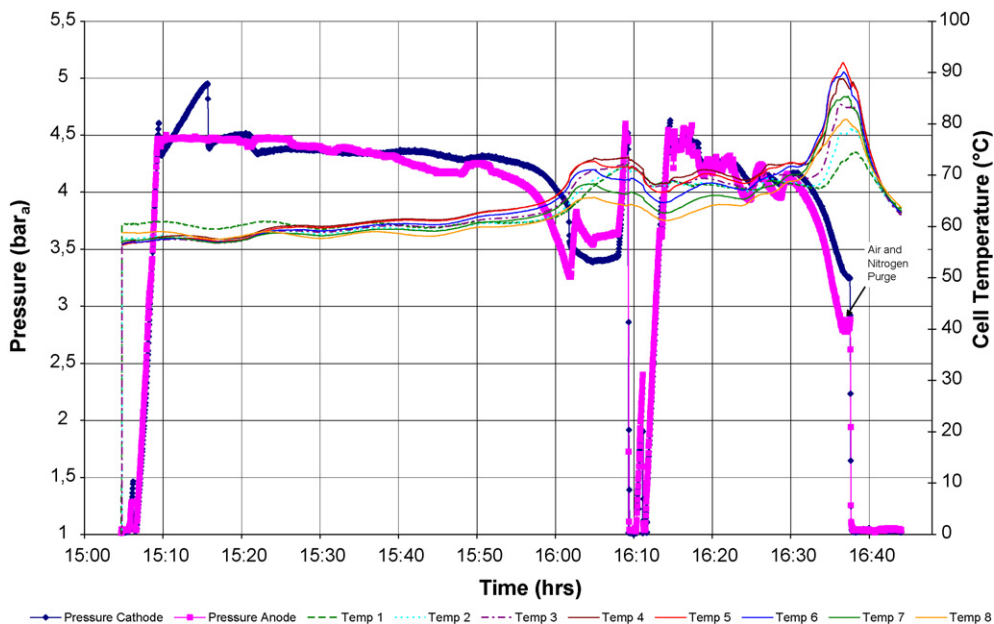
The stack temperature was the indicator that led to the final shutdown of the stack. The stack was being operated with oxygen and hydrogen and no humidification. The stack temperature reached 90 °C without current or resistance heaters enabled. The hot point in the stack was in the middle cells, which read a temperature of 91 °C. The pressure in the stack could not be

maintained. Both of these symptoms indicated the presence of a crossover leak and combustion. So the stack was purged with nitrogen, and declared inoperable.

The data for these final hours with respect to pressure and temperature is shown in Fig. 4, which shows spikes in temperature as the pressures decayed. The cell temperature measurements were taken at eight different points throughout the stack located in the bipolar plates in between each cell. For simplicity purposes they were called measurements 1–8, where measurement 1 is located between the end plate and cell #1, where cell #1 is the first cell the gasses encounter when they enter the stack.

Fig. 4. Pressure of the reactant gasses vs. cell temperature during the last hours of operation. H<sub>2</sub>/O<sub>2</sub>, no humidification.

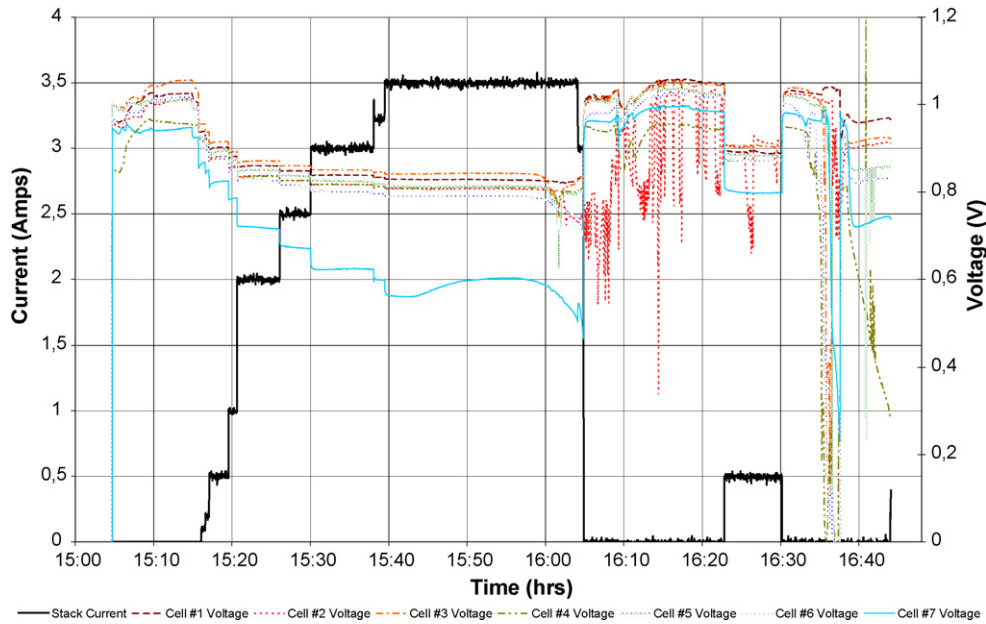
Fig. 5. Stack current vs. individual cell voltage during the last hours of operation,  $H_2/O_2$ , no humidification and a gas pressure.

Fig. 5 depicts the stack current versus the individual cell voltages. It shows how, after the current was reduced to 0 at around 16:05, the open circuit voltages became very unstable especially that of cell #2.

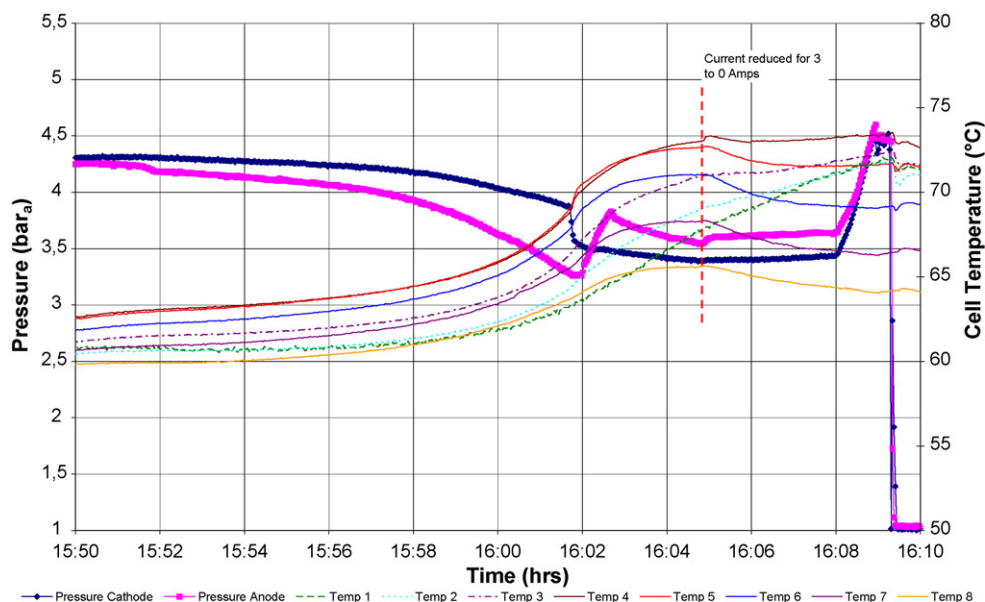
In Fig. 6 the time between 15:50 and 16:10 is examined with respect to pressure and cell temperature. When the load was removed from the stack at 16:05 the temperature measurements 4–8 started to decline, as was expected. However, the temperature measurements 1–3 continued to increase. This temperature rise showed signs of a breach possibly in cell #1 and/or #2.

Fig. 6. Zoom of Fig. 4 between 15:50 and 16:10. Increase in temperature in cells #1 and #2 with no electric load or external heaters on the stack and an anode reactant pressure higher than the cathode pressure when the load was removed.

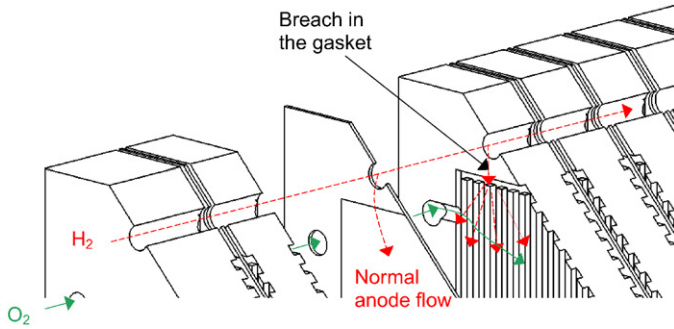
Fig. 7 explains how a breach in one cell affects the flow of the reactant gases when the pressure of the anode is higher than the cathode. Hydrogen enters directly into the breached cell and combusts in the catalyst layer, therefore increasing the temperature for just that one cell.

Fig. 7. Flow of the reactant gases when there is a breach in the seal at the anode inlet port that goes into the cathode flow field. Anode pressure is higher than the cathode's.

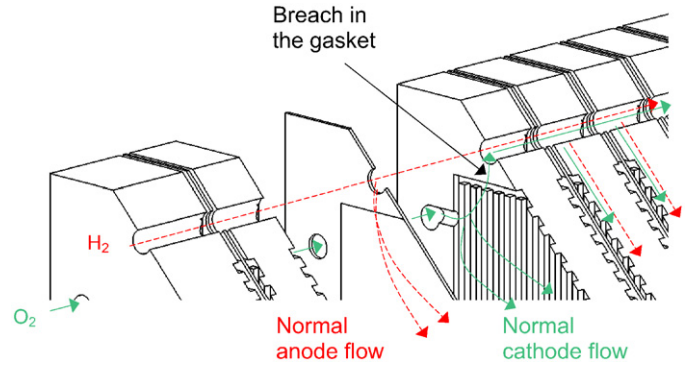
Since the breach is reversible it should permit the oxygen to enter into the anode inlet port if the cathode pressure was higher than that of the anode as shown in Fig. 9. Therefore, the oxygen breach should only affect the subsequent cells.

Fig. 9. Flow of the reactant gases when there is a breach in the seal at the anode inlet port. Oxygen is entering into the anode inlet port. Cathode pressure is higher than the anode's.

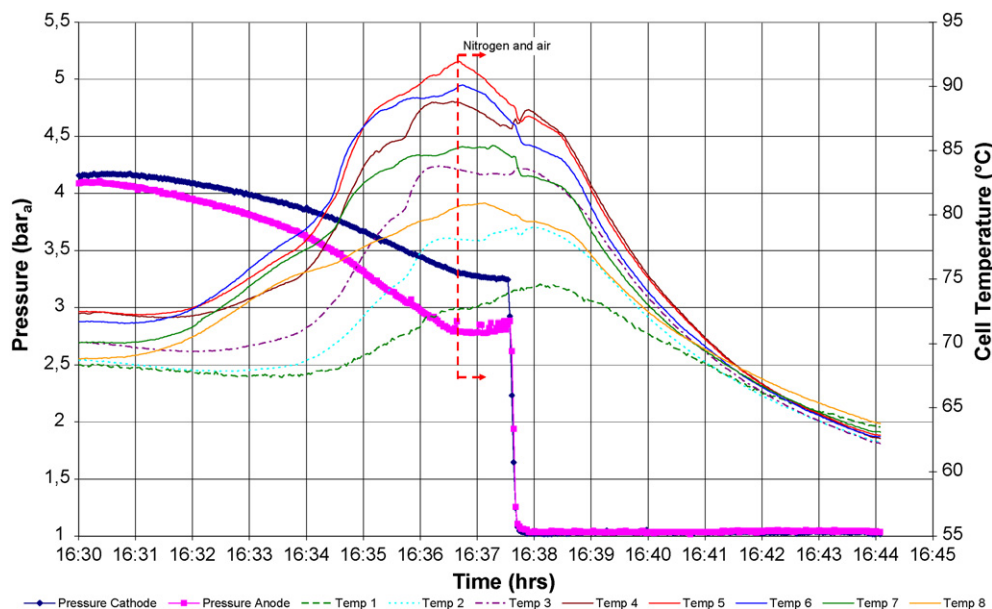
In Fig. 8 the time between 16:30 and 16:45 is examined with respect to anode and cathode pressure and temperature. Initially both pressures were equalized. However, the anode pressure started to decline more rapidly than the cathode because hydrogen was being consumed at twice the rate of oxygen due to combustion which, in turn, caused more oxygen to be forced

into the anode inlet port thus, increasing the rate of combustion in the cells located after the breach. Once the nitrogen purge was initiated on the anode and the air purge on the cathode the pressures began to stable out and the cell temperatures decreased. Shortly after, the pressure was reduced to atmospheric and the stack was declared inoperable.

Fig. 8. Zoom of Fig. 4 between 16:30 and 16:45. Cathode pressure is higher than the anode's and the hot spots in the stack are from cell #3 to #6 indicating that the oxygen was entering into the hydrogen stream through the inlet port.

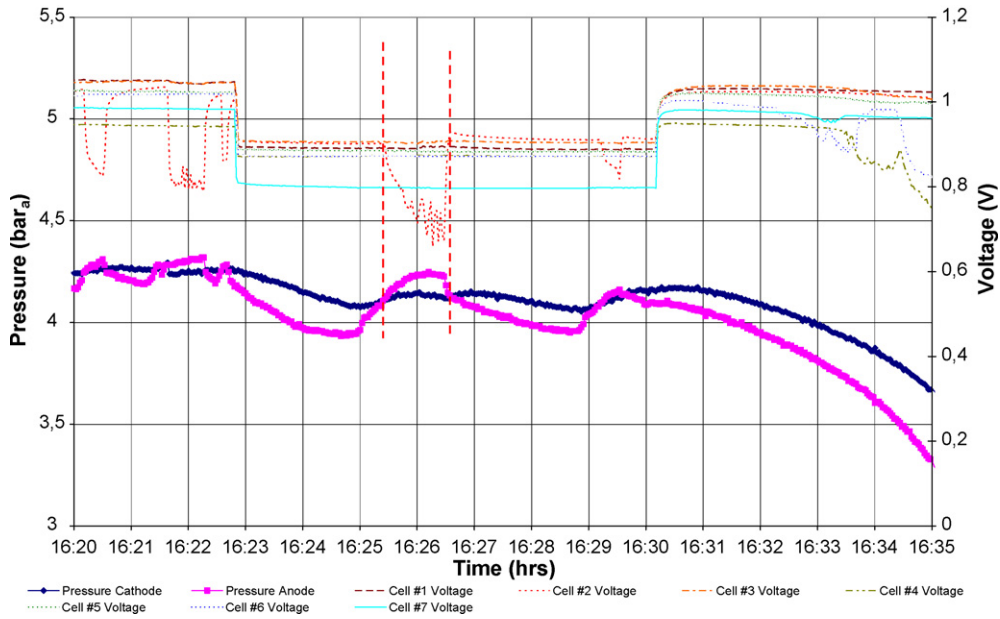
Cell #2 in Fig. 10 showed a unique behavior when the anode pressure was higher than the cathode pressure. The cell lost about 20 mV and became unstable. Then, when the anode pressure was decreased to be lower than the cathode's the cell stabilized. This indicated the presence of a hydrogen crossover in cell #2.

Fig. 10. Temporary instability of cell #2 when the anode pressure is higher than the cathode's. Hydrogen enters directly into the cathode flow field of the cell.

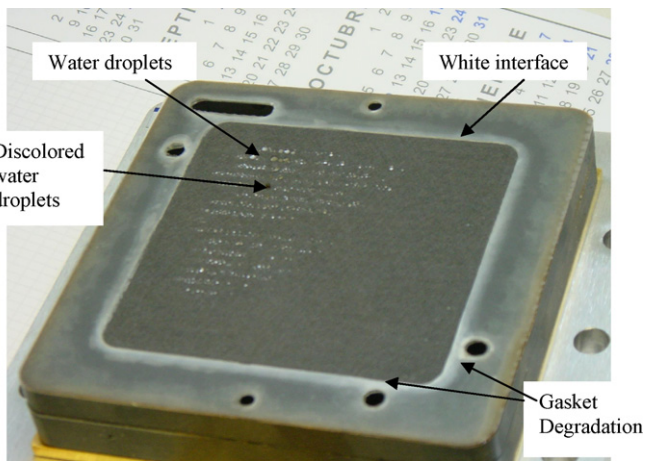
Upon opening the stack it was clear that it was cell #2's cathode side gasket that had failed. Fig. 11 shows the cathode gasket

and GDL for cell #2 while still attached to the bipolar plate. The interface between the gasket and the GDL is a white color indicating degradation.

Interestingly, this was the only cell that had water droplets on the gas diffusion layer and a few of the droplets were brown in color which is a sign of contamination possibly from combustion on the cathode side.

Fig. 11. Cathode GDL and gasket of cell #2 before it was removed from the bi-polar plate.

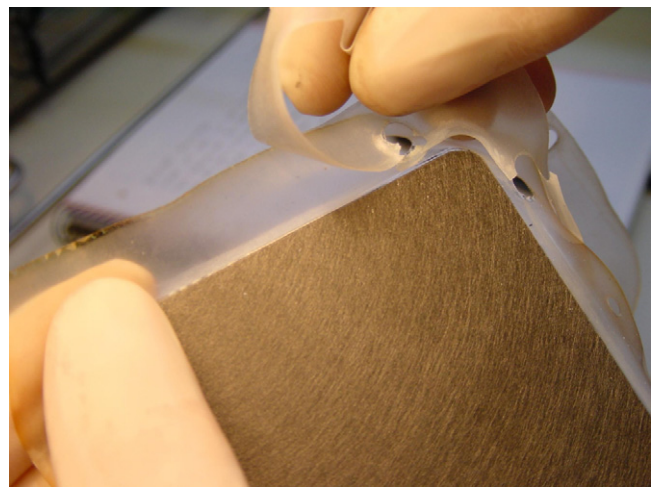
When the gasket and MEA were peeled off of the anode side of the bi-polar plate it revealed that there was severe degradation of the gasket material around the anode inlet port towards the GDL as shown in Fig. 13. There was also some degradation around the cathode inlet. This degradation occurred on the cathode gasket.

Fig. 13. Cell #2 cathode gasket degradation.

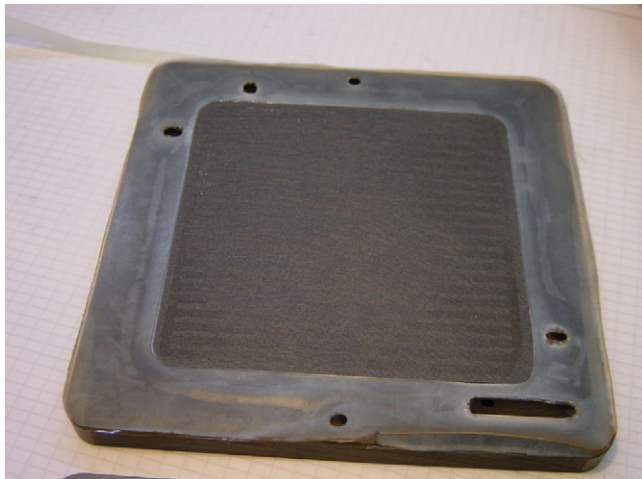
Fig. 12 illustrates what a good cell with no degradation of the gasket looked like.

Fig. 12. Cell #5 gasket and diffusion layer which showed no degradation.

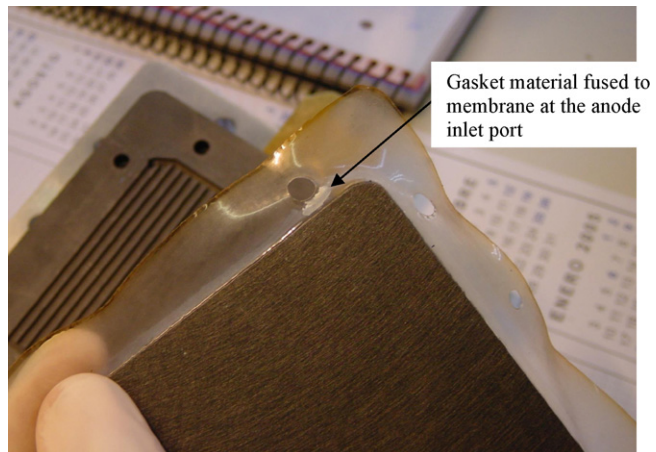
Finally, when the gasket was totally detached from the membrane it was discovered that a piece of the gasket material was fused to the membrane at the anode inlet port as seen in Fig. 14.

Fig. 14. Gasket material left on the membrane at the anode inlet port and on the cathode side of the membrane.

This could be explained by the high temperature reached due to combustion that caused the gasket material to disintegrate and fuse to the membrane.

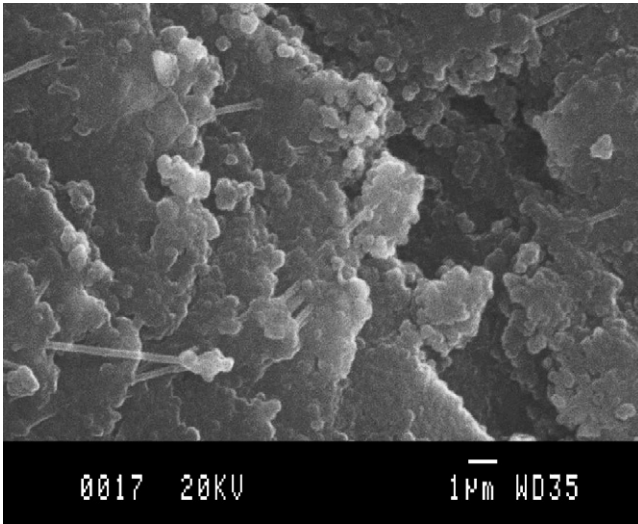
Fig. 15. Silicon gasket material that was exposed to the combustion from cell #2.

Figs. 15 and 16 show images of the silicon gasket material taken with the scanning electron microscope. In Fig. 15 shows the silicon gasket material from cell #2 that was exposed to combustion and Fig. 16 shows what the same material looks like under regular conditions.

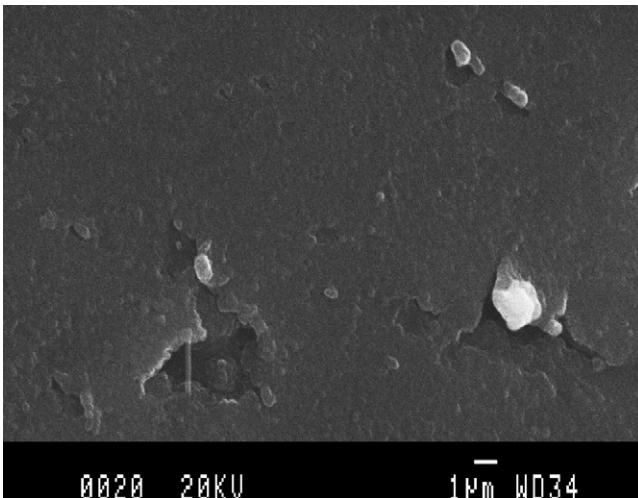
Fig. 16. Silicon gasket material that was not exposed to the combustion from cell #4.
