## Screening Li-ion batteries for internal shorts

Eric Darcy

NASA-Johnson Space Center, Houston, TX, USA

A Li-ion polymer pouch cell battery design for a spacesuit developed an internal short during ground storage. A detailed failure investigation found that native contamination was the most probable root cause as the failure mechanism was successfully replicated. Lessons learned are applicable to the implementation of most Li-ion cell designs for critical applications.

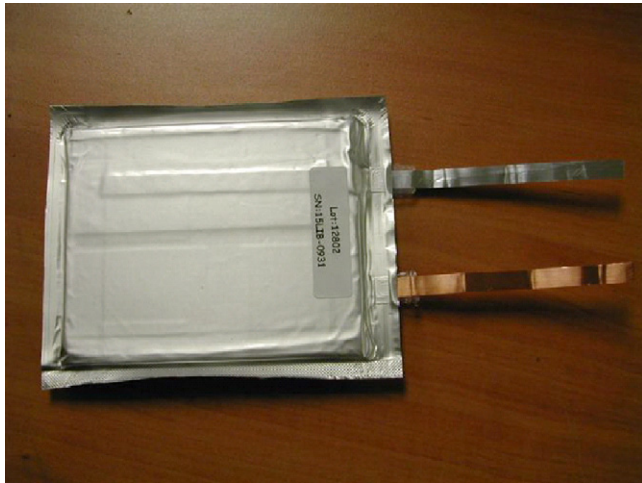
Fig. 1. One of the five cells that make up a cell module.

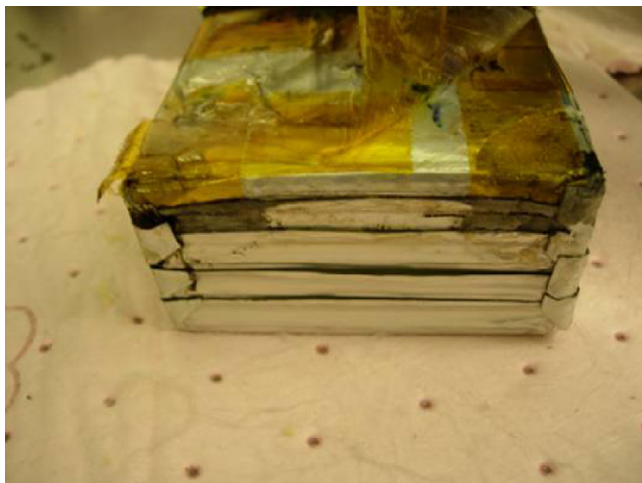
Careful, deliberate, non-destructive, and destructive physical examinations (DPA) isolated the short to within one of the cell pouches within the defective cell module, specifically, the outer most cell #5 in the stack (Figs. 2 and 3). Specifically, both cell bottom corners show evidence of high heat-affected zones with their centers located very near the corners. There appears to be two “ground zeros” for the short, which when fed by the energy of all five cells caused intense heating, high enough to melt the copper foil (1084 °C) in microscopic locations (Fig. 4). This damaged the bottom corners of the adjacent cell #4. No evidence of separator failure or foreign object debris (FOD) was found to be root cause. This leaves electrode misalignment, native contamination, cold flow through the plastic-aluminum laminate, and pouch seal fold impingement as remaining possible root causes aggravated by the thermal cycling or/and vibration.

During the DPA, non-uniformities in the thickness of the urethane foam potting around the cell module were found in the layers adjacent to the affected bottom corners of cell #4

Fig. 2. Five-cell stack of internally shorted cell module after outer pouch was removed. Note the heat-affected bottom corners of cells #4 and #5.

and #5. Thin and thick spots could have left the stack of pouch cells unsupported at the corners, allowing relative motion during vibration. This could have contributed to any of the four root causes mentioned earlier.

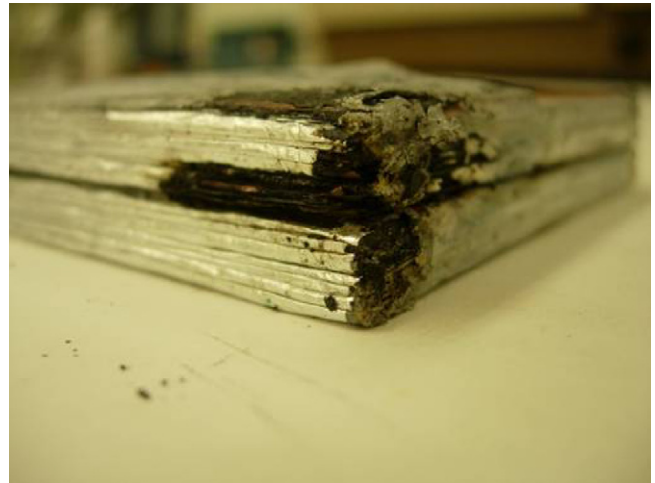
Fig. 3. Damaged bottom corner of cell #5 on top of cell #4 with cell pouches removed.

The internal short that occurred in spacesuit lithium ion battery was most probably caused by native contamination in one bottom corner of a cell coupled with an insulation defect in the pouch adjacent to the opposite cell corner. This subtle internal short was not detected during the acceptance testing because it was very subtle (high impedance) during those tests and later transitioned into a low impedance short, causing localized damage. The difficulty the investigation had in replicating the failure supports the argument that these type of subtle, smart shorts are extremely rare. It also concludes that the acceptance tests were clearly inadequate and must be supplemented with more thermal, vacuum, and charge/discharge cycling to provide any latent workmanship defect a much greater probability of manifesting itself.

The proposed corrective actions are to perform thermal and vacuum cycling, random vibration, and charge/discharge cycling at the cell module level. This should be followed with capacity cycling tests that include hold times designed to detect high self-discharge and soft shorts. Short shorts are detected by fully discharging a cell module at 3.0 V to a 125 mA taper current and monitoring cell open circuit voltage on days 14 and 21. Any

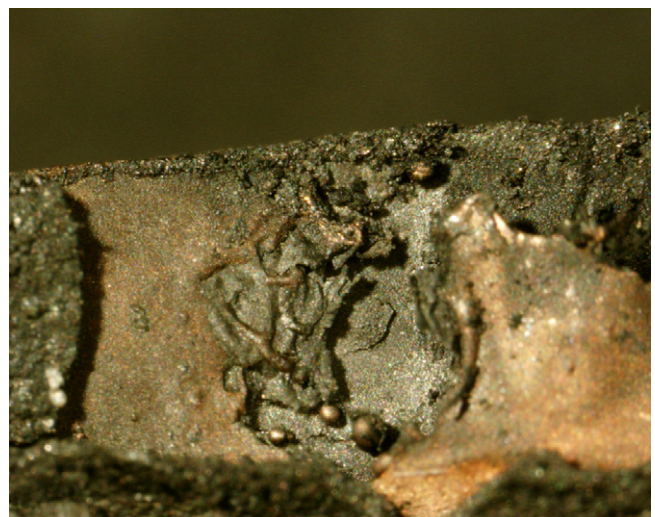
Fig. 4. Ground zero arc damage on the copper foil substrate on a torn side fold near the bottom corner of cell #5.

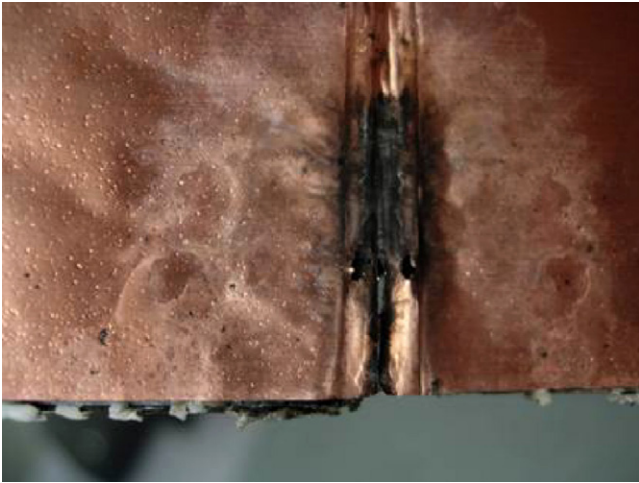
Vibration could have stressed the unsupported electrode substrate folds and cause them to tear (Fig. 5). This in turn could have damaged the separator and allowed misalignment of the electrode folds. Similarly, vibration could have caused some active electrode material to break loose and contaminate the substrate fold area, where no active material should be present. This contamination could have caused separator damage and a short. Also, impingement of the cell stack corner against the laminate pouch could have caused its plastic outer layers to cold flow until the folded cell stack made direct contact with the aluminum layer in the pouch. Two cold flow shorts to the pouch would be required for this mechanism, since the pouch is electrically isolated from the cell tabs. Alternatively, the folded pouch seal on the external edges and corners of the cells could have damaged the cell

Fig. 5. Unfolded cell #5 stack showing the torn copper folds and ground zero of the internal short.

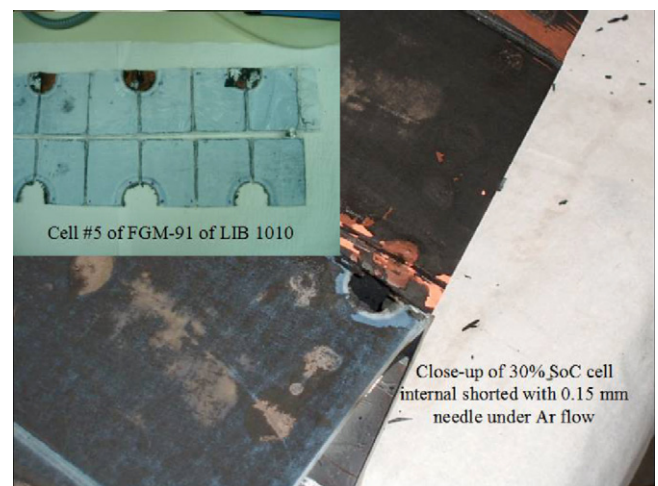
Attempts to replicate the native material contamination theory were done with foreign contamination. Specifically, pins, staples, and finally acupuncture needles were used in a set of trial and error experiments. Success in replicating the original damage (Fig. 3) was achieved when puncturing cells with a 0.15 mm diameter acupuncture needle on their edge where the current collectors are z-folded while under an argon flow and with the cells at 30% SoC. The steel needle was insert through a pre-made hole in the pouch on the side of the cell, such that the Al current collector was first punctured, then the two layers of separator, and

Fig. 6. Comparison of the damage caused the internal short in cell#5 (inset) and in a cell internally shorted with an acupuncture needle. Note the similarity of the localized damage.

then formed a short when it reached the graphite coated copper current collector. The short caused a small puff of smoke which quickly extinguished itself. The OCV of the cell dropped from 3.78 to <0.1 V in <15 h. The test was performed twice, once as a single cell test and another time as five cells in parallel. Subsequent DPA revealed mechanics of failure closely resembling the original damage shown in Fig. 3 and a comparison is shown in Fig. 6.
