# Behaviour of a rupture of the 21 June 2000 earthquake in South Iceland as revealed in an asphalted car park

Jacques Angelier\*, Françoise Bergerat

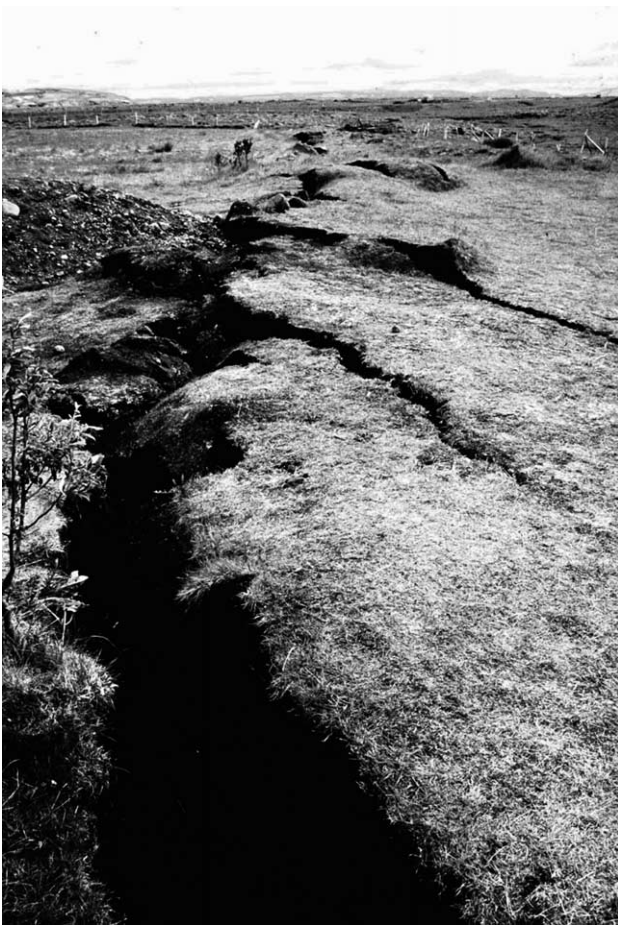
The 21 June earthquake left spectacular traces in the grassy soils near a summerhouse named Bitra, south of the main road (Iceland n°1) from Reykjavik to southeastern Iceland. En échelon fissures (Fig. 2) and push-up structures indicate left-lateral strike-slip in the WSW–ENE direction (N50–60°E). The area described in this paper is a few hundred metres to the ENE of the summerhouse, on the northern edge of the main road (63°57'N and 20°42'W).

Fig. 2. Rupture trace of the 21 June earthquake near Bitra. En échelon fissures and small push-ups indicate left-lateral motion. The car park area analysed in this paper is located to the ENE, in the background near the upper-right of the photograph.

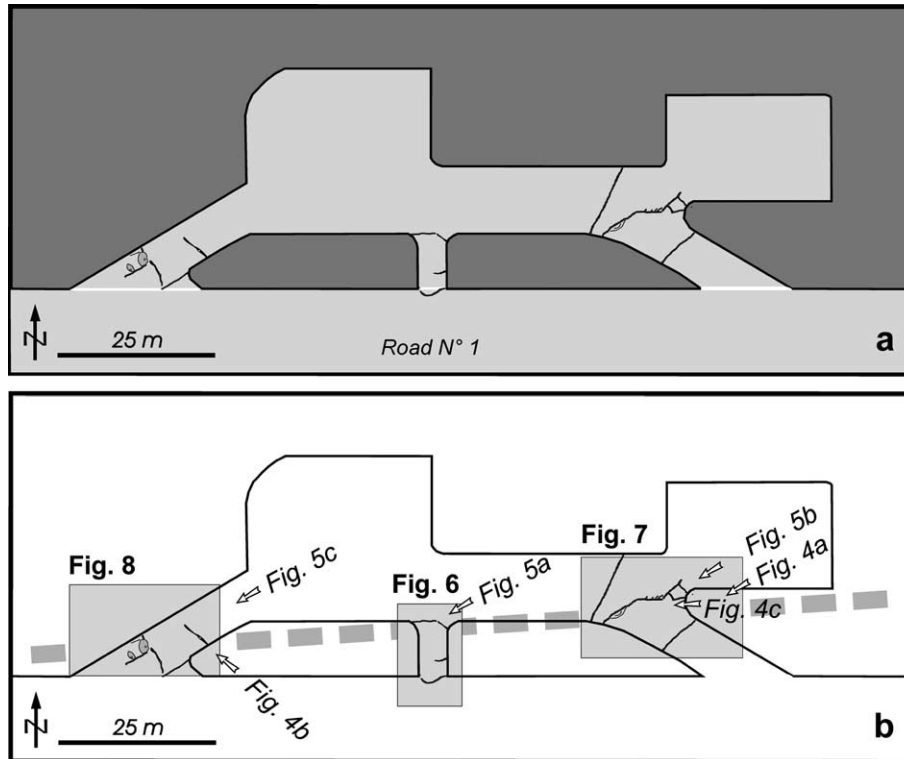
As compared with the earthquake rupture traces in the natural ground surface, these fractures, albeit less spectacular (compare Figs. 2 and 4), allowed accurate reconstruction of the deformation. As Fig. 3a indicates, very little brittle deformation affected the main road and the main car park area. The rupture traces concentrated in the three asphalted access roads which connect the car park and the road. This is not surprising because, near Bitra, the fault trace trends ENE–WSW and the rupture of the 21 June 2000 earthquake essentially propagated between the E–W main road and the car park area (Fig. 3b). Evidence of surface ruptures was present in the soil and the gravel layer, but did not allow the quantification of the deformation at the Bitra car park area. Note that quantification could be done in grassy soils at other sites of the 17 and 21 June 2000 rupture traces (Bergerat and Angelier, 2001).

Fig. 3. Map of the car park area near Bitra. (a) General map obtained with a GPS differential system. Grassy soil in dark grey, asphalted areas in light grey, fractures as thin lines. (b) Location of subsequent figures. Mapped sub-areas shaded with figure references in bold characters. Photographs located with open arrows indicating viewlines and references to figures in italic. Fault trace of the 21 June 2000 earthquake as grey dashed line.

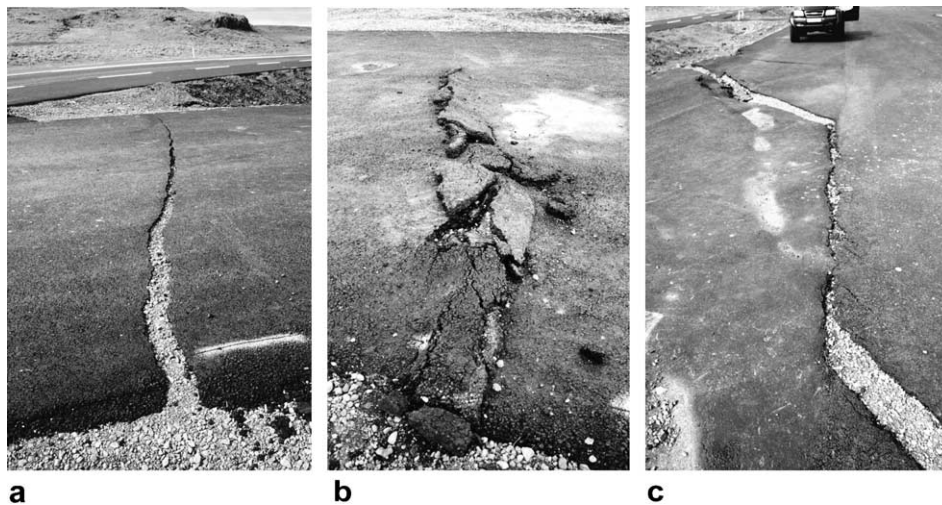
types: open fissures, pressure ridges and left-lateral strike-slip fractures (Fig. 4). Some open fissures show relative displacements that progressively decrease from one edge of the asphalt layer towards a point where the fracture disappears near the opposite edge (Fig. 4a). This is also the case for some pressure ridges (Fig. 4b). A zigzag fracture shows a strike-slip segment that connects two open gashes (Fig. 4c).

Rupture traces were observed at three sub-sites, which correspond to the three access roads of the car park area (Fig. 3). Although both the open fissures and the pressure ridges were observed at these three localities, their relative abundance and size vary. The central access road (Fig. 5a), which trends N–S, is affected by two open fissures and two pressure ridges or highs. The eastern access road shows large open fissures and short pressure ridges (Fig. 5b): the open fissures are more abundant and accomplish more strain than the pressure ridges (Fig. 4a and c). In contrast, well-developed pressure ridges affect the western access road (Fig. 5c); these pressure ridges are composed of thrusts and folds in the asphalt layer (Figs. 4b and 5c).

Left-lateral shear was observed along a straight, E–W-trending line between the eastern access road and the car park area (Figs. 4c and 5b). This line coincides with a pre-existing junction between two asphalt surfaces, made during the car park construction. During the earthquake,

Fig. 4. Photographs of typical brittle features of the 21 June 2000 earthquake in the asphalted car park surface (for location and orientation, see Fig. 3b). (a) Open fissure (referred to as 5 in Fig. 7). (b) Pressure ridge (referred to as 3 in Fig. 8). (c) Left-lateral shear line connecting open fissures (referred to as 4 in Fig. 6).

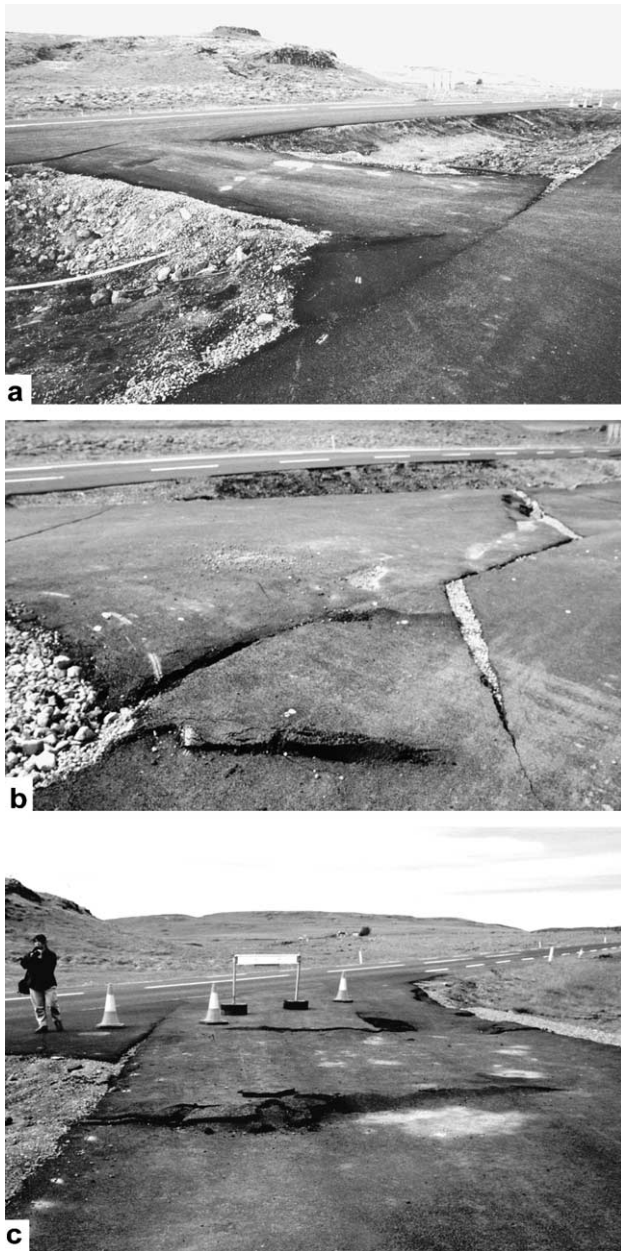
the left-lateral slip locally concentrated along this line of mechanical weakness in the asphalt cover so that this slip trace can be regarded as an inherited feature. As Fig. 5b demonstrates, the same E–W line of mechanical weakness also behaved as an open fissure at its eastern tip, so that with the main NE–SW open fissure it defines a triangular area where two parallel pressure ridges trend NW–SE and

accommodate shortening (in the foreground of Fig. 5b). In addition, elliptical troughs resulted from the co-seismic collapse of small underground cavities (e.g. a drainage pipe), and are not suitable strain indicators.

Fig. 5. Photographs of the three sub-areas of asphalted car park surface broken by the 21 June 2000 earthquake (for location and orientation, see Fig. 3b). (a) Central access road (view from NE to SW, map in Fig. 6). (b) Eastern access road (view from NE to SW, map in Fig. 7). (c) Western access road (view from NE to SW, map in Fig. 8).

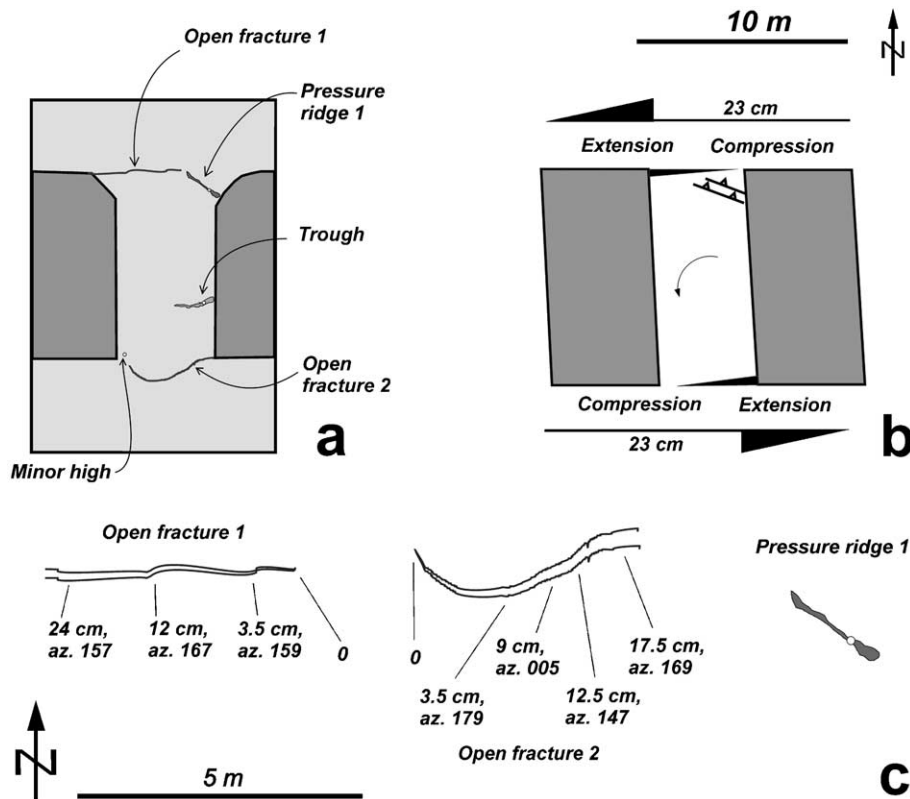
The distribution of open fractures and thrust ridges in the central access road (Fig. 6) is characterised by a centre of symmetry. The tension fissures are located at the NW and SE corners of this rectangular asphalt road segment,

whereas the pressure ridges or highs occur at the opposite, NE and SW, corners (Fig. 6a). This distribution indicates left-lateral shear and rotation of the N–S-trending asphalt access road (Fig. 6b). It is even possible to quantify the deformation, based on serial measurements of the trends and amounts of opening across the open fractures (Fig. 6c).

The two open fractures are 4–5 m long. Their largest dilation is located along the edge of the access road (western and eastern for the northern and southern fractures, respectively). The amount of dilation continuously decreases inside the asphalt surface and vanishes at the opposite tip of the fissure. The trends and the amounts of opening could be accurately measured by matching the irregularities of fissure edges at several places along the fissures. Both the trends and the amplitudes of the relative displacement vectors were thus determined, as shown in Fig. 6c. Because the position of each vector along the fracture was also noted, the variation in opening as a function of the along-fracture position could be analysed. The data showed that this along-fracture variation of dilation is nearly linear. This indicates that the rectangular asphalt access road, bounded by deformation zones at its northern and southern tips, behaves as a rigid plate. The fissure dilation increases in opposite directions for these two fractures, indicating consistent anticlockwise rotation (Fig. 6). It is easy to quantify the rotation through a least-square adjustment of these vectors (in other words, one reconstructs for each fissure the pole of rotation between two rigid bodies). With the data illustrated in Fig. 6c, one obtains consistent values around  $3^\circ$  for open fractures 1 and 2. This indicates that the access road underwent anticlockwise rotation of about  $3^\circ$  during the 21 June earthquake. Then, knowing that this N–S elongated rectangular access road is almost 9 m long, the amount of left-lateral displacement in the E–W direction is easily estimated as the product of this length by the angle in radians, giving a value of 0.46 m (Fig. 6b).

Fig. 6. 21 June 2000 deformation of the central sub-area (location in Fig. 3b). (a) General map obtained with a GPS differential system. Grassy soil and gravel layer in dark grey, asphalted area in light grey, fractures and open fissures as thin lines, pressure ridges as elongated dark areas, pressure ridge top or trough bottom shown as small open dots. (b) Deformation pattern, explanation in text. (c) Relative displacement across fractures (amplitude and azimuth in degrees indicated).

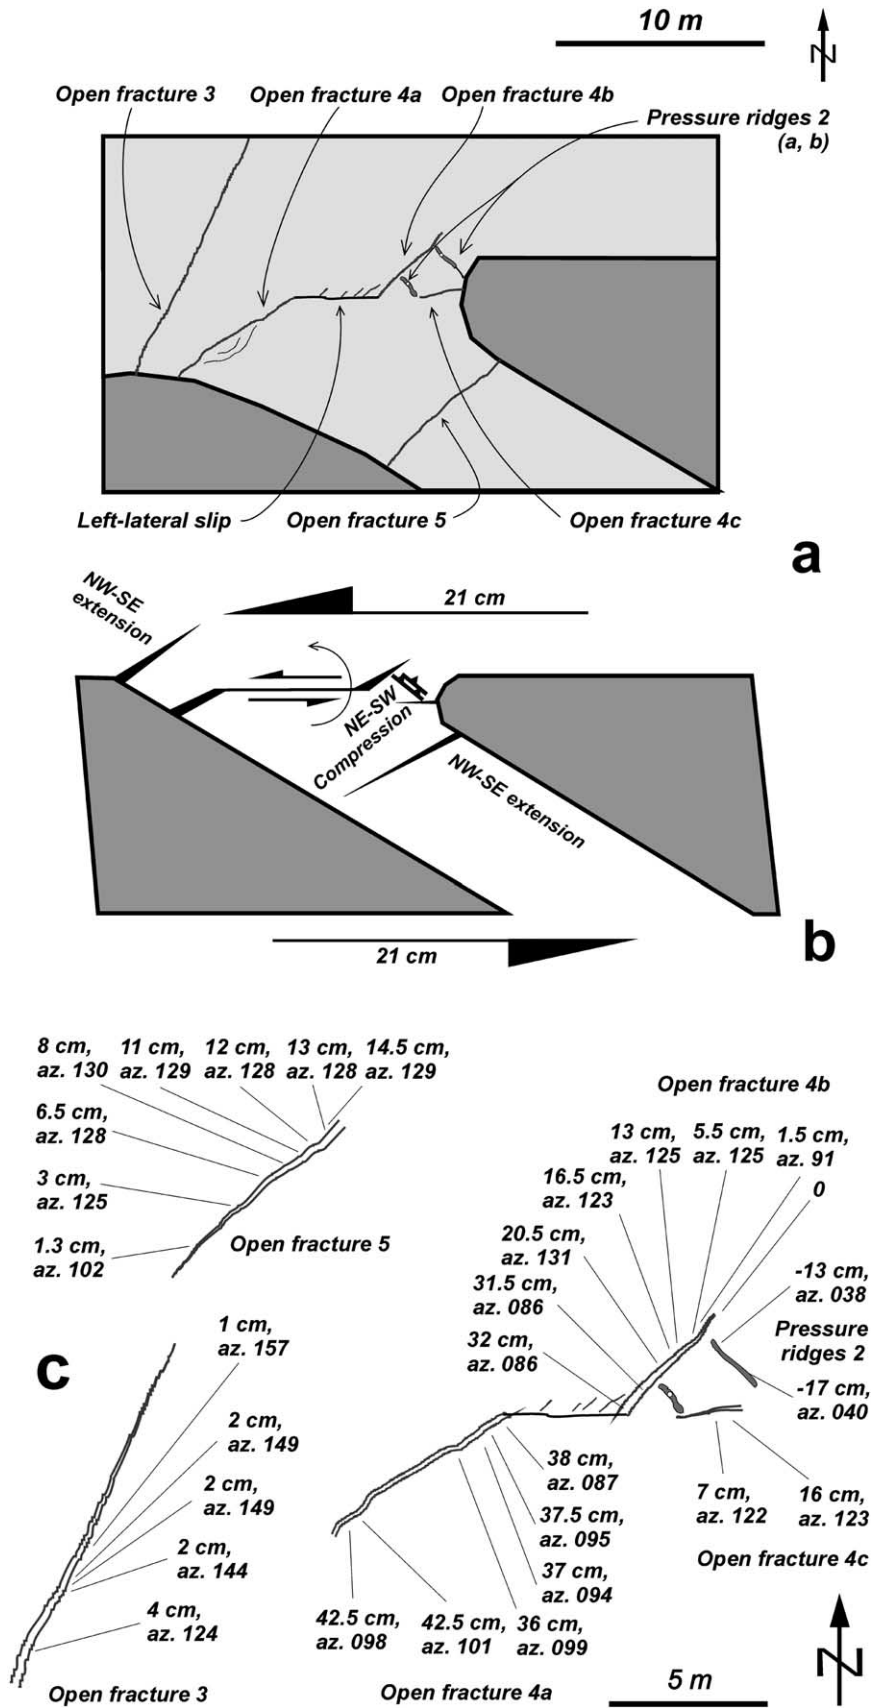
The pattern of brittle features in the eastern, NW–SE-trending access road is more complex (Fig. 7). Three main open fractures were measured. Two of these fissures (3 and 5 in Fig. 7a) trend NE–SW and cut across the car park area and the access road, respectively. The remaining fissure has three separate segments, located at both tips of the left-lateral shear line (Figs. 4c and 5b). The two widest segments (4a and b in Fig. 7a) strike NE–SW at the two tips of, and in close connection with, the E–W shear line. Several minor fissures that also strike NE–SW are arranged en échelon along the shear line. Most displacement vectors of this fissure system trend approximately E–W (Fig. 7c), revealing consistency with E–W left-lateral slip along the shear line. The third segment (4c in Fig. 7a) strikes E–W and was inherited from the same line of mechanical weakness in the asphalt cover as for the shear line, as discussed before (Fig. 5b). Two pressure ridges locally occur, indicating NE–SW shortening. The geometry of this tension-shear pattern indicates a left-lateral slip of about 0.4 m, related to a NW–SE opening of about 0.25 m and an anticlockwise rotation of  $2^\circ$  on average.

The contribution of tension fractures located on both sides of the tension-shear system (3 and 5 in Fig. 7a) must be added to determine the total deformation. Typically, the trend of fissure opening in this system markedly deviates clockwise from the E–W direction and tends to become NW–SE as the distance to the E–W shear line increases (Fig. 7c). Accordingly, the trend of opening is also NW–SE for the two fissures located away from the shear zone. According to the data shown in Fig. 7c, these fractures accommodate a NW–SE opening of 0.06 m and an anticlockwise rotation of  $1^\circ$ . Note that because the dilation across these tension fractures decreases to zero in opposite directions, the moment of rotation of the deformed plate between them is consistent and anticlockwise, compatible with the left-lateral shear.

All these data indicate that the total rotation of the asphalt layer at the junction between the car park area and the eastern access road is  $3^\circ$  anticlockwise while the NW–SE dilation reaches 0.3 m. The most reliable estimate of left-lateral displacement in this area is given by summing up the E–W opening of the central fissure system in the vicinity of the shear line (0.38 m on average) and the E–W component of dilation across the other fissures (about 0.04 m), giving a total of about 0.42 m (Fig. 7b). This amount of left-lateral shear in the E–W direction is consistent with the estimate of 0.46 m obtained from reconstruction in Fig. 6.

Fig. 7. 21 June 2000 deformation of the eastern sub-area. Caption as for Fig. 6.

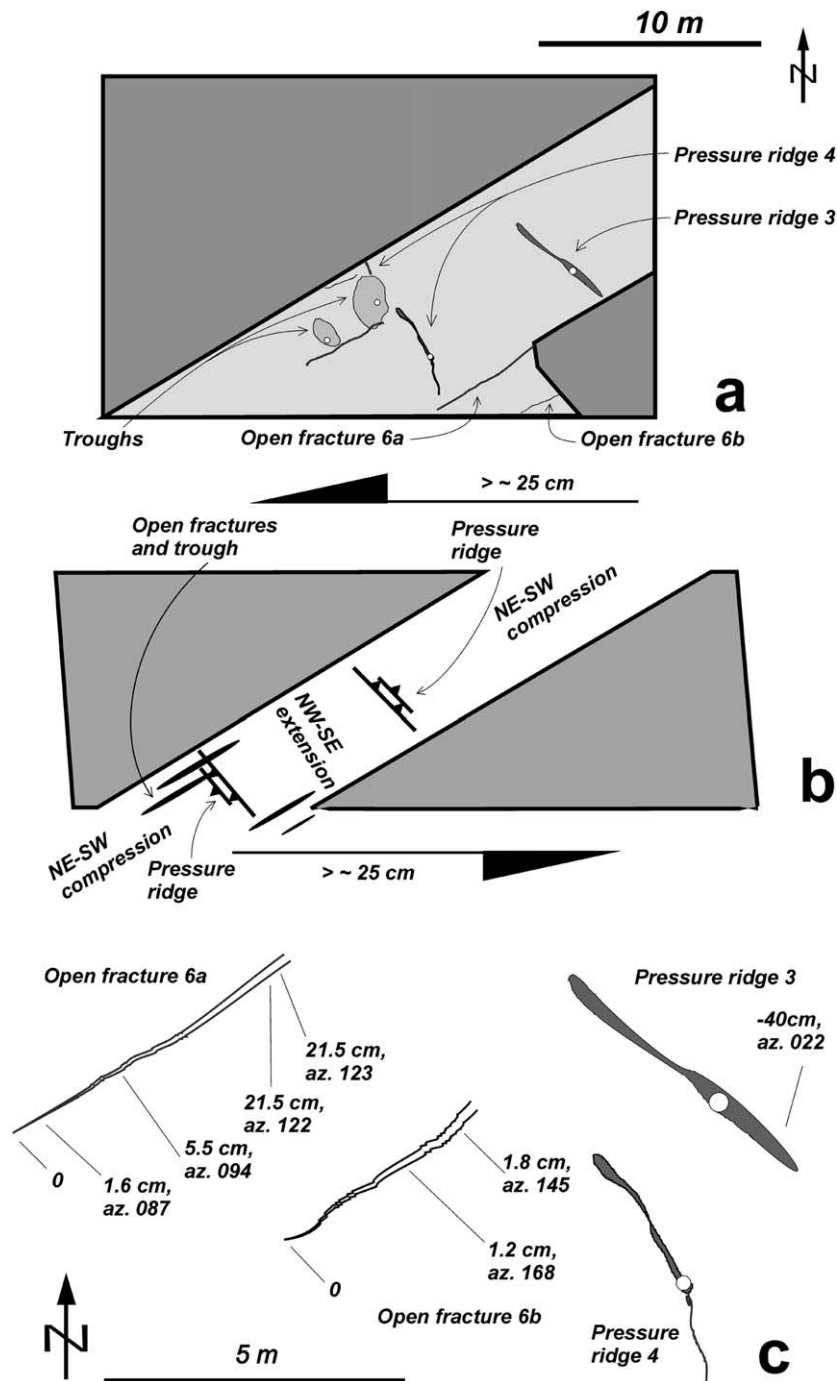
The brittle pattern observed in the western access road differs from those of the other two access roads, because it shows little rotation and horizontal simple shear (Fig. 8). Two open fissures reveal minor rotation (about  $2^\circ$  together). The deformation is dominated by pure shear, with NE–SW elongated tension fissures and a trough, indicating transverse dilation of the access road, and NW–SE-trending pressure ridges revealing along-strike shortening (Fig. 8a and b). The amounts cannot be estimated because it was unclear whether some of the brittle features were a consequence of ground collapse, or damage by vehicles passing through after the earthquake. However, a shortening of 0.4 m could be measured across one of the two pressure ridges (Fig. 8c), giving a lower bound for the NE–SW shortening, and the NW–SE dilation is certainly larger than 0.3 m. Thus, the amount of left-lateral displacement in the E–W direction cannot be smaller than 0.5–0.6 and 0.4–0.5 m, the minimum required to account for the observed NE–SW shortening and NW–SE dilation. This result is compatible with the previous estimates of left-lateral motion obtained in the two sub-sites to the east (Figs. 6 and 7), although it suggests a slightly larger amount of left-lateral displacement.

Fig. 8. 21 June 2000 deformation of the western sub-area. Caption as for Fig. 6.
