## **APPLICATION OF TGA/DTA/MS TO THE HISTORIC PRESERVATION OF STONE**

*C. Gembinski<sup>1</sup>, A. E. Charola<sup>1</sup>, B. Price<sup>2</sup> and A. R. McGhie<sup>3\*</sup>*

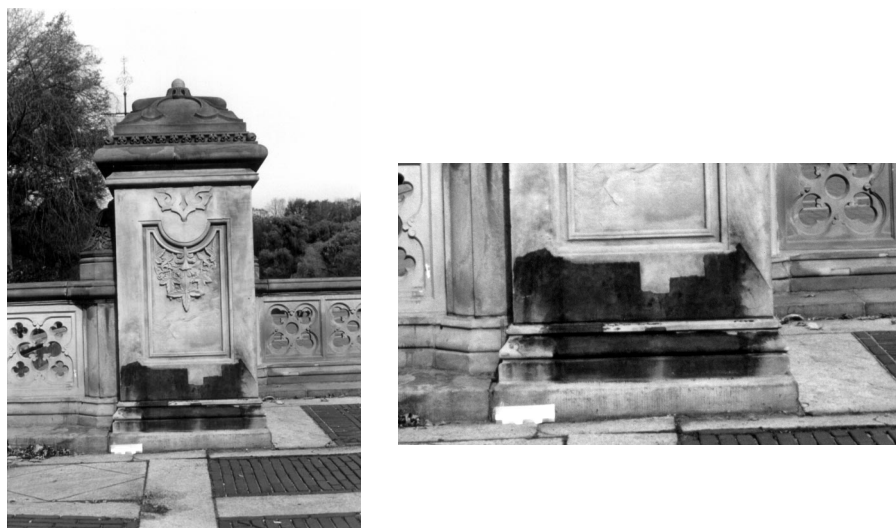
At Bethesda Terrace in Central Park, New York, several patches, which were applied during the 1980's restoration of this site, developed a disfiguring black coloration on the surface or around the edge of the stone-patch interface [1] (Fig. 1). No records were available to indicate whether or not a polymeric resin binder had been used with the patching formulation.

**Fig. 1** Stone pillar at Bethesda Terrace, Central Park, New York, showing discoloration of a patch at the base

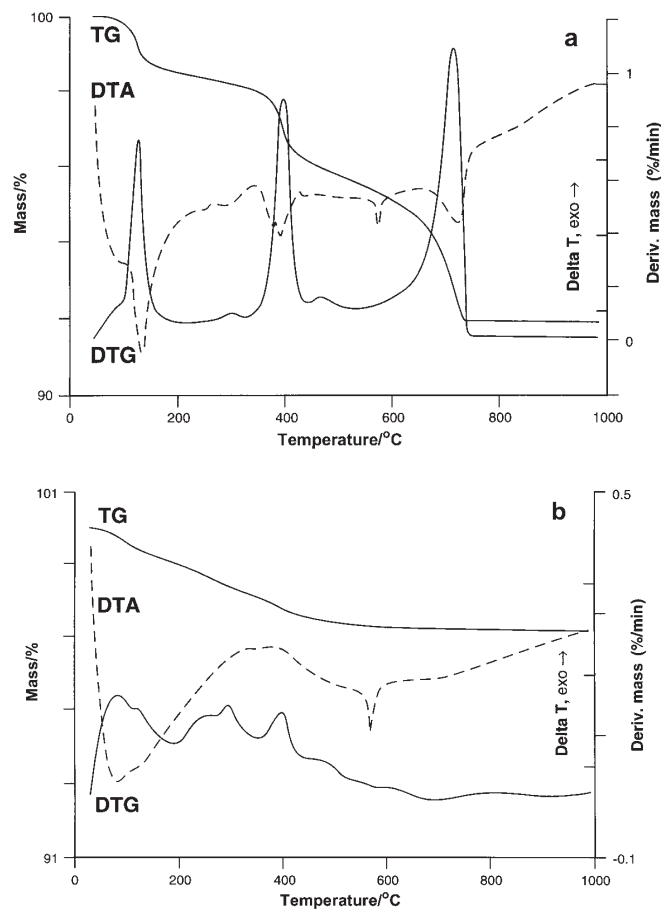
Figure 2 shows the comparison of the TGA/DTA data between the patch interior and exterior, black patch, samples of the patching material at Bethesda Terrace. Of

**Fig. 2** Combined TG/DTA of stone patch interior. Sample size, 24.5 mg, heating rate  $20^{\circ}\text{C min}^{-1}$  in  $\text{N}_2$  (a). Black patch from sample exterior. Sample size, 23.8 mg, heating rate  $20^{\circ}\text{C min}^{-1}$  in  $\text{N}_2$  (b)

particular interest is the organic component that was evolved between 200–600°C. In the interior sample of the patch there was only one predominant mass loss regime between 206–535°C. This occurred with a maximum in DTG at 398°C and a total mass loss of ~3.0% in this range whereas the black patch had a total mass loss of only ~1.8% in the range 184–620°C and was accompanied by three small maxima in the DTG, at 248, 295 and 396°C. This indicates that the organic product on the surface is of totally different composition from that in the bulk. Note also the difference in character of the bound water, peak maximum at 120–125°C, and carbonate decomposition at 720–730°C, from calcite crystals that were also identified by XRD. The latter components of the patch were confirmed by mass spectrometry with evolution of H<sub>2</sub>O and CO<sub>2</sub>, respectively.

The other interesting feature observed in the DTA curves of all patching material was the sharp endotherm at approximately 575°C that had no associated mass loss. This is due to the alpha-beta phase transition in quartz and could, in principle, be used to determine the amount of sand in the patch.

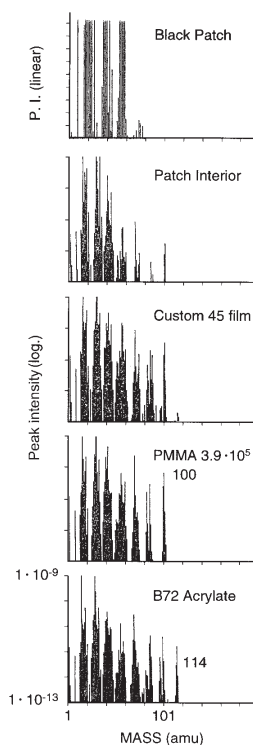
**Fig. 3** Mass spectra of volatiles detected at the maximum rate of evolution in the temperature range 200–600°C during combined TG/DTA/MS runs for the samples shown. All intensities are on a logarithmic scale, range  $1 \cdot 10^{-13}$  to  $1 \cdot 10^{-9}$ , except for the black patch which is linear ( $0$ – $10 \cdot 10^{-13}$ )

DTA data also show striking differences between the organic components in both samples. The DTA of the patch interior organic component showed behavior consistent with that of an acrylate. This was confirmed by mass spectrometry of the volatile component at the point of maximum rate of mass loss, approximately 400°C, which showed strong similarities to the degradation pattern of both a pure sample of polymethylmethacrylate and of the Custom SYSTEM 45 acrylate, though there are slight differences in the mass spectra of each (Fig. 3). It is clearly not a co-polymeric acrylate like B72 in which one of the monomers in the co-polymer, ethylmethacrylate, can be observed in the mass spectrum at 114 amu compared to methylmethacrylate at 100 amu. Note that in these mass spectra the intensity of the black patch is shown on a linear scale ( $0-10 \cdot 10^{-13}$  ion current) whereas all others are on a logarithmic scale from  $1 \cdot 10^{-13}$  to  $1 \cdot 10^{-9}$ . This indicates that very little of the volatiles evolved from the black patch makes its way through the heated capillary tube to the mass spectrometer. The DTA of the black patch also indicates the existence of exothermic behavior in the range 200–300°C that may be due to production of  $\text{CO}_2$  and water, which could not be observed in the mass spectra due to their relatively high background concentrations.

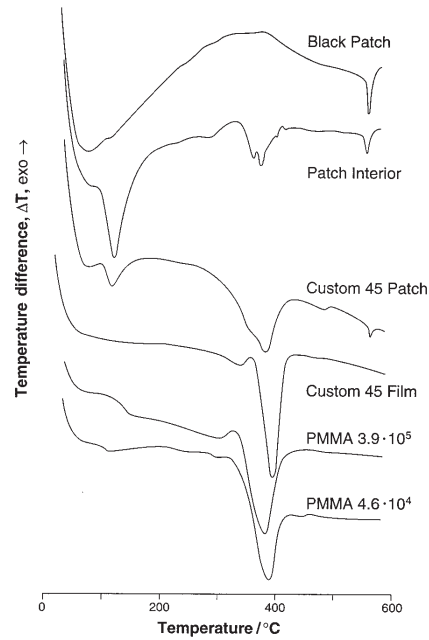
**Fig. 4** DTA curves for the samples of patching material and pure polymers as indicated. Heating rate  $20^\circ\text{C min}^{-1}$  in  $\text{N}_2$ . Exotherms are up

Figure 4 shows the DTA thermal degradation patterns in the organic region of the curves for the subject material and representative pure acrylates and patching materials. Observe that the patch interior showed very similar characteristics to the Custom 45 patching material whereas the pure Custom 45 film decomposed much more

cleanly at slightly higher temperature and was qualitatively similar to the degradation of the pure PMMA films. The dependence of this shift in peak maximum with the presence of patching material makes it difficult to assign the polymeric species by this measurement alone and the simultaneous measurement of the mass spectrum is essential.

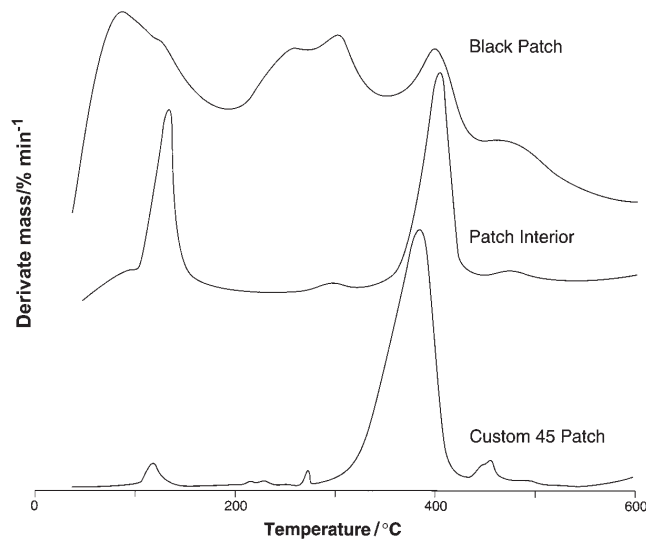
**Fig. 5** DTG curves, %mass change/min vs. temperature, for black patch, patch interior and Custom 45 patch. Note that the vertical scale is arbitrary. Conditions as above

Figure 5 shows the DTG plots for the black patch and patch interior samples of the Bethesda samples compared with that of a Custom 45 patch that had been freshly prepared. The similarities in the patch interior and the fresh Custom 45 patch can be clearly observed while the black patch has a small maximum around 400°C and two new, small maxima in the range 200–300°C. No differences were observed on fresh Custom 45 patching material that had been allowed to stand for either 3 or 20 h after mixing.

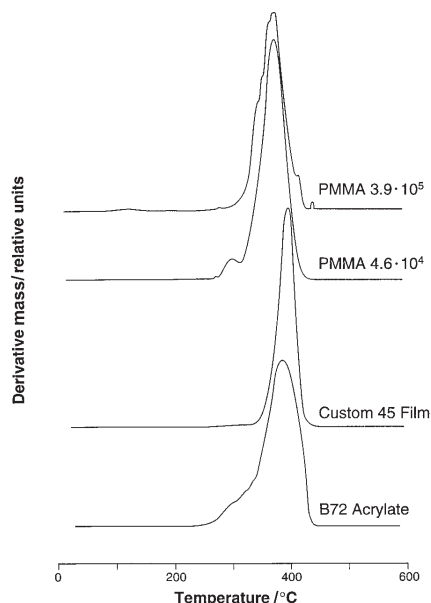
**Fig. 6** DTG curves for pure polymer samples as shown. Vertical scale is arbitrary. Conditions as above

Figure 6 compares the DTG plots for pure polymer samples, two PMMA samples, a Custom 45 film and a B72 acrylate film. Again these results are consistent with the organic component being a pure PMMA-type rather than a co-polymer such as B72. The mass spectrum of the Custom 45 film, Fig. 3, indicates the possible presence of a low concentration of ethylmethacrylate co-polymer that results in a slightly higher maximum temperature in the DTG and corresponds to that of B72 acrylate.

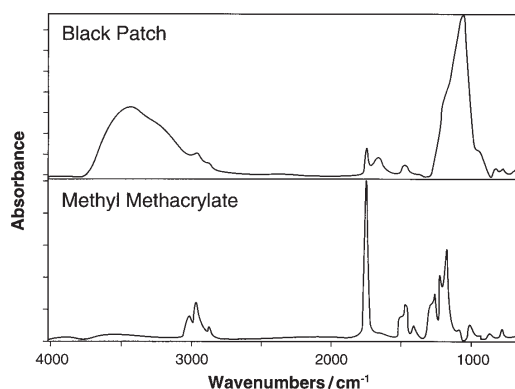
Infrared spectroscopy is also consistent with the polymer being a polyacrylate (Fig. 7), in which the FTIR spectrum of the black patch, obtained using an infrared microscope, was compared with that of a sample of methylmethacrylate in solution.

Fig. 7 FTIR spectra of the black patch and a methylmethacrylate solution obtained using an FTIR microscope
