The Application of Thermal Sprayed Coatings for Pig Iron Ingot Molds

H.-J. Kim and Y.-G. Kweon

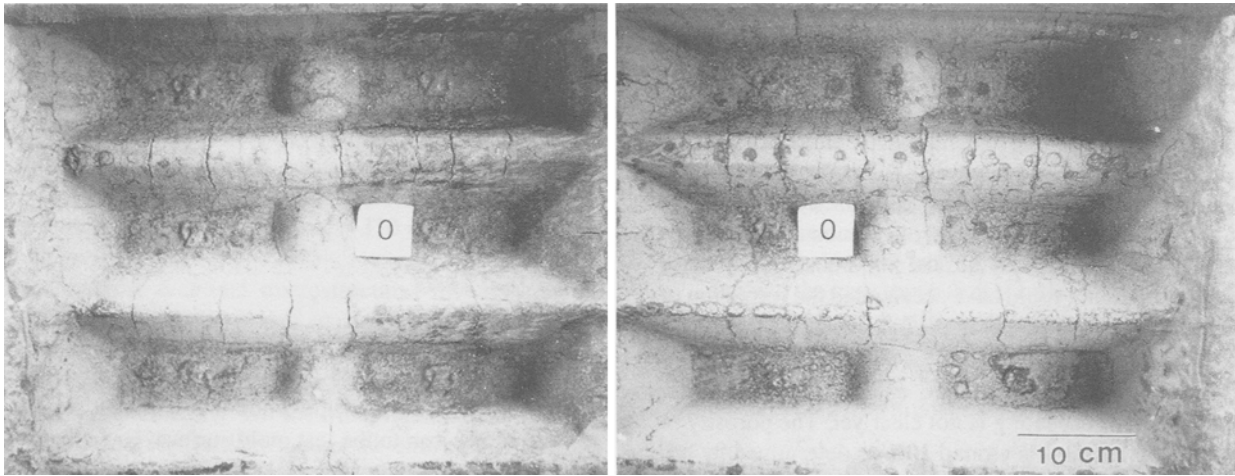
Evaluation of the performance of each coating was carried out by measuring the total number of cracks (n), the maximum crack length (D_{max}), the average crack length (D_{ave}), the total crack length (T), and the total crack area ($n \times D_{ave}^2$) in a mold. A typical crack pattern in a mold is shown in Fig. 3. Note that most of the main cracks for both coated and uncoated molds were parallel to the direction of molten iron flow, which is perpendicular to the longer dimension of the rectangular molds in Fig. 3. An expected benefit of a ceramic coating was that solidified pig iron would shake out better from ceramic coated molds than from uncoated molds even if the coated molds exhibited the same crack length and density.

Fig. 3 Typical surface morphology of field tested mold specimen showing many vertical cracks

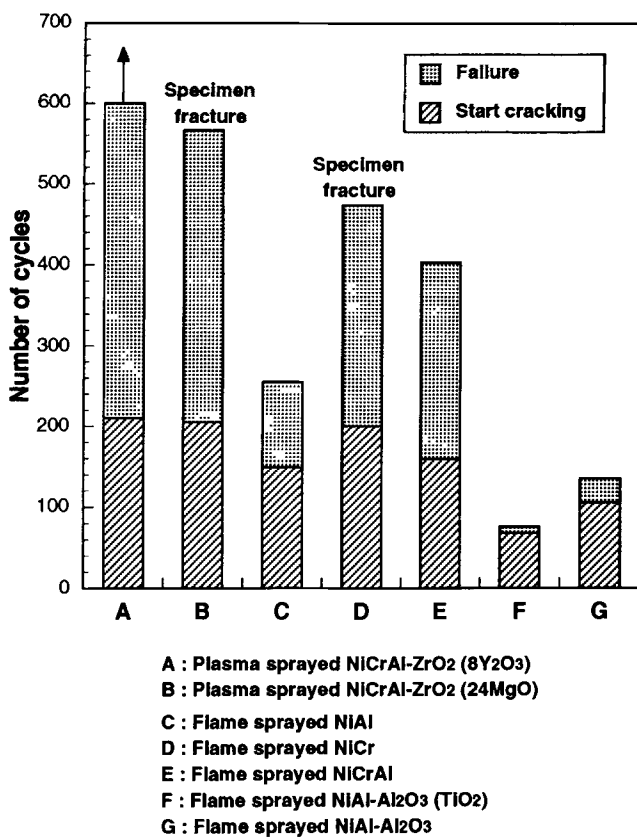
The results of cyclic furnace tests in air are shown in Fig. 4. The failure of the plasma sprayed $ZrO_2-24MgO$ coating (B) and the powder flame-sprayed NiCr coating (D) was by cross-

tional fracture of the whole specimen rather than spalling of the coating. The spalling of the coating started around the center of the specimen. The poor performance of the flame-sprayed alumina and alumina/titania coatings are considered to be due to their high proportion of unmelted particles and high porosity.

Fig. 4 Results of thermal cycling tests in air

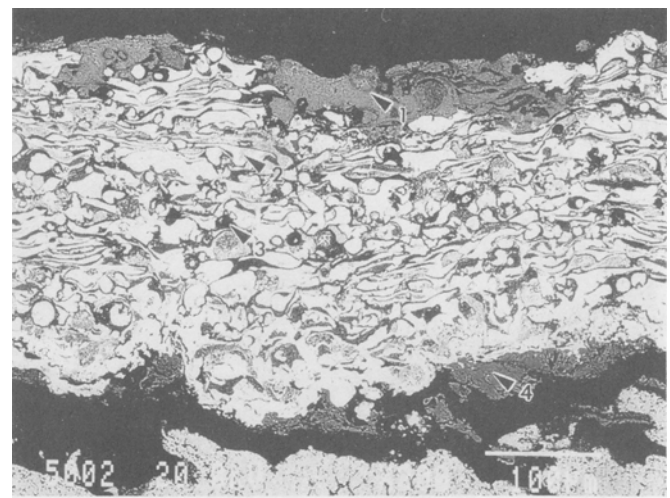
The cross-sectional view (backscattered electron) of the NiCr coating after the thermal cycling test is shown in Fig. 5. The No. 1 region is NiO and $NiCr_2O_4$, as determined by energy-

dispersive spectroscopy (EDS) analysis (Table 2) and x-ray diffraction (XRD). The No. 4 region is considered to be iron oxide based on Table 2. The failure clearly occurred along the iron oxide layer between the bond coating and the gray iron substrate. Spalling of the NiAl and NiCrAl coatings also occurred along an iron oxide layer between the bond coating and the gray iron substrate.

Fig. 5 Backscattered electron image of flame sprayed NiCr coating after thermal cycling test in air

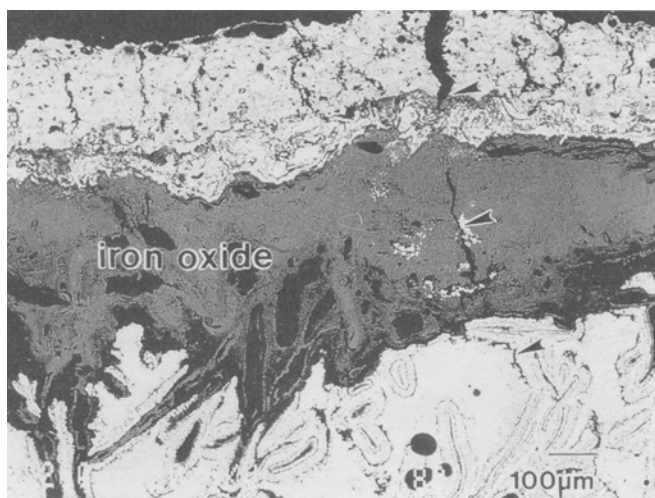
A backscattered electron image of the ZrO₂-24MgO coating after thermal cycling is shown in Fig. 6 where a thick iron oxide

layer formed between the bond coat and the gray iron substrate. Many vertical cracks exist in the ceramic top coating, but one large crack, as indicated by the arrow, propagates through the iron oxide layer and the substrate although blunting of the crack seems to have occurred in the bond coating.

Fig. 6 Backscattered electron image of plasma sprayed $ZrO_2-24MgO$ coating after thermal cycling test in air

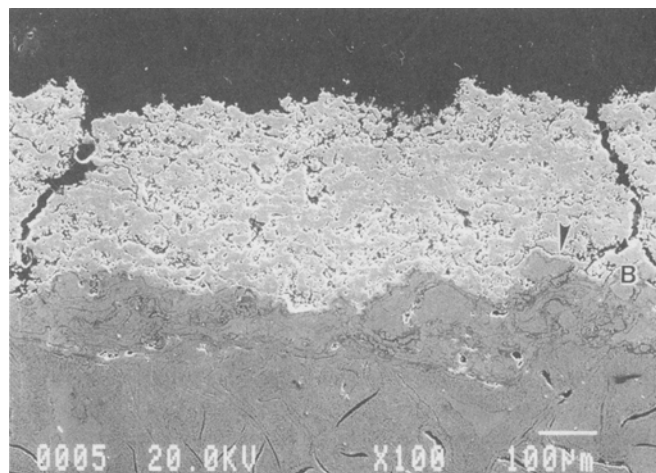
On the other hand, the ZrO₂-8Y₂O₃ coating after the thermal cycling test has no sign of iron oxide formation under its bond coat, as shown in Fig. 7. The only difference before and after the thermal cycling test is the existence of the vertical cracks. The

vertical cracks stop at the bond coating and propagate along the ceramic coating as indicated by the arrow in region B.

Fig. 7 Cross-sectional scanning electron microscopy (SEM) image of plasma sprayed $ZrO_2-8Y_2O_3$ coating after thermal cycling test in air

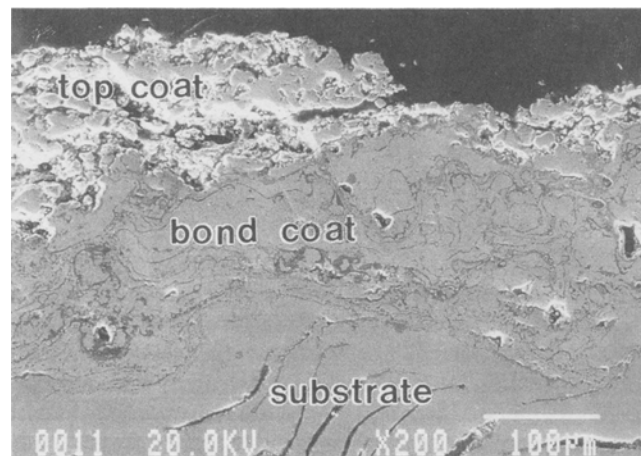
Based on the thermal cycling tests in air, 12 coating specimens mounted in a mold were tested in a pig iron production line. This test was interrupted due to significant attachment of solidified pig iron to the test mold surface. Examination of the coating microstructures revealed comingling of the metallic coatings and the solidified iron. Erosion of the ceramic top coating occurred as shown in Fig. 8. Therefore, powder flame-sprayed metallic coatings were excluded from further field tests because the erosion behavior led to attachment of the metallic coating and the solidified iron. Plasma sprayed alumina coatings were tested further because of their excellent wear resistance and better properties.

Fig. 8 Cross-sectional microstructure of $ZrO_2-8Y_2O_3$ coating after approximately 140 operating cycles exposed to iron casting environments

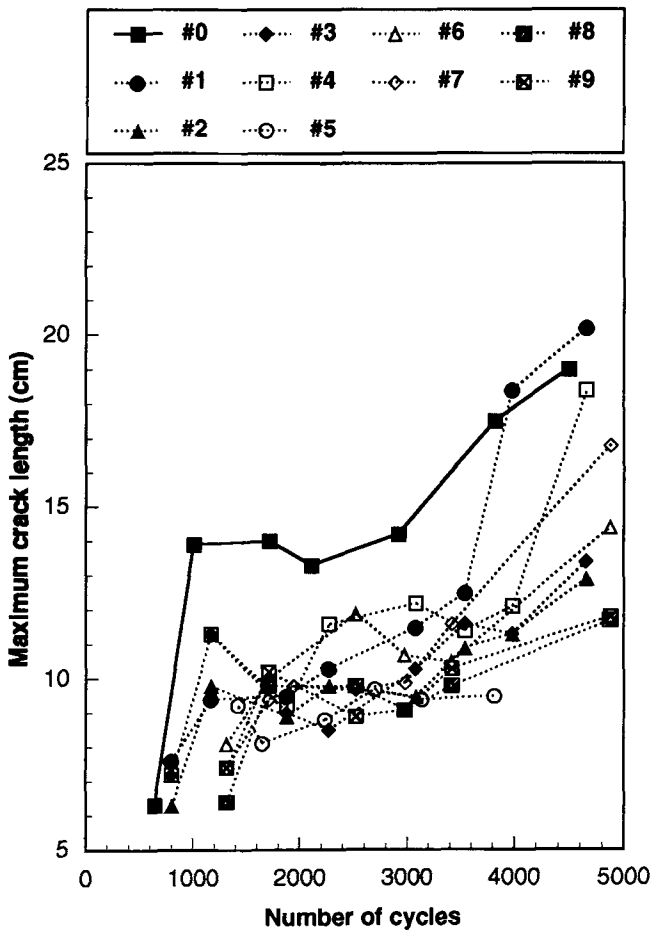
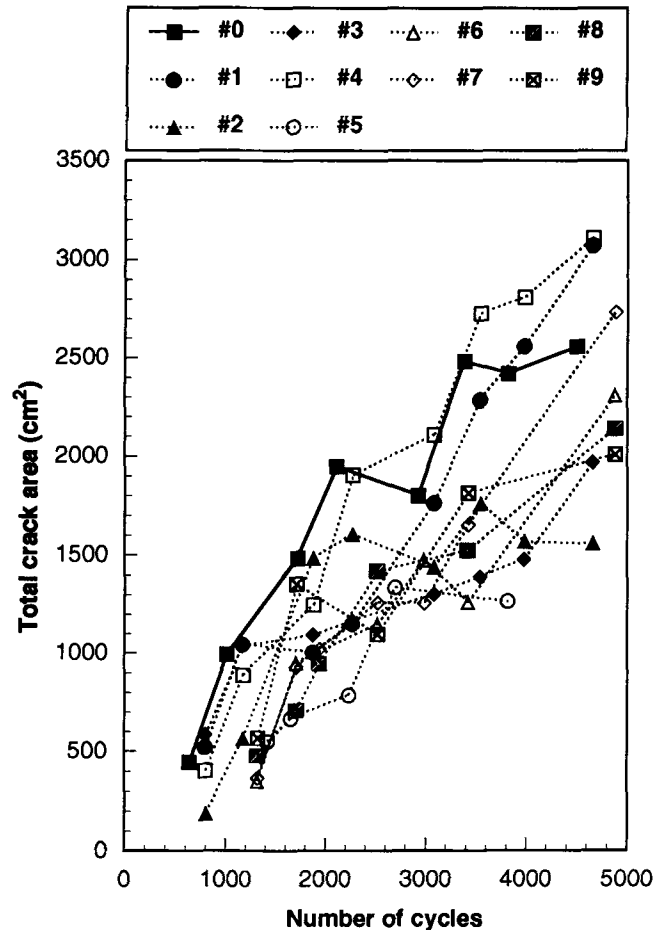
For the whole-mold coatings, the variations of maximum crack length and total crack area as a function of operating cycle are shown in Fig. 9 and 10, respectively. The crack dimension was measured without grinding the surface; thus the values sometimes appeared to decrease as the test proceeded. This can be explained by the fact that solidified iron can penetrate the cracks during the cycle making the measurements misleading. Another explanation is that cracking propagated along a main crack after the formation of the first few cracks, and the thermal stress was then dissipated in extending the main cracks instead of creating more new cracks. These phenomena are typical for flake cast iron as reported in Ref 1 and were confirmed by the cross-sectional examination (both parallel and perpendicular to the main cracks) of 5,000 cycled molds. Therefore, the thermal fatigue cracking behavior of fully

Mold life is evidently governed mostly by maximum crack length, and the detachability of solidified pig iron from molds is governed mostly by total crack area. Plasma sprayed alumina-based and $ZrO_2-8Y_2O_3$ based coatings with 200 μm top coating thickness are the most promising materials after approximately 5,000 operating cycles (approximately 110 operating days) as shown in Fig. 9 and 10.

Fig. 9 Maximum crack length in a mold as a function of operating cycles. Sample codes are given in Table 1.

Fig. 10 Total crack area in a mold as a function of operating cycles. Sample codes are given in Table 1.

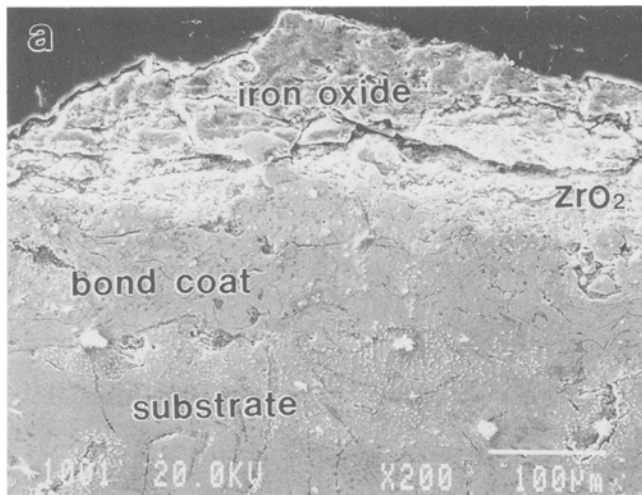
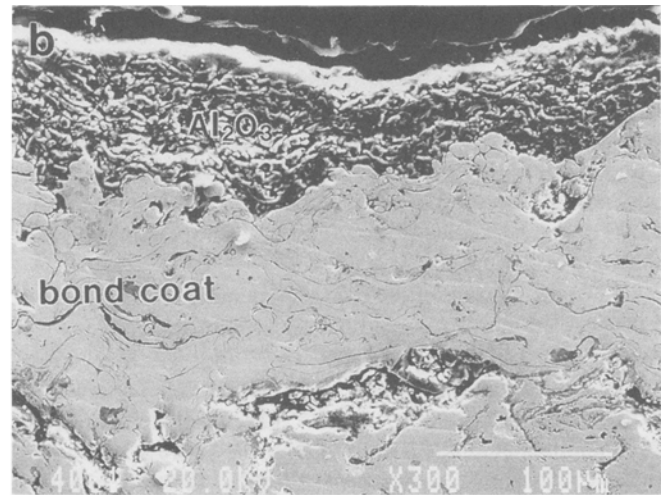
However, cross-sectional microstructural investigation of 5,000 cycled molds revealed that erosion of the coatings was caused by molten iron as indicated in Fig. 11. Most $ZrO_2-24MgO$ coatings were eroded, and an iron oxide layer was attached to the bond coating. On the other hand, about 100 μm thick alumina coatings remained over the entire bond coating surface. The coated molds behaved better than the uncoated ones until around 3,000 cycles, and then their performance fell down (Fig. 9 and 10) because of either erosion or spalling of the ceramic top coatings in service. Note that both bond coatings in Fig. 11 are virtually intact even after approximately 5,000 operating cycles. Therefore, mold life and detachability of the solidified pig iron from molds were independent of the bond coating materials used. Thus, plasma sprayed alumina coatings with 200 μm top coating thickness were the most promising materials for

Fig. 11 Cross-sectional microstructures of plasma sprayed coatings on cast iron molds after approximately 5,000 operating cycles for pig iron ingot production. (a) ZrO_2 -24MgO and (b) Al_2O_3

pig iron casting environments taking also into account cost and erosion resistance.
