Assessment of Damage Accumulation in Thermal Barrier Coatings Using a Fluorescent Dye Infiltration Technique

B. Barber, E. Jordan, M. Gell, and A. Geary

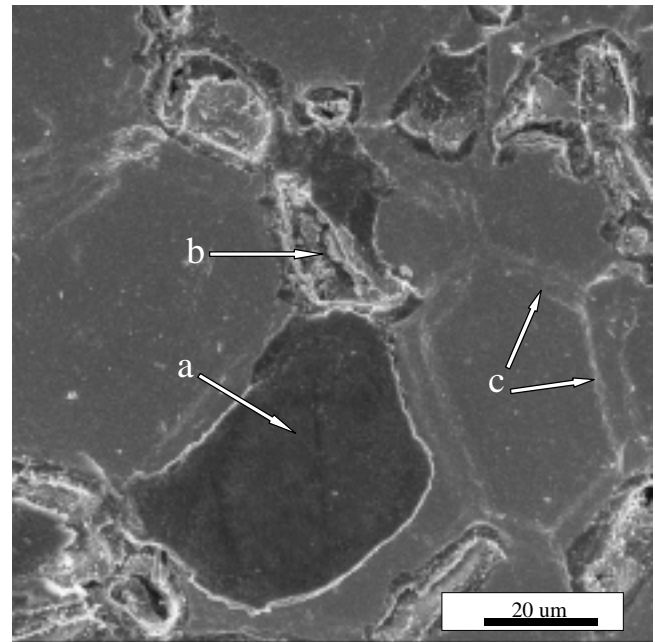
When the fracture surface of the EB-PVD samples was investigated after spallation or after failure in the direct pull test, the mechanism leading to the weakening and failure was not clearly apparent. There was evidence of grain boundary ridges formed during the specimen manufacturing and deep crevices formed in the bond coat during thermal cycling (Ref 3), as seen in Fig. 4. Oxide flakes (see white arrows in Fig. 4) on the metallic bond coat were also apparent across the fracture surface in samples that failed during thermal cycling (Ref 3). When an uncycled specimen was fractured in the direct pull test, ridges at

Fig. 4 Fracture surface of spalled Pt-Al / EB-PVD specimen (arrows indicate (a) oxide flake (b) crevice and (c) grain boundary)

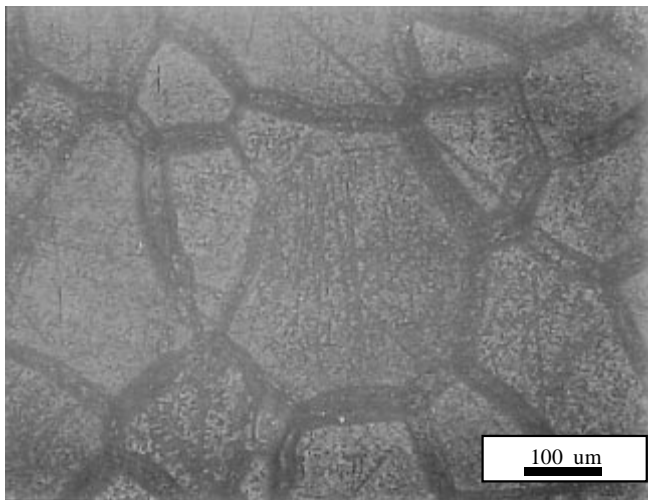
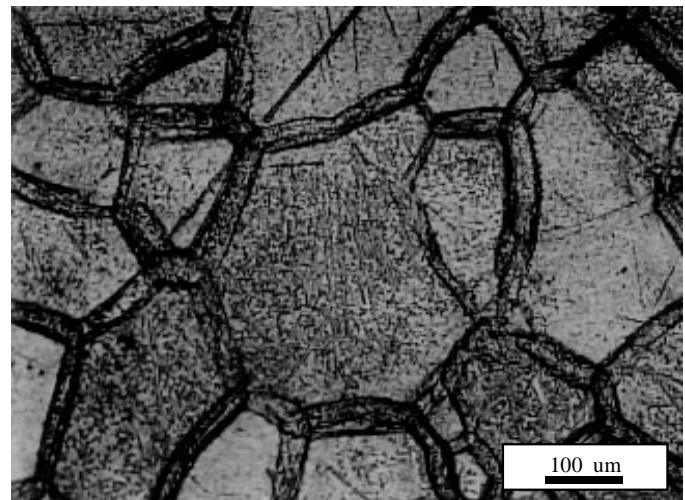
Fig. 5 Paired optical micrograph of 0-cycle Pt-Al / EB-PVD fracture surfaces infiltrated with fluorescent epoxy (ceramic fracture surface (left), opposing substrate fracture (right))

The Pt-Al/EB-PVD zero cycle specimen was prepared with the rhodamine dye and fractured in the direct pull test. Figure 5 shows the fracture surfaces at the ceramic to bond coat interface. For both fracture halves, there was no dye evident. This indicated that there were no preexisting flaws such as debonds or voids at the failure interface. The integrity of the zero cycle specimens was consistent with their high bond strengths exceeding 65 MPa (9500 psi) as was measured by the conventional direct pull test without infiltration.

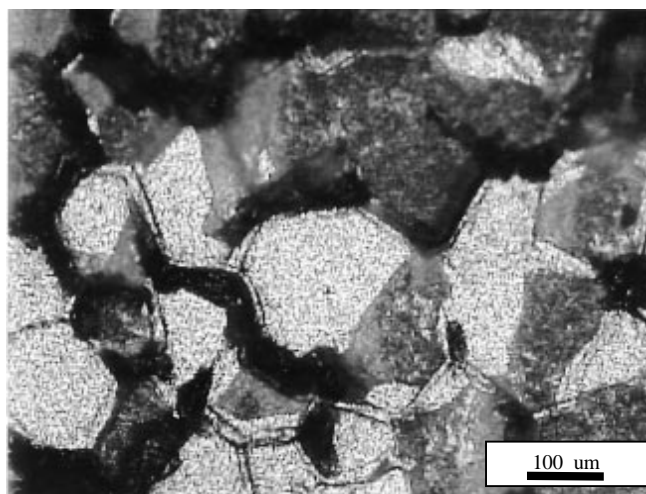
When the same coating system was thermally cycled 400 times and then impregnated with the fluorescent epoxy prior to the direct pull test, regions infiltrated with the fluorescent epoxy became evident on the failure surfaces. Most of these damaged regions corresponded to grain boundaries or grain boundary junctions, as shown in Fig. 6. The damage helps to explain the decrease in bond strength for the EB-PVD to 38 MPa (5500 psi).

Fig. 6 Paired optical micrographs of cycled Pt-Al / EB-PVD fracture surface infiltrated with fluorescent epoxy (ceramic side left, substrate side right)

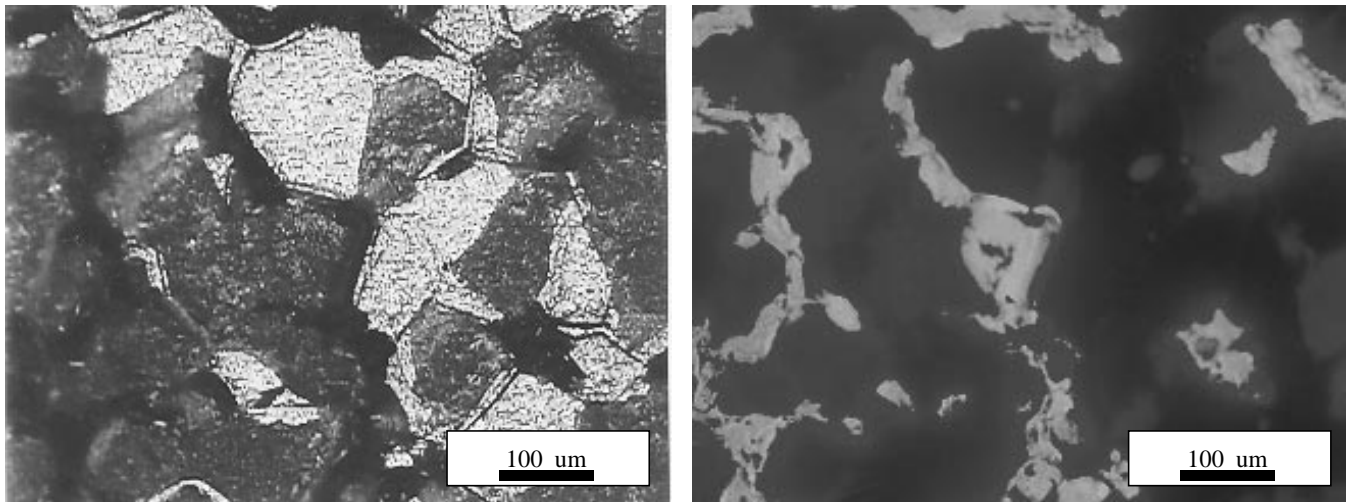
As shown in Fig. 6, the distinct color of the rhodamine dye helped reveal damage in the TBC microstructure. In some instances, however, the conventional optical microscope did not show a clear distinction between regions infiltrated with the fluorescent dye and regions devoid of the dye. To further enhance the contrast of the dye to the surrounding surfaces, a mercury light source was used in a fluorescence microscope to fluoresce the rhodamine dye. An example of the contrast enhancement is seen in the cycled EB-PVD fracture surface shown in Fig. 7, which compares the same region as seen with and without fluorescence. As clearly shown, all damage is associated with grain boundary regions.

Fig. 7 Optical versus fluorescence micrograph of cycled Pt-Al / EB-PVD fracture surface infiltrated with fluorescent epoxy (conventional optical left, fluorescence right)

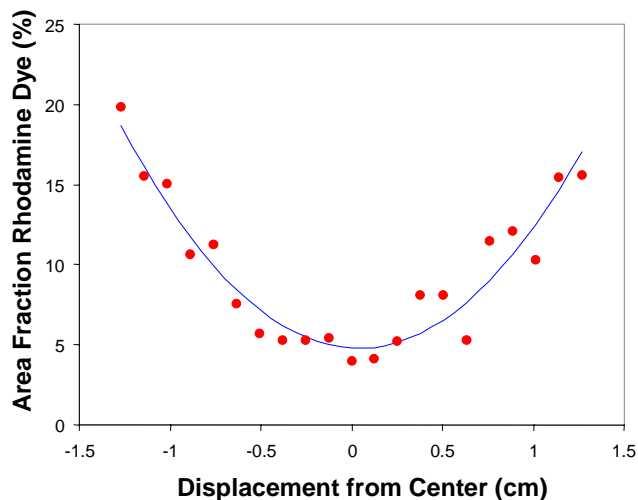
Fig. 8 Variation of area fraction of debonds across the fracture surface of Pt-Al / EB-PVD 400-cycle specimen

Once a fluorescence micrograph was produced from an area of the sample, image analysis was conducted to determine the area fraction of fluorescence and hence the area fraction of debonds. Figure 8 shows how the area fraction of debonds, as determined by fluorescence micrographs at a magnification of 100 \times , varied across the 2.54 cm diameter fracture surface of the EB-PVD system.

Area fractions of debonds were found to vary from 4% in the center to 20% near the edge in the 400 cycle specimen. To get an average area fraction of debonding around the entire area of the circular specimen, an area integration must be made from the data plotted in Fig. 8. The data were fit with a parabola that was integrated using the cylindrical shell method and divided by the fracture area of the disk. The average area fraction of debonding as calculated by this method was found to be 11.4%. The in-

crease in damage at the free surface might be correlated with the higher oxide tensile stresses due to edge effects quantified in previously reported finite element analyses (Ref 3). However, the edge effect predicted by this finite element analysis was much more localized than was observed in the rhodamine dye experiment. The magnitude of the scatter in the data can be seen by evaluating the variation in the adjacent data points in Fig. 8 and is approximately $\pm 1\%$. The error in using this method is difficult to establish because it is not possible to compare the measured result to the actual area fraction of debonding.

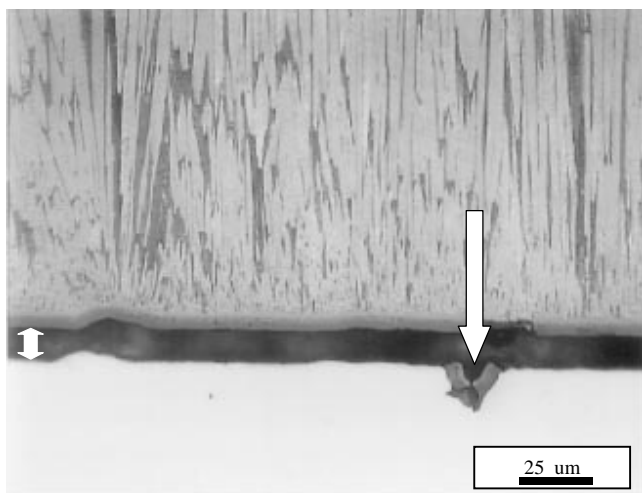
Figure 9 shows a typical coating cross section containing a crevice formed during thermal cycling (Ref 3). The fluorescent epoxy infiltrated into the crevice prior to debonding of the ceramic (see arrows in Fig. 9) due to shrinkage of the mounting epoxy.

The crevice penetrated about 12 μm into the bond coat. A void was apparent within the oxide layer (see single arrows in Fig. 9 and 10), at the ceramic to TGO interface above the crevice. To investigate the nature of the void, serial polishing was employed to show two additional sections through this three-dimensional defect and the associated crevice (see Fig. 10 and 11). Approximately 200 μm (0.008 in.) of material was removed between the sections shown in Fig. 10 and 11 as measured using a micrometer.

Fig. 9 Cross section of typical crevice in Pt-Al / EB-PVD sample

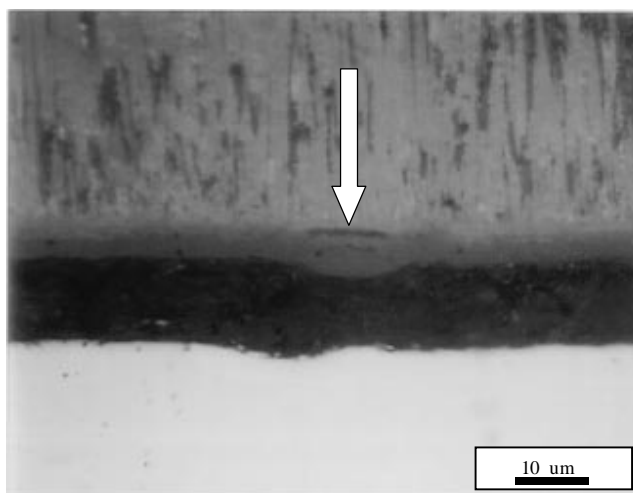
These observations suggest that a void initiates to one side of the grain boundary ridge between the ceramic and thermally grown oxide. The void grows until cracking occurs in the protective oxide formed between the ceramic and the bond coat. Once the protective oxide cracked, oxygen was admitted to the bond coat grain boundary, which in turn accelerated oxidation of the bond coat to develop the crevice by forming more

Fig. 10 Cross section of void initiating between the ceramic and substrate in Pt-Al / EB-PVD sample

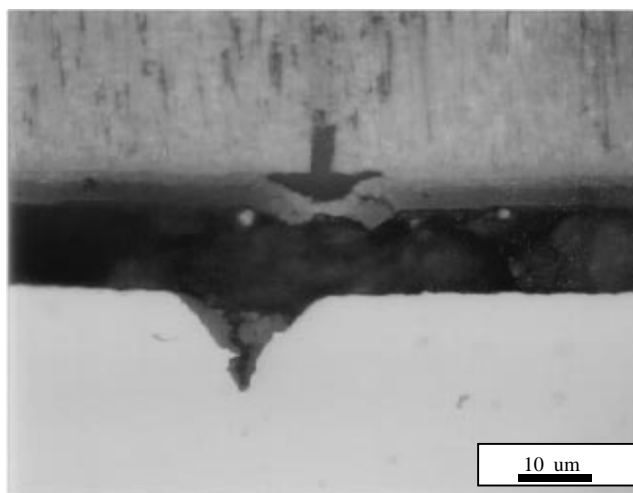
Fig. 11 Cross section of cracks forming around void initiating between the ceramic and substrate in Pt-Al / EB-PVD sample
