# Enhancement of Service Life of Steam Generating Tubes in Oil-Fired Boiler for Power Generation Employing Plasma Spray Technology

Kazumi Tani and Yoshio Harada

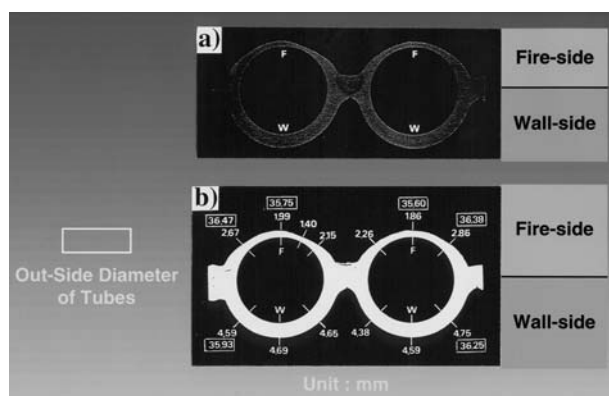
Figure 2 shows a typical cross-section of a corroded tube without sprayed coating that has been employed for 8 years. The tube wall, which was directly exposed to the combustion flame, was thinned significantly, a thickness of 1.40-2.86 mm thickness compared with 4.60 mm for the original thickness while the wall side (facing downward in the photograph) remained at its original thickness. Assuming a maximum difference in thickness of 3.20 mm, the corrosion rate is estimated to have been only from 0.3 to 0.5 mm a year. The microstructure of these deposits is shown in Fig 3. Relatively thin and dense scale adhered to

**Fig. 2** Typical cross-section of a corroded tube without sprayed coating employed for 8 years. (a) Macro structure and (b) distribution in thickness of wall tube

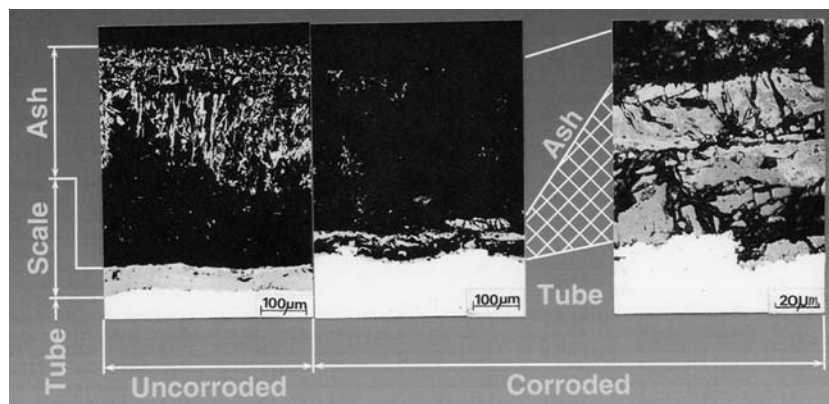
the uncorroded steel substrate. On the other hand, the corroded area was covered with coarse and cracked scale, and its scale had partially dropped off, resulting in uneven corrosion. The scale on the corroded area was composed of sulfur, oxygen, sodium, and vanadium to a large extent, and these elements were distributed almost uniformly throughout the scale. As listed in Table 2, they existed as metal oxide, sulfate and/or sulfide, depending on various conditions. In contrast with the corroded area, sulfur was concentrated near the boundary between the scale and the substrate of the uncorroded area, while the outer surface was enriched with oxygen. These results were obtained by using electron probe micro analysis.

**Fig. 3** Microstructure of the corroded and uncorroded area on the evaporator tube without sprayed coating

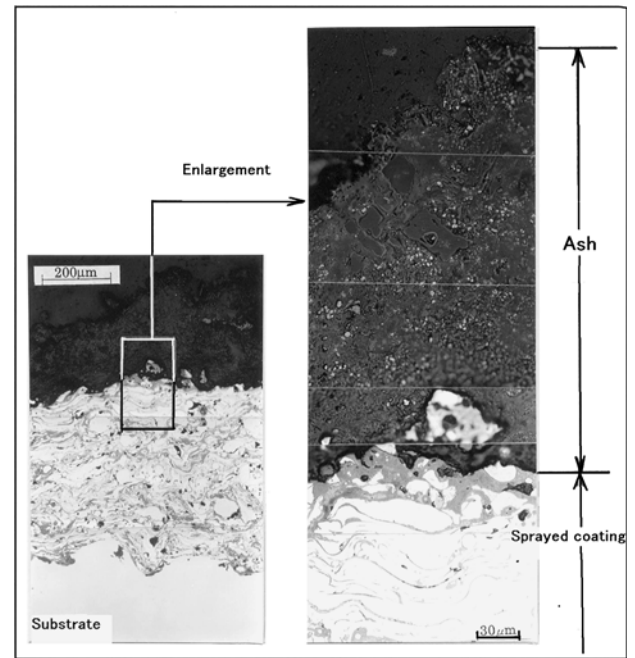
The cross-section of removed portion of plasma spray coated evaporator tube, which was employed in the boiler combustion chamber for 72,000 h, was inspected. The metallographic result was shown in Fig. 5. The cross-sectional image of the coating shows good adhesion to steel substrate and sufficient thickness. The excellent corrosion resistance was observed and the continuous employment for longer time was presumed. The magnified image of outer surface of sprayed coating is shown in Fig. 6. The constituent materials for the corrosion layer denoted in

**Fig. 5** Cross-section of removed portion of plasma spray coated evaporator tube employed in the boiler combustion chamber for 72,000 h

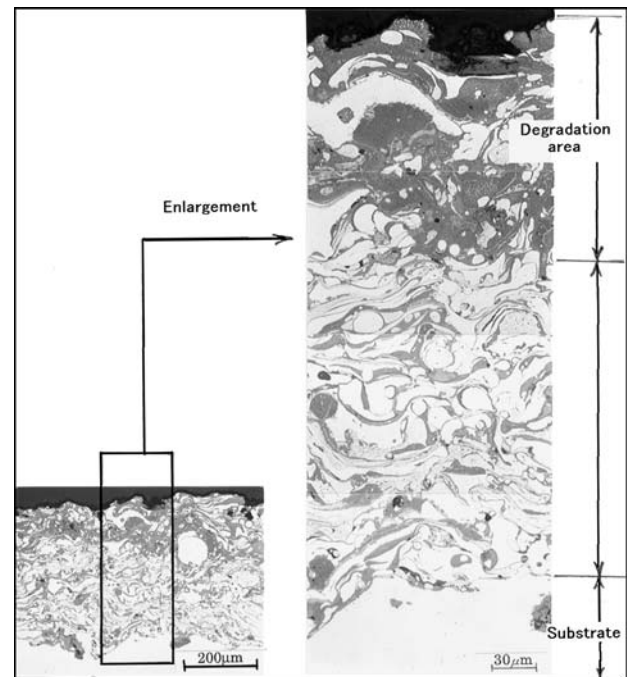
**Fig. 6** Magnified image of outer surface of sprayed coating of removed portion of plasma spray coated evaporator tube employed in the boiler combustion chamber for 72,000 h

Fig. 6 are mainly vanadium, sodium, and sulfur compounds as described in Table 2. The result shows that the combustion ash penetrated into the grain boundaries of

Ni-50 mass% Cr to exfoliate alloy grains from the coating lamellar structure. Even with the sprayed coating, which has the porosity of several percent, the corrosion reaction with ash tends to progress with the consecutive peeling off of the alloy particles of the coating surface section. This phenomenon suggests that the corrosion rate could be determined nondestructively by the measurement of coating thickness. Moreover, the phenomenon that the reduction of corrosive action of ash penetrated into the pores of sprayed coating and grain boundaries of alloy particles was prominently observed in the sprayed coating for superheater tubes. This result suggests that the pores or grain boundaries in the sprayed coating have no adverse effects. As mentioned above, the chemical composition of the ash penetrated into the pores and grain boundary has no great difference from that of ash that covers the sprayed coating surface (Ref 15, 16). The ash penetrated into the narrow labyrinth path of the sprayed coating, for instance, grain boundary between alloy particles limit the supply of  $O^{2-}$ ,  $S^{2-}$ , and the reaction of ash with the sprayed coating increases the melting point to promote the solidification of ash (Ref 16). It is considered that as the solidification tends to interfere the mobility of metallic ions and corrosive ions, the corrosion rate inside the sprayed coating is remarkably decreased.

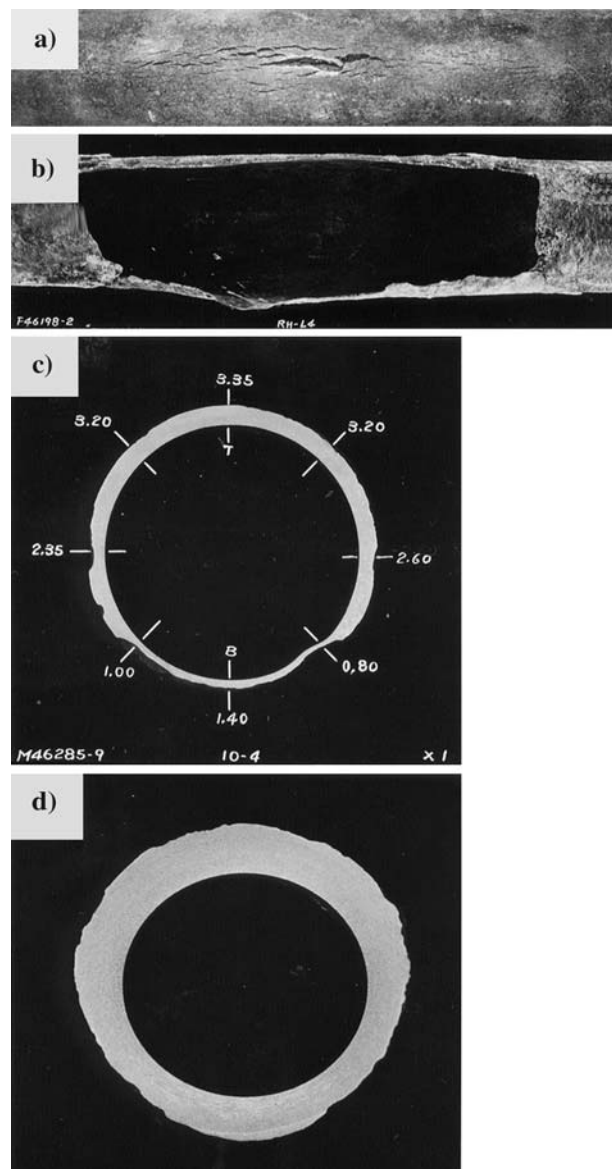
Figure 7 shows the typical high temperature corrosion situation of superheater tubes (a, d) and reheater tubes (b, c) installed in high temperature zone in boiler. In the case of superheater tubes, the overheating damage caused by the yield to high-pressure steam is derived from the remarkable decrease in thickness in the corrosive environment of elevated temperature of superheaters. On the other hand, in reheaters tubes with thickness like a sheet of paper are often discovered. This damage is obviously derived from the corrosion by vanadium (vanadium attack), because the ash, which deposited on the surfaces of the superheater and reheater tubes includes vanadium compounds from 30 to 50 mass% and it is low-melting eutectics. The fundamental corrosion reaction is considered that the accelerated oxidation corrosion reaction by vanadium complex contained in combustion ash, is dominant as follows (Ref 17, 18):

Here  $m$ ,  $n$ , and  $p$  are integers. Also,  $Na_2SO_4$  coexisted in  $V_2O_5$ ,  $SO_3$ , and  $O_2$  is formed in corrosion reaction, and the lower melting point than  $V_2O_5$  (melting point is 963 K) such as  $5Na_2O \cdot V_2O_4 \cdot 11V_2O_5$  (melting point is 808 K) might accelerate the corrosion reaction.

**Fig. 7** Typical high temperature corrosion situation of superheater tubes (Type 321) and reheater tubes (Type 304) installed in high temperature zone. (a) Outside of superheater tube, Type 321 (b) Outside of reheater tube, Type 304 (c) Cross-section of reheater tube, Type 304 (d) Cross-section of superheater tube, Type 321

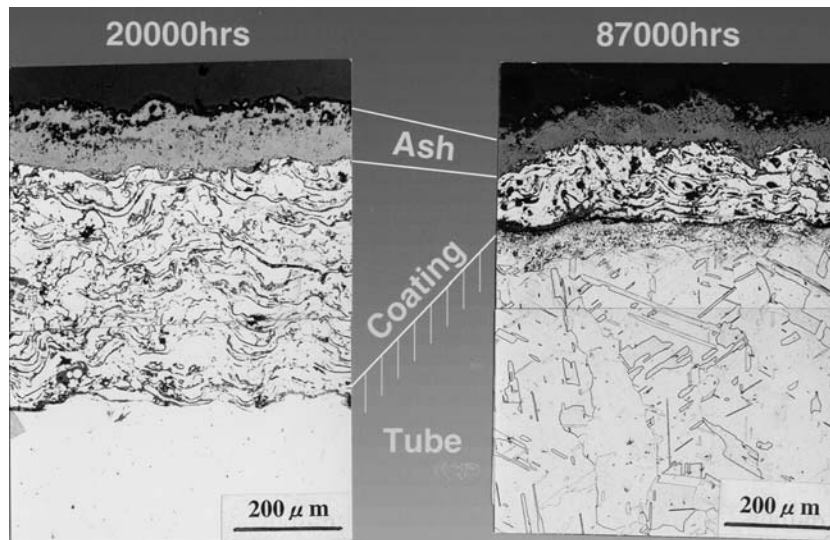
The cross-sectional micrograph of Ni-50 mass% Cr alloy sprayed coating onto superheater tubes for corrosion prevention employed for 20,000 and 87,000 h are shown in Fig. 8. Though the remaining thickness of sprayed coating is less than that onto evaporator tubes, the consumption of coating caused by corrosion reaction was proceeding equally from surface to inside. The corrosion rate of this superheater tube without sprayed coating was from 0.3 to

**Fig. 8** Cross-sectional micrograph of Ni-50 mass% Cr alloy sprayed coating onto superheater tubes for corrosion prevention employed for 20,000 and 87,000 h

0.5 mm a year, however, that of sprayed coating was only from 0.1 to 0.2 mm a year. The decreasing of corrosion degradation rate of superheater tubes is recognized. As shown in the cross-sectional micrograph of Ni-50 mass% Cr alloy sprayed coating, the penetration of ash through pores or grain boundaries of the sprayed coating is observed regarding this environment. Vanadium complex, which is a major constituent of ash inside sprayed coating, chemically reacts with nickel and chromium. The vanadium complex is reduced to form low complex oxide that is less corrosive. For example,

Furthermore in this case, chromium or nickel oxide (formed by plasma spray heat source), which is contained in sprayed coating, is considered to operate as a mass-transfer barrier against corrosion reaction of ash. The results indicate that the corrosion degradation phenomenon is confined to the surface area of the sprayed coating, where oxygen is easily supplied from outside atmosphere. As described above, Ni and Cr react with vanadium complex ash to form low melting point and higher melting point complex oxide. The pores of sprayed coating and grain boundaries of sprayed particles are impregnated with this vanadium compounds. Due to the impregnation effect, the supply of  $O^{2-}$ ,  $S^{2-}$  is restricted to the surface of the sprayed coating. In the environment of poor  $O^{2-}$ ,  $S^{2-}$ , the high temperature corrosion by vanadium compounds is obviously suppressed. This is the mechanism of the exhaustion of the coating layer. Such a corrosion product or layer tends to peel-off and break away from the coating. Due to this, corrosion product is not observed in the coating specimen for microscopy.
