Control of *Legionella pneumophila* in a hospital water system by chlorine dioxide

JT Walker¹, CW Mackerness¹, D Mallon², T Makin², T Williets³ and CW Keevil¹

Immuno-compromised patients are particularly susceptible to Legionnaires' Disease. After three cases of the disease occurred in a hospital, a continuous dosing regime using chlorine dioxide was initiated to replace chlorination of the water system. This study identified a number of factors which may have resulted in conditions that would encourage the growth of the water-borne pathogen *Legionella pneumophila*. The residual chlorination was inadequate for microbial control at the taps furthest from the four storage tanks, of which two were found to be in excess for demand. The temperature of the water in the storage tanks was also found to be above 20°C; a temperature that would encourage microbial growth. A back-up calorifier was present and was found to contain *L. pneumophila*, and linseed oil-based sealants that provide nutrients for microbial growth were also prevalent as jointing compounds in the water circuit. Although the shower heads were routinely disinfected, a requirement was identified to also disinfect the sho

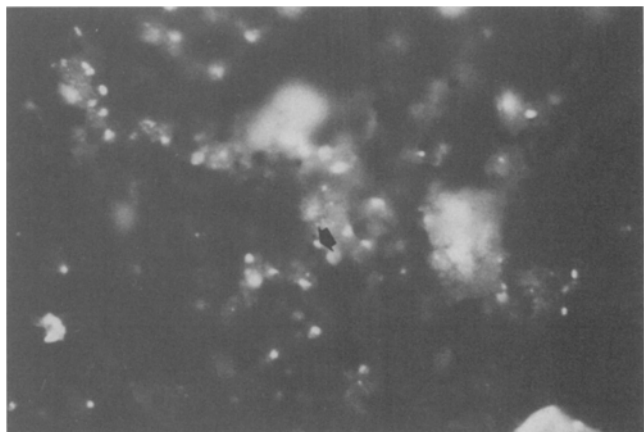
Ward A (pre-treatment): The non-return hot water pipe supplying the sink unit constituted a dead-leg in which linseed oil-based sealant was observed and the pipe surface was covered with a dark soot-like layer. The water retrieved from the pipe was cloudy green, indicative of copper corrosion deposits. When viewed microscopically there was patchy film on the surface with evidence of bacteria and exopolysaccharides (EPS) (Figure 1). Large mounds or tubercles were also present on the copper pipe surface. Water from the cold water shower pipe was relatively clear. Many bacteria were observed on the surface. Water from the hot water pipe was very green in appearance and corrosion deposits as well as blackened areas were observed on the internal surface. The surface appeared to possess a thicker layer of scale and a greater amount of EPS in the hot than the cold supply. All microbial cells were metabolically active as detected by the reduction of CTC (Figure 2).

Figure 1 Demonstration of a mosaic and patchy film on the pre-treated copper tube pipe removed from the hot water circuit of the sink-unit in ward A. Bacterial colonies (identified by arrow) are demonstrated on the surface

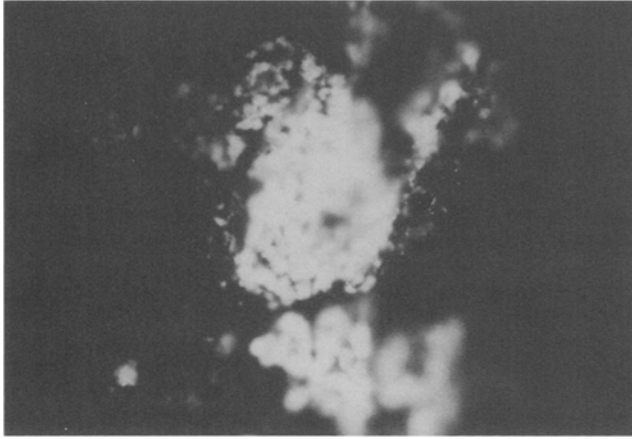
Figure 2 Copper pipe removed from pre-treated ward A hot shower circuit demonstrating a large microcolony in which all the microbial cells present were shown to be metabolically active as detected by the reduction of CTC (as shown by arrow)

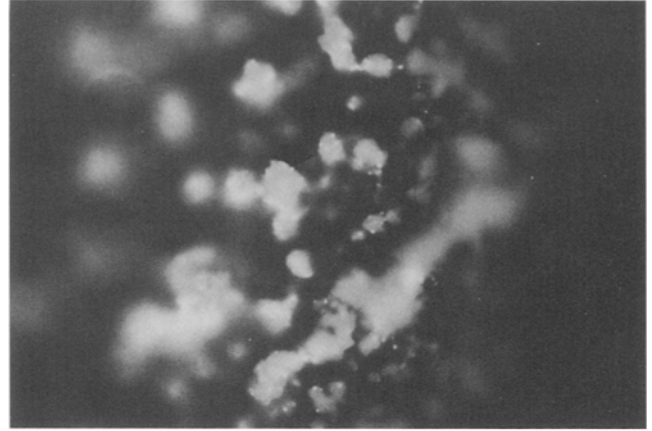
Figure 4 Significant amounts of debris consisting of scale and bacteria were present on the inside surface of the shower unit hot copper pipe of ward B (arrow indicates the position of the bacteria in the microcolonies)

the pipe (Figure 4). When stained for vitality approximately 50% of the microorganisms were metabolically active, suggesting the presence of a thermotolerant population of microorganisms in the shower pipe which was supplied with water originally at 60° C. These microorganisms were presumably resistant to or had been shielded in the biofilm from the effects of the ClO₂ during the time of treatment.

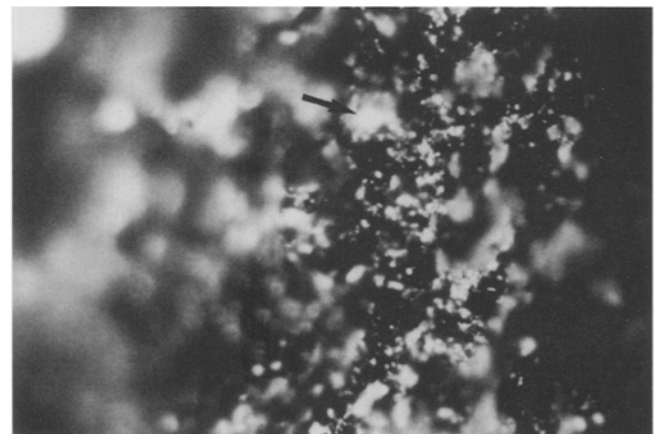
Figure 5 Copious amounts of bacteria were observed, particularly on the surface of the cold water copper pipe from Audrey Leigh control ward (arrow indicates a microcolony)

Copious amounts of EPS and bacteria were observed, particularly on the surface of the cold water pipe (Figure 5). EPS has been demonstrated to chelate copper ions and participate in microbially induced corrosion [12]. Bremmer et al [6] studied the presence of microorganisms on copper specimens using atomic force microscopy and demonstrated the difficulty of studying copper tube that has not been abraded. Using DIC and fluorescence microscopy demonstrates the rapidity with which field samples can be analysed and viewed to investigate biofouling [21]. The whole internal surface of the pipe from the hot water supply was covered with scale (Figure 6). No *L. pneumophila* were cultured from the water or pipe samples in the Audrey Leigh Ward's water system.

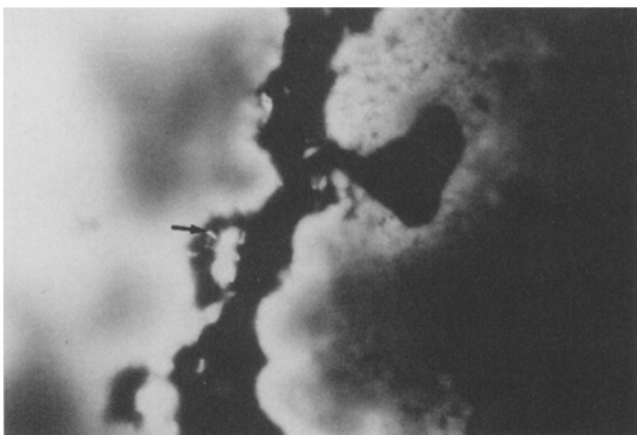
Figure 6 The whole internal surface of the hot water copper pipe from the Audrey Leigh control ward was covered with scale in which bacteria (indicated by arrow) were occasionally observed
