Mechanical failure of a Thompson's hemiarthroplasty stem 28 years post-implantation: an investigation with electron microscopy

Ioannis Maris · Spyros Darmanis · Victor Kytopoulos ·
Angela Economakis · Konstantinos Kazakos

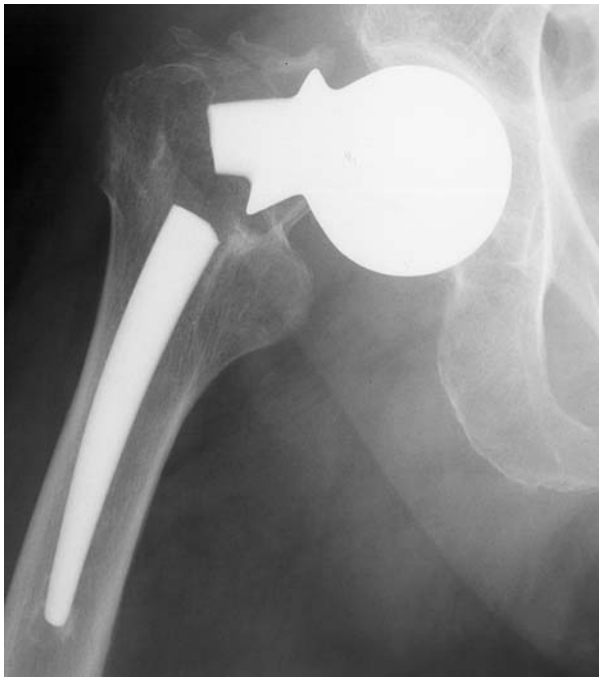
A 95-year-old lady (S.P) (BW 70 kg/height 166 cm) was admitted to our hospital following a fall. She was otherwise fit and healthy. She was mobilizing without any walking aides and she had a good level of pre-injury function. A thorough medical investigation was carried out and apart from a history of mild diabetes which was under dietary control (and on investigation was found to be within the normal range) all other findings were otherwise unremarkable. On examination, shortening and external rotation of the involved limb (right femur) was apparent. No neurovascular compromise was found on the fractured limb. On radiographs, a periprosthetic fracture and a fracture of the implant (stem) were found. Patient's medical records revealed a Thompson's hemiarthroplasty performed 28 years ago. A careful history revealed that she did not trip over and fall of her own accord, but instead she reported hearing and feeling something crack, and then fell down. X-ray revealed radiolucent lines (Fig. 1) and loosening of the prosthesis in zones A and Z according to Dunn's classification [1]. She was

Fig. 1 Radiograph of the hip with the broken stem

taken to surgery and although the central part of the prosthesis was easily removed, the distal part was very well bonded to the bone and was unable to be removed. In order to avoid prolonging the operative procedure and risk additional blood loss, we decided to leave the distal stem in place and convert it to a Girdlestone resection arthroplasty.

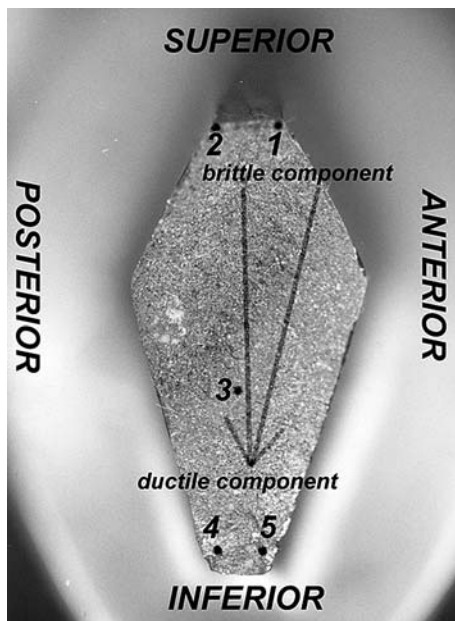
Fig. 2 Section of the broken surface of the stem, showing the different points which were investigated with electron microscopy

which in our case was the posterosuperior area of the stem (Fig. 2). The origin is indicated on the fatigue fractured surface shown in point 2 of the stem (Fig. 2) (posterosuperior area), (Fig. 4A) as well as in Fig. 5A where the crack's front entrance can be seen.

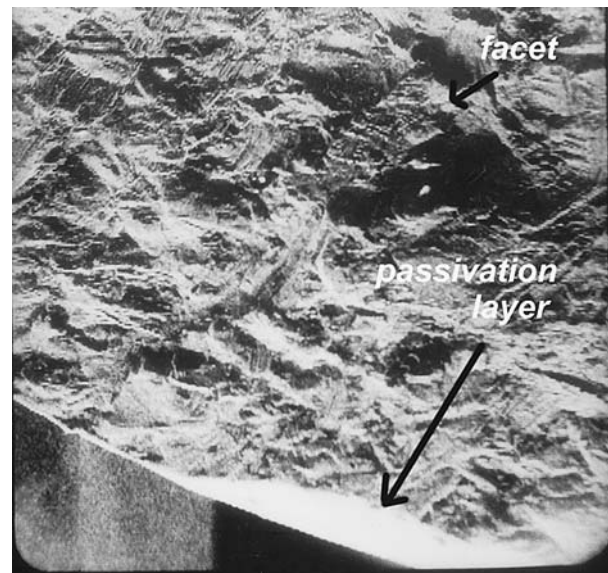
The fatigue fractured surface of a metallic component normally consists of two distinct regions [6, 7]. The relatively smooth region is characterized by the so-called striation or ripple marks as shown in Fig. 3 [7]. These marks indicate the various positions at which the crack was arrested as it propagates intermittently through the component in response to the varying load. The second region is either granular or fibrous in appearance. The markings in this region often allow the origin (or origins) of the fracture to be located,

Fig. 3 Photograph showing the passivation layer (outer surface) in the lower area of the stem (magnification $\times 200$)

It can also be stated that there are no abnormally coarse crystals, no large non-metallic inclusions or inclusion agglomeration, neither undissolved master alloy particles nor gas porosity from which fracture could have been initiated. The passivation layer can also be seen in point 4 (Fig. 2) of the stem, (Fig. 3), which is a metal oxide layer giving anti-corrosion protection and is well preserved, even 28 years post-implantation.

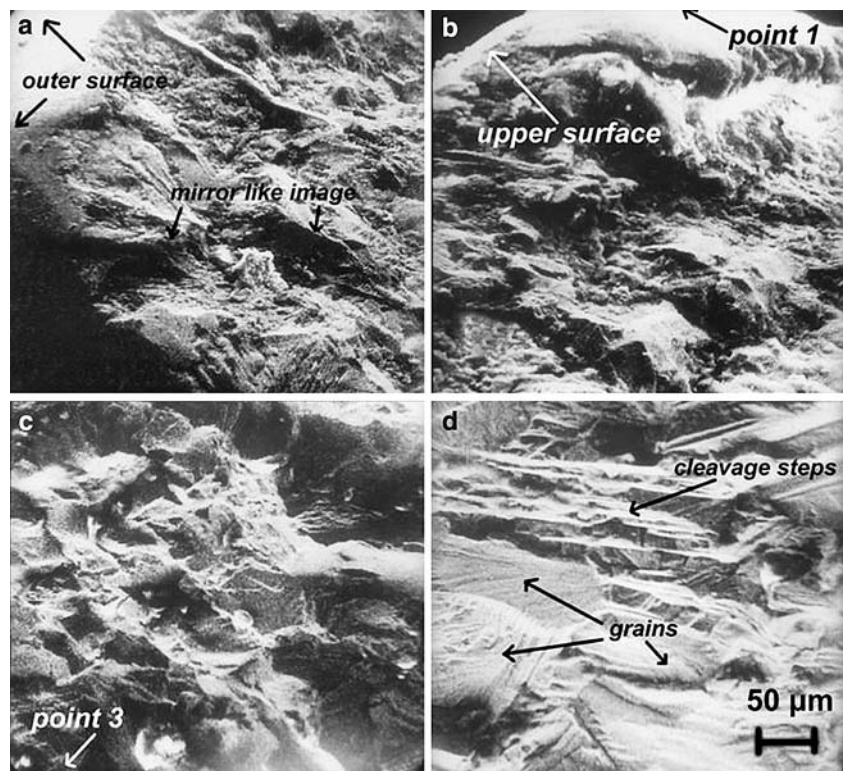
In the present fractographs, it can be seen that there is no typical type of failure but, as described at the beginning, the brittle component of fracture predominates. In addition, there are very few intrinsic structural defects (metallurgical inclusions) in the material (Fig. 4C) that may have not contributed to it failing. The initiation site of the crack in the posterosuperior area can also be seen as expected, due to the magnitude of the alternating (tensile) loads that causes it to fail from the outer surface in a centripetal trajectory. For instance, in the points indicated by arrows in Fig. 4A and also in Fig. 5A of the stem there is a localized mirror-like zone of initiation of a brittle microfracture [8]. This point is located in the posterosuperior zone of the stem, the area of maximum tensile stress. At the same point a large dimple can be depicted, in a point just below the outer surface, where the fracture propagation has started (Fig. 5A). Furthermore, in area 2-1 (Figs. 2 and 4B) where the bending moment is being applied, there is a region dominated by tensile stresses in which mostly a brittle fracture occurs. On the other hand in point 3 of the

stem (Figs. 2 and 4C) the appearance of the fracture surface changes and becomes more ductile one in the sense that compressive forces, may cause even, a more smooth-type of ductile fracture (See arrow in point 3 (Figs. 2 and 4C)). The same occurs at the lower part of the stem because although at the point of tensile failure, there is an abrupt brittle initiation, at point 3 (Fig. 2) the material was found to fail in compression. In point 5 of the stem, (Figs. 2 and 4D) two grains can be seen and a number of distinct cleavage steps within them. Cleavage steps represent characteristic fractographic features of a transgranular (intragranular) brittle mode of fracture and are created within a grain of the polycrystalline material in the direction of weakest crystallographic resistance during fracture propagation. In this aspect, the microfailure behavior was transgranular (Fig. 5B) mixed-mode (Fig. 5C) and intergranular (Fig. 5D).

Fig. 4 (A) Area of initiation of a fracture in the posterosuperior area of the stem (magnification $\times 200$). (B) Area in the upper surface of the stem revealing no metallurgical defects (magnification $\times 200$). (C) Area in the middle of the broken surface, mostly with a brittle type of failure but with a ductile component as well (magnification $\times 200$). (D) Photograph showing two grains and a number of cleavage steps between them (brittle fracture) (magnification $\times 300$)

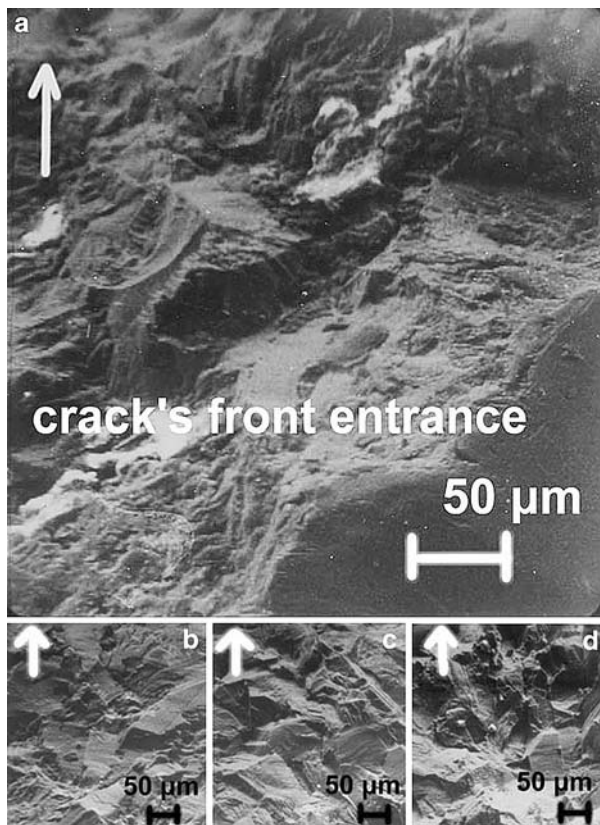
Fig. 5 (A) Initiation site of crack propagation (crack front entrance) with high magnification ($\times 300$). (B) Transgranular dominated propagation (magnification $\times 200$). (C) Mixed-mode of crack propagation (magnification $\times 200$). (D) Intergranular dominated crack propagation (magnification $\times 200$). White arrow in A–D pictures, indicates the direction of crack propagation
