Natural weathering of polyester filaments

J. W. S. HEARLE
B. LOMAS

Department of Textile Technology,
University of Manchester,
Institute of Science and Technology,
Manchester, UK

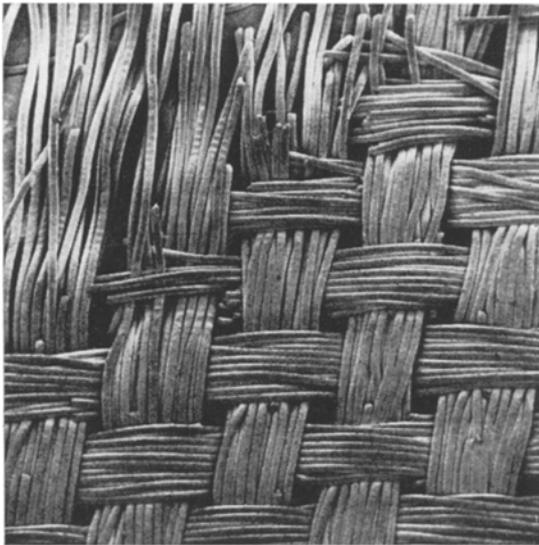
Figure 1 Torn region at edge of fabric ($\times 55$).

Portions of the burgees were examined in the Cambridge Stereoscan scanning electron microscope. The surface of the filaments in the yellow fabric was found to be highly pitted, and some of the filaments on the yarn crowns had broken (Figs. 1 and 2). It was observed that the flag did not tear preferentially in either the warp or weft direction (Fig. 1), but breakdown had resulted from general weakening of the fabric. The broken filaments had a very ragged and pitted appearance (Fig. 3), although there was some evidence of the broken ends beginning to be rounded off, in a way similar to that observed in worn garments made from polyamide and polyester yarns. There were indications of loss of material at some distance along the filaments from the broken ends. Fig. 4 shows such a region of reduction in filament diameter, where the filament would be very susceptible to breakdown, and is taken several fibre diameters back from the broken filament end shown in Fig. 3. Examination of the filaments at higher magnifications showed that besides holes and

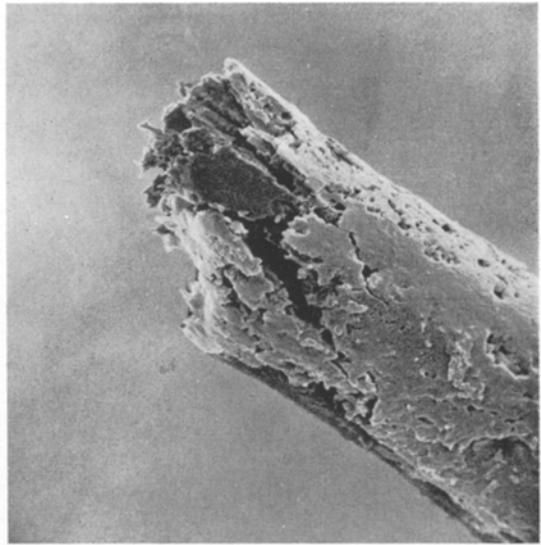
Figure 3 Broken end of filament ($\times 1590$).

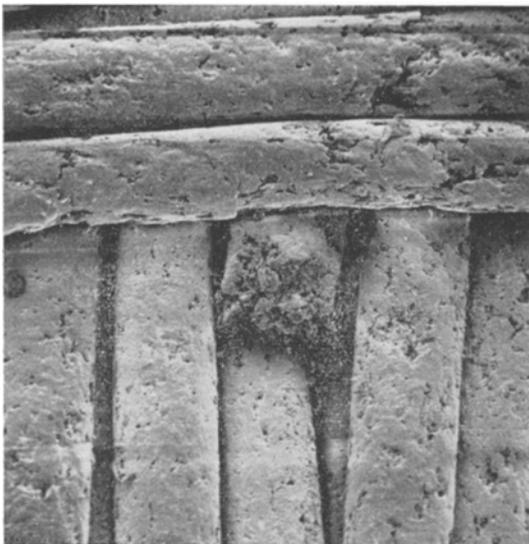
Figure 2 Surface of crowns, showing broken filament ($\times 710$).

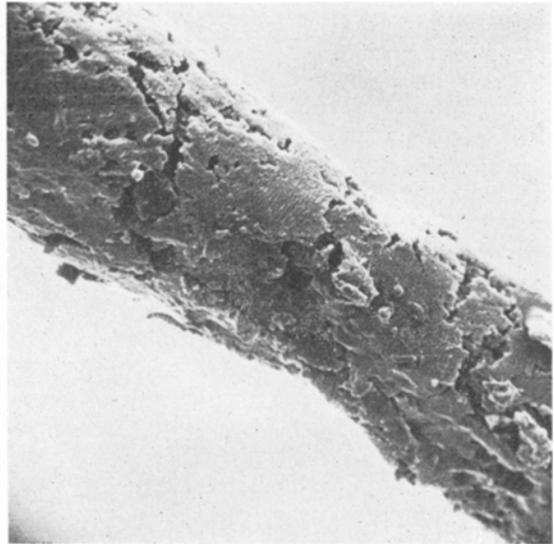
Figure 4 Region slightly away from broken end ($\times 1700$).

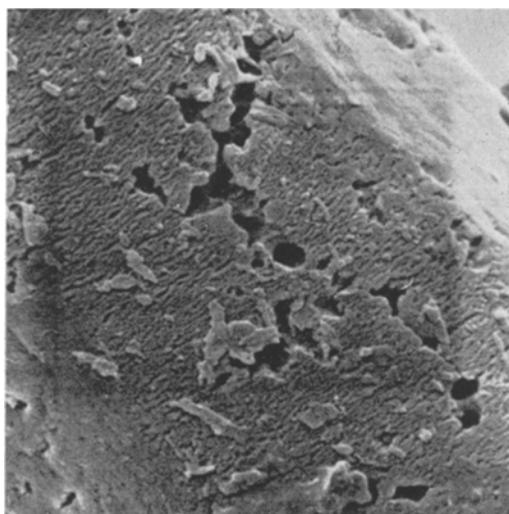
Figure 5 Crazing of filament surface ($\times 4700$).

crevices, the filament surfaces frequently showed many cracks perpendicular to the fibre axis (Fig. 5). However, where filaments were in contact with one another, these surfaces had a smoother appearance but still contained holes and crevices.

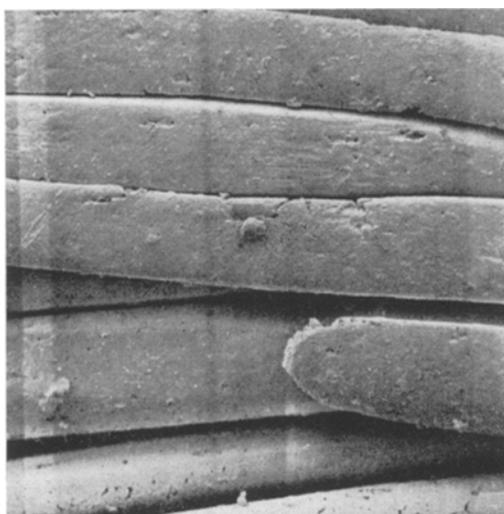
Figure 6 Crown of blue burgee showing some pitting and cracking ($\times 860$).

The lower level of damage in the blue burgee, which had not been used quite as much as the yellow one, is shown in Figure 6. This is similar in type, but no fine crazing of the surface of the filaments was observed. There was also evidence of a fungus growth on the yarns but not of actual damage to the filaments.
